BS5837 2012 Trees in Relation To Design, Demolition and Construction

39 Evelyn Avenue
Ruislip
HA4 8AR

PBA Ref: Q14659

Report Date: 31st January 2025

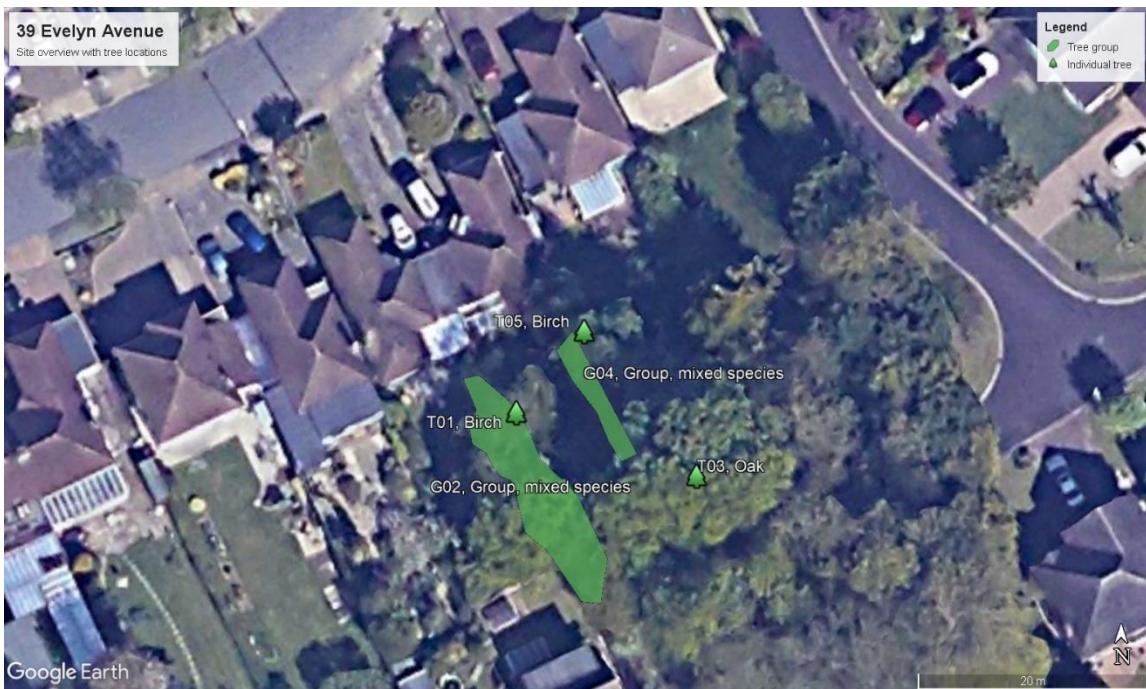
Figure 1 – Site overview showing tree locations

2.2.3 Trees T01 and T05 are early mature birch trees located close to the proposed development. The proposed extension footing is situated outside of the RPAs of these trees. There is a risk of damage to these trees and their rooting systems from the development process.

2.2.4 T03 is a mature oak tree located in the grounds of number 37. This tree is considered to be of high amenity value. The proposed extension footing is situated outside of the RPA of this tree. There is a risk of damage to this tree and its rooting systems from the development process.

2.2.5 Groups G02 and G04 are boundary trees, consisting predominantly of laurel, rhododendron and leylandii which have been reduced historically. There is a risk of damage to these trees and shrubs and their rooting systems from the development process.
