### **Arboricultural Impact Assessment** **(in accordance with BS:5837 2012)**

**Land adjacent to 442 Victoria Road**  
**Ruislip, HA4 0EU**

Date: 26<sup>th</sup> February 2020

Ref: TH 2281

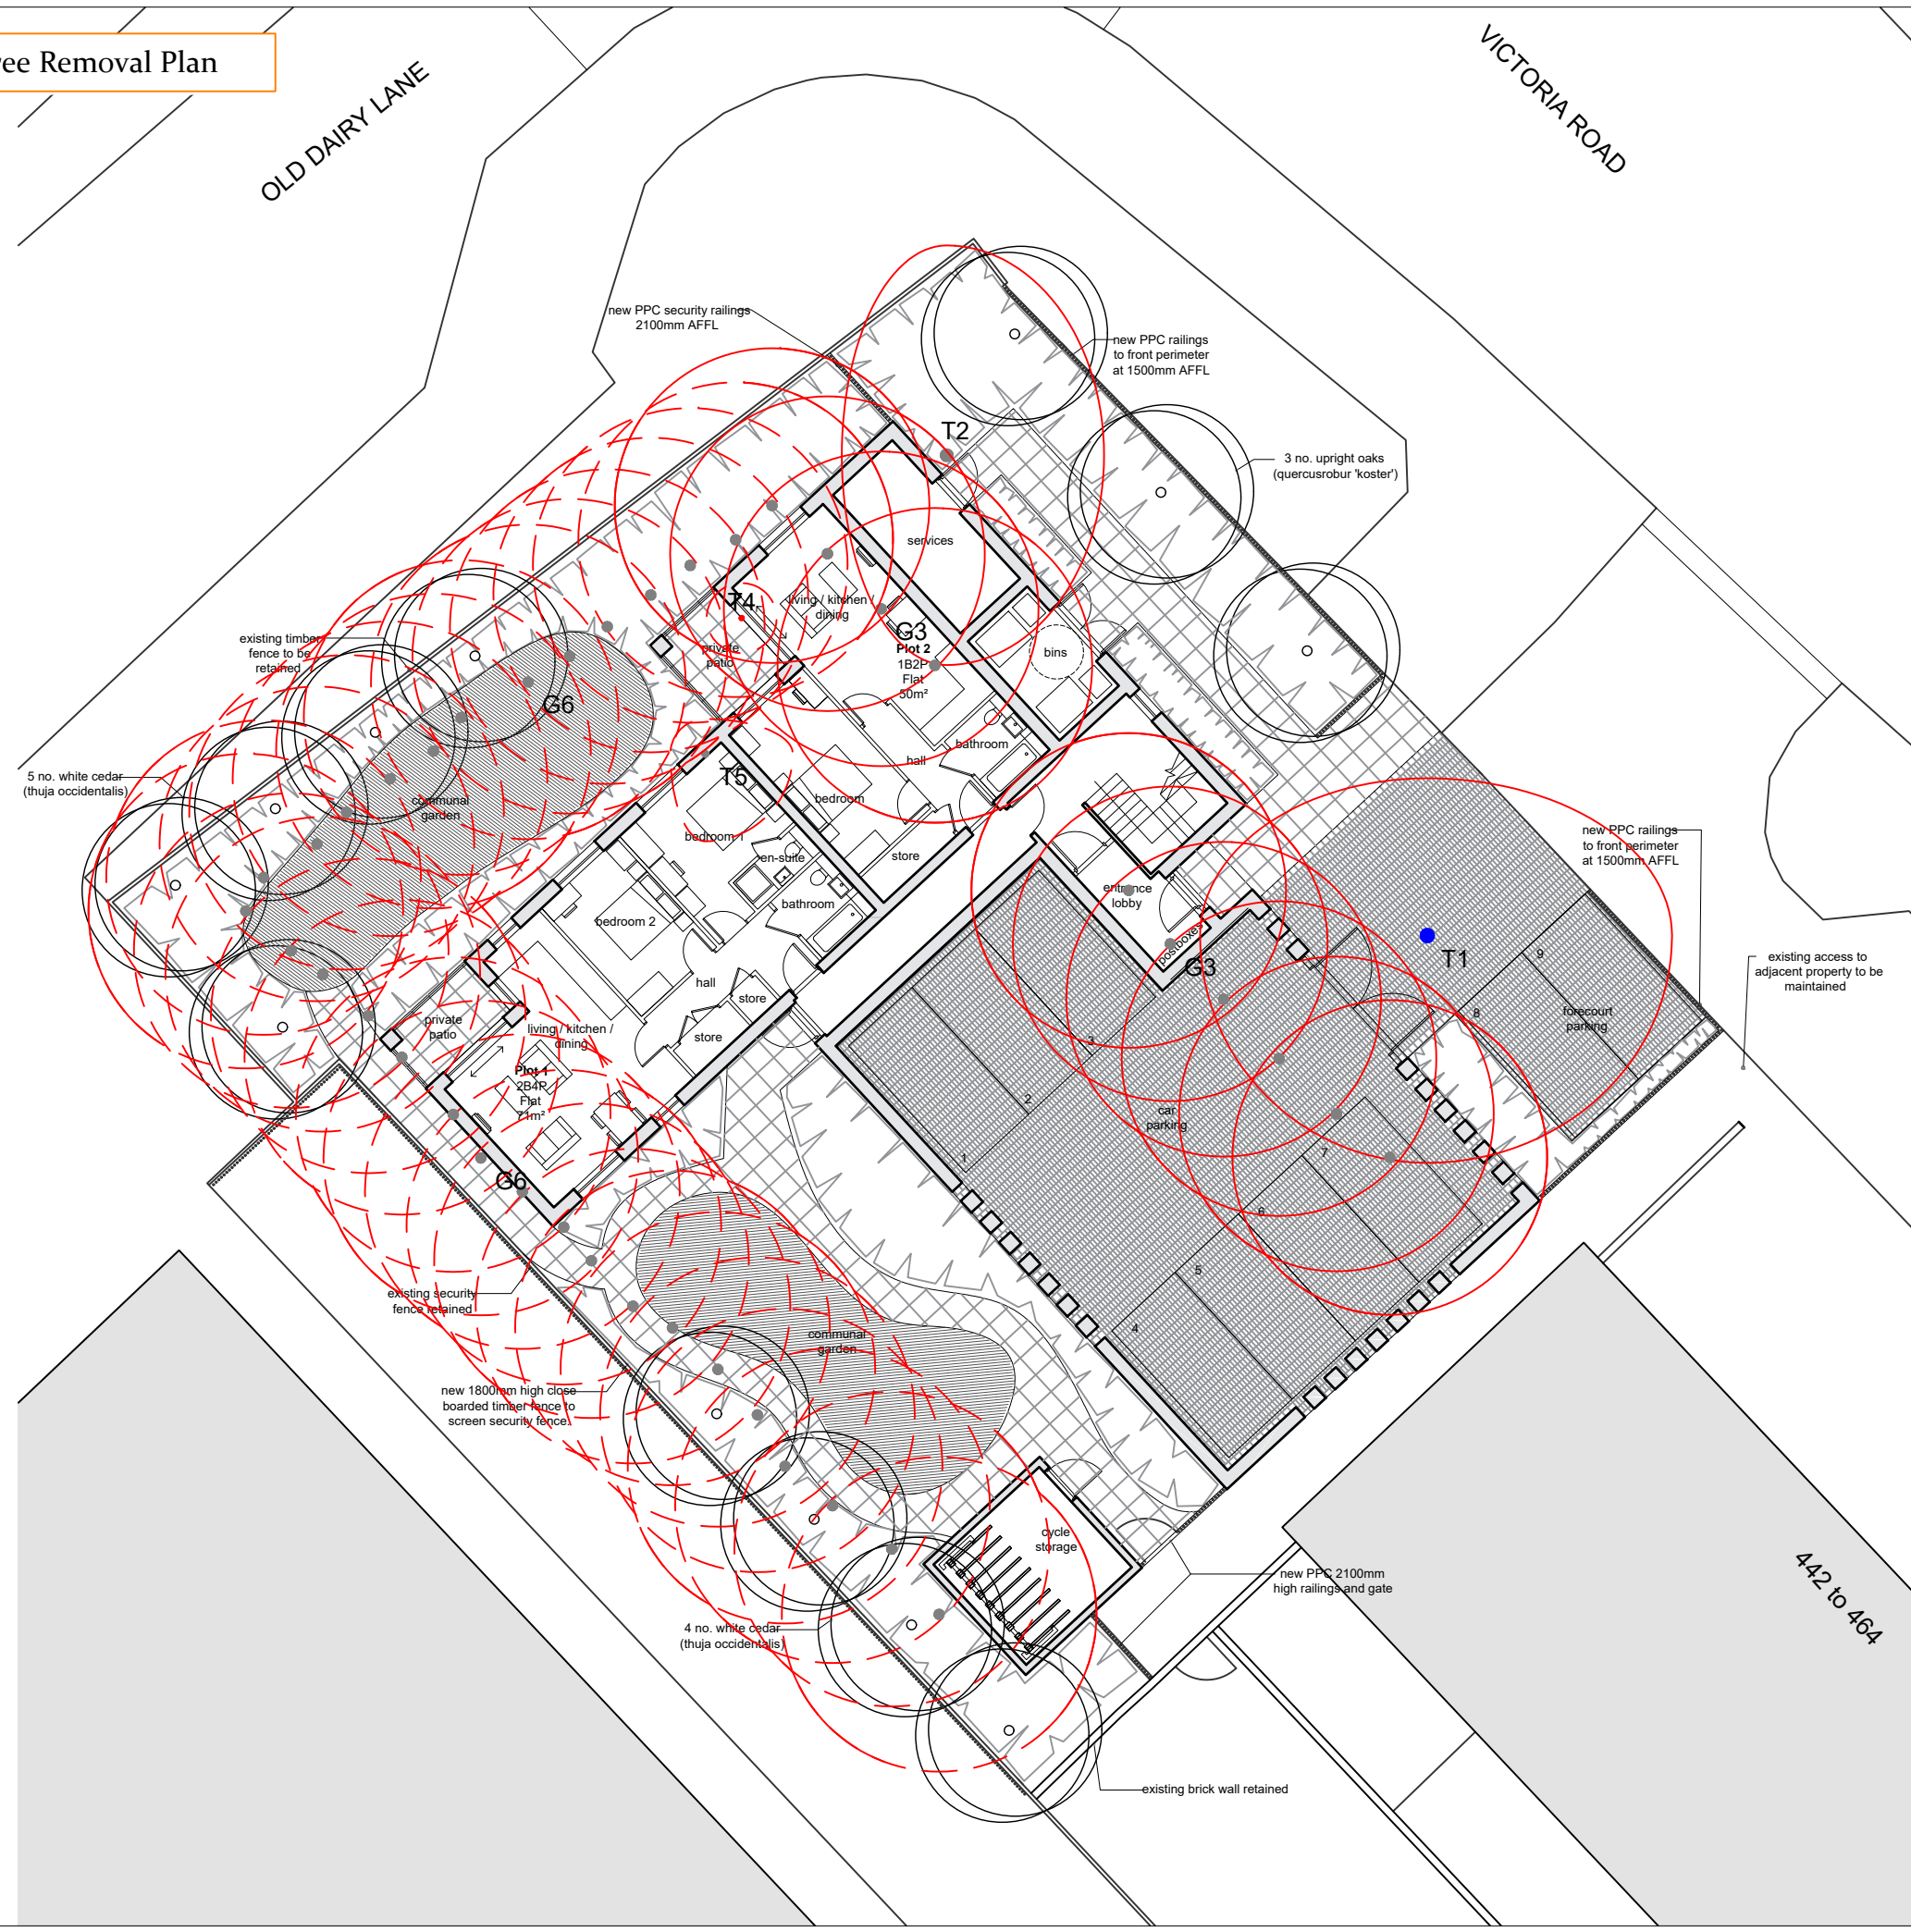
Appendix 4: Tree Removal Plan

9.3.2 The only tree of any significance is the Norway Maple T1. It is mature and reasonably large; however, it has lost a major limb on its northern side in the past, and now has a large wound on the northern side of its main stem. It also has an asymmetrical crown.

9.3.3 The other three trees are all Cherry's, but these are all in a poor, suppressed condition with a limited life expectancy.

9.3.4 The Leyland hedge that runs through the site and also around the north-western and south-western boundaries is suffering from Coryneum Canker and is declining. Subsequently, the hedge is very sparse, dying back in places and detracts from the amenity of the local area.

9.3.1 All of the existing trees and hedges within this site will need to be removed to facilitate development. Further information is provided below:
