Arboricultural Impact Assessment Report

CLIENT: Mr B. Berisha

SITE: 140 Linden Avenue, Ruislip, HA4 8UB

DATE OF REPORT: 2nd May 2024

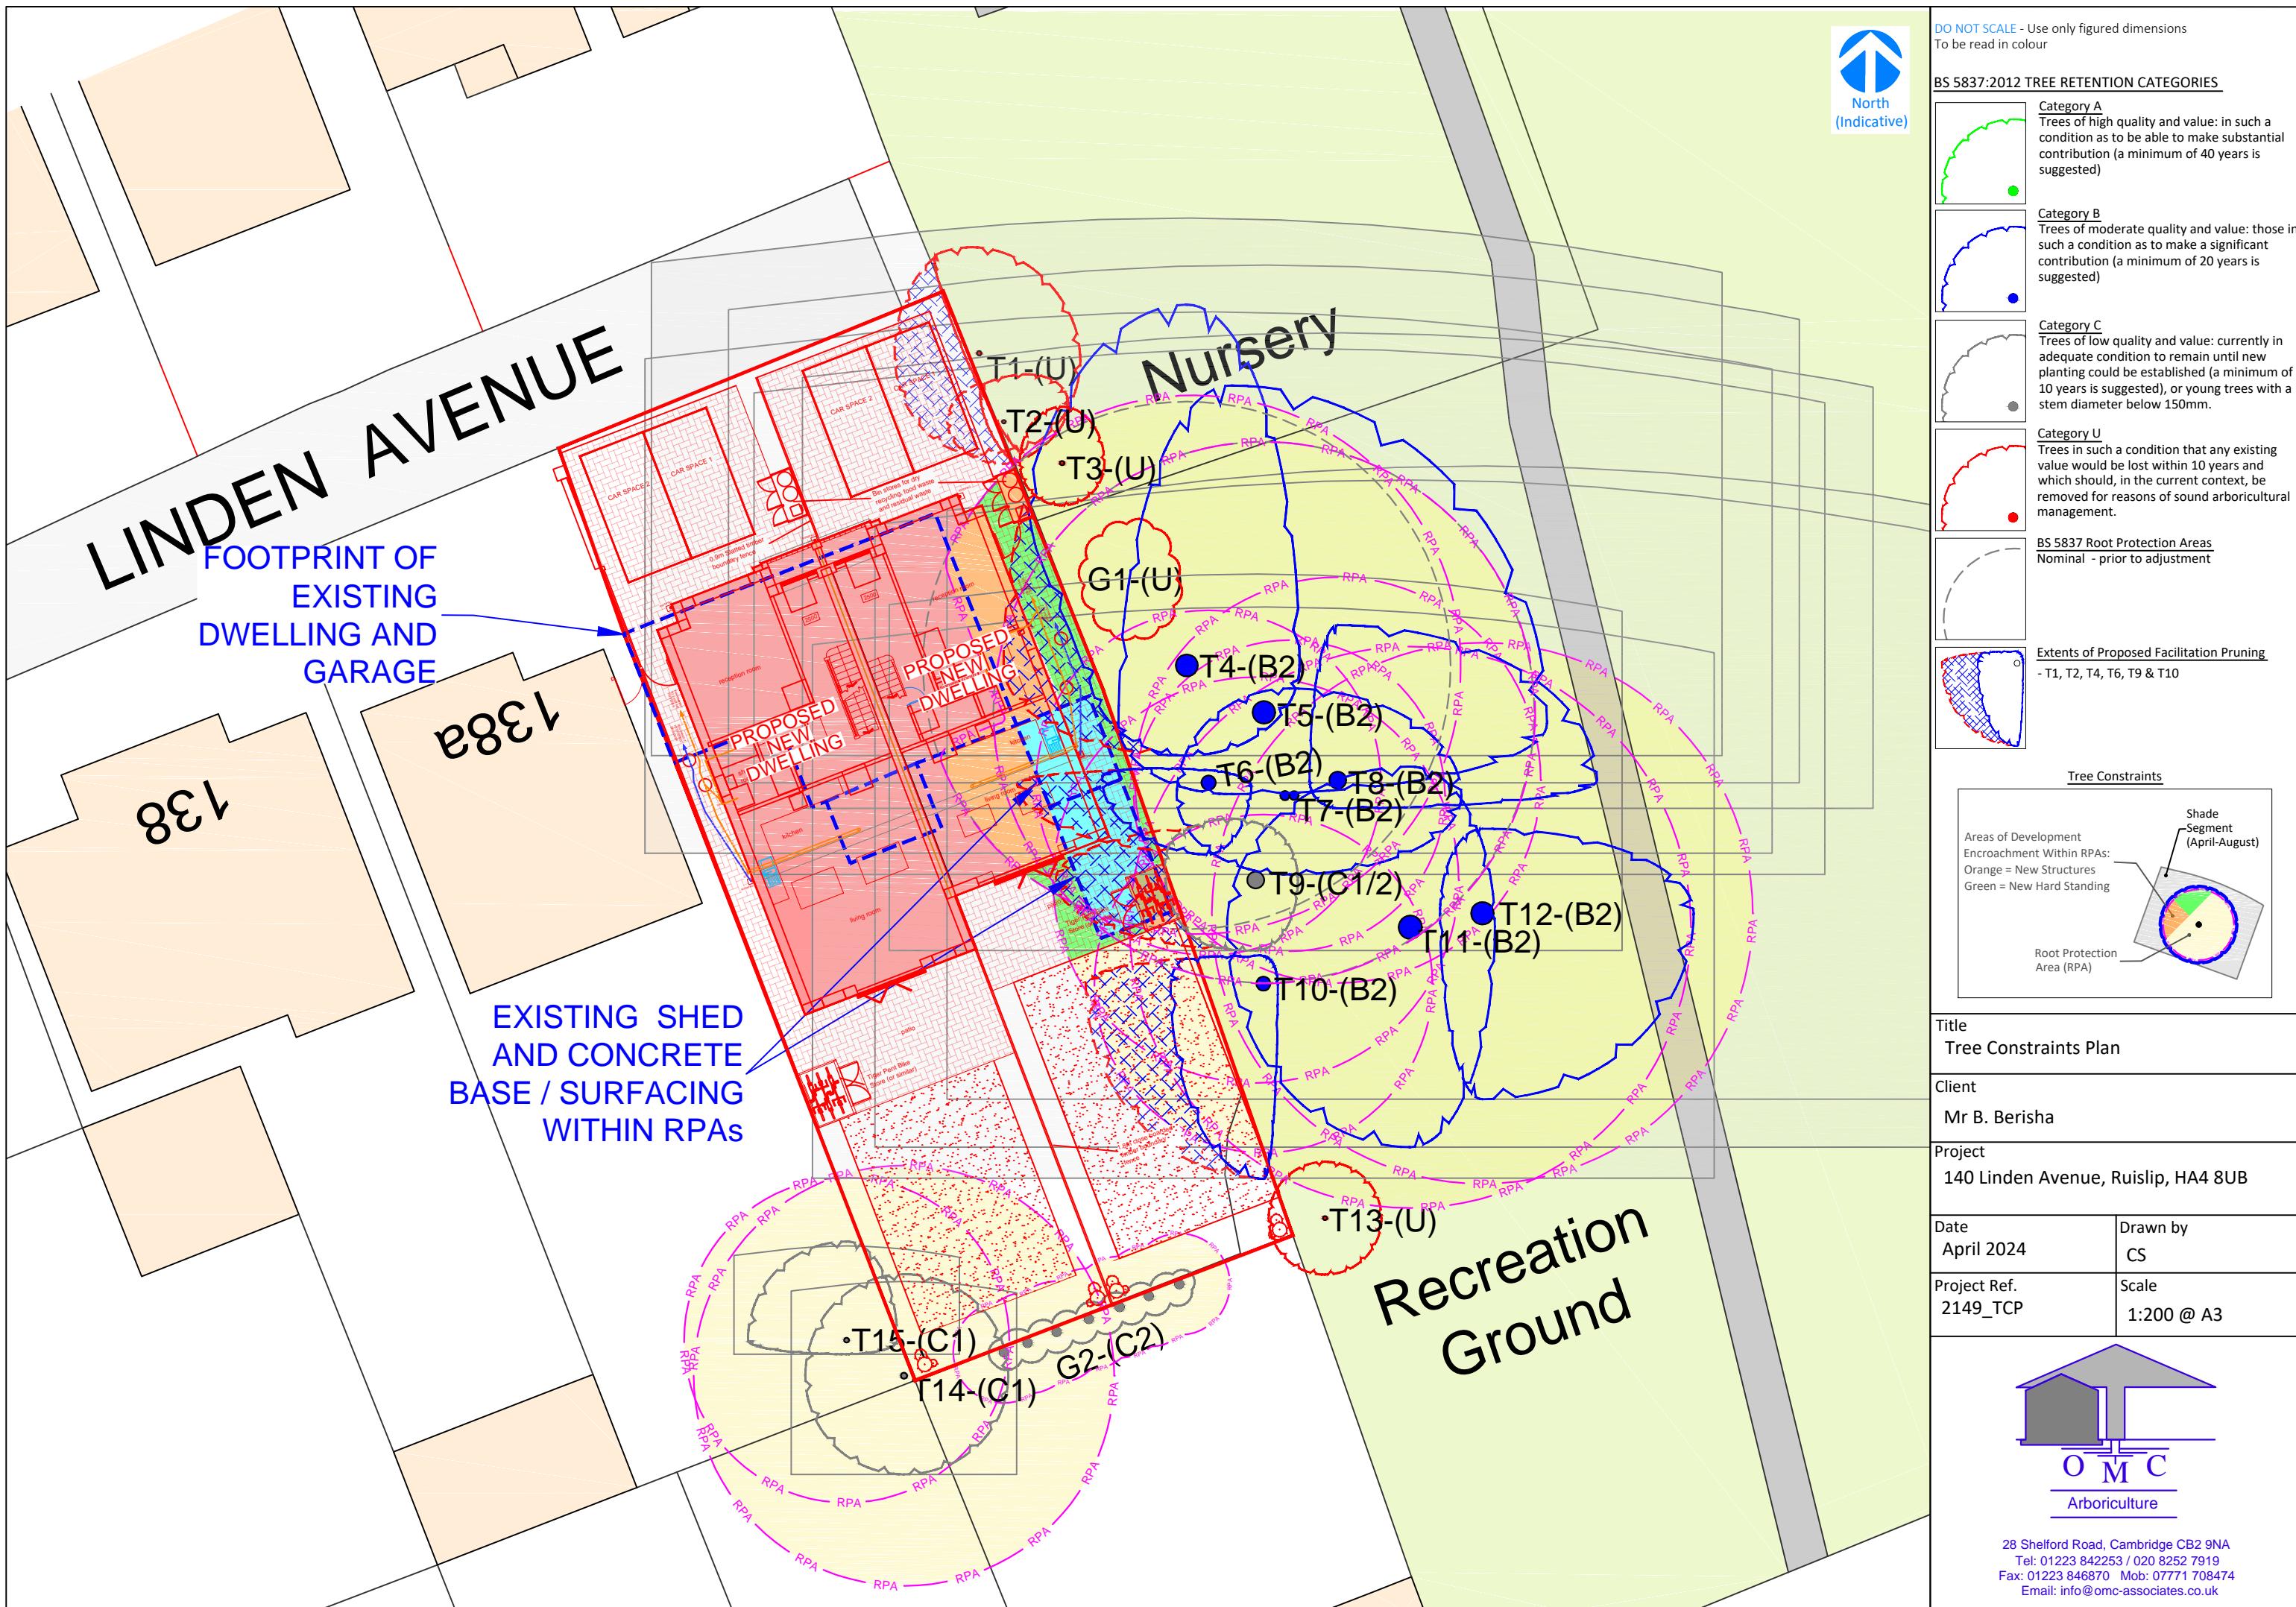
Appendix 3 Tree Constraints Plan

The 2012 British Standard calculation has been used to determine the extents of RPAs. Existing site conditions having the potential to influence the morphology and disposition of tree roots have also been accounted for when determining shape of RPAs. In this instance it is unlikely that any significant root presence will exist beneath the existing bungalow; the RPA of T4 and T5 have been adjusted accordingly. The RPAs of all surveyed trees, modified or otherwise, are illustrated within the Tree Constraints Plan at Appendix 3.

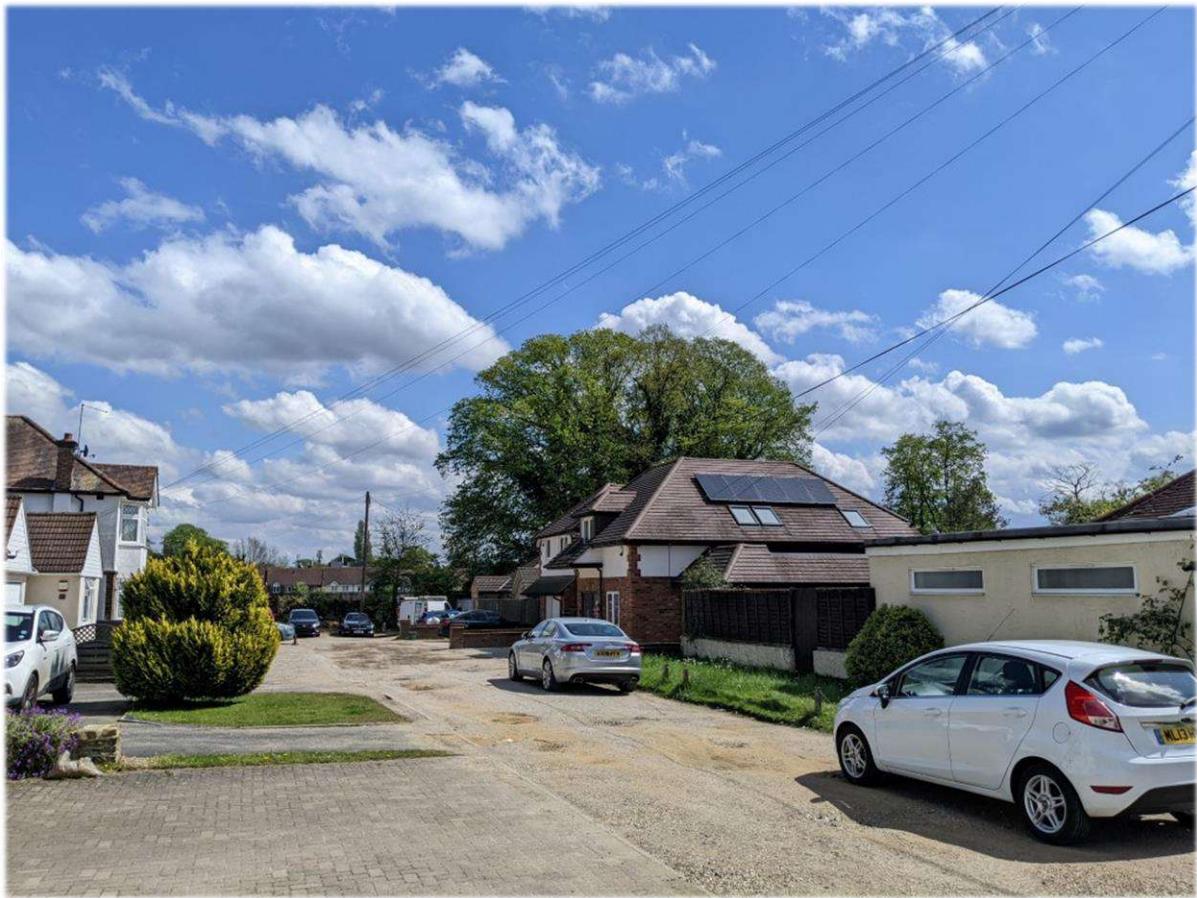
Above: view of the trees and site from the west

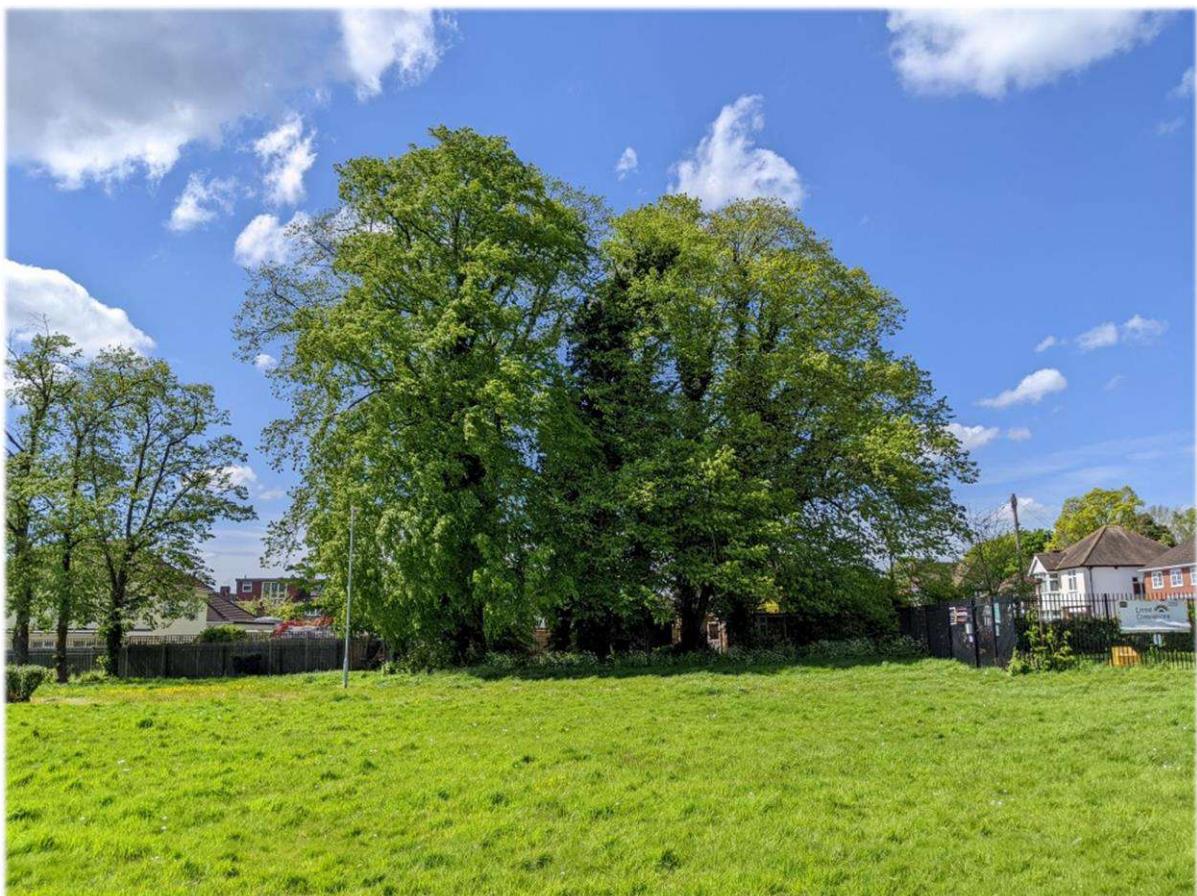
Below: view of trees from the east (Columbia Avenue Field)

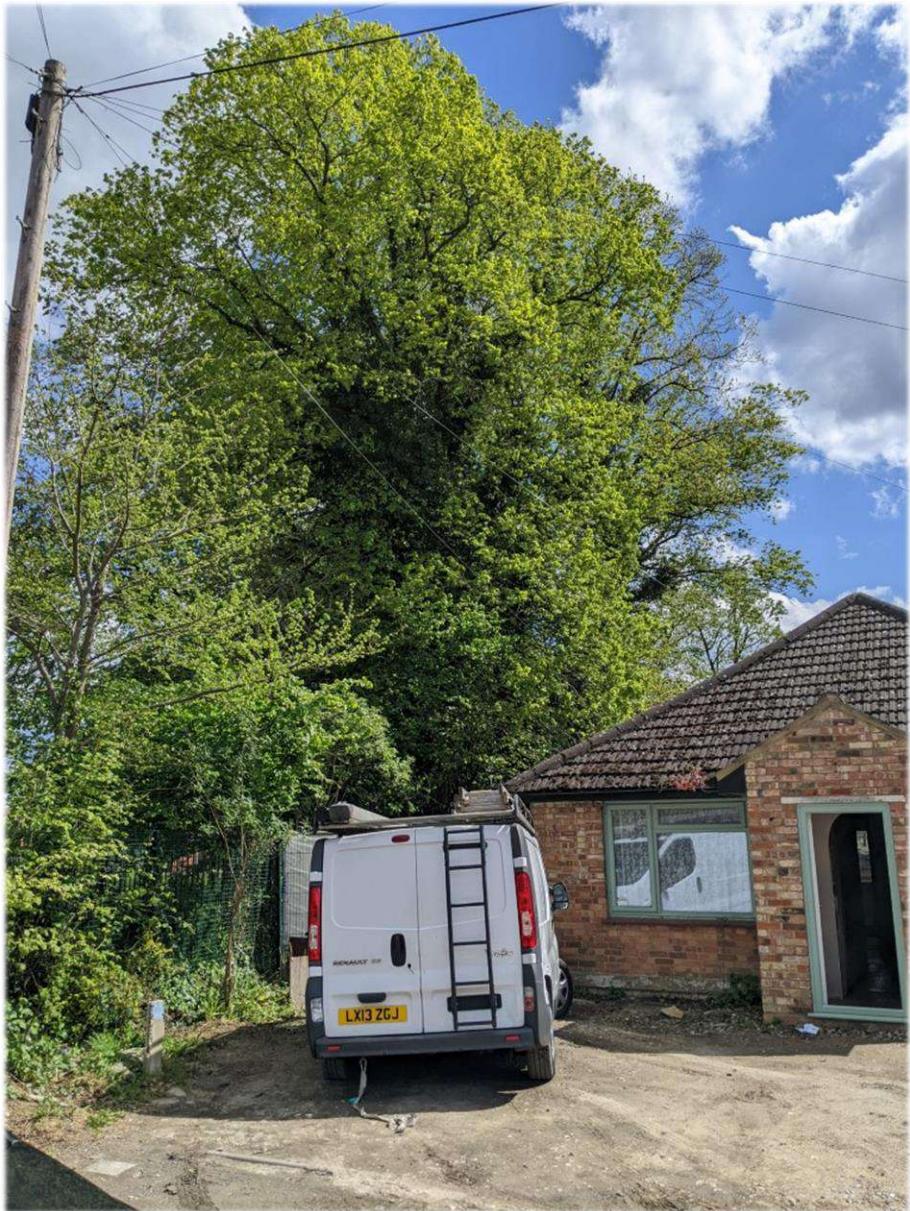
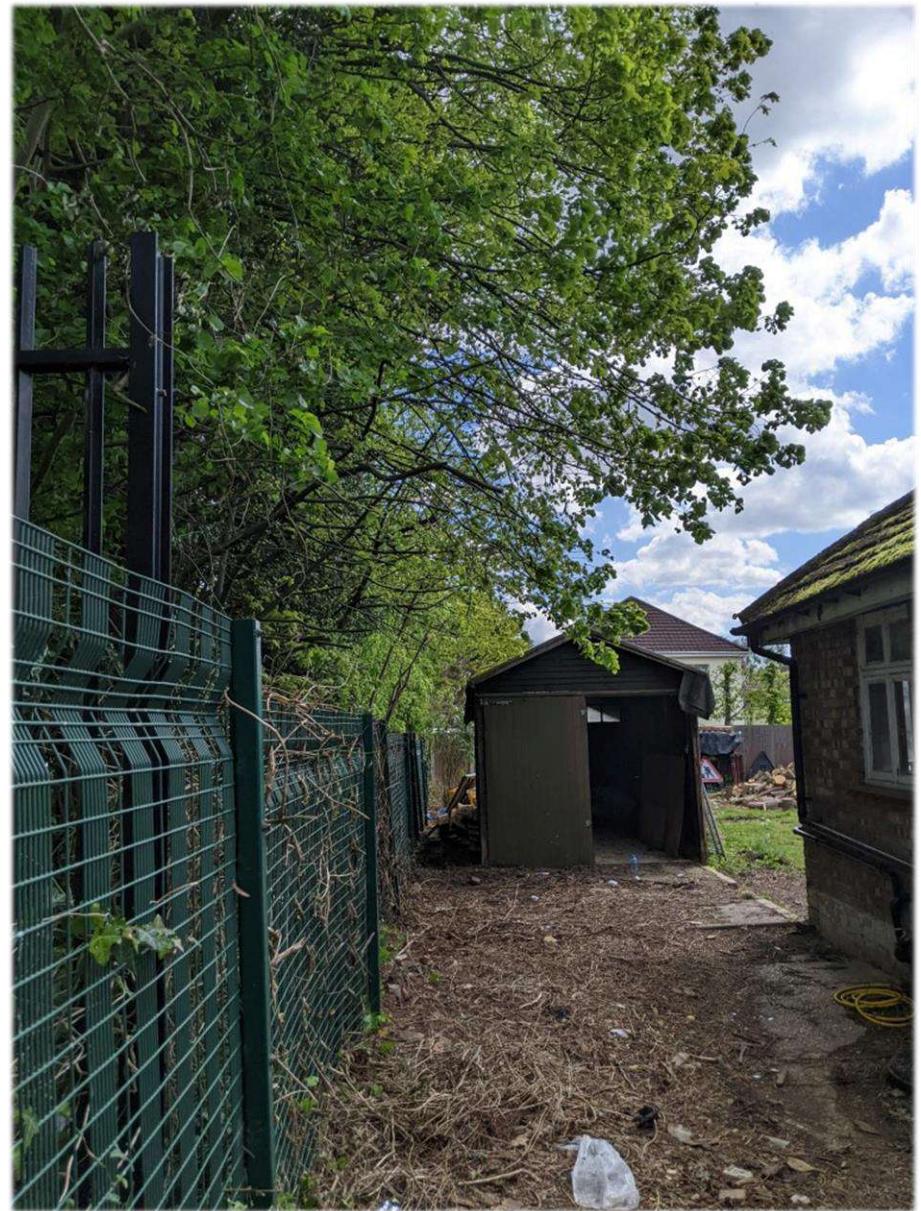
Above: view of the trees from outside the existing property and overhang within the garden

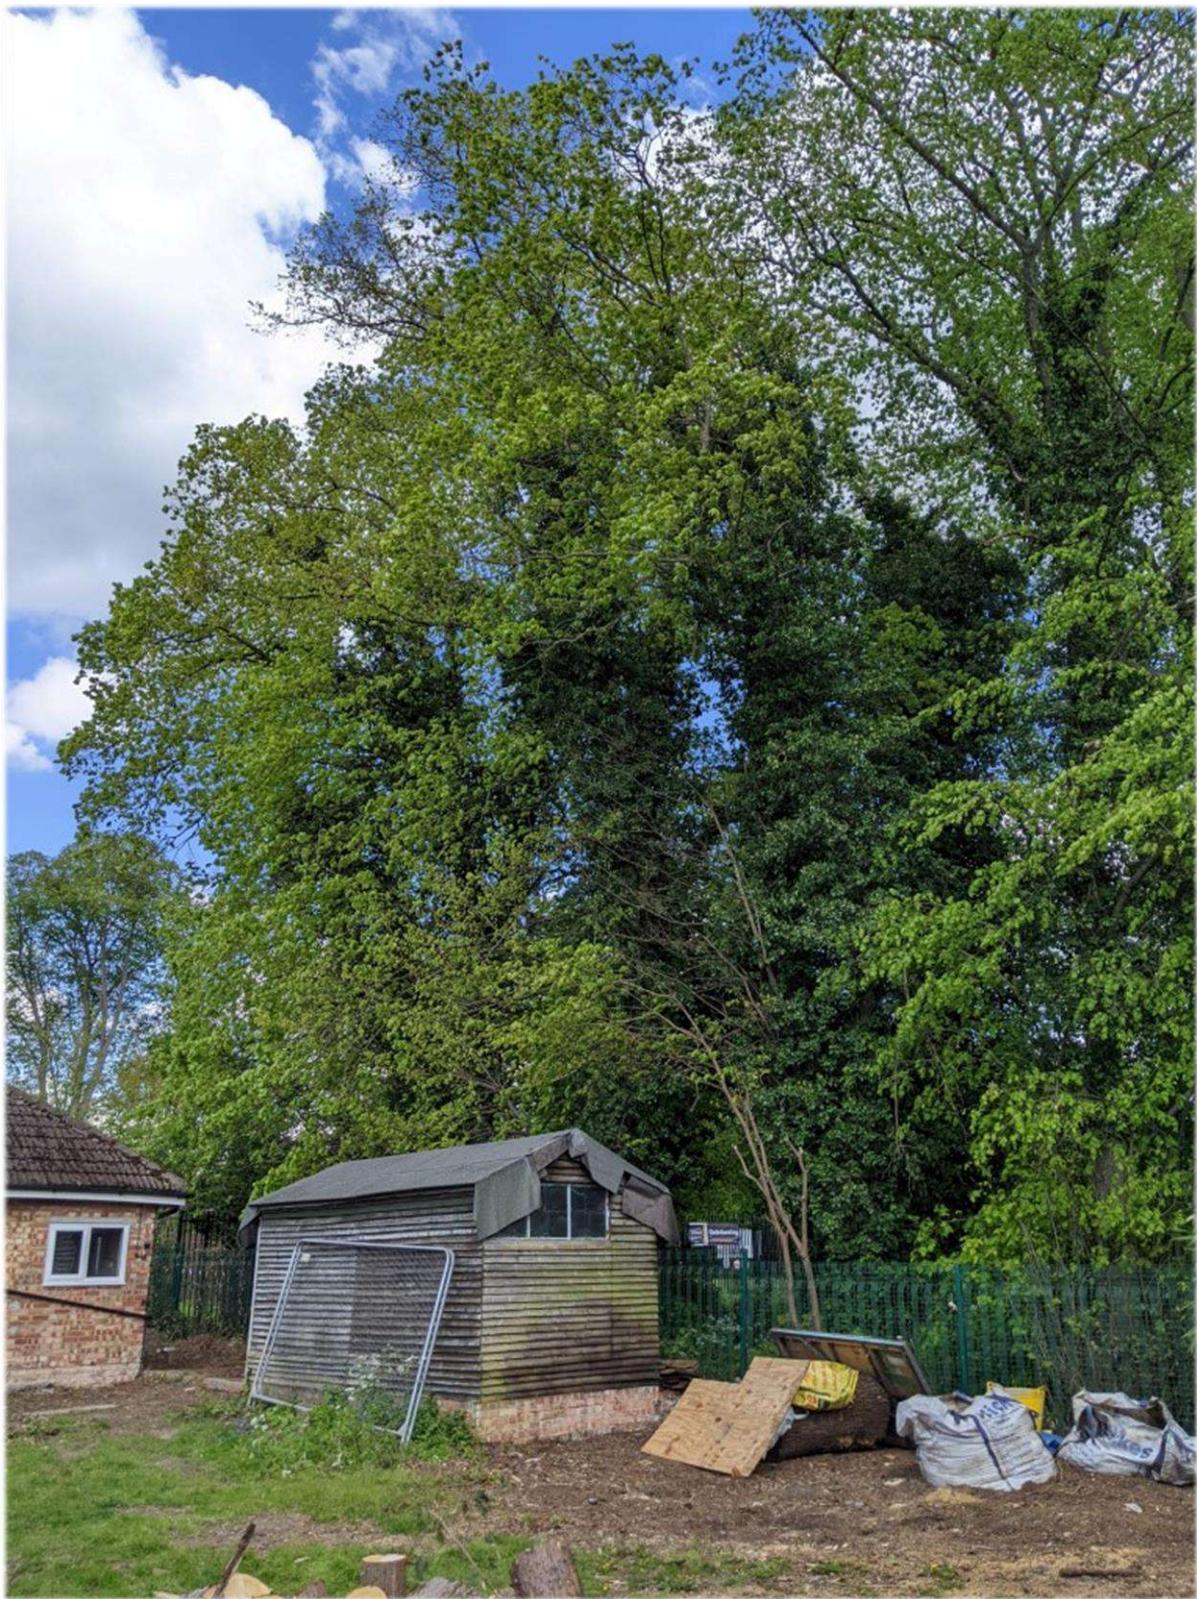
Above: view of the trees from the south western corner of the property's rear garden
