Arboricultural Impact Assessment Report

CLIENT: Mr B. Berisha

SITE: 140 Linden Avenue, Ruislip, HA4 8UB

DATE OF REPORT: 10th October 2024

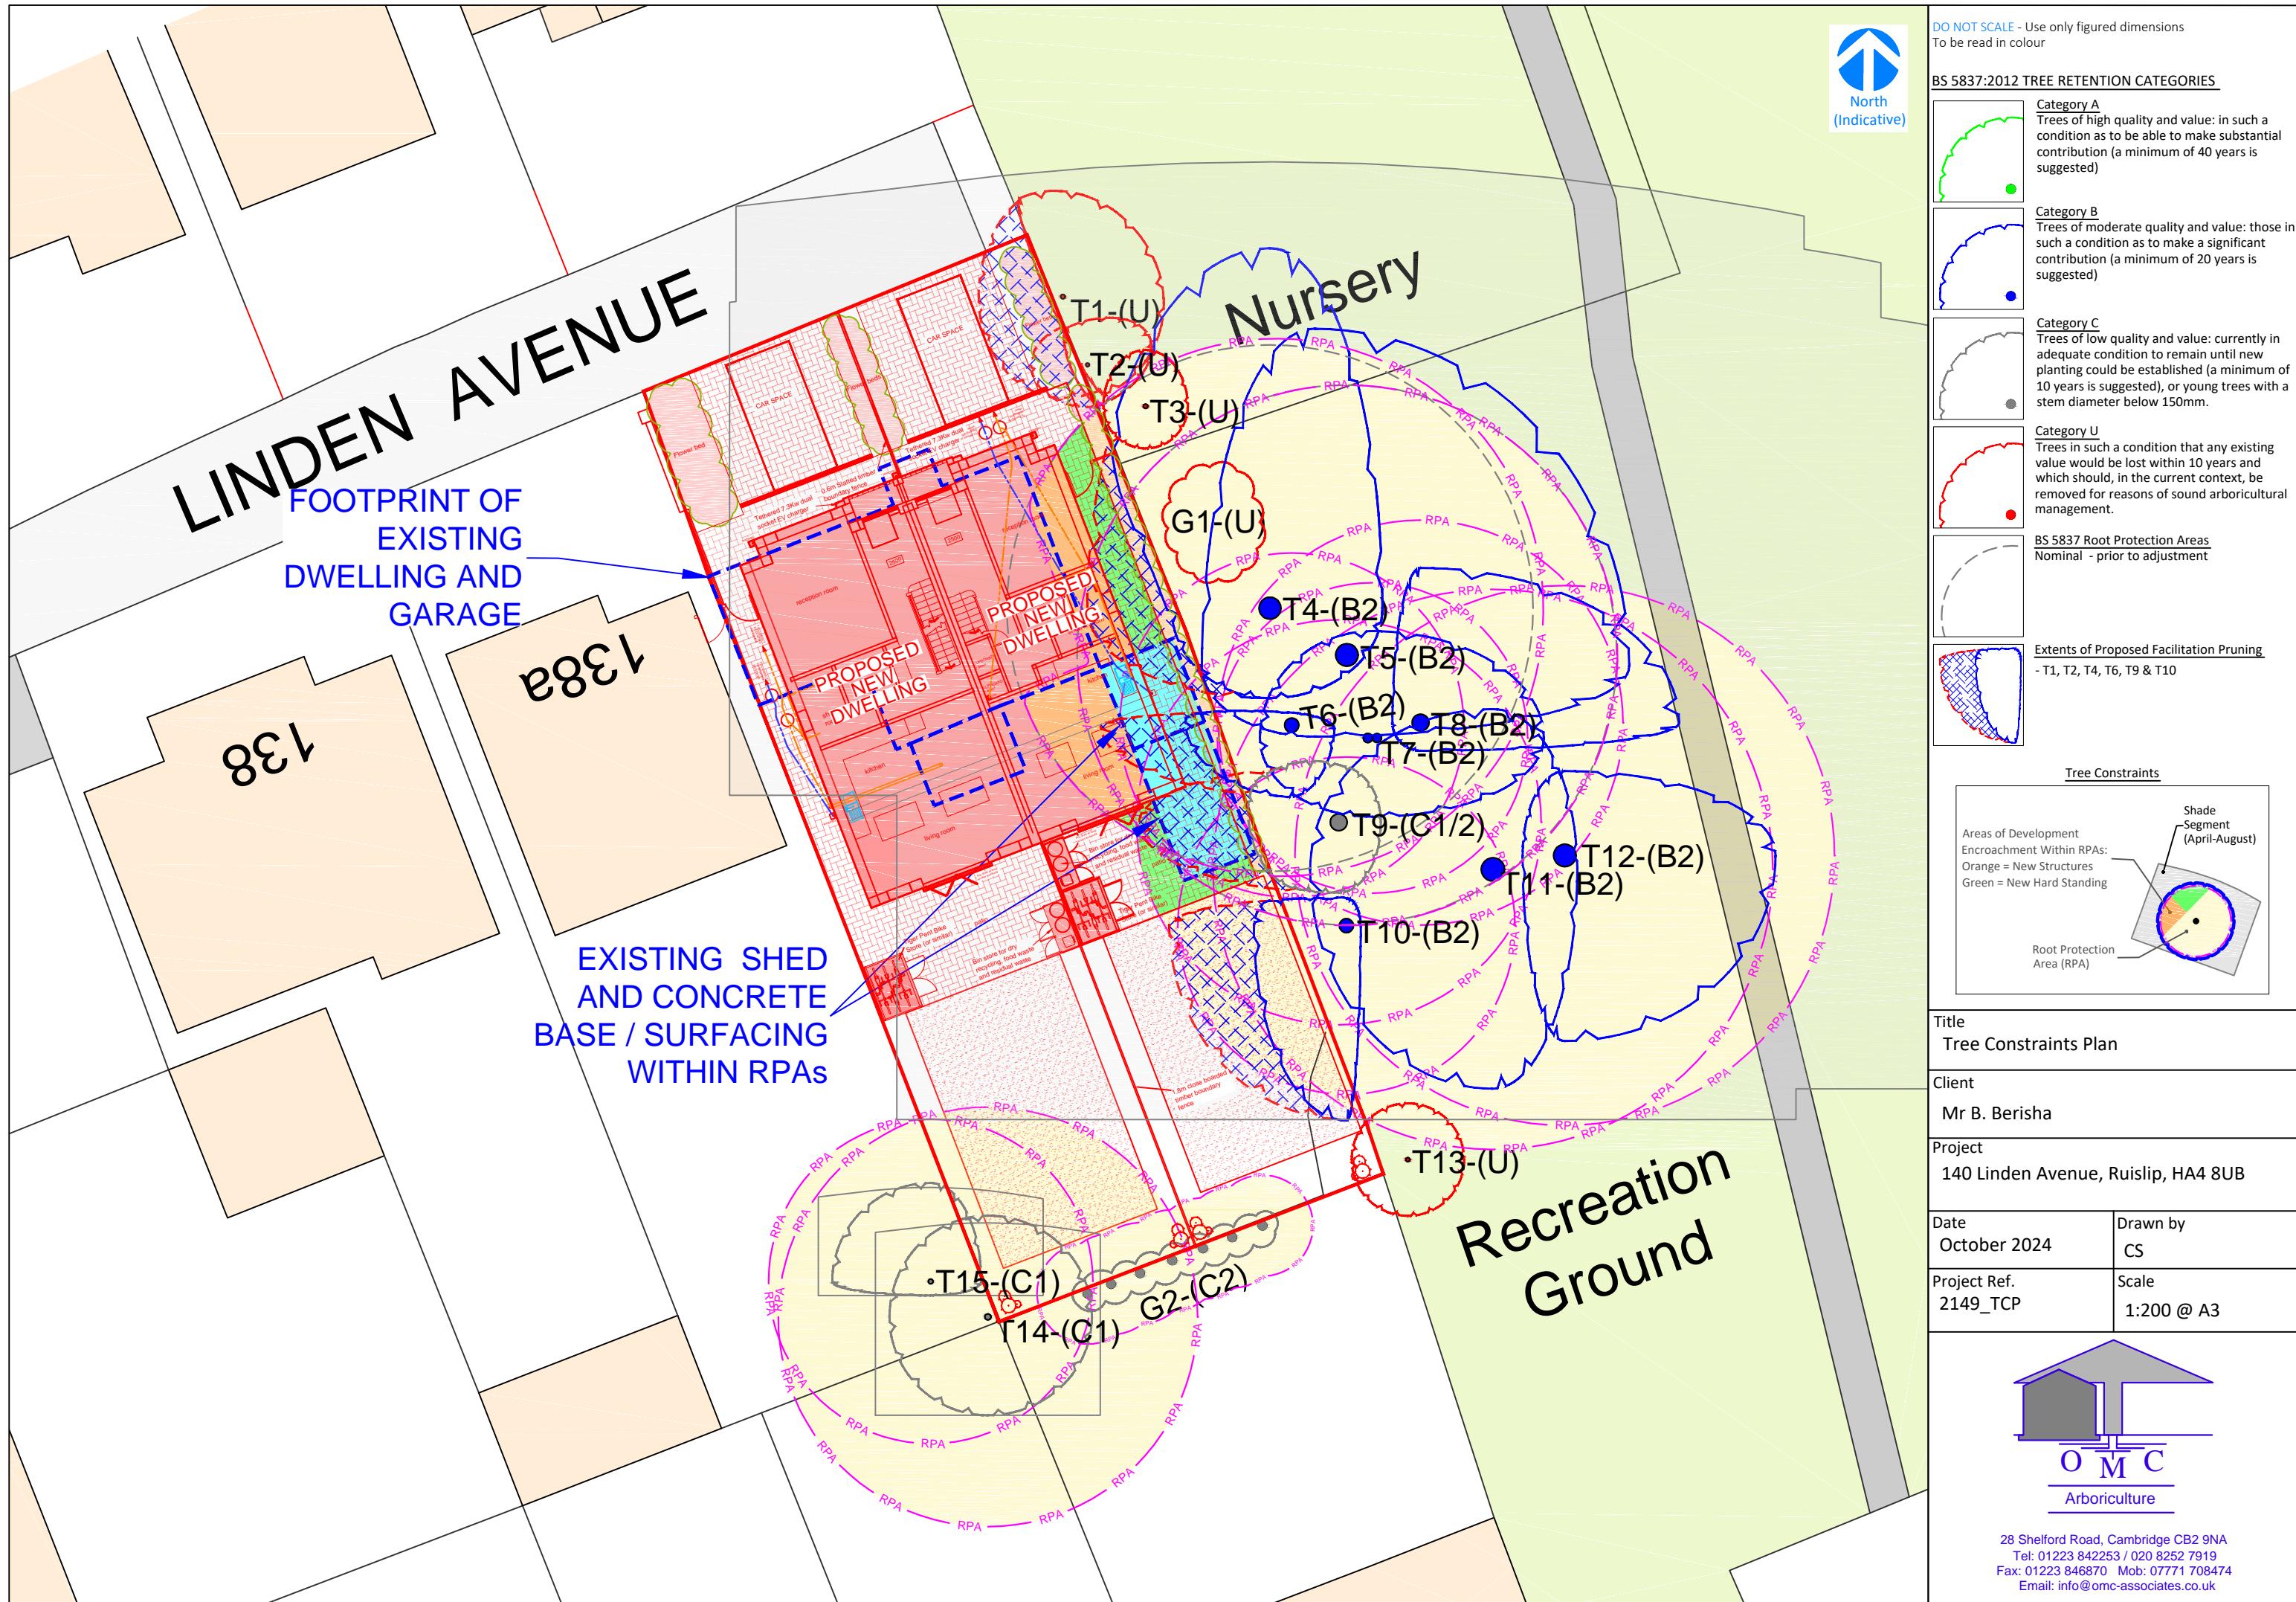
Appendix 3 Tree Constraints Plan

Appendix 3: A Tree Constraints Plan (TCP) indicating root protection areas (RPAs) of retained trees with the proposed scheme superimposed to indicate location and extent of encroachment

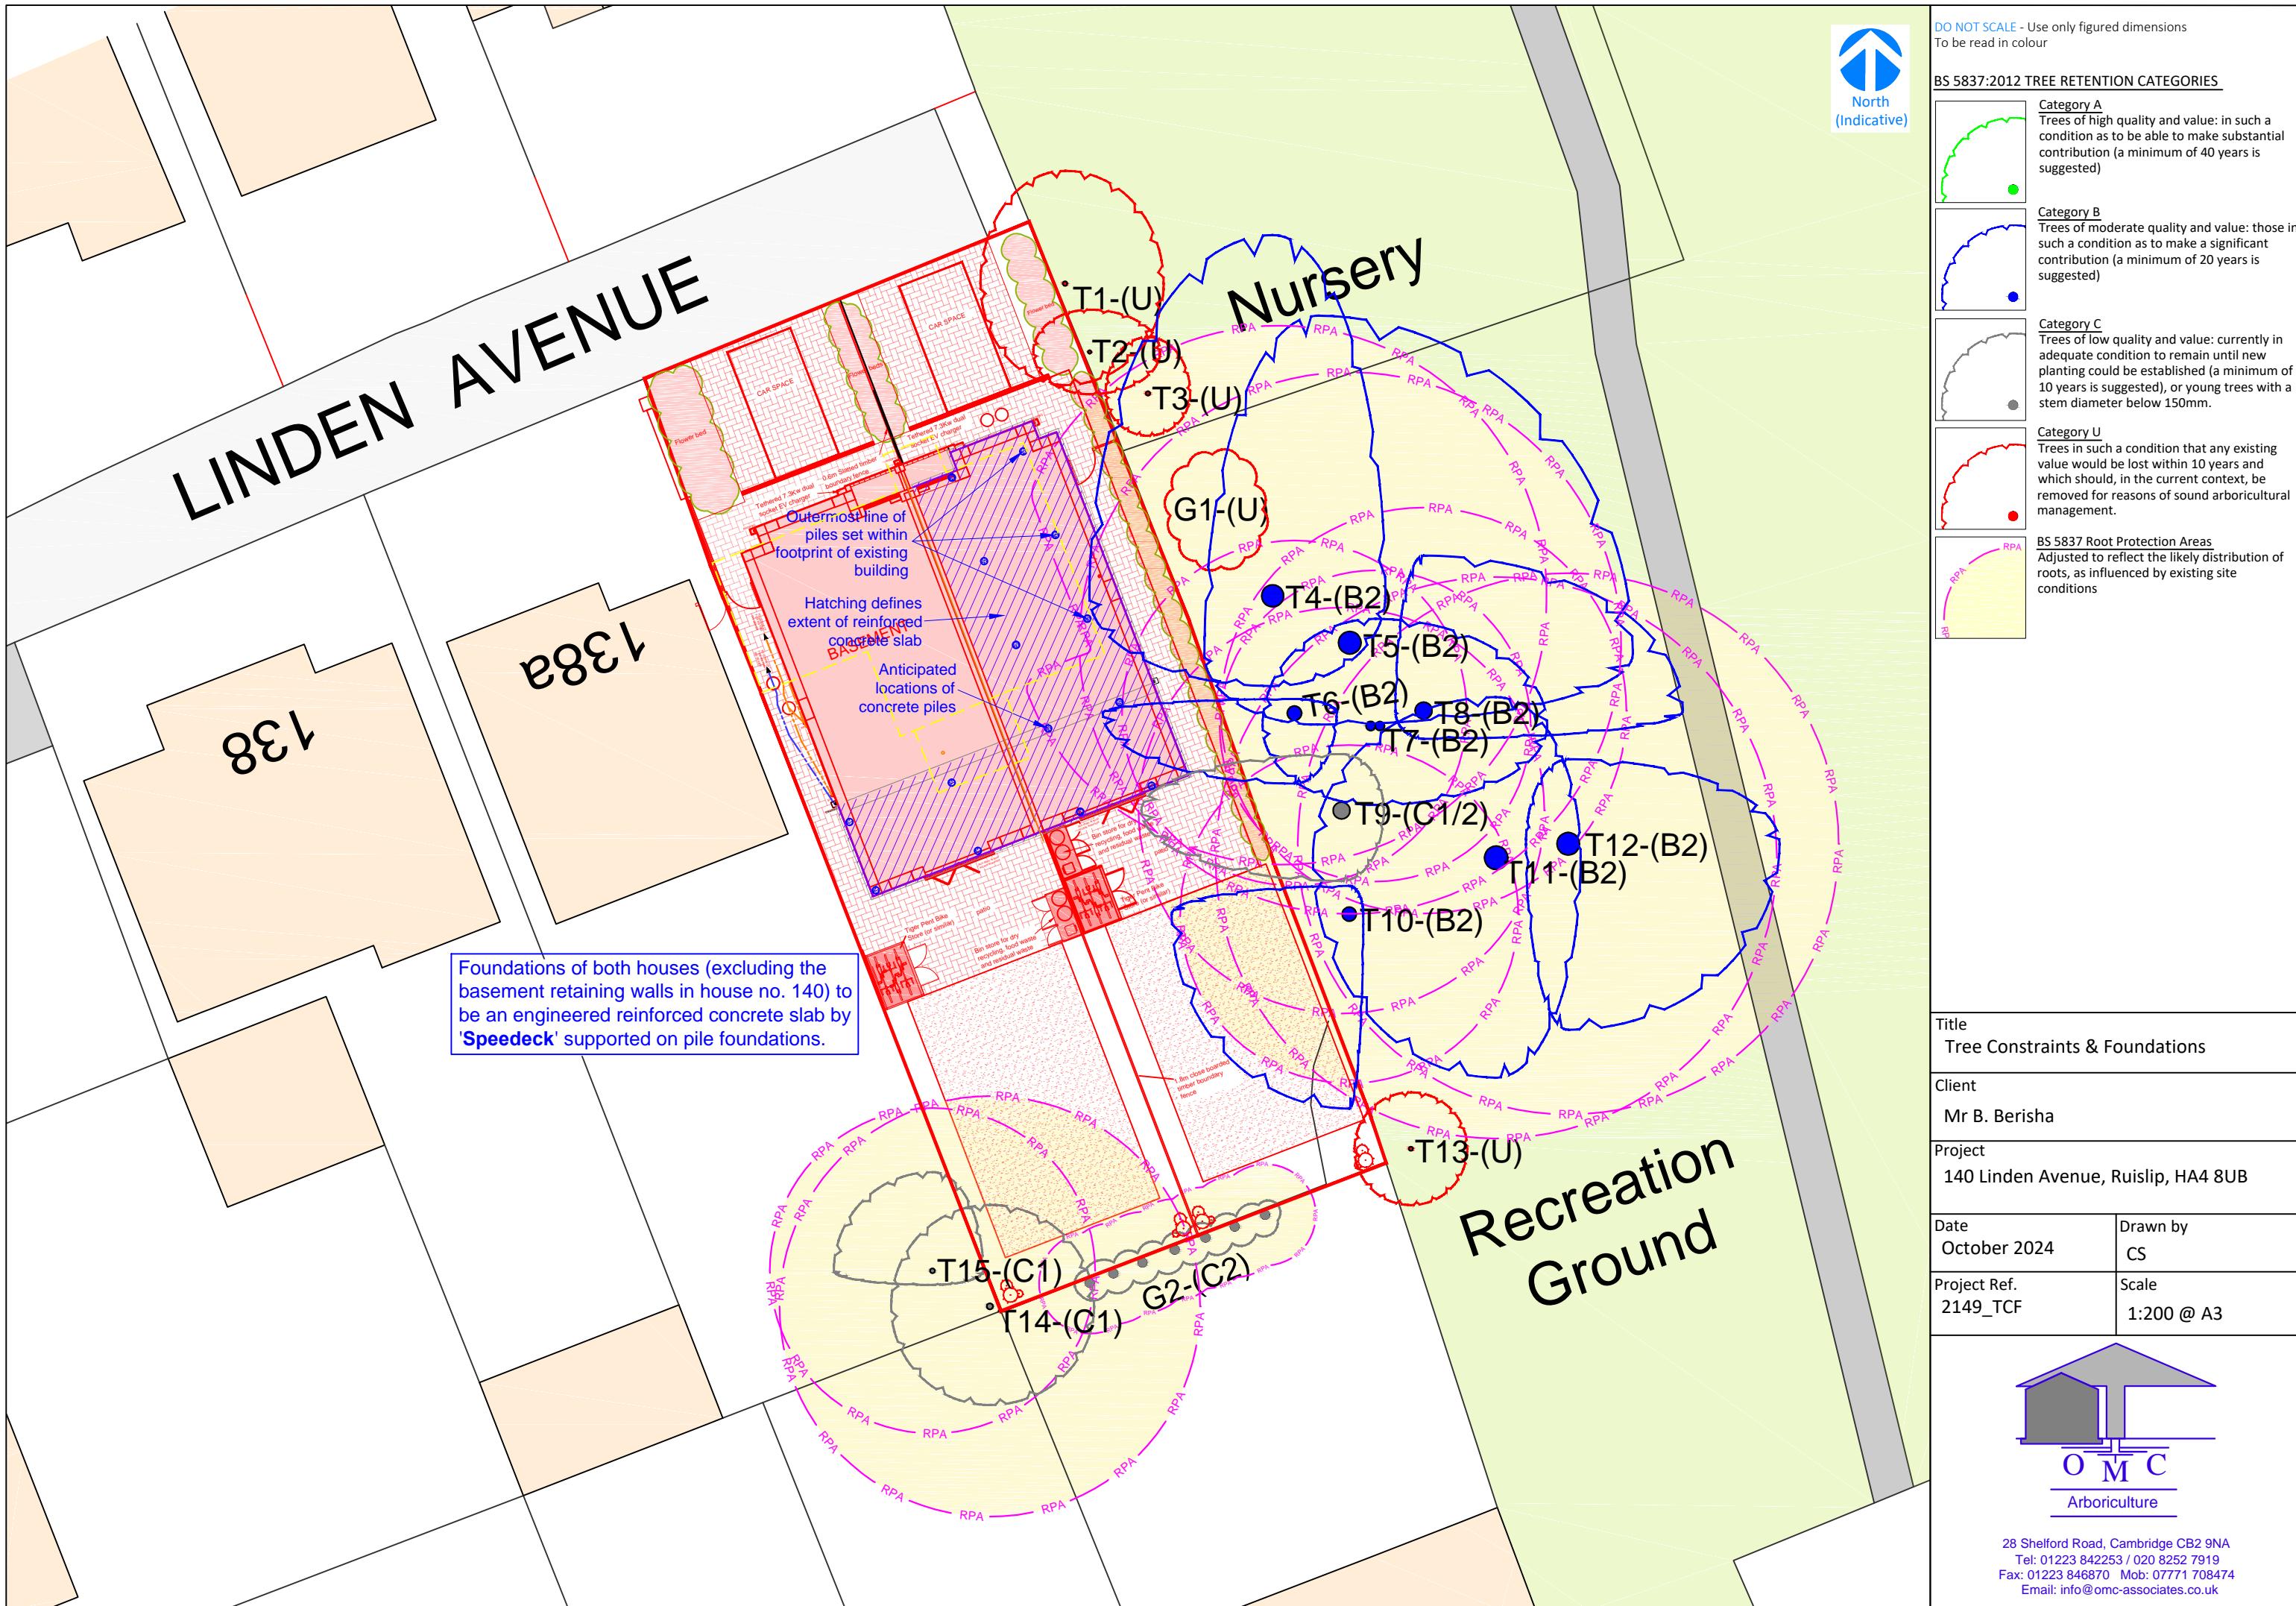
Appendix 4 Tree Constraints and Foundation Plan

The foundations of the dwelling nearest the trees would comprise a reinforced concrete raft cast at existing ground level, supported by concrete piles. The line of piles closest to the trees would be set within the footprint of the existing bungalow and eastern edge of the slab cantilevered over the trees' RPAs, so minimising any disturbance of the root systems of T4 – T6. The theoretical encroachment upon these trees without the utilization of engineered foundations would have been 12% and 6% respectively. The extents of the raft foundation and locations of the piles are shown within the Tree Constraints and Foundation Plan attached at Appendix 4.
