APPENDIX 8.3
FURTHER GEO ENVIRONMENTAL
INFORMATION

Former Nestle Factory, Hayes -
Proposed Commercial Development
Further Geo-environmental Assessment
6 June 2016

Job No	CS-075666		
Project	Former Nestlé Factory, Hayes Proposed Commercial Development		
Location	Hayes, London Borough of Hillingdon		
Title	Further Geo-environmental Assessment		
Client	SEGRO plc		
Document Ref	CS-075666-PE-16-113-R		
File Reference	U:\CS-075666 - Project Lightning Hayes\Geotech\Reports\2016\CS-075666-PE-16-113-R Rev A.docx		
Date	6 June 2016		
Prepared by	PWE	Signature (for file)	
Authorised by	NRB	Signature (for file)

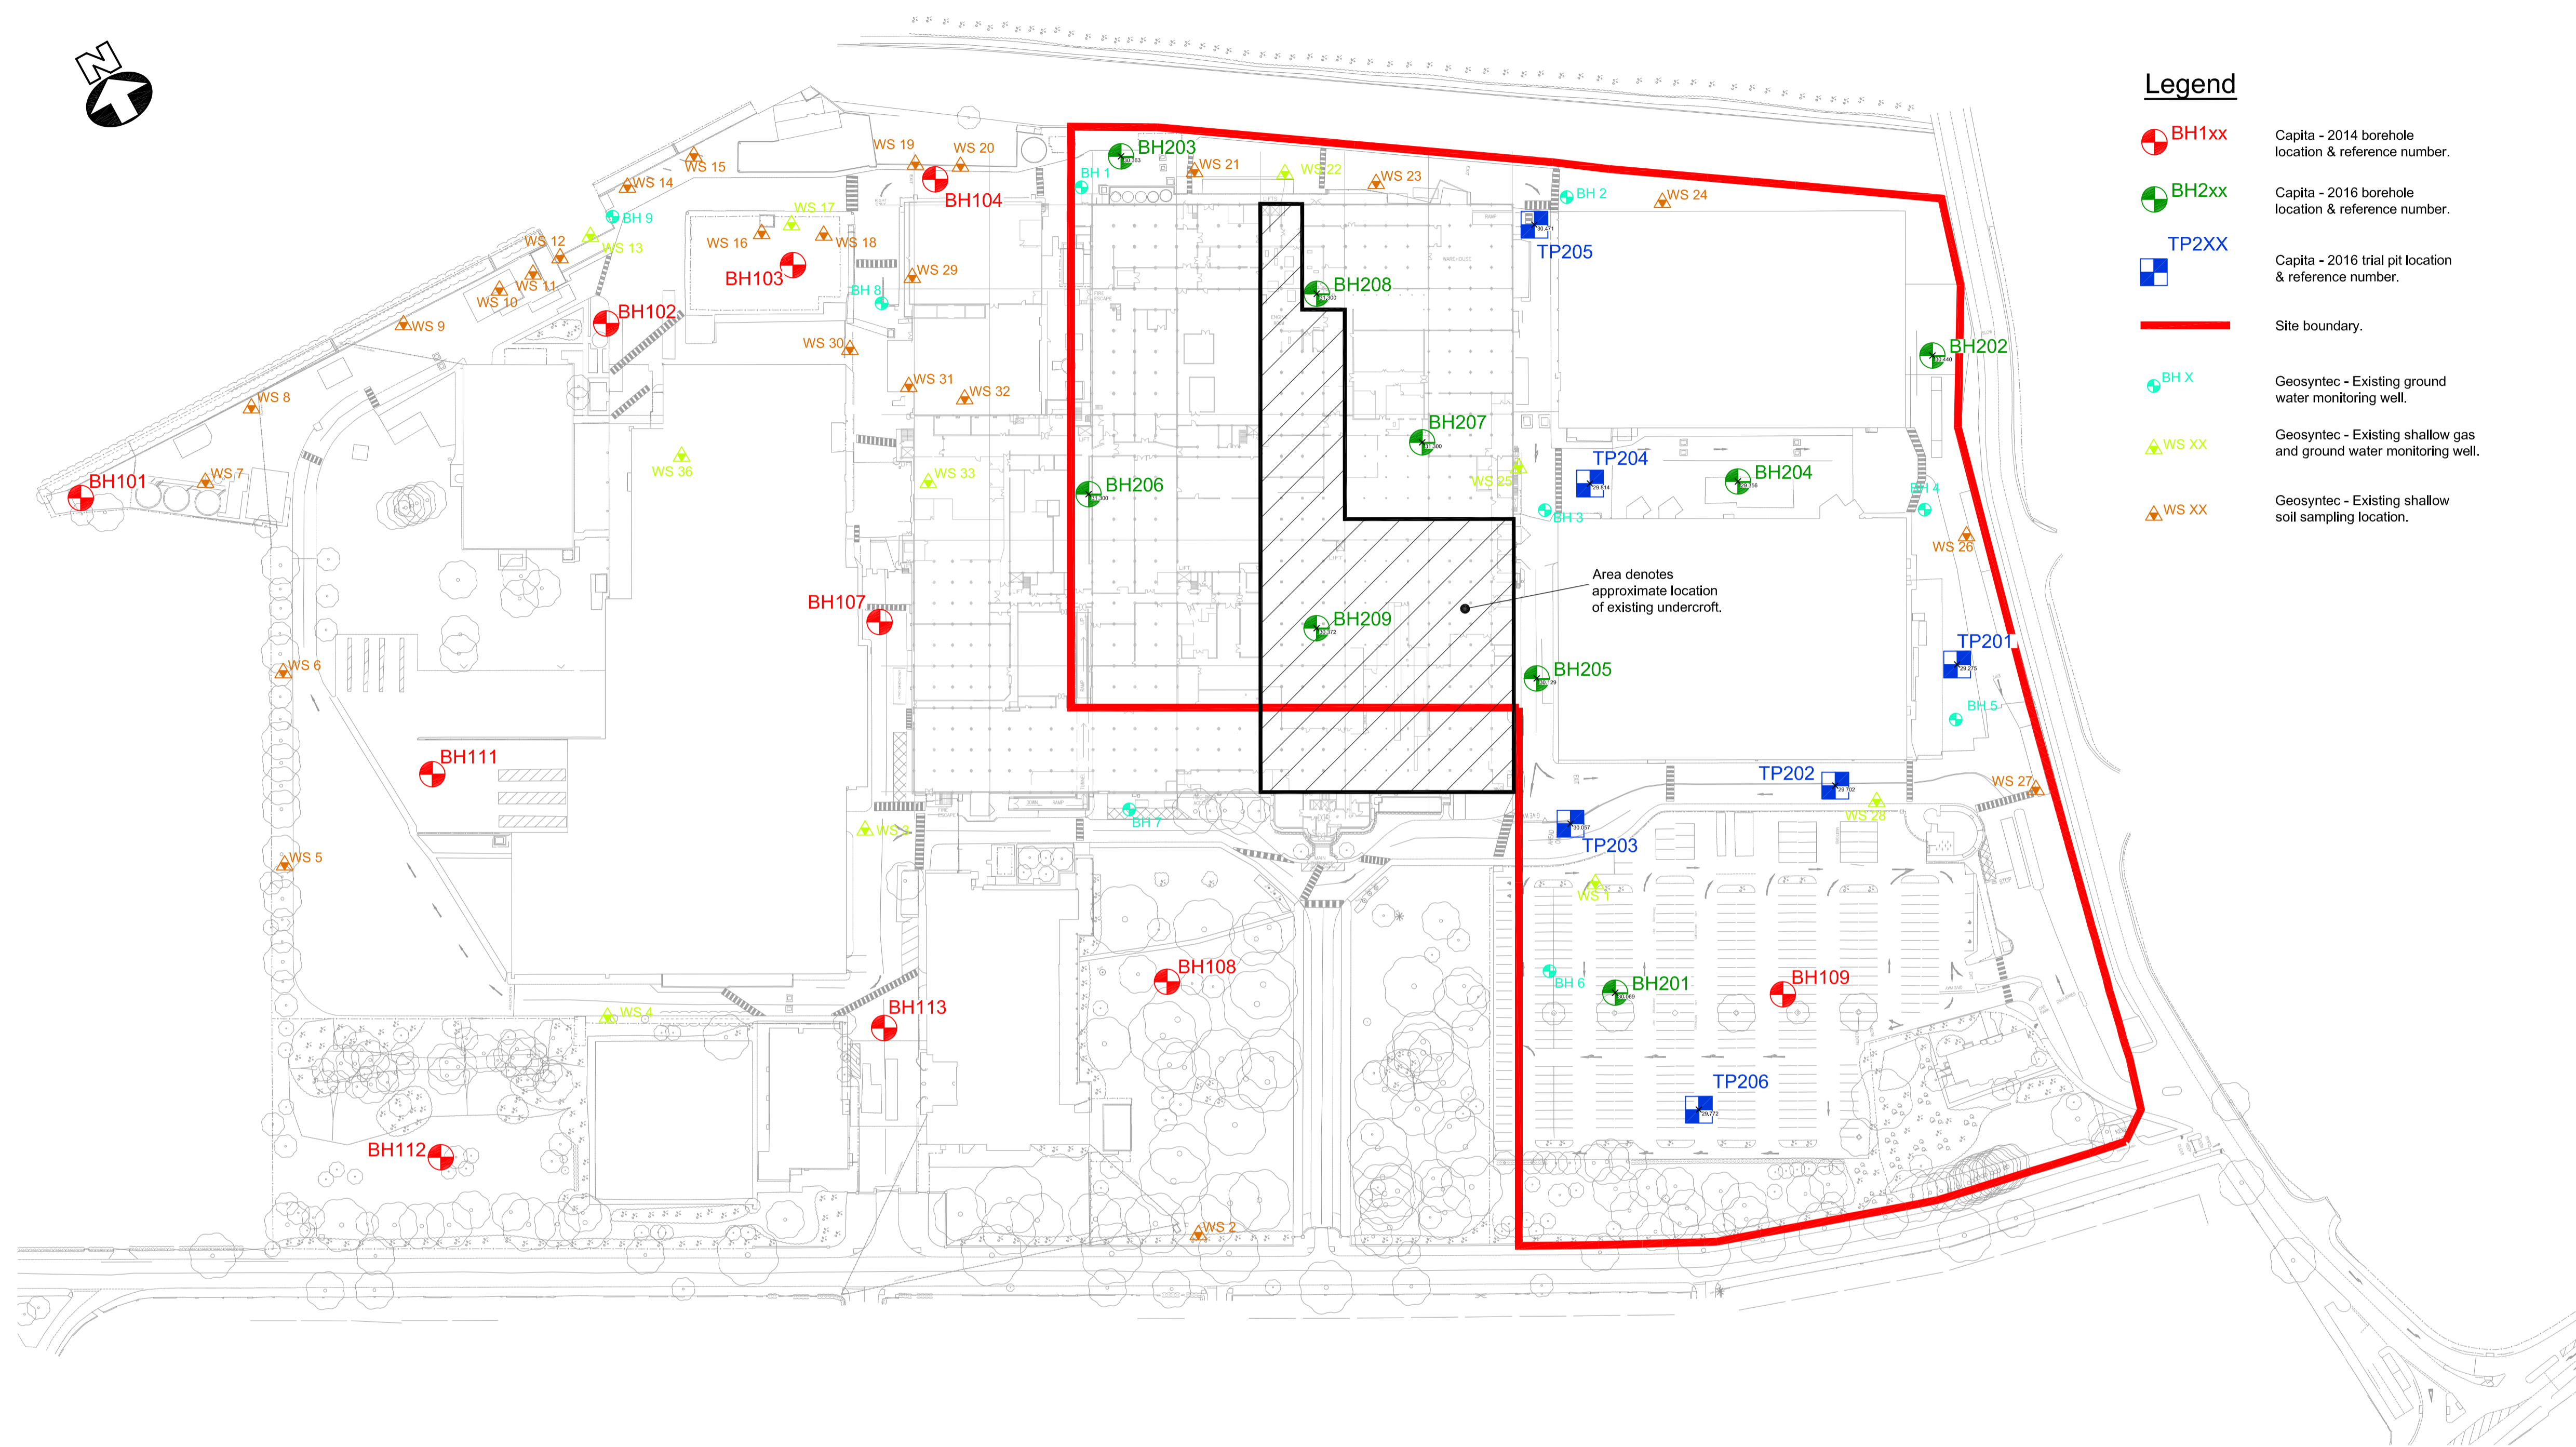
Drawing
EXPLORATORY HOLE LOCATION PLAN

- BH1xx Capita - 2014 borehole location & reference number.
- BH2xx Capita - 2016 borehole location & reference number.
- TP2XX Capita - 2016 trial pit location & reference number.
- Site boundary.
- BH X Geosyntec - Existing ground water monitoring well.
- ▲ WS XX Geosyntec - Existing shallow gas and ground water monitoring well.
- ▲ WS XX Geosyntec - Existing shallow soil sampling location.

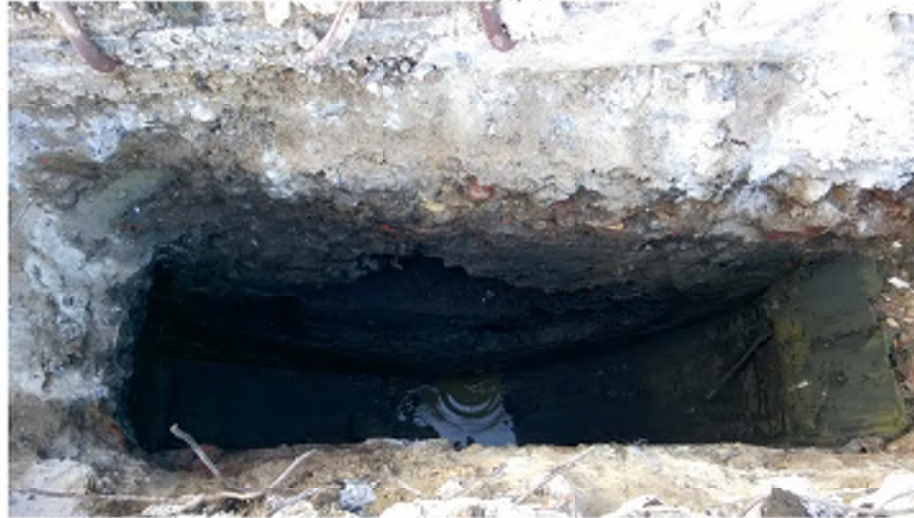
TP201 iv

Water Strike	Samples & In Situ Testing			Depth (m)	Level (m)	Legend	Stratum Description	
	Depth	Type	Results					
▼				0.30	28.98		Concrete with reinforcing bar.	
	0.50	D		0.70	28.58		Compacted sandy gravel of brick, concrete and ceramic fragments in a reddish-brown silty clay matrix. (MADE GROUND)	
	0.90	D		1.00	28.28		Soft dark grey gravelly silty clay with fragments of brick and concrete. (MADE GROUND)	1
							Soft to firm dark grey SILT/CLAY.	2
				2.50	26.78		End of Pit at 2.50m	3

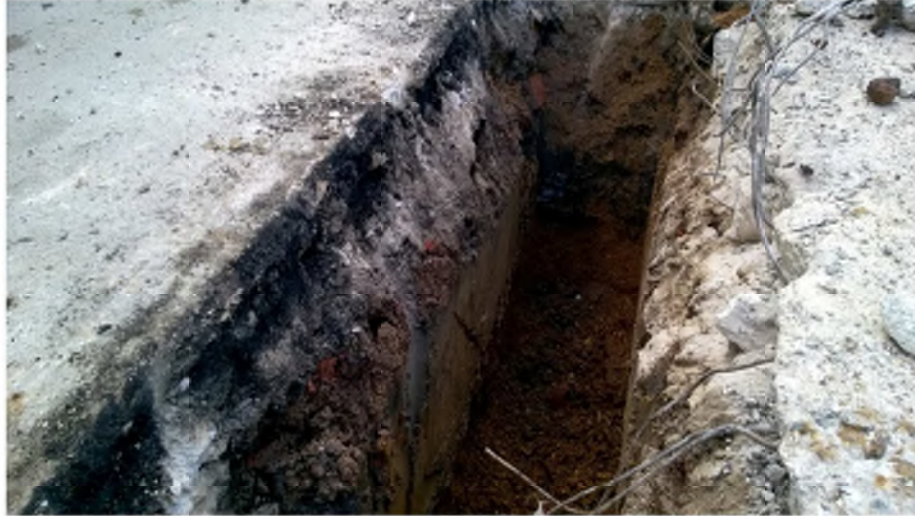
TP202

Water Strike	Samples & In Situ Testing			Depth (m)	Level (m)	Legend	Stratum Description	
	Depth	Type	Results					
				0.25	29.45	[Asphalt pattern]	Asphalt	
				0.50	29.20	[Compacted gravel pattern]	Compacted orange-brown sandy gravel subbase. (MADE GROUND)	
	0.80	D				[Clay pattern]	Firm dark brown slightly gravelly sandy CLAY. (BRICKEARTH)	1
				1.20	28.50	[Gravel pattern]	Medium dense orange-brown silty sandy GRAVEL of fine to coarse flint. (LYNCH HILL GRAVEL)	
	1.60	D						
				1.80	27.90		End of Pit at 1.80m	2
								3
								4
								5

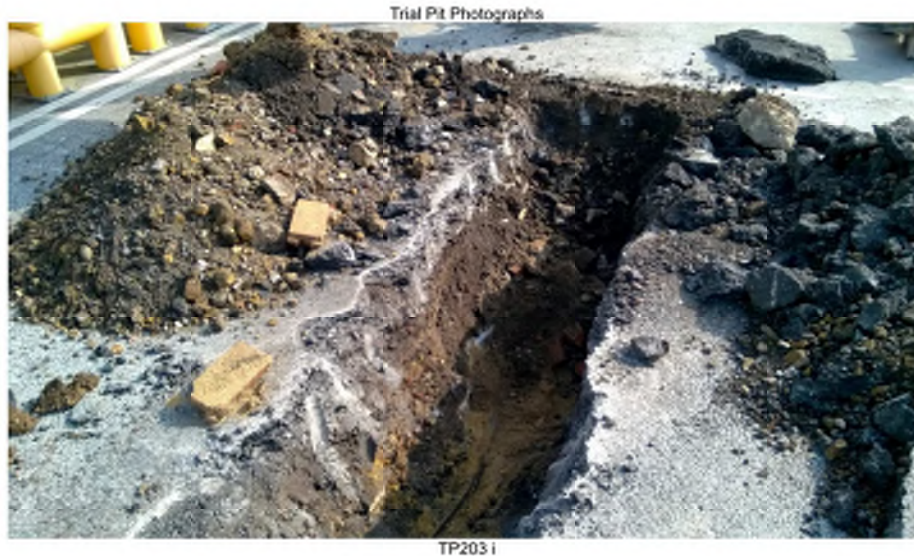
Water Strike	Samples & In Situ Testing			Depth (m)	Level (m)	Legend	Stratum Description	
	Depth	Type	Results					
	0.50	D		0.20 0.35 0.70	29.86 29.71 29.36		Asphalt Compacted dark grey sandy gravel of brick, macadam, concrete and tile fragments. (MADE GROUND) Medium dense dark orange-brown and grey gravelly sand with half bricks, concrete cobbles, flint and rock fragments. (MADE GROUND)	1 2 3 4 5
							End of Pit at 0.70m

Remarks: 2No armoured cables, one with warning tiles over, encountered at 0.65mbgl. Cables are oriented NW-SE and E-W. E-W cable is surrounded by coarse sand. Trial pit abandoned and backfilled with arisings.

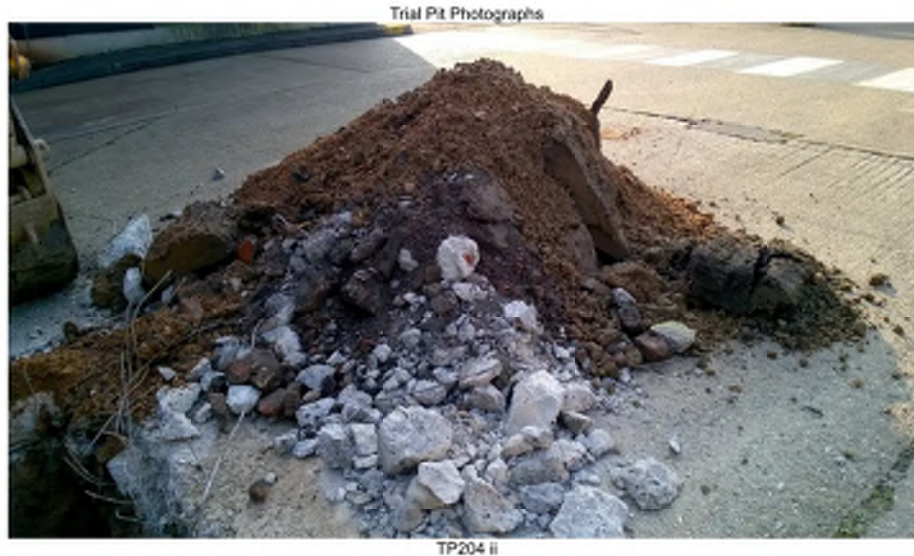
Water Strike	Samples & In Situ Testing			Depth (m)	Level (m)	Legend	Stratum Description	
	Depth	Type	Results					
▼	0.40	D		0.30	29.51	[Pattern]	CONCRETE with reinforcing bar	1 2 3 4 5
				0.50	29.31	[Pattern]	Lean mix concrete / compacted granular sub-base. (MADE GROUND)	
	1.00	D		1.05	28.76	[Pattern]	Firm orange-brown slightly sandy silty CLAY. (BRICEARTH)	
				1.65	28.16	[Pattern]	Medium dense orange-brown silty sandy GRAVEL of fine to coarse flint. (LYNCH HILL GRAVEL)	
						End of Pit at 1.65m

Remarks: Backfilled with arisings on completion.

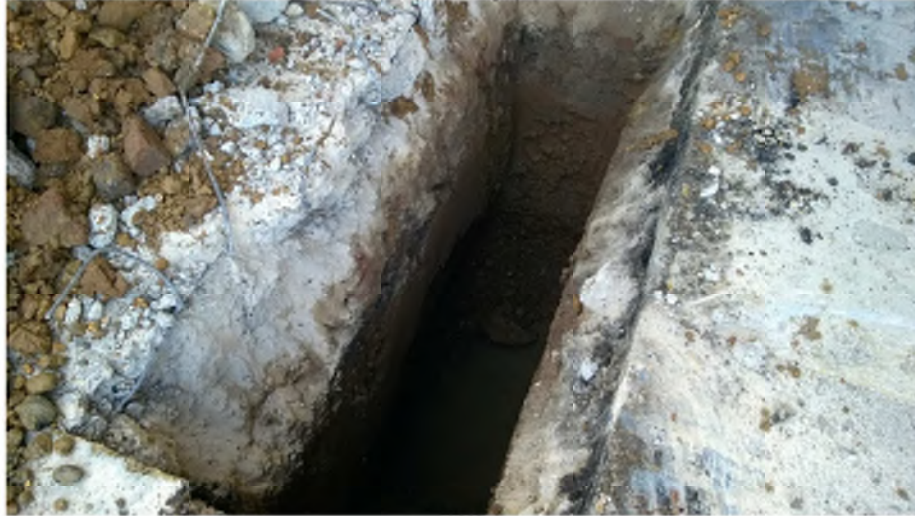
TP205

Water Strike	Samples & In Situ Testing			Depth (m)	Level (m)	Legend	Stratum Description	
	Depth	Type	Results					
▼	0.45	D		0.30	30.17	[Pattern]	CONCRETE with reinforcing bar.	1 2 3 4 5
				0.50	29.97	[Pattern]	Compacted sandy gravel of concrete and brick fragments. (MADE GROUND) Firm orange-brown silty sandy CLAY. (BRICKEARTH)	
	1.50	D		1.35	29.12	[Pattern]	Medium dense orange-brown silty sandy GRAVEL of fine to coarse flint. (LYNCH HILL GRAVEL)	
				1.95	28.52		End of Pit at 1.95m

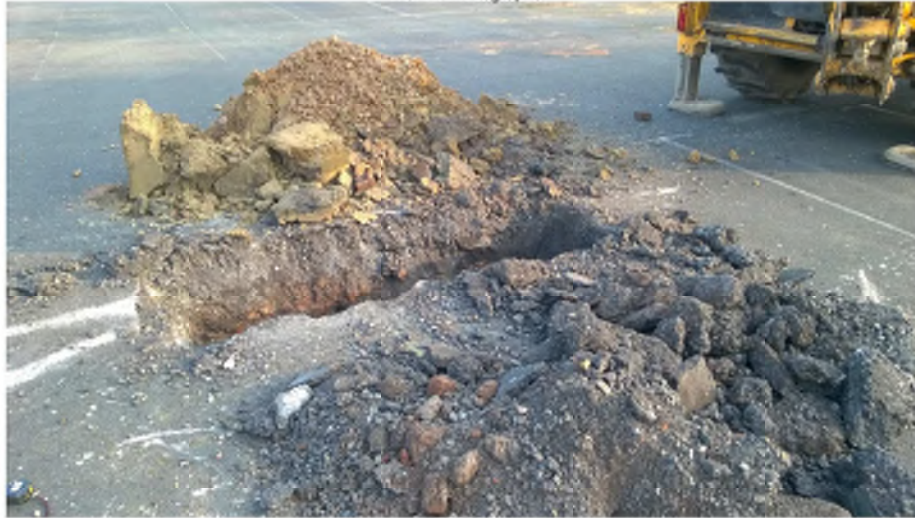
TP206 ii

Water Strike	Samples & In Situ Testing			Depth (m)	Level (m)	Legend	Stratum Description	
	Depth	Type	Results					
▼				0.20	29.57		Asphalt	1
				0.60	29.17		Compacted sandy gravel of brick, concrete and rock fragments. (MADE GROUND)	
	0.75	D		1.10	28.67		Firm orange-brown and grey silty sandy CLAY. (BRICKEARTH)	
	1.50	D		1.75	28.02		Medium dense orange-brown clayey silty sandy GRAVEL of fine to coarse flint. (LYNCH HILL GRAVEL)	
							End of Pit at 1.75m	2
								3
								4
								5
