FORMER NESTLE FACTORY, HAYES

ARCHAEOLOGICAL DESK-BASED ASSESSMENT

**THE FORMER NESTLE
FACTORY SITE
NESTLES AVENUE
HAYES
LONDON**

**November 2014
Updated May 2017**

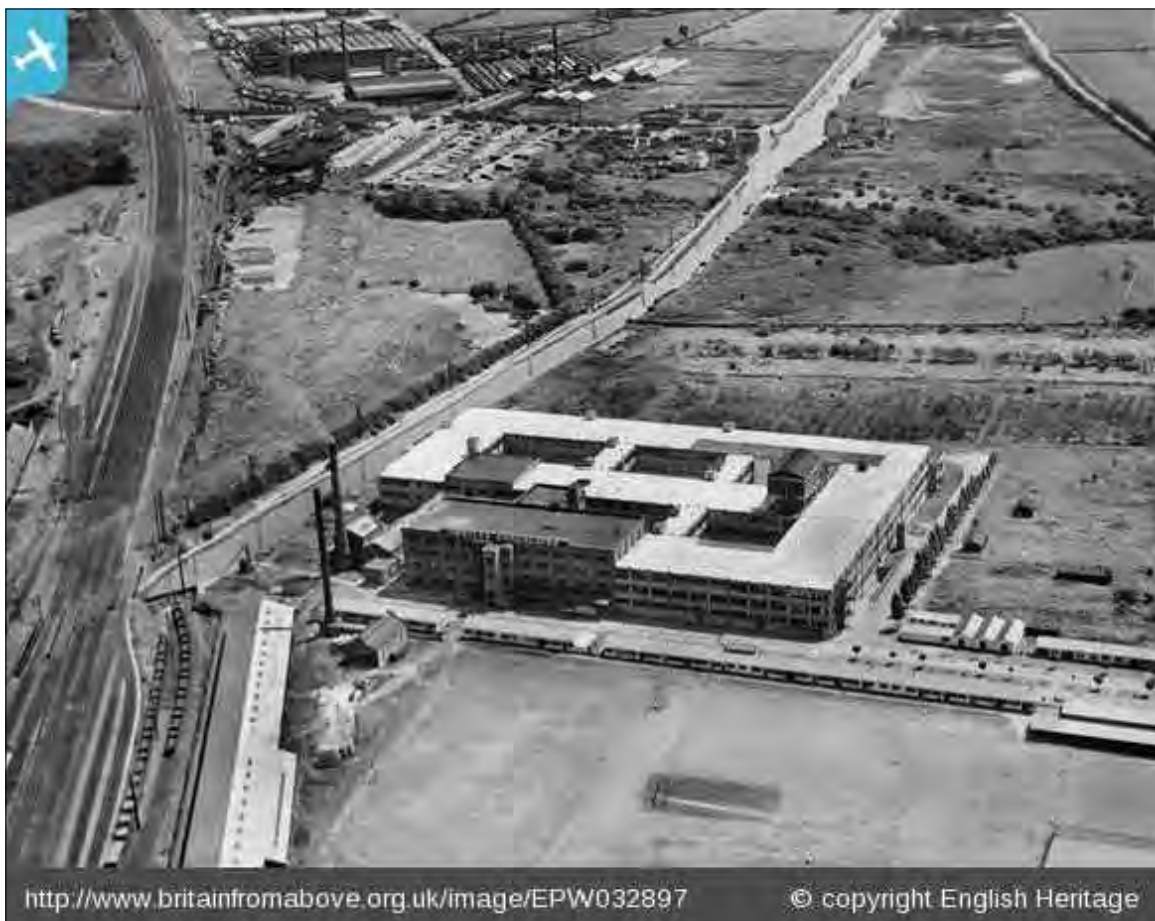
Plate 4: Aerial view of Nestle Works 1930 looking east

4.7.11 In 1929 The Nestle Company took ownership of the chocolate factory. Aerial photographs taken of the site in 1930 and 1932 indicate that the layout of the site has changed significantly (Plates 4 & 5). The original chocolate factory is still present, although the greater majority of the munitions factory buildings and walkways have been removed. The railway warehouses and few single storey northeast-southwest aligned rectangular huts appear to have been retained, with the remaining area left as open ground or landscaped as playing fields. A substantial three storey factory complex has been constructed abutting the original factory building.

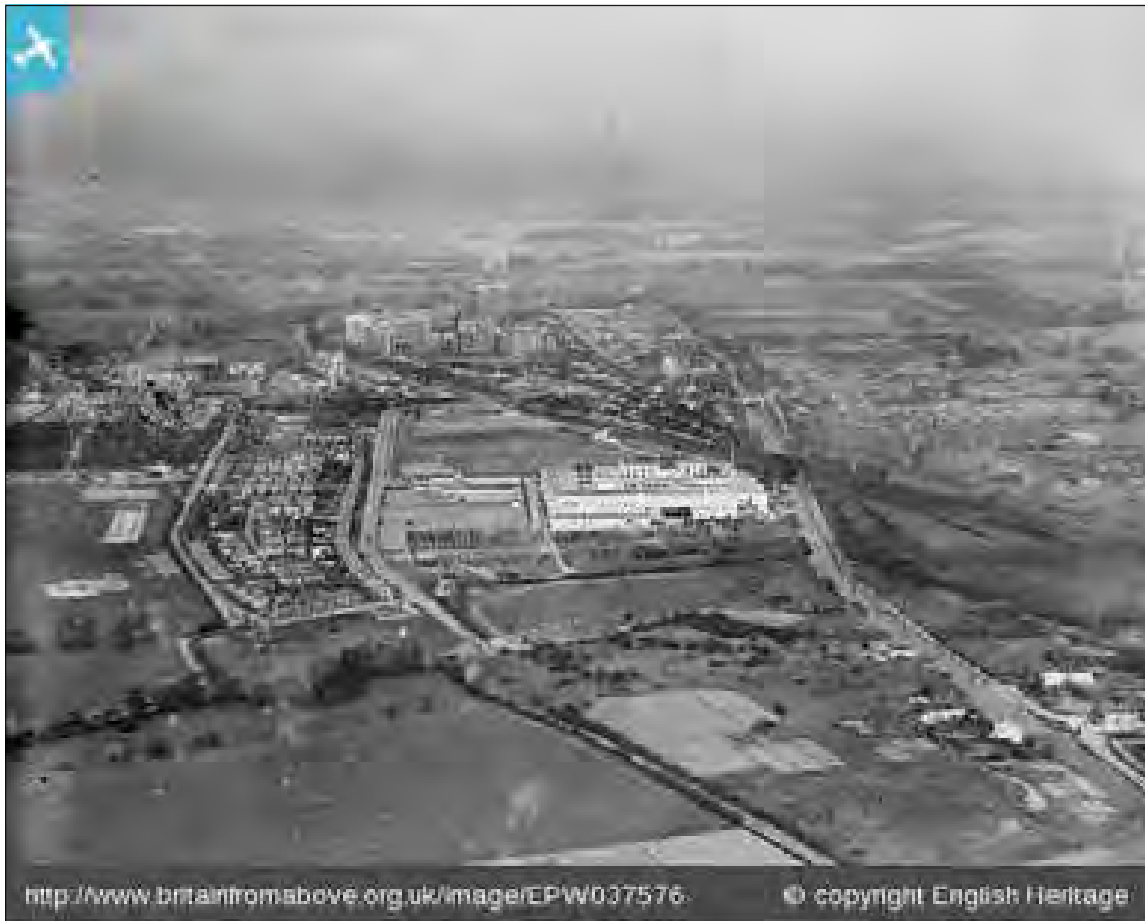
Plate 5: Aerial view of Nestle Works 1932 looking west

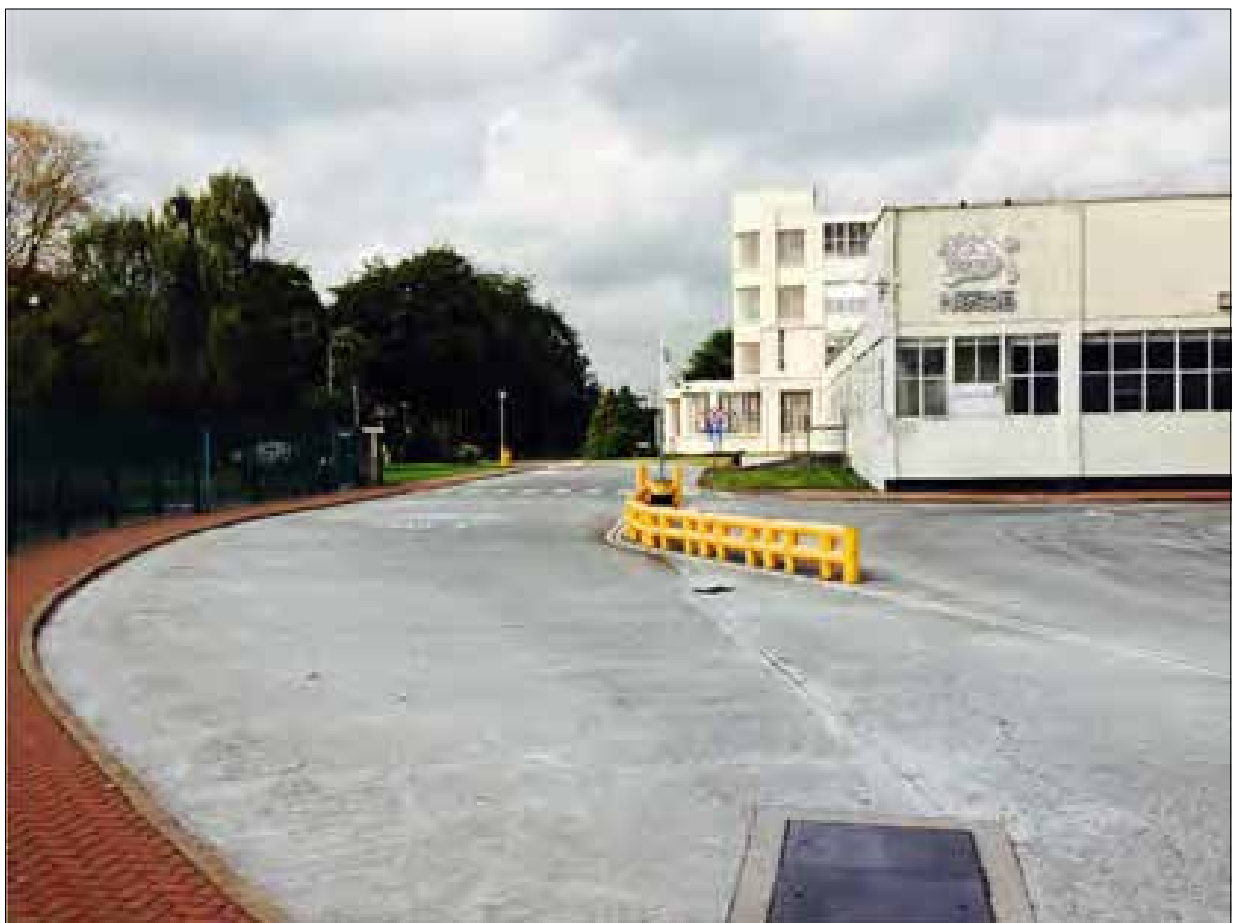
Plate 6: General view of the factory buildings

- 5.1.1 The site is currently occupied by multiple 20th century factory buildings and ancillary buildings associated with Nestle Works (Plates 6 & 7). Access roads, loading yards and car parks subdivide these buildings (Plates 8 & 9). Grassed areas line the former Nestle Avenue entrance (Plate 10).

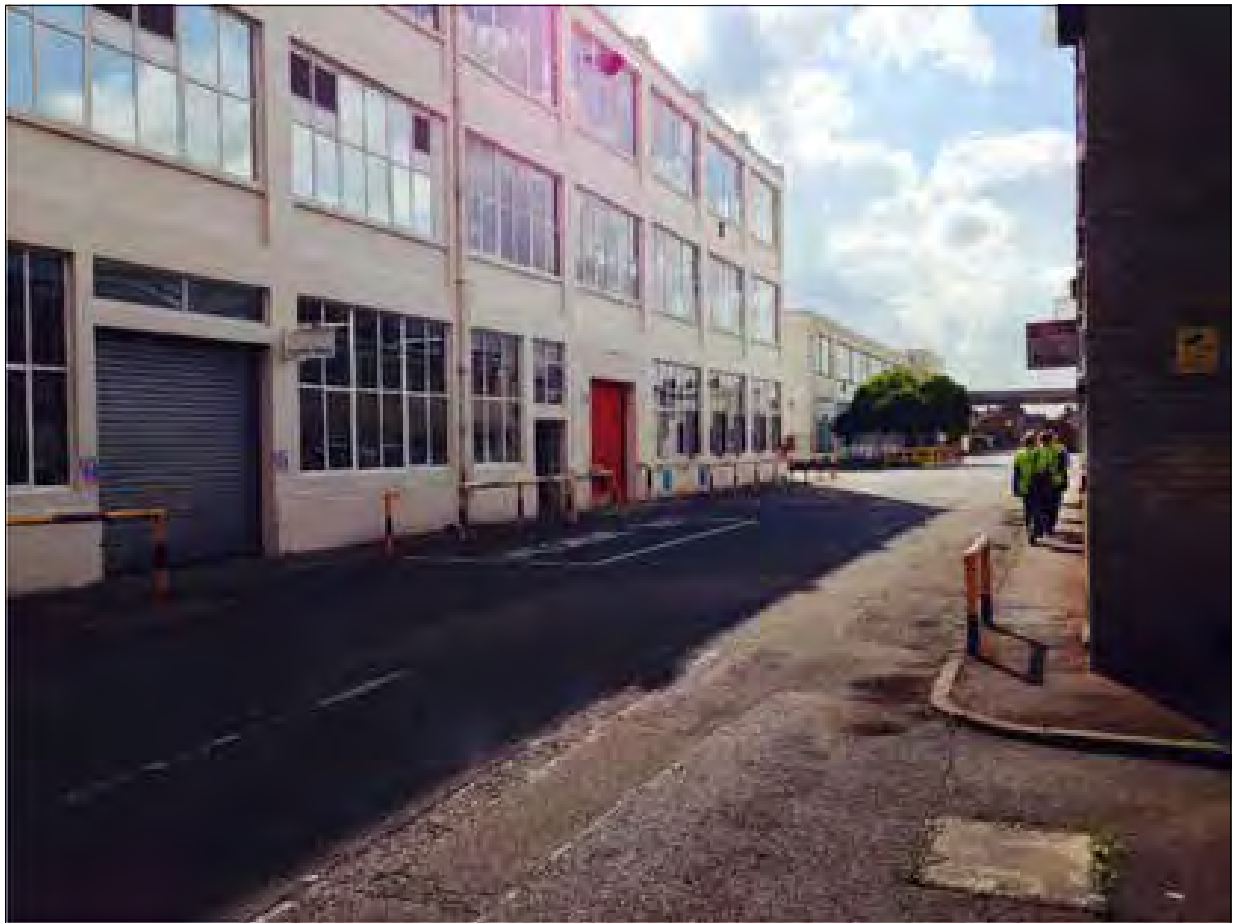
Plate 7: General view of the factory buildings
