TECHNICAL NOTE TN02

Former Nestle Site, Nestle Avenue, Hayes

CERS AUDIT

Project No. 16018-01

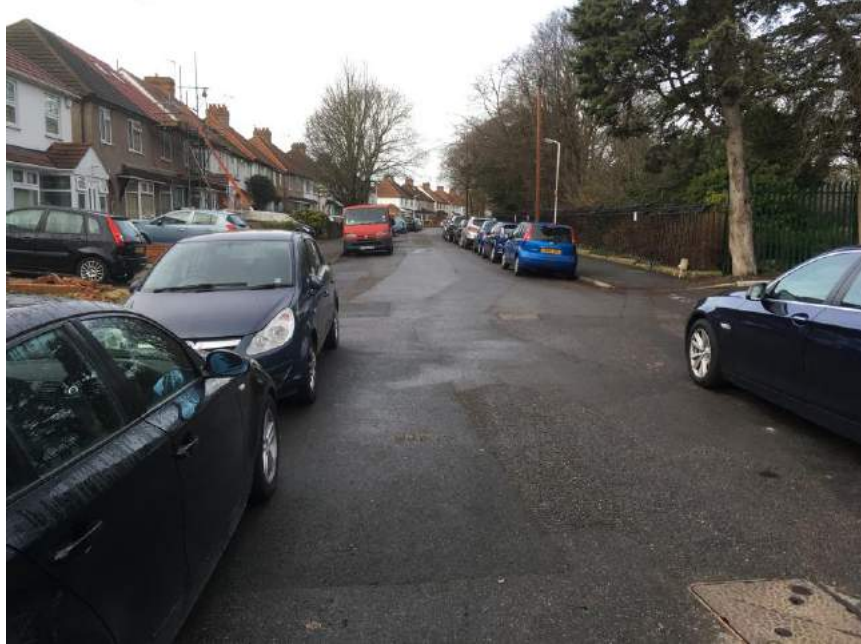
5.3 Many of the links benefit from effective widths of both on and off-road cycle links, adequate space / comfort for cyclists, continuity in facility types and surfacing, and good surface quality. **Photo 1** shows a typical cycle link along Nestle Avenue (L11) which is the site's western boundary, and links with Station Road to the west and North Hyde Gardens to the east. **Photo 2** identifies the Harold Avenue cycle link (L10), which will link the site to North Hyde Road. Both links are on-road cycle links and were awarded 'Good' (Green) RAG scores. The cycle links provide a safe cycle route, with a low traffic flow and traffic proximity. The routes were scored highly for surface quality, quality of the environment, effective road widths.

Photo 1 – Nestle Avenue which borders to southern boundary of the site

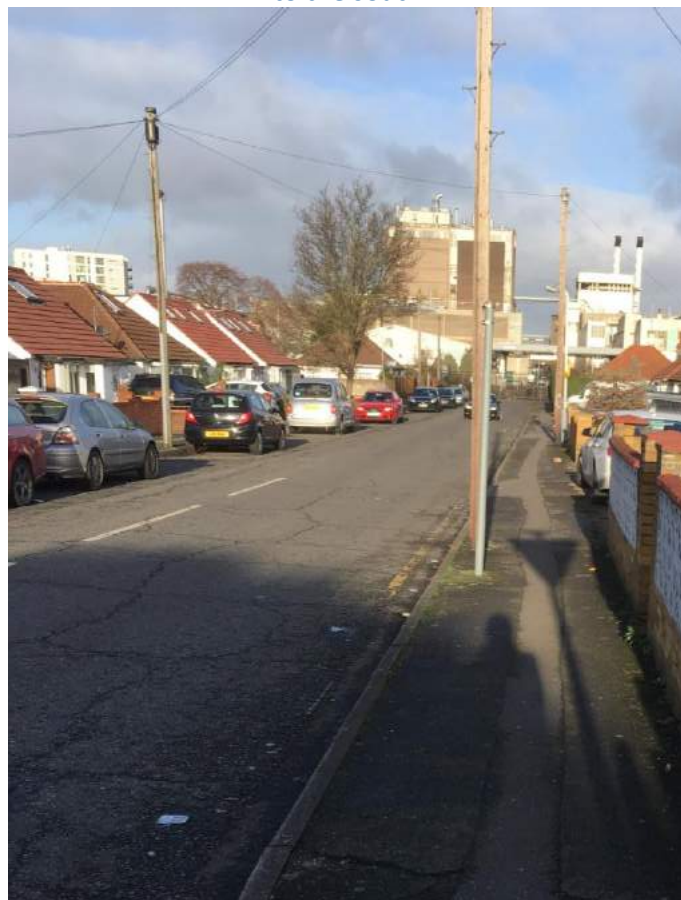
Photo 2 – Harold Road which links with Nestle Avenue to the north and North Hyde Road to the south

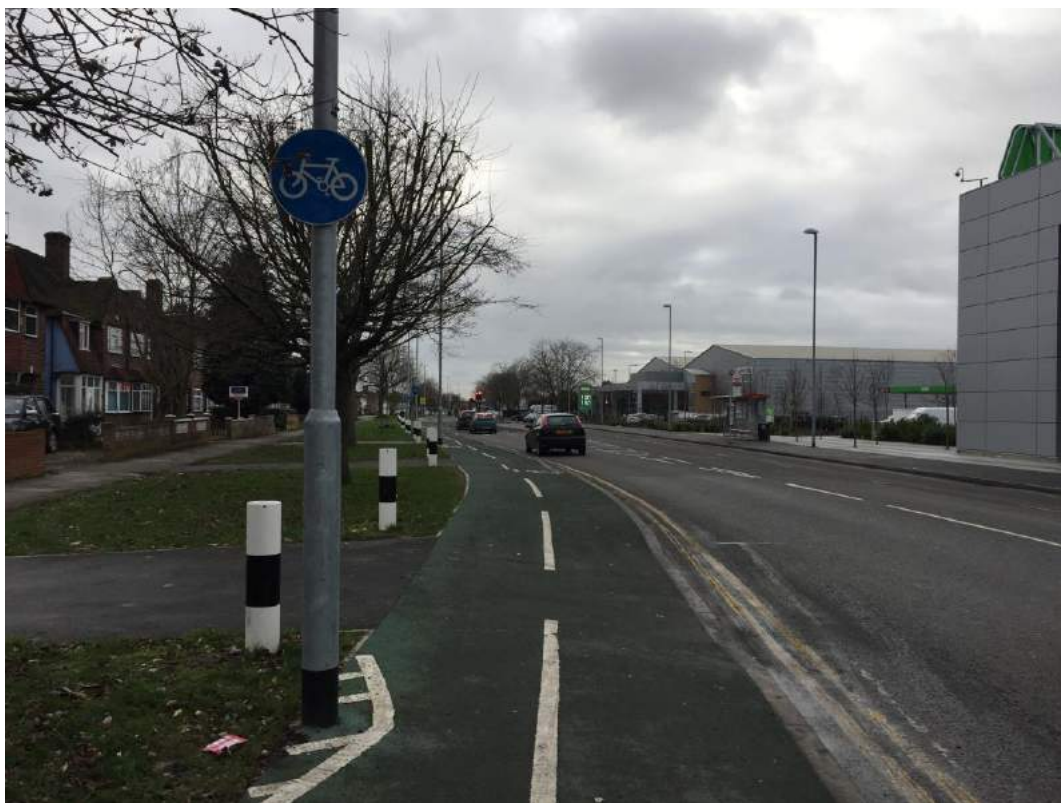
- 5.4 **Photos 3, 4 and 5** identify some of the cycle links along Station Road, providing cycle links north to Hayes and Harlington Station and town centre and south past ASDA supermarket towards Harlington. **Photo 3** shows the Station Road two-way off-road cycle route, which was given an overall 'Good' (Green) score. The cycle lane is well segregated from the pedestrian pathway, and therefore this route is safe for pedestrians and cyclists. At either end of the cycle route there are Toucan crossings, allowing cyclist to safely cross the road. The cycle lane is of adequate width, with an approximate 3m wide two-way cycle lane. The cycle lane was scored highly for surface quality, signage, personal security and desirable gradients, and therefore will encourage people to travel via bike.

Photo 3 – Station Roads Two-way cycle lane

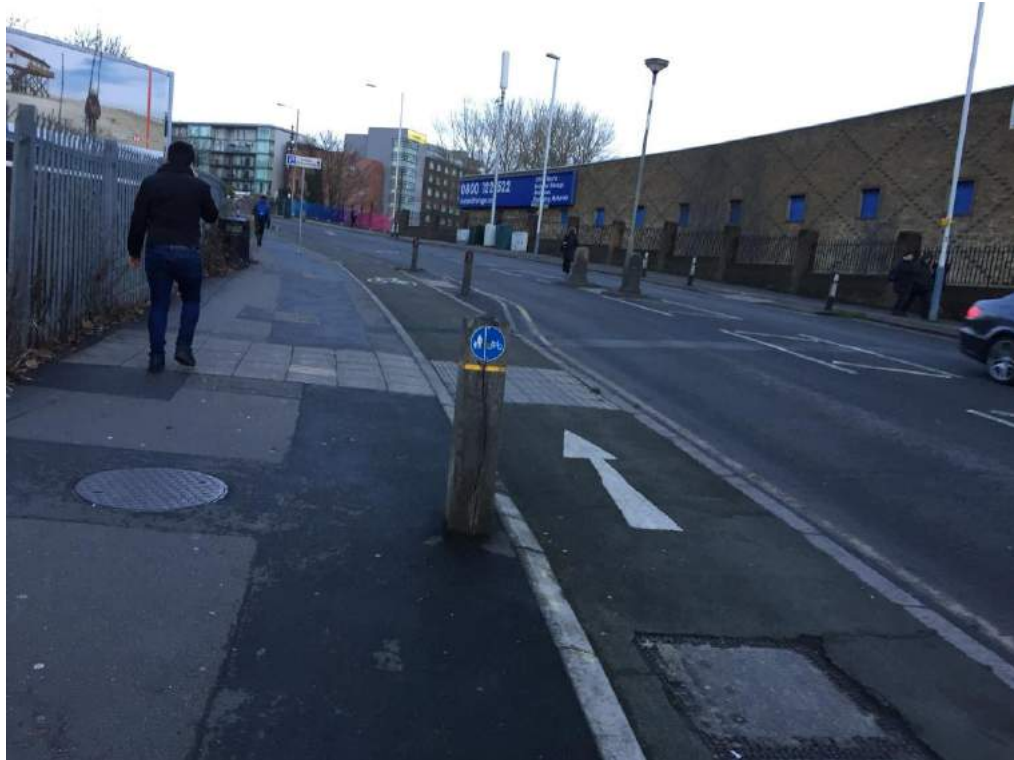
- 5.5 **Photos 4 and 5** show the off-road cycle links along Station Road (L3) which travel north towards the station. **Photo 4** shows the northbound cycle link and **Photo 5** identifies the southbound cycle link which connects with Nestle Avenue. This link was given an 'Average' (Amber) rating due to the lack of continuity of the link. The link did, however, score highly due to high quality off-street cycle lanes demonstrated in **Photo 4 and 5** below.

Photo 4 – Northbound off-road cycle lane on Station Road

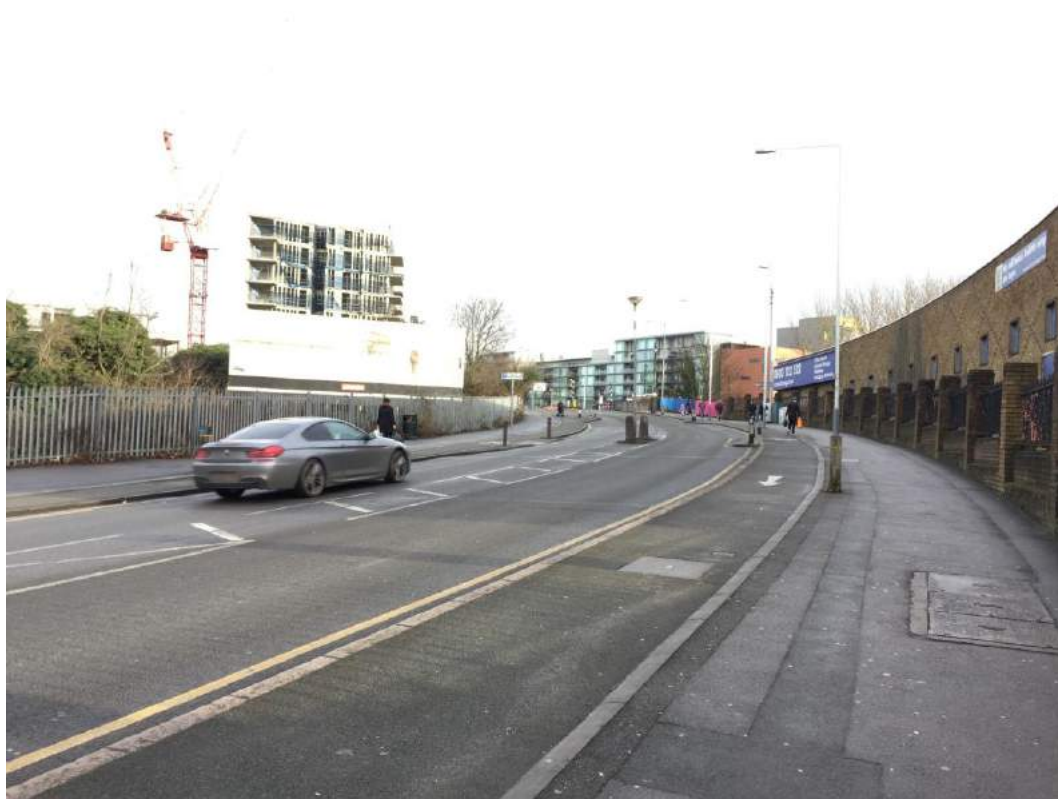
Photo 5 – Southbound off-road cycle lane on Station Road

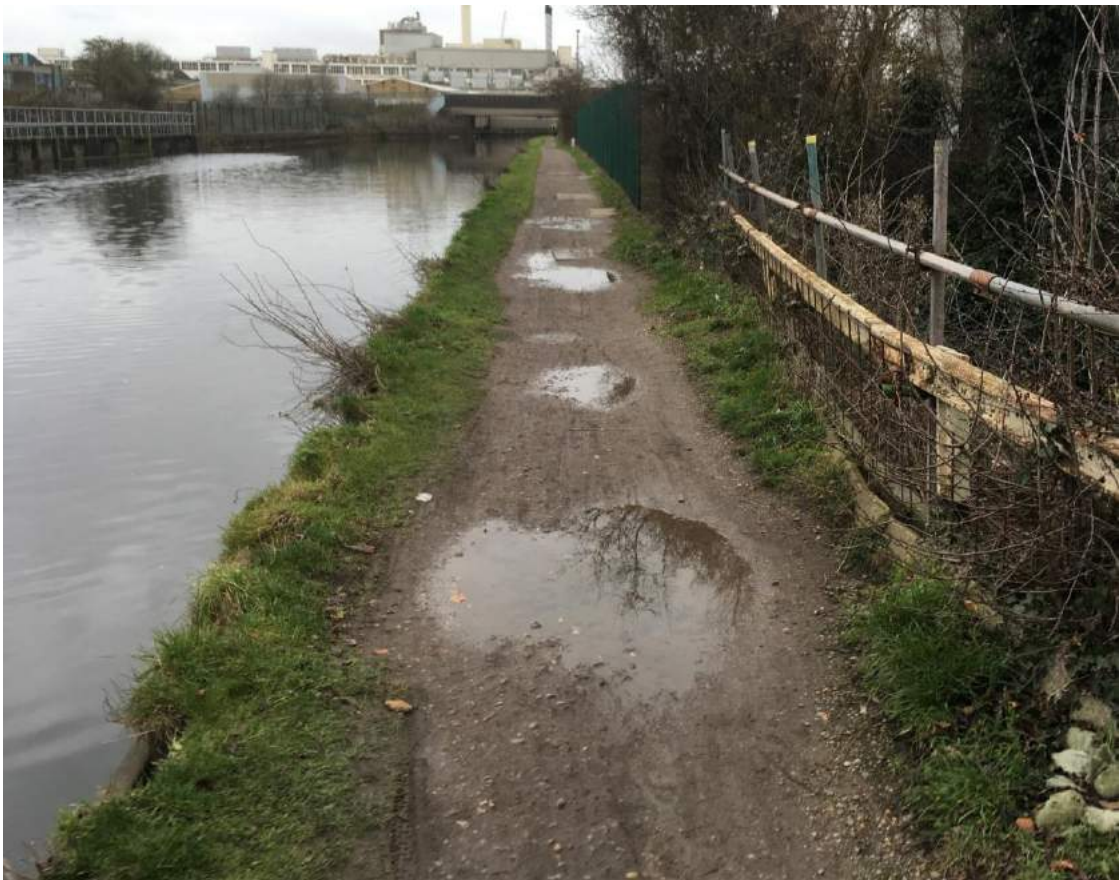
- 5.6 **Photo 6** identifies the Grand Union Canal towpath (L4), which was rated an 'Average' (Amber) RAG score. This cycling link scored high for providing a direct link into the town centre, lack of traffic and traffic proximity. The link scored negatively for lighting, personal security due to the segregation of the pathway and severe ponding along the route which could deter cyclists from using this route.

Photo 6 – Grand Union Canal Towpath

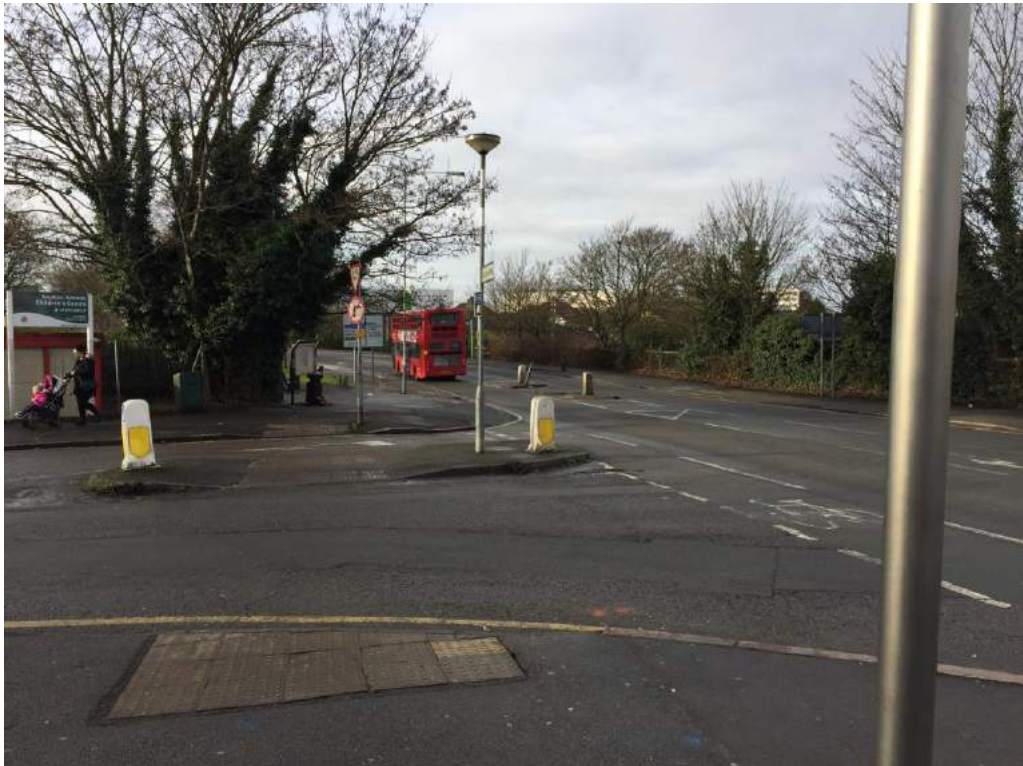
6.4 **Photo 7** shows the Nestle Avenue / Station Road junction (J3) which was given a 'Good' (Green) RAG score. The junction was scored highly due to its capacity and lack of delays at the junction. The junction also has good visibility and sightlines for oncoming traffic from both directions and there are no obstructions.

Photo 7 – Nestle Avenue / Station Road junction (J3)

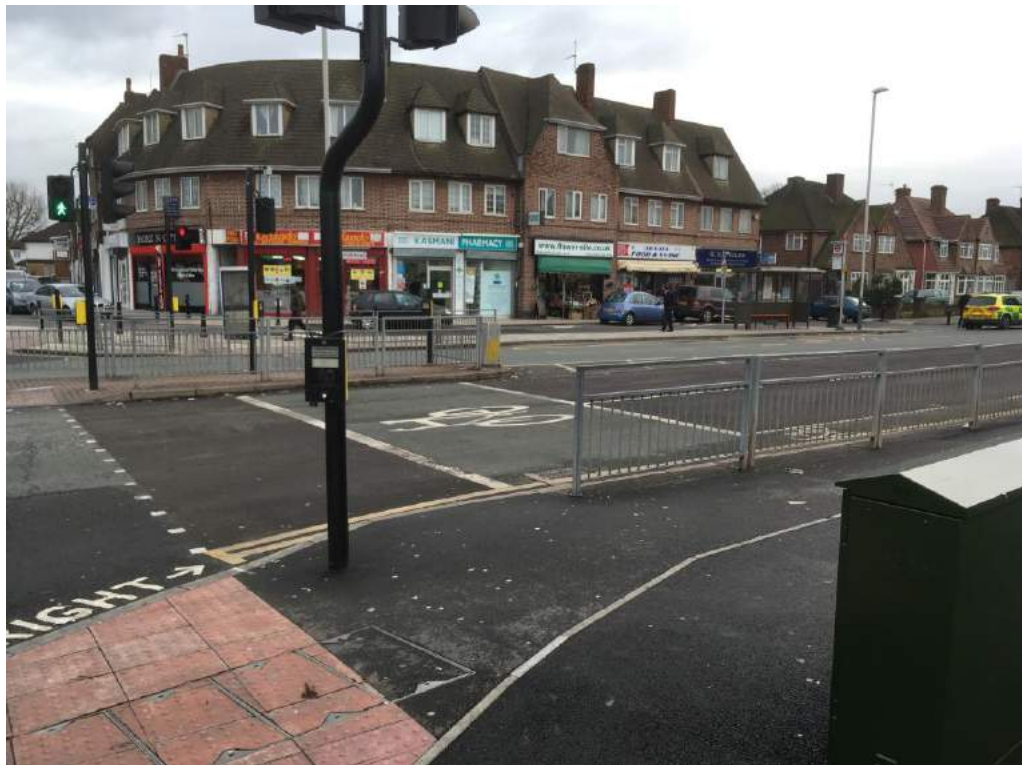
6.5 **Photo 8** identifies the Station Road / North Hyde Gardens junction (J1) which received an 'Average' (Amber) RAG score. The Station Road / North Hyde Gardens junction, is a 4-arm junction, which means the junction received a low score for delays, as on-street cyclist have to wait a while for a green light. The junction scored well for gradient, sightlines and adequate capacity is provided due to Advance Stopping Lines (ASL's) for cyclists to wait safely.

Photo 8 – Station Road / North Hyde Gardens junction (J1)

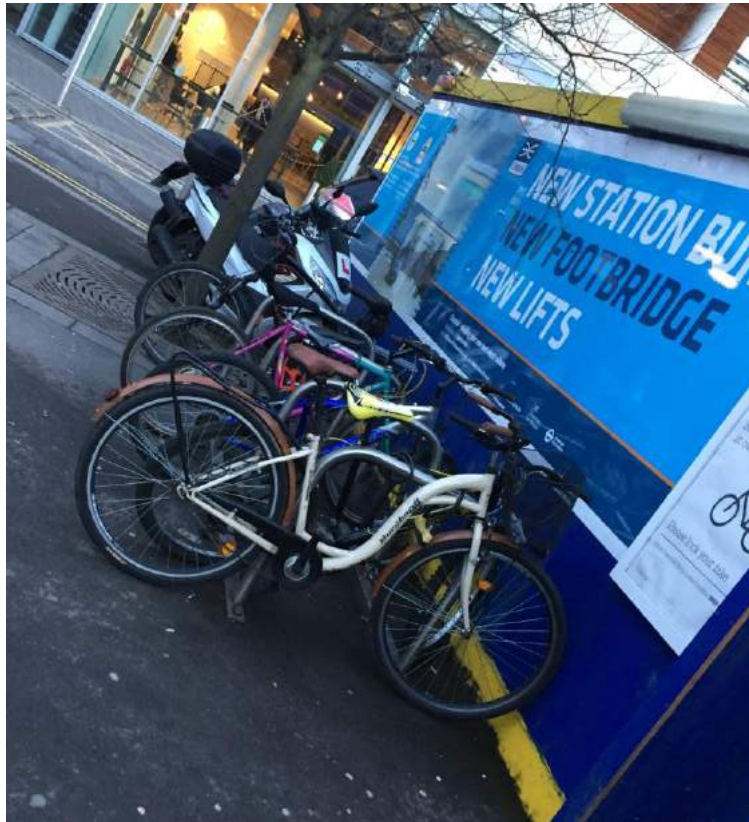
7.4 **Photo 9**, identifies the cycle parking provided at the Hayes and Harlington Station (CP1) which is located on Station Approach. The sheffield stands provided received an 'Average' (Amber) score, and received low scores for lack of availability of cycle stands. On the day of audit there were no free stands. The stands also received low scores for evidence of overspill and over parking at stands, which therefore in turn reduced the ease of use, due to overcrowding. The stands also received low scores for lack of shelters, positioning and visibility, as the stands are located on Station Approach which away from the station's main access. The cycle stands were score highly for theft and damage as there was no evidence of cycle theft or any damage to any bicycles locked to the stands on the day of audit.

Photo 9 – Lack of cycle parking availability at Hayes and Harlington Station (CP1)

7.7 In summary, and as indicated in **Table 7.1**, all of the assessed cycle parking facilities benefit from average to good parking facilities. The cycle parking located at the North Hyde parade could be improved, and the cycle parking at the Hayes and Harlington station needs an increased provision and should be sheltered to increase more sustainable modes of travel to the station.

- 8.3 Whilst the majority of the links, junctions, cycle parking facilities and interchanges areas achieved an average to good overall RAG score, some sections of cycle parking would be encouraged to be improved as presented above. Cycle parking at the Hayes and Harlington Station, as presented in **Section 7.4**, received an 'Average' score due to overcrowding and lack of availability of cycle parking spaces, therefore on that basis, increase provision would be encouraged. **Section 7.5**, also identified that the cycle parking provided at the North Hyde parade was of poor environmental quality and suffered from obstructions, ponding and litter, which should be improved.

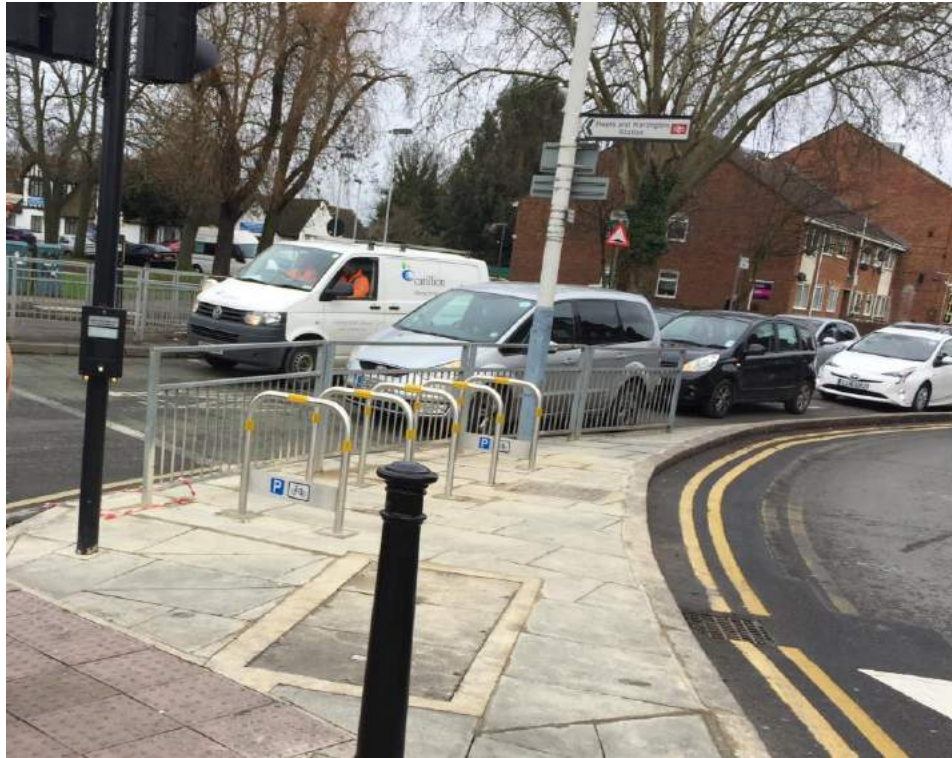
7.5 Cycle parking stands are provided on Station Road adjacent to the parade of shops at the Station Road / North Hyde Road junction (CP2) and are presented in **Photo 10**. The cycle parking facilities looked reasonably new and of high quality. The stands provided are sheffield stands, and received a 'Good' (Green) rating, due to the lack of litter, high quality durable materials and proximity to trip attractors.

Photo 10 - Station Road / North Hyde Road Junction Sheffield Stand Facilities (CP2)

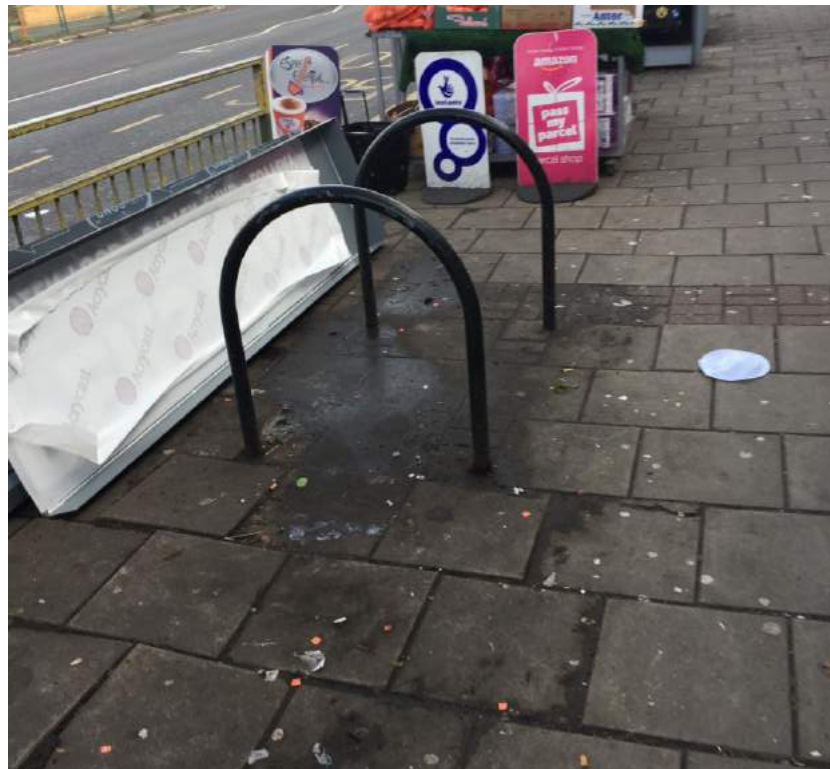
7.6 **Photo 11** presents the cycle parking provided on North Hyde Road (CP3), located adjacent to the parade of shops. This cycle parking facility was awarded an 'Average' (Amber) RAG score, and received its highest scores for its proximity to trip attractors and the sheffield cycle stands provided are suitable for context and provide adequate spacing for bicycles to be locked with ease. The cycle parking facility received a very low score due to lack of shelter and local cycling information, as well as suffering from ponding and littering around the sheffield stand which may deter people from cycling to this a parade of shops.

Photo 11 – Sheffield Stands suffering from obstructions, litter and ponding on North Hyde Road (CP3)
