**FULL STATEMENT OF CASE IN SUPPORT OF  
SECTION 78 APPEAL**

Installation of vehicular crossover to front

**269 VICTORIA ROAD, RUISLIP, LONDON HA4 9DF**

Title: MOX\_269VR\_AIA\_001

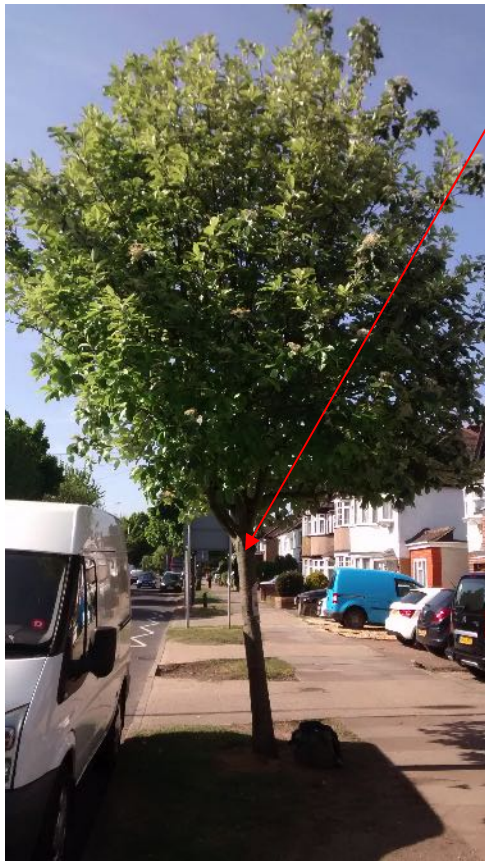
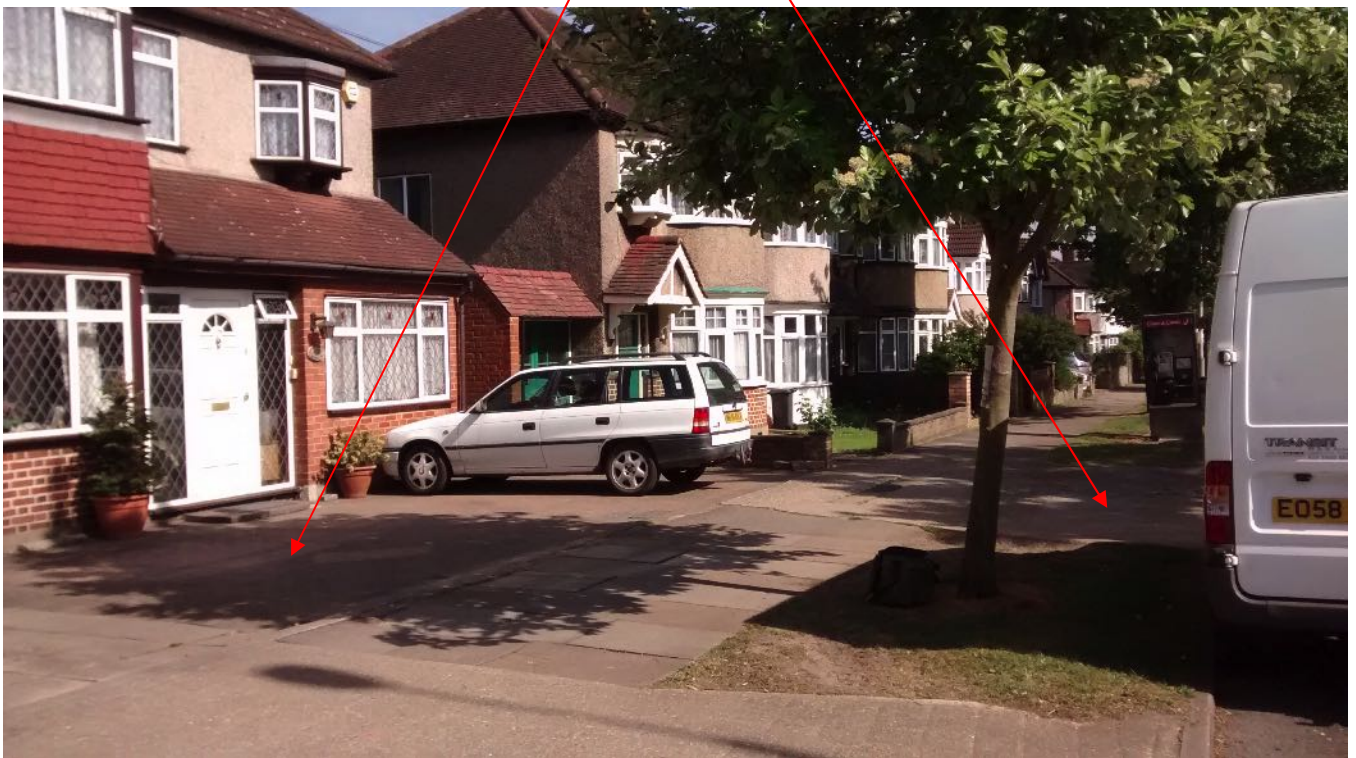
*T1 is a young Sorbus.sp street tree which features within a small grass verge in front of the property at 269 Victoria Road.*

*The property features a block paved driveway at the front for off street parking for 2 cars, which is currently accessed via a crossover on the south side of the tree.*

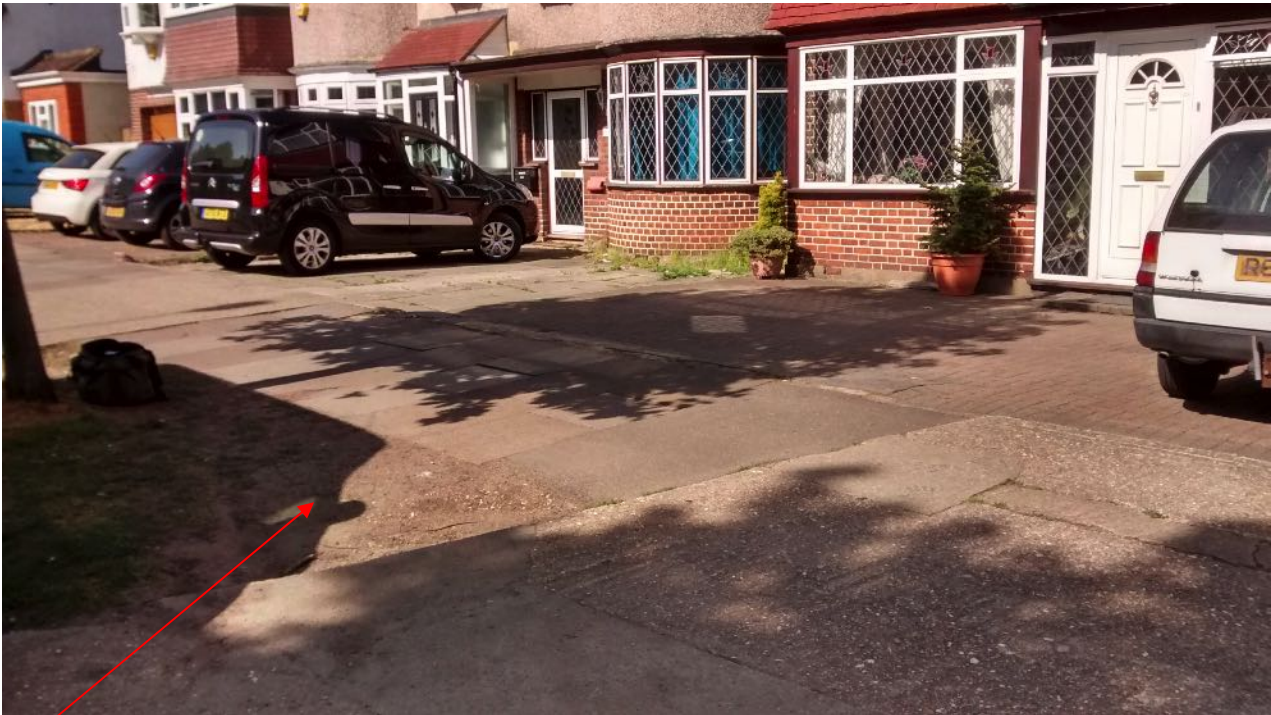
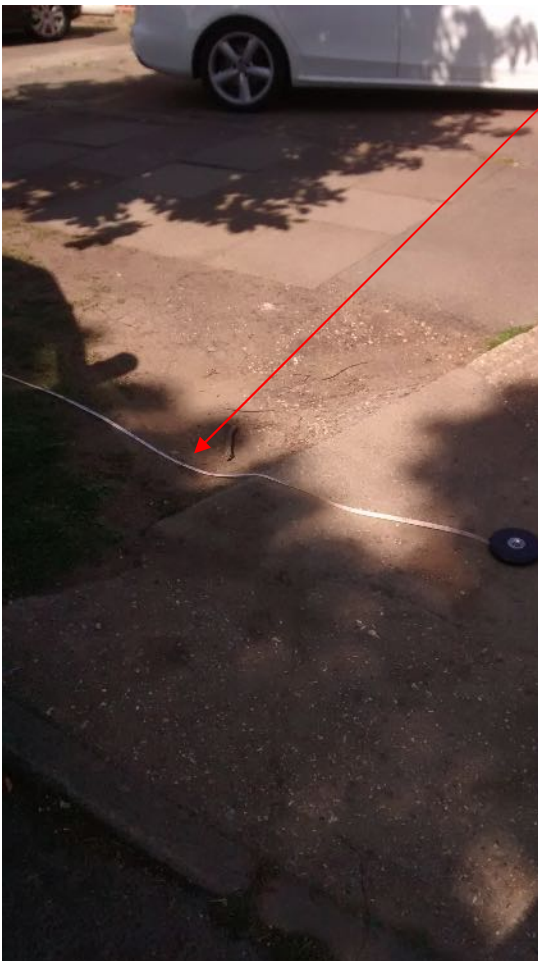
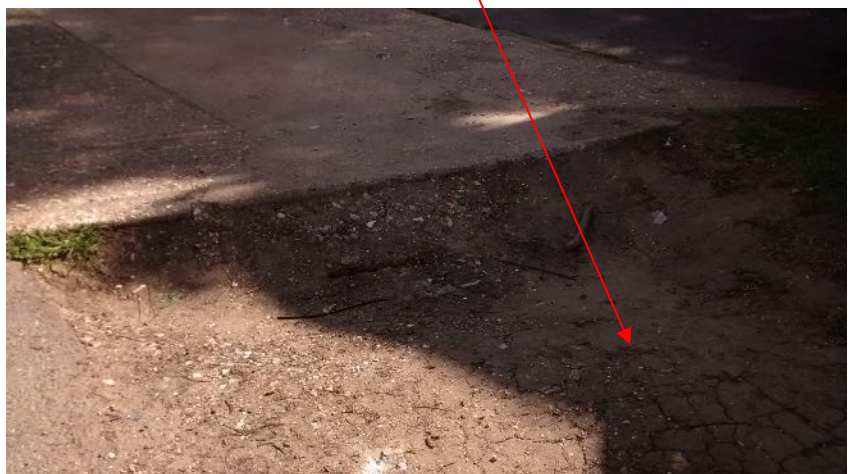
*Currently, the transit of vehicles on and off of the driveway has caused the soil in the grass verge to become heavily compacted. The proposal to widen the crossover will encroach into the grass verge and concerns have been raised by the Local Authority that the installation of new hard surfacing to widen the crossover will be detrimental to the health and safety of the tree.*

The effects of vehicle transit on and off the driveway over time can be clearly seen to have compacted the soil on the south side of the verge, where the grass has worn away and a distinctive dip has been created.

Compaction of the soil creates unfavourable conditions for root development, survival and function and is also considered as detrimental to the long term health of the tree.

Currently, access on and off of the driveway via the existing crossover by vehicles has caused compaction of the soil on the verge to the south of the tree.

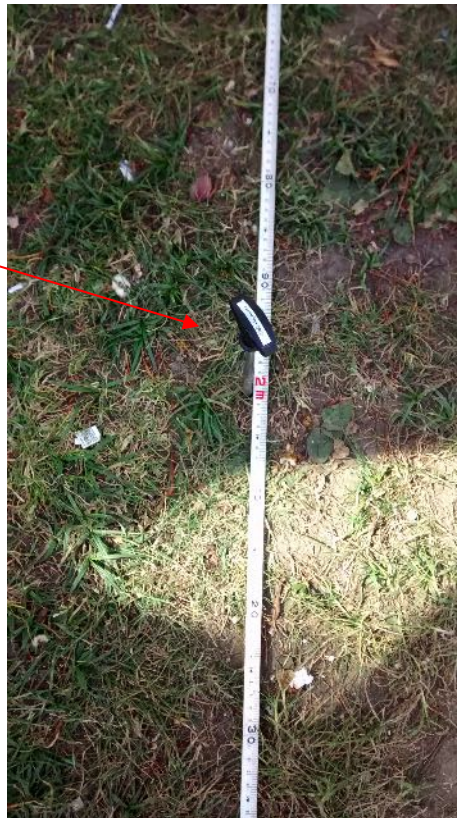
*The proposed widening of the crossover by 1.5m will encroach into the grass verge area by 400mm. This incursion equates to just 0.65m<sup>2</sup>, which is only 5% of the total calculated RPA area (13m<sup>2</sup>). (See Tree Constraints Plan and Tree Constraints Assessment in Sections 8.0 and 8.2 respectively).*

*In terms of impact on the health and safety of T1, this minor incursion at the extremity of the calculated nominal RPA circle will not adversely impact on the physiological health of the tree. Any ephemeral feeder roots which seasonally regenerate would normally be found at this extremity. However, feeder roots are unlikely to be encountered in this case, due to the compacted nature of the soil environment.*

*Precautionary measures are advised to reduce any potential for root damage or disturbance during the process. (See Sections 9.0 and 9.1).*
