Preliminary Ecological Appraisal and Roost Assessment

15 The Avenue, Ickenham, Uxbridge, UB10 8NR

This report is prepared to inform a planning application with the London Borough of Hillingdon. The proposal is described as:

The construction of a part two-storey, part one-storey side and rear extension

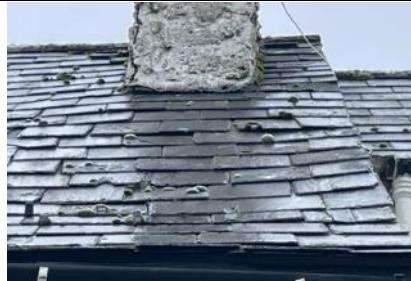
Figures 3 and 4 show the raised tiles on the southern and western elevations of B1 which could allow for crevice dwelling bats to roost.

Figure 3: raised tiles on W. elevation

<i>Recommendations</i>	<p>Roosting habitat [Buildings]</p> <p>B1: Two bat emergence/re-entry surveys are required on B1 during the active bat season (May – September) to confirm presence/likely-absence of bats roosting in or on the building.</p> <p>B3: One bat emergence/re-entry surveys are required on B3 during the active bat season (May – September) to confirm presence/likely-absence of bats roosting in or on the building.</p>

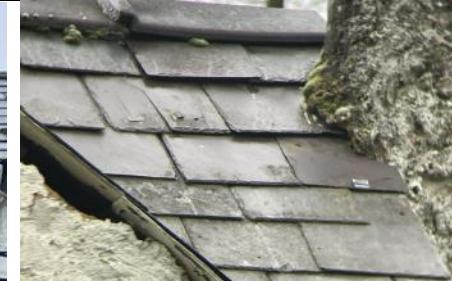
There are three dormers on B1, on the eastern, southern and western elevations. The dormers on the eastern and western elevations are in relatively good condition. However, the dormer on the southern elevation, has a raised end roof tile (as seen in figure 4) which could allow crevice dwelling bats to roost.

Figure 4: raised tiles on S. elevation

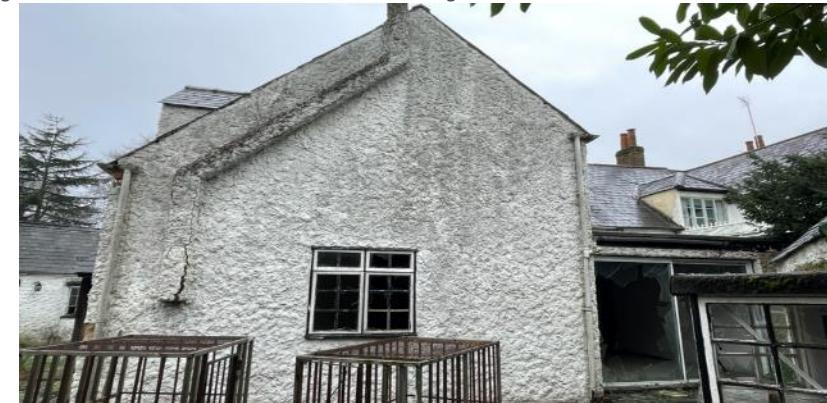
Figure 5: the eastern elevation of B1

There are three chimneys located on the roof of the building. The brickwork on the chimneys is in good condition. The render at the base of the chimney on the eastern elevation has cracked causing a gap behind the render which crevice dwelling bats could utilise.

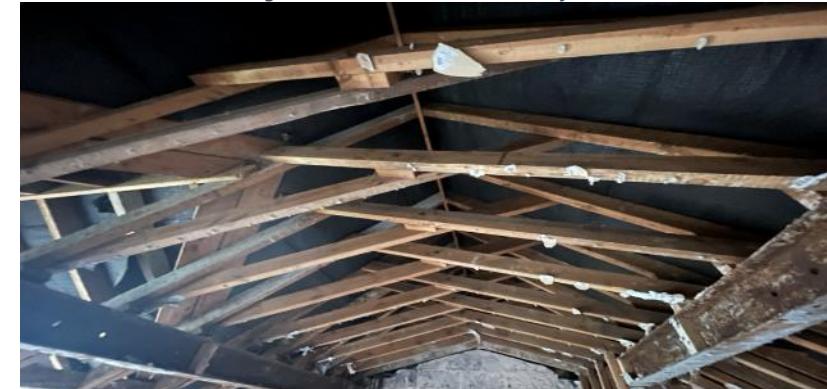
Figure 6: internally within B1

There is one loft space within the main roof void of B1. The roof structure is built from modern timber beams including the ridge beam. The roof is lined with bitumen felt which is in good condition with no gaps or tears. The building has been gutted internally, and the loft floor has been removed. There was no evidence of void dwelling bats (including droppings, fur stains, urine stains or bats themselves) within B1. However, droppings, which previously would have been on the loft floor could have been lost when this was removed. As shown in figure 6, the loft is very well illuminated by the windows on all elevations and will be prone to temperature fluctuations.

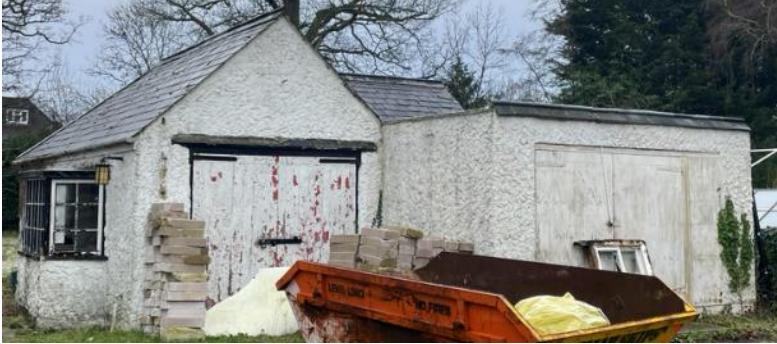
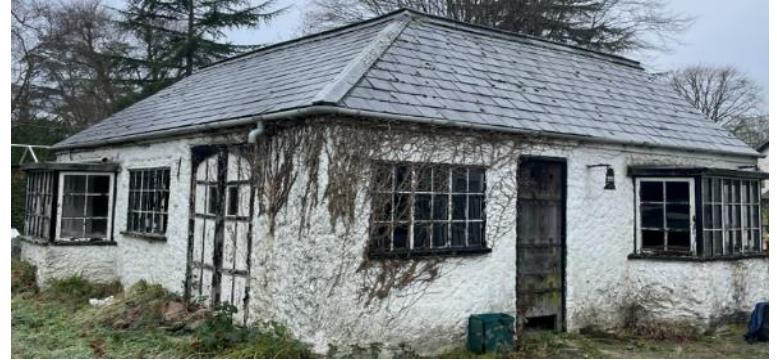
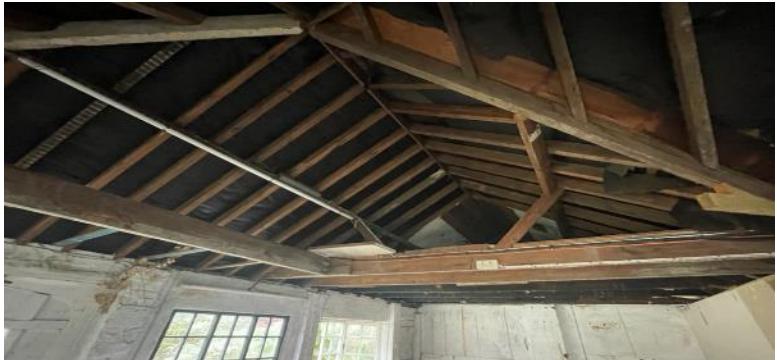
B2 Building description	Photographs
<p>B2 is a detached single-storey brick-built building with a cross-pitched and gabled roof clad in slate roof tiles. The roof tiles are in good condition with no raised tiles under which bats could roost.</p> <p>There are flat roof sections located on the western elevation of the building. The flat roofs are bitumen felt lined and are in very good condition with no gaps in which bats could roost.</p> <p>The doors and windows are wooden framed and appear in good condition with no suitable bat roosting sites.</p> <p>The brickwork around the building is rendered and appears in excellent condition with no gaps or cracks in which crevice-dwelling bats could roost.</p> <p>There are timber soffits around the building which are generally in good condition.</p> <p>The brick gable ends are all rendered and are in very good condition with no gaps around the tops of the gable ends.</p> <p>There is no loft space within B2 as the ceiling is vaulted. The roof structure is built from modern timber beams including the ridge beam. The roof is lined with bitumen felt which is in relatively good condition with no gaps. There was no evidence of void dwelling bats (including droppings, fur stains, urine stains or bats themselves) within B2. As shown in figure 9, B2 is very well illuminated by the windows on all elevations and will be prone to temperature fluctuations.</p> <p>B2 has negligible habitat value for roosting bats.</p>

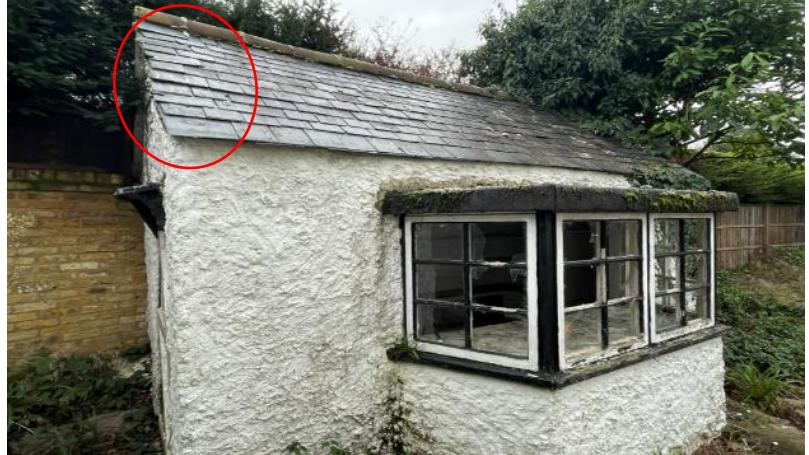
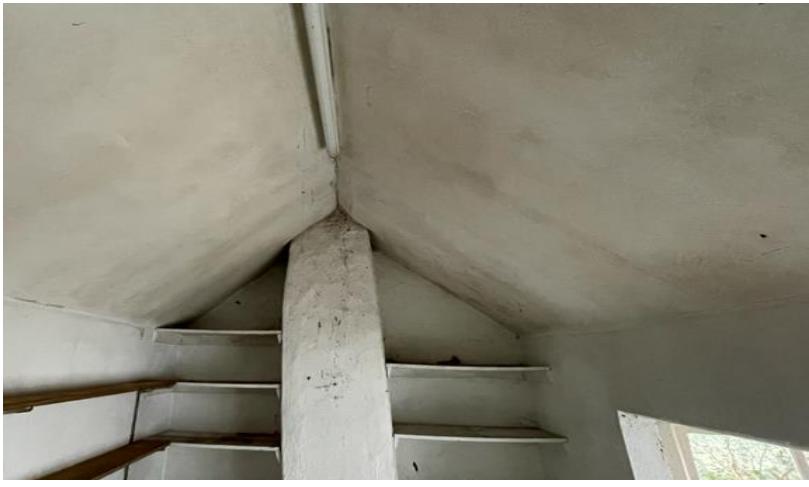
B3 Building description	Photographs
<p>B3 is a detached single-storey brick-built building with a pitched and gabled roof clad in slate roof tiles. The roof tiles are in relatively good condition with a few raised tiles under which bats could roost.</p> <p>The doors and windows are wooden framed and although, some of the windowpanes are broken, the frames are well sealed into the building. The broken windowpanes allow direct access internally into the building, however, internally there is no ridge beam for void dwelling bats to roost. Additionally, the high levels of light internally, reduces the suitability for void dwelling bats. Furthermore, the broken windowpanes will cause temperature fluctuations internally and the building will be prone to adverse weather.</p> <p>The brickwork around the building is rendered and appears in excellent condition with no gaps or cracks in which crevice-dwelling bats could roost.</p> <p>The brick gable ends are all rendered and are in very good condition with no gaps around the tops of the gable ends.</p> <p>There is a flat roof dormer located on the southern elevation of the building. The flat roof is bitumen felt lined and in good condition with no gaps in which bats could roost. There is no loft internally as the ceiling is vaulted. Additionally, B3 is plastered internally so there are no suitable roosting features for void dwelling bats.</p> <p>B3 has low habitat value for roosting bats.</p>

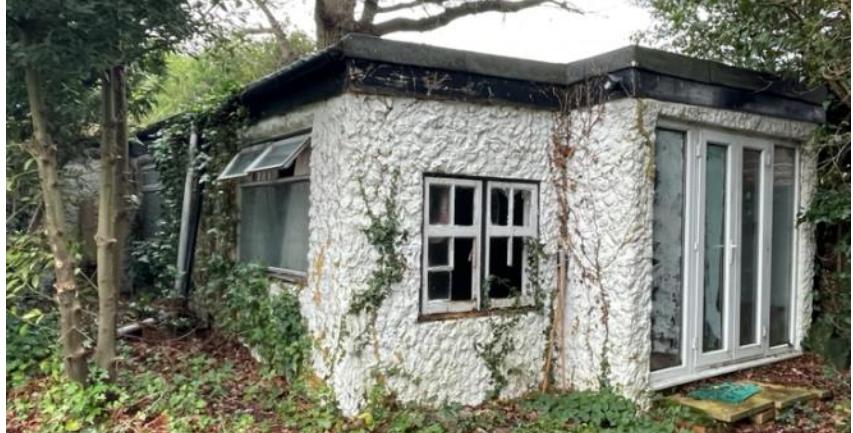
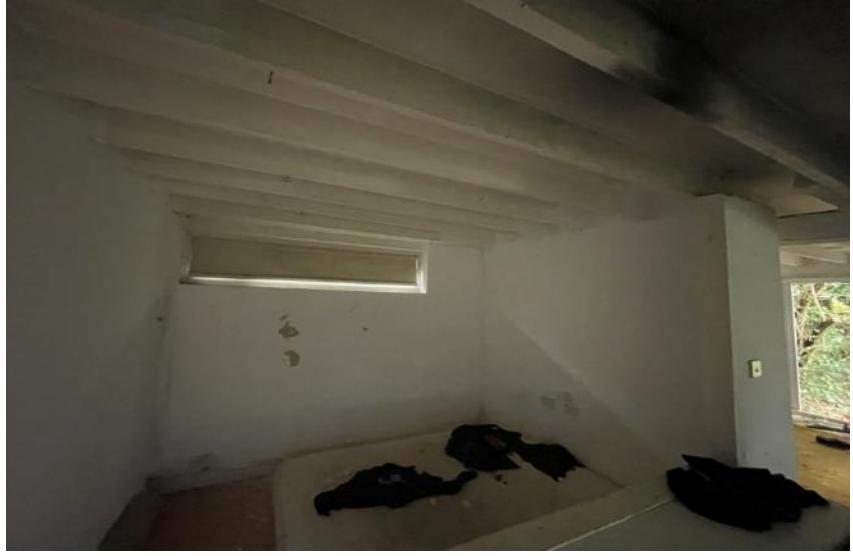
B4 Building description	Photographs
<p>B4 is a detached single-storey brick-built building with a flat roof clad in bitumen felt. The roof felting is in very good condition with no raised sections under which bats could roost.</p> <p>The doors and windows are UPVC and wooden framed and appear in excellent condition with no suitable bat roosting sites.</p> <p>The brickwork around the building is rendered and appears in excellent condition with no gaps or cracks in which crevice-dwelling bats could roost.</p> <p>There are timber soffits around the building which are generally in good condition.</p> <p>There is no loft internally within B4 as the roof is flat.</p> <p>B4 has negligible habitat value for roosting bats.</p>

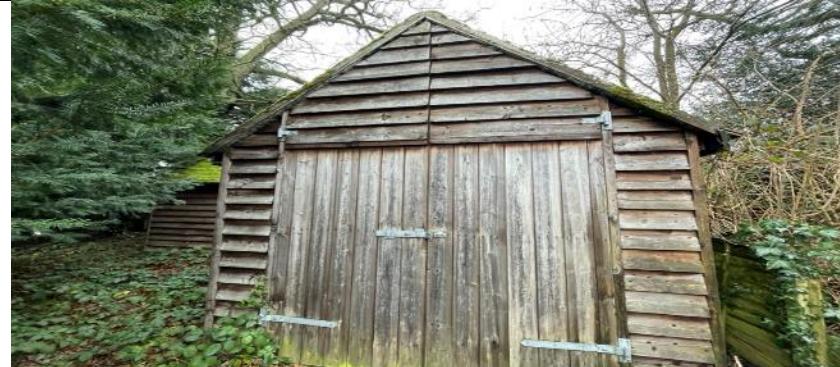
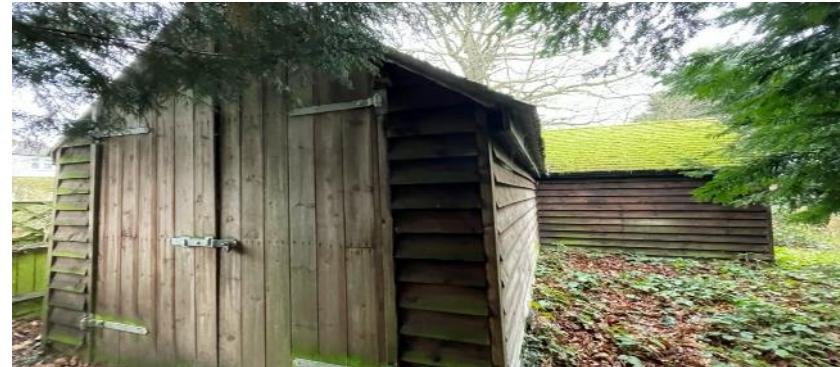
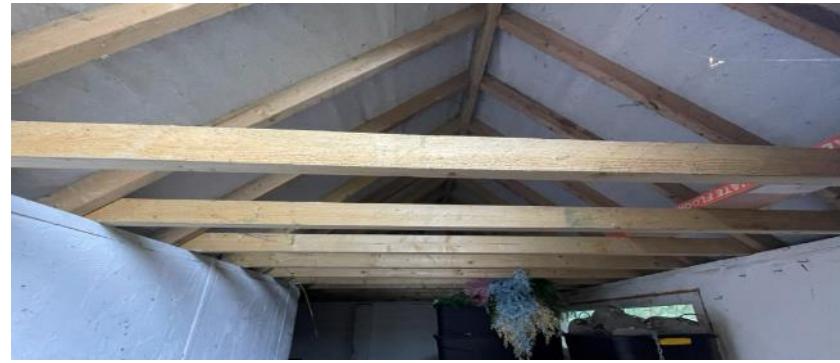
B5 is a detached single-storey wooden-built building with a cross-pitched and gabled roof clad in clay roof tiles. The roof tiles are in good condition with no raised tiles under which bats could roost.

The building is clad in wooden weatherboarding which is in good condition with no missing or raised boards under which bats could roost.

There is no loft space within B5 as the ceiling is vaulted. The roof structure is built from modern timber beams including the ridge beam. The roof is lined breathable roofing membrane which is in very good condition with no gaps. There was no evidence of void dwelling bats (including droppings, fur stains, urine stains or bats themselves) within B5.

B5 has negligible habitat value for roosting bats.

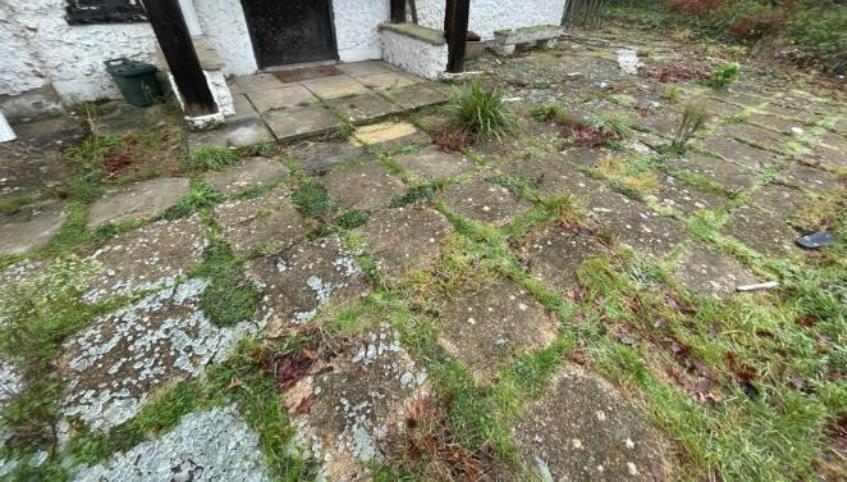
The hard standing to the south of B1
Vegetated garden	
Photograph	Description

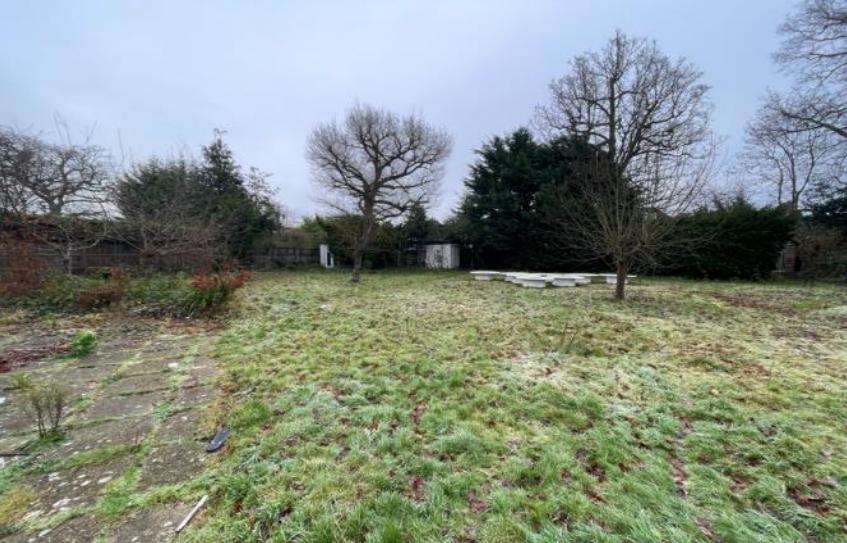
The vegetated garden to the east of the site

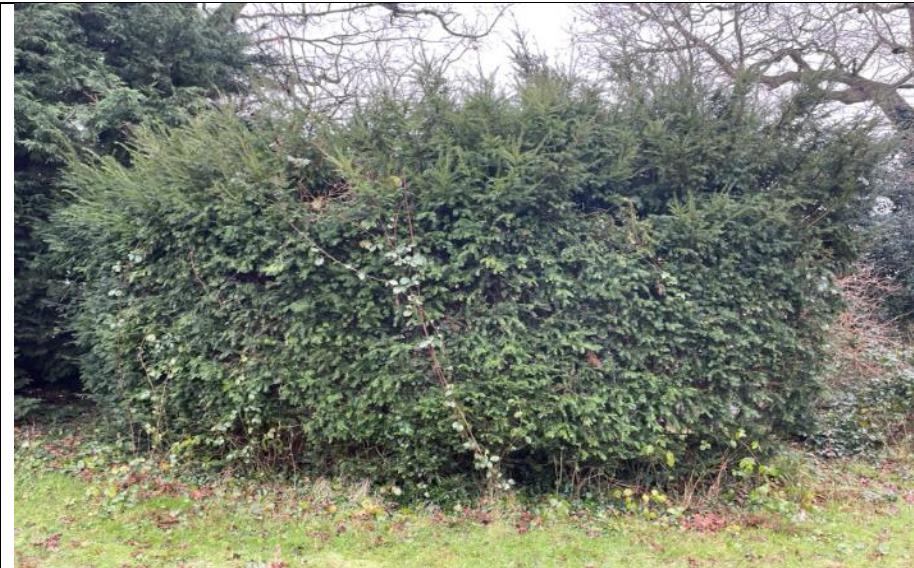
The yew hedge surrounding B5 in the south-eastern corner of the site
