Report prepared for: Oak Court Partnerships Ltd

For the Site of: Paddington Packet Boat, High Road, Cowley, Uxbridge, UB8 2HN

Preliminary Roost Assessment (PRA)

The following report details the findings and recommendations for the site of Paddington Packet Boat, High Road, Cowley, Uxbridge, UB8 2HN.

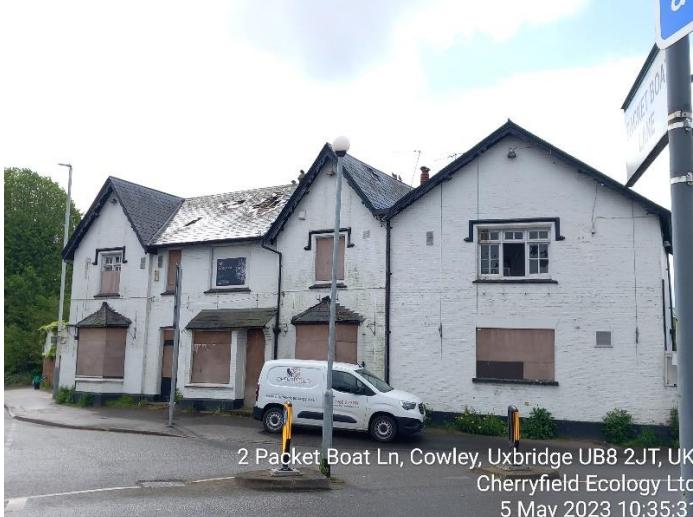
Building/Tree/Structure Number	Description
B1	<p>External</p> <p>The pub has been unused for approx. 3 years (based on anecdotal evidence) and is in a state of disrepair with large holes in the roof and ceilings. The roof is a series of gable ends and valleys, covered in slate roof tiles with lead flashing over the ridge. There are a number of chimneys present and decorative timber fascia boards over the eaves.</p>

<p>2 Packet Boat Ln, Cowley, Uxbridge UB8 2JT, UK Cherryfield Ecology Ltd 5 May 2023 10:35:31</p> <p>Figure 2: Front elevation of B1</p>

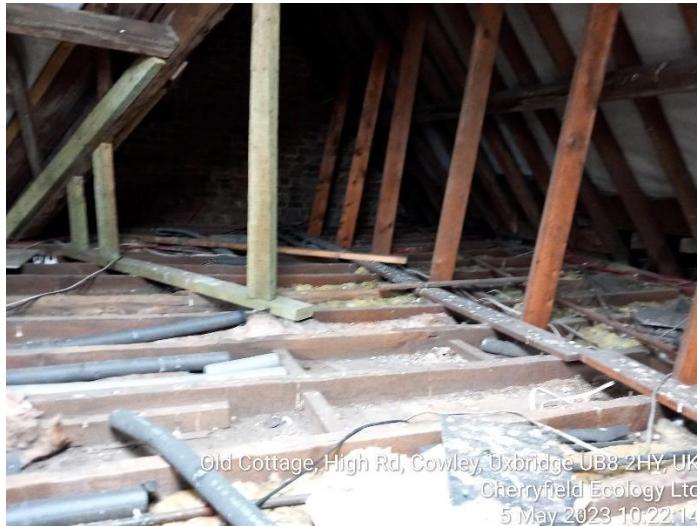
Within, the roof is lined with a MRM type lining. Pigeons are nesting in the roof space, and as there are large holes within the second floor ceiling, pigeons are also occupying a number of the upstairs rooms.

Figure 3: Example of loft void in B1

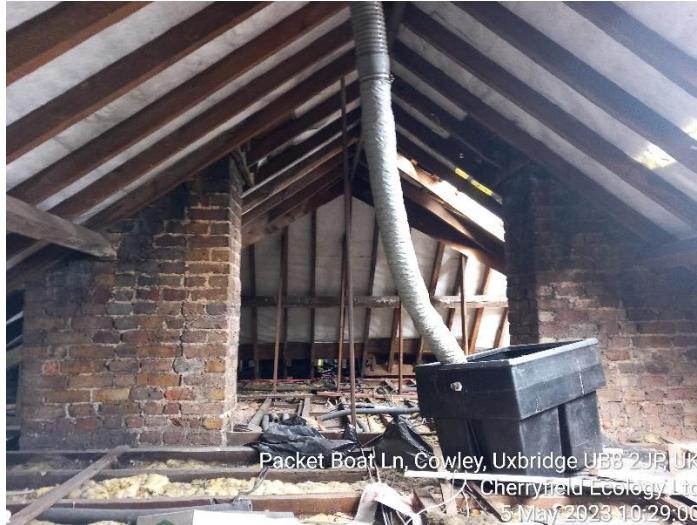
Figure 4: Example of loft void in B1

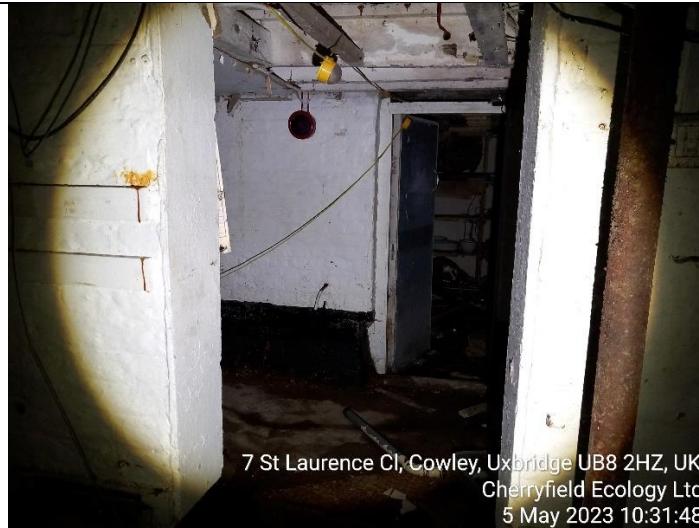
A cellar is also present, accessed from within the building.

Figure 5: Example of cellar within B1

The cellar has some suitable crevices, however, the only access observed was via the internal stairway.

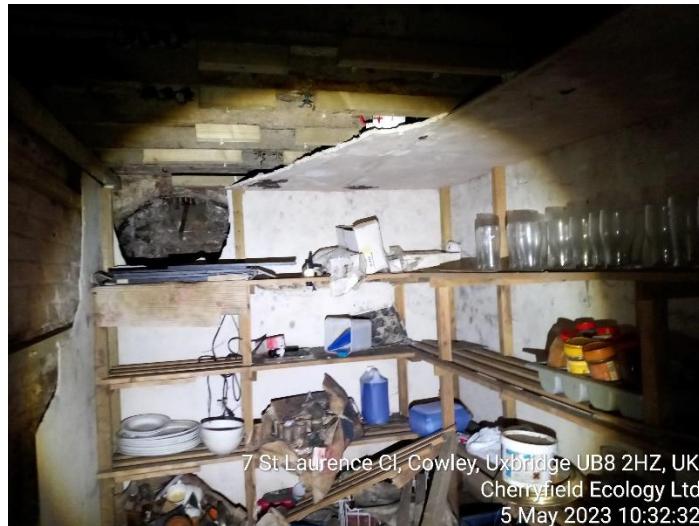
Example 6: Example of cellar within B1

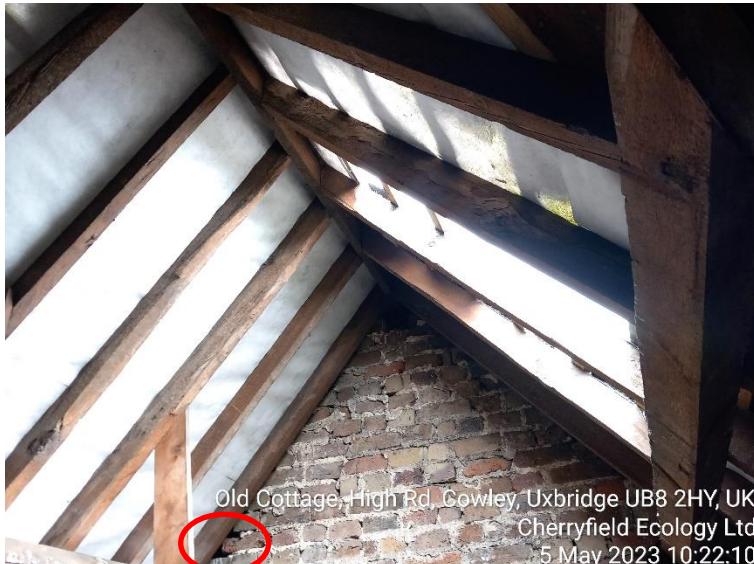
There are numerous large gaps within the roof due to damage, providing suitable access to the interior and access to the space between the tiles and the lining.

Additionally, within the loft void there were some suitable crevices found within the brick walls and the more sheltered areas of the roof could be suitable for void dwelling bats.

However, the roof void is largely well lit from daylight due to the holes within the roof and as the surroundings are of an urban nature, there are street lights situated immediately adjacent to the building.

Figure 7: Large hole in roof and potential suitable crevices within brick wall

B1 - Presence/Likely Absence surveys will be required (two surveys, a minimum of two weeks apart).

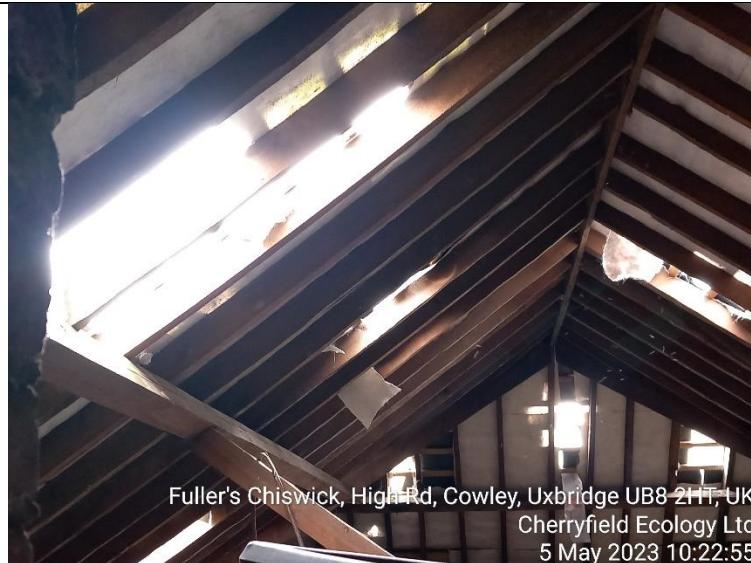
Figure 8: Further example of holes in roof

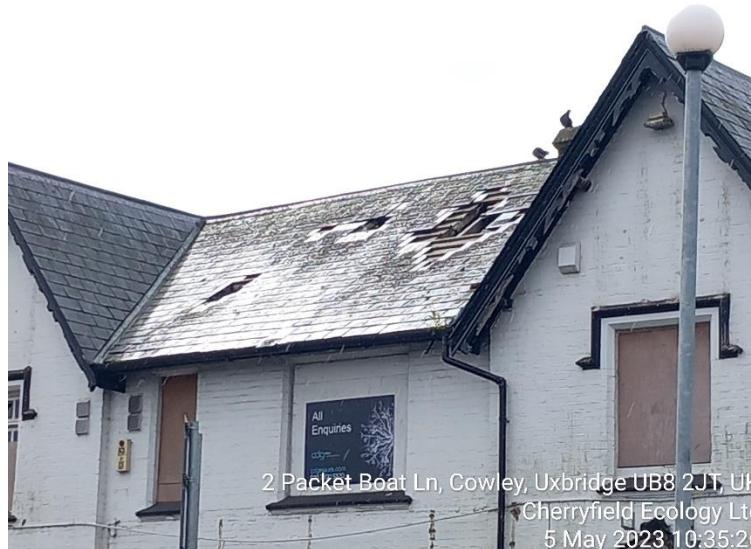
Figure 9: Holes shown in the exterior, with potential access to the space between the tiles and the lining

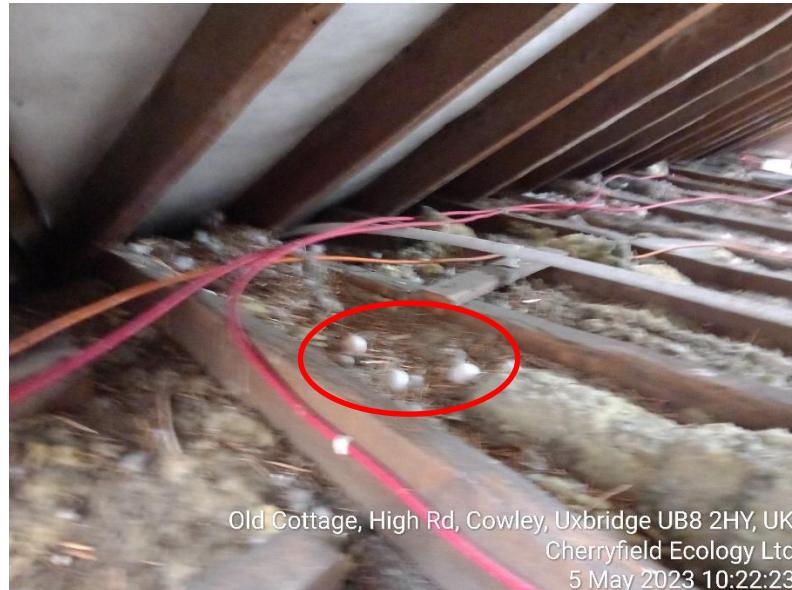
Pigeons are using the building to nest, with active nests observed at the time of the survey.

Figure 10: Pigeon eggs present within the loft void

No further surveys are recommended; however, the development should take place outside the nesting season (March to August). If this is not possible, it is recommended that a qualified ecologist is on site to ensure the building/vegetation is not occupied by breeding birds, prior to demolition/clearance. Should an occupied nest be found, a buffer zone would need to be created until the nest is no longer in use.

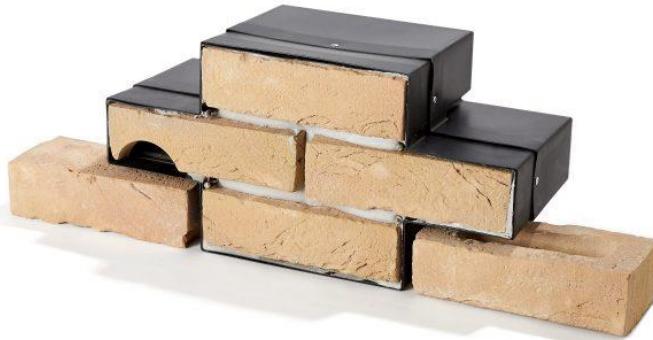
- Integral swift bricks are the preferred option on new housing developments. These should be fitted in clusters of 2 to 4 on gable ends and near the roofline where swifts would naturally look for a potential nest site. On larger commercial buildings include one swift brick per 6 m² of wall, mounted near the roofline, in clusters of 3 or more, with approximately 1m between entrance holes.

Figure 17: Example of swift bricks, that can be built into a dwelling, Source:
<https://www.birdbrickhouses.co.uk/brick-nesting-boxes/>

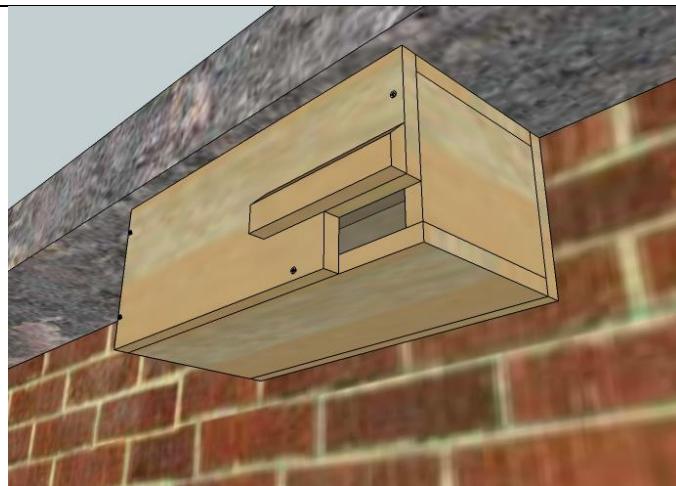
- Alternatively, swift boxes can be placed on the external walls of a building when a restoration or opportunities don't exist to build in the boxes.

Figure 18: Swift box, source: <http://actionforswifts.blogspot.com/p/diy-swift-box-designs.html>
