Phase I Desk Top Study Report

830
Uxbridge
Road,
Hayes,
UB4 0RR

Ref: 17-3077

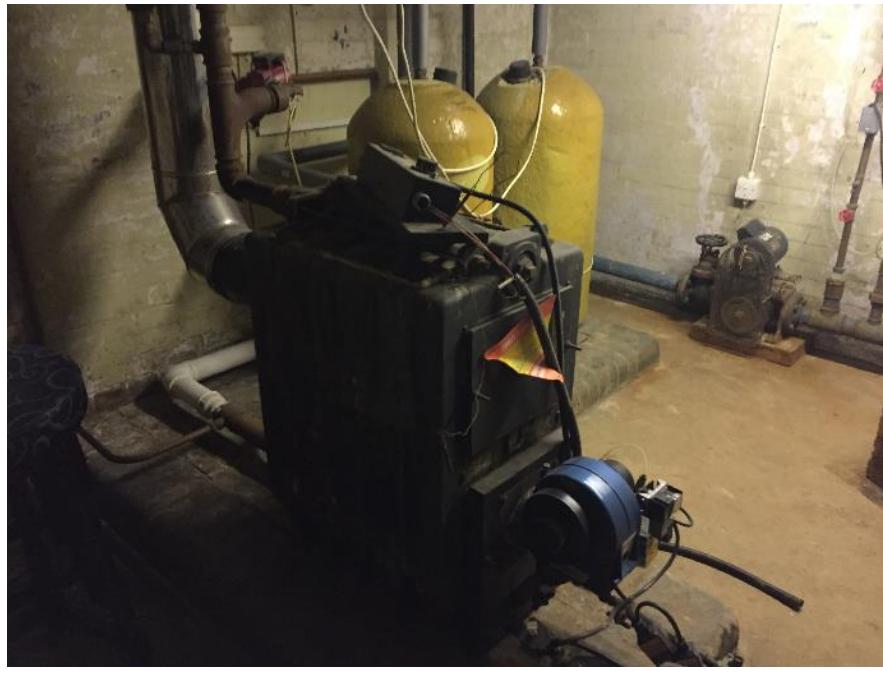
At the time of the walkover, the site was divided into two (2no.) separate land uses. The first site use was the Adam and Eve Public House located within the southern area of the site fronting onto Uxbridge Road. The building comprised an irregular shaped two-storey brick built public house. The building was in a generally good visual state of repair with no significant aesthetic damage noted. Adjoining the public house to the north was a single storey brick built function room, also in a generally good visual state of repair. To the south of the Adam and Eve public house, adjacent to the main entrance, an area of outside seating area was present with multiple tables. A boiler room was present within the interior of the public house, housing a disused boiler with two (2no.) yellow water tanks.

Photograph 1 – Interior of the basement of the Adam & Eve Public House, housing boiler room

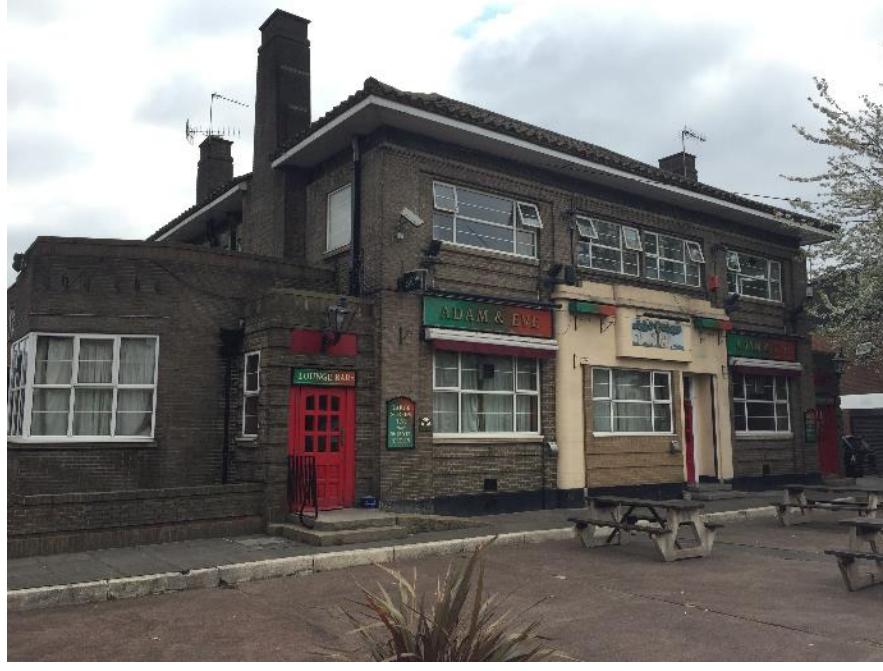
Photograph 2 – Orientated north-east showing the front exterior of the Adam & Eve Public house

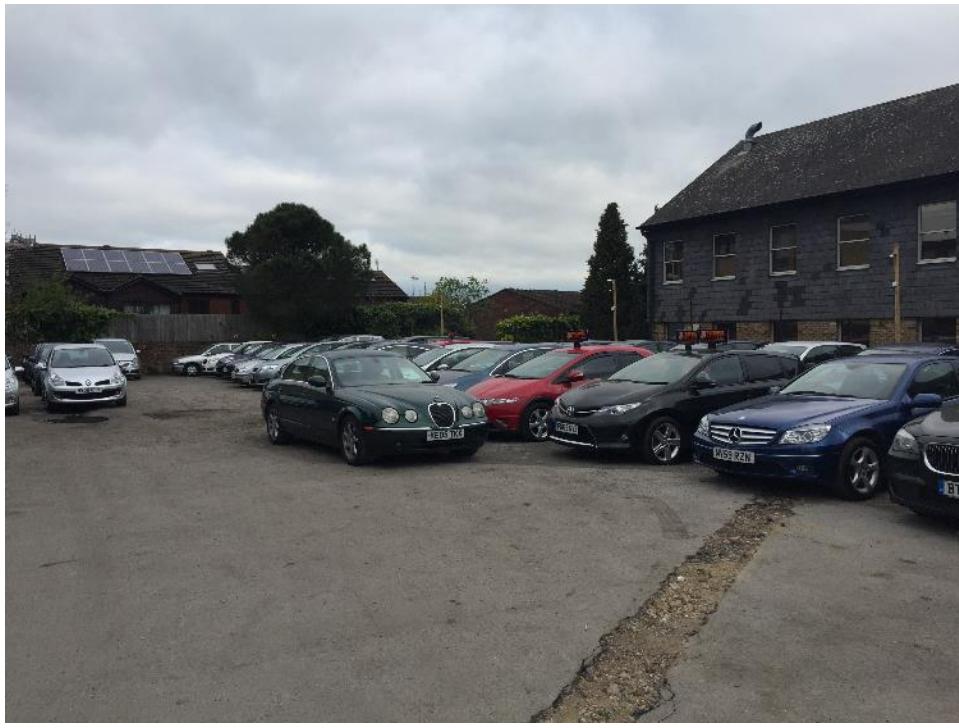
The area of the site utilised by Heathrow General Cars, the northern area of the site was surfaced by asphalt hardstanding. The condition of the hardstanding was in a relatively good state of repair, with notable potholes located within the north-western area of the site. The main site activities were the parking of vehicles for sales purposes with an area within the western portion of the site utilised as a cleaning bay, where the vehicles would be sprayed down and washed.

Surface water was present within the Heathrow General Cars area of the site associated with the deteriorated areas of hardstanding.

Photograph 3 – Orientated north-west showing the northern area of the site with visible surface scarring.

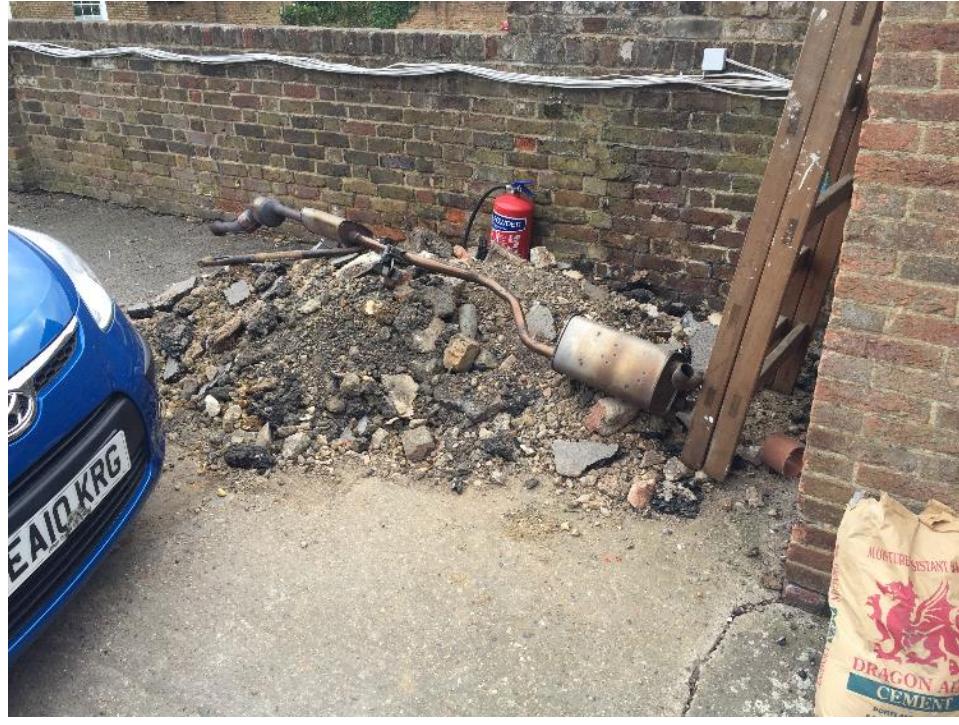
Waste storage was identified within the centre of the site adjacent to the public house, along the east of the building. This was noted to comprising multiple recycling and general waste bins. Within the area of the site utilised by Heathrow General Cars a small heap pile of debris was present, and included a vehicle exhaust pipe.

Photograph 4 – Orientated north-east showing stockpile of debris and vehicle parts located within the northern area of the site.

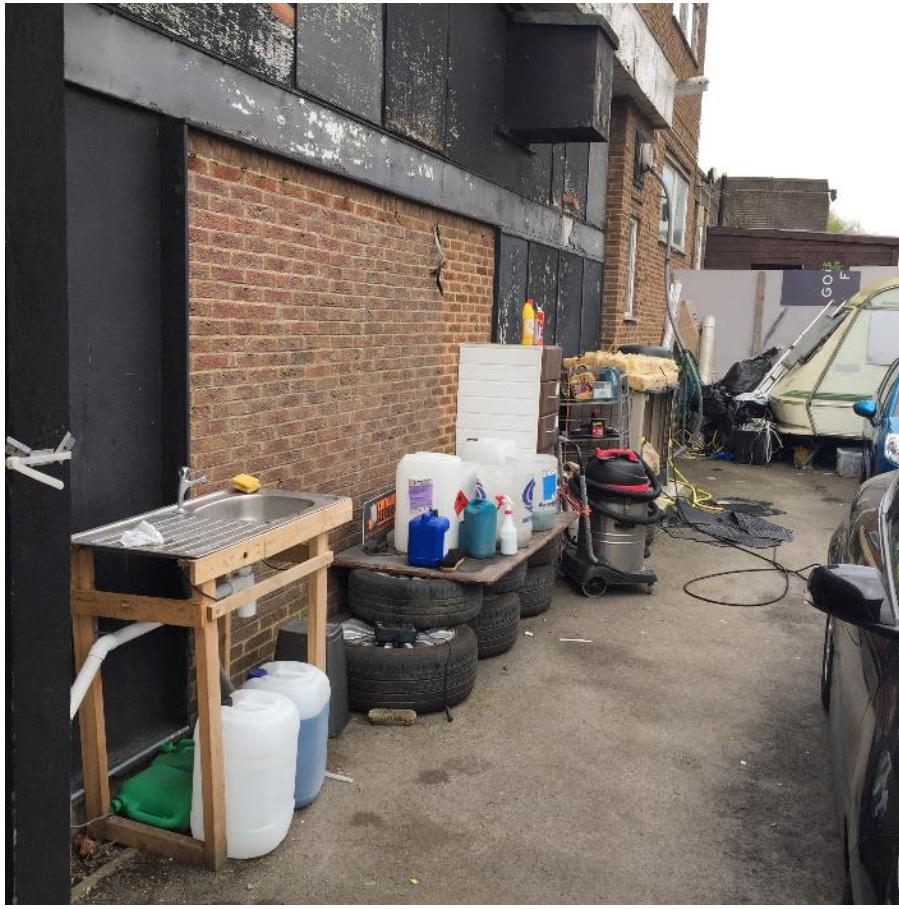
Hazardous materials were noted within the north-western area of the site during the site walkover within the area utilised by Heathrow General Cars. The materials identified included a mixture of industrial cleaning products which were observed to be stored in containers ranging from <1 litre to 25 litres in volume and were used for cleaning vehicles prior to display.

Photograph 5 – Orientated south showing area utilised as a vehicle cleaning area located within the north of the site.
