**Preliminary Roost Assessment (PRA) Associated with
98 Evelyn Avenue, Ruislip**

Kraig Morbey

11th May 2026

RBM_0417

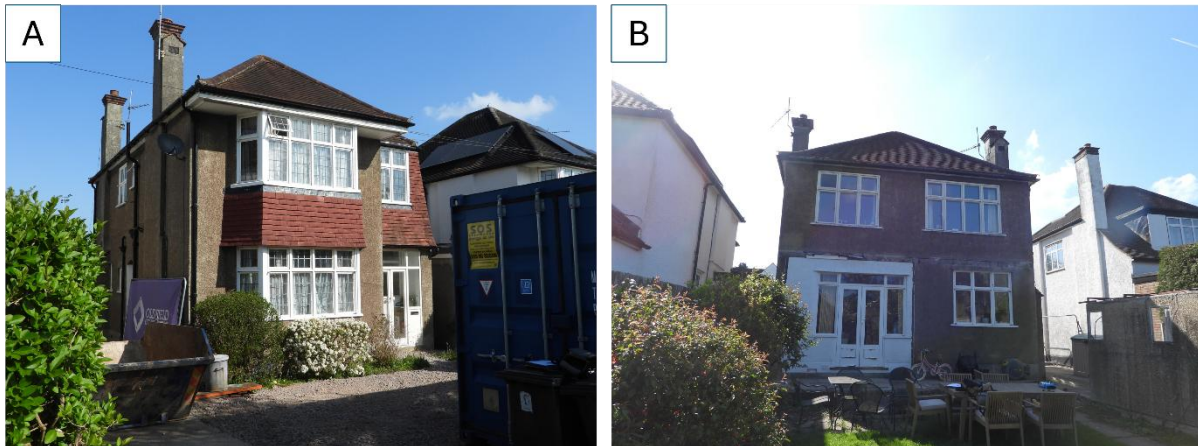
The principal (front) elevation exhibits characteristic interwar suburban architectural detailing, including prominent canted bay windows at ground and first floor level with tile-hung cladding beneath the upper bays. White-painted timber or uPVC-framed multi-pane windows are present throughout. Rainwater goods appear to be modern replacement plastic fittings. The property is set back from the road behind a gravel driveway.

The rear elevation is comparatively plain and includes a central rear projection/extension at ground floor level incorporating glazed doors and flat or shallow-pitched roof elements. The rear garden is enclosed by neighbouring residential properties and boundary vegetation. The roof structure appears uninterrupted across the main ridgeline, with soffits, fascias, and eaves visible around the roof perimeter.

Figure 2: A) Front / southern, B) back / northern elevation of 98 Evelyn Ave, Ruislip

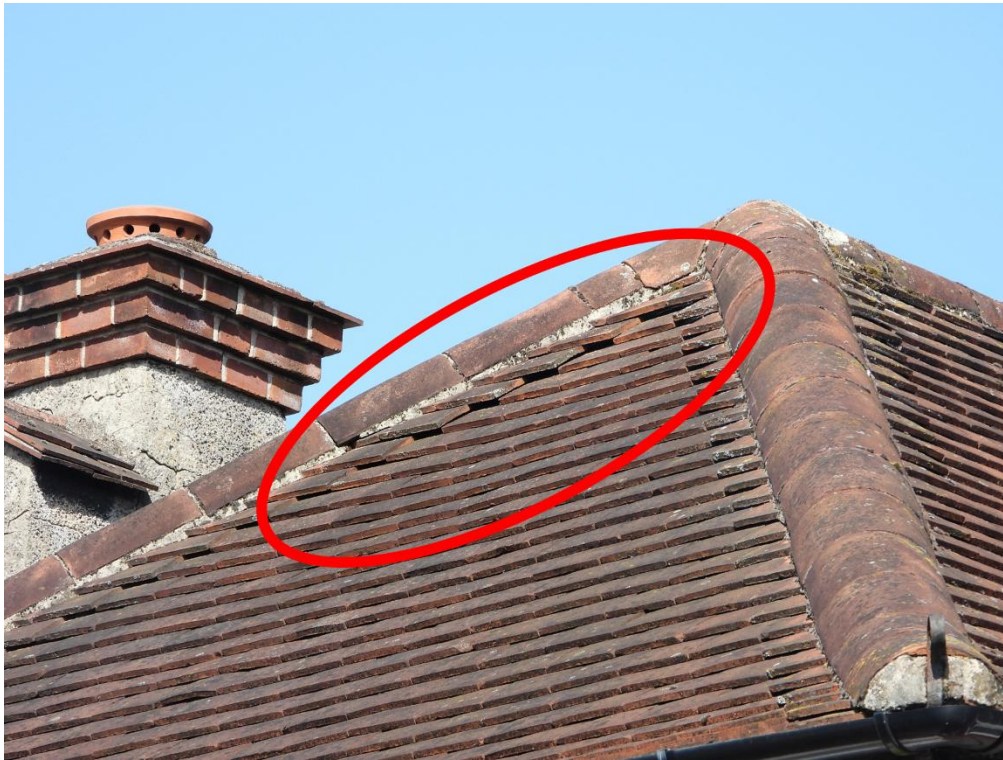
PRFs observed on the southern façade comprised gaps under roof tiles (Figure 6).

Figure 6: PRFs noted on the southern façade of 98 Evelyn Ave Ruislip

Current guidance recommends at least one dusk emergence or dawn re-entry survey to confirm the likely absence of bats and to ensure compliance with wildlife legislation before works proceed.

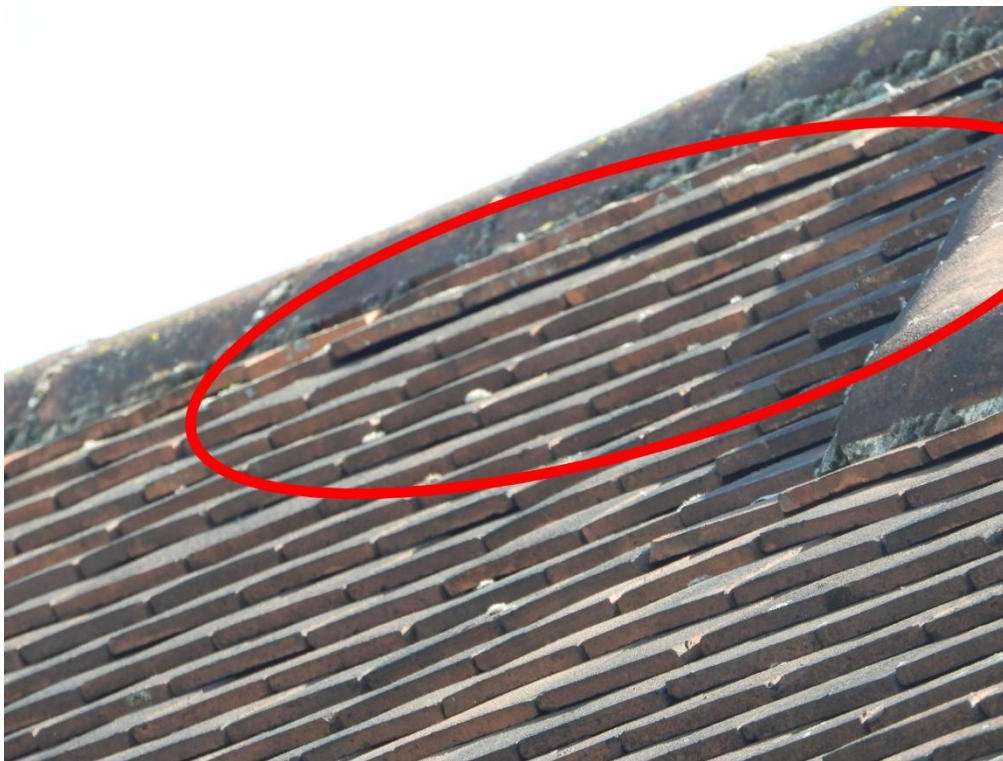
PRFs observed on the western façade comprised gaps under roof tiles (Figure 7).

Figure 7: PRFs noted on the western façade of 98 Evelyn Ave Ruislip

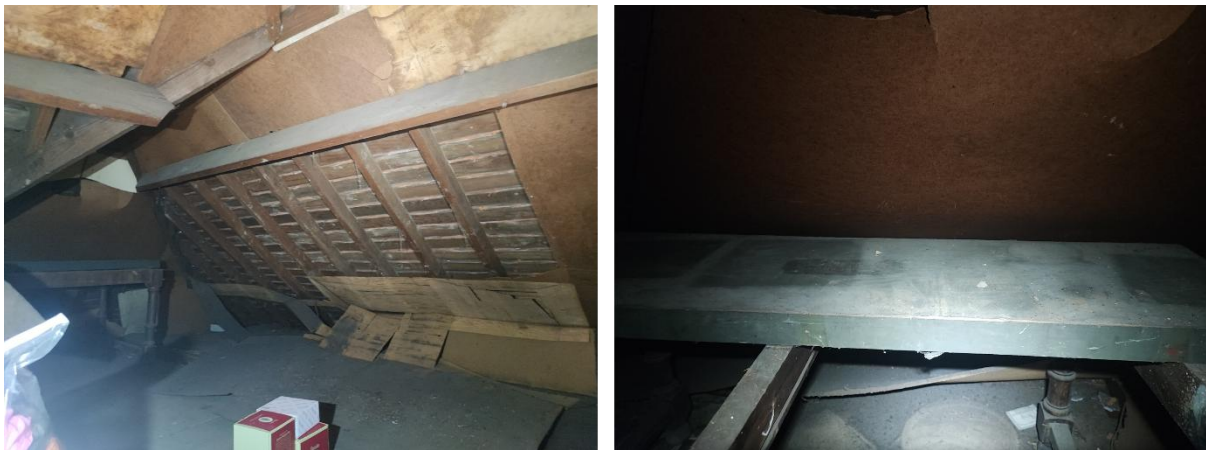
No bat droppings were observed in the loft space at 98 Evelyn Ave Ruislip. No bat feedings signs (moth wings), living or dead bats were observed in the loft space.

Figure 8: View of internal loft space at 98 Evelyn Ave Ruislip
