Arbtech Consulting Ltd  
HQ  
3, Well House Barns  
Chester, CH4 0DH  
01244 661170

14 August 2021

**Report of Preliminary Bat Roost Assessment at 78 The Drive, Ickenham, Uxbridge, Middlesex, Greater London, UB10 8AQ.**

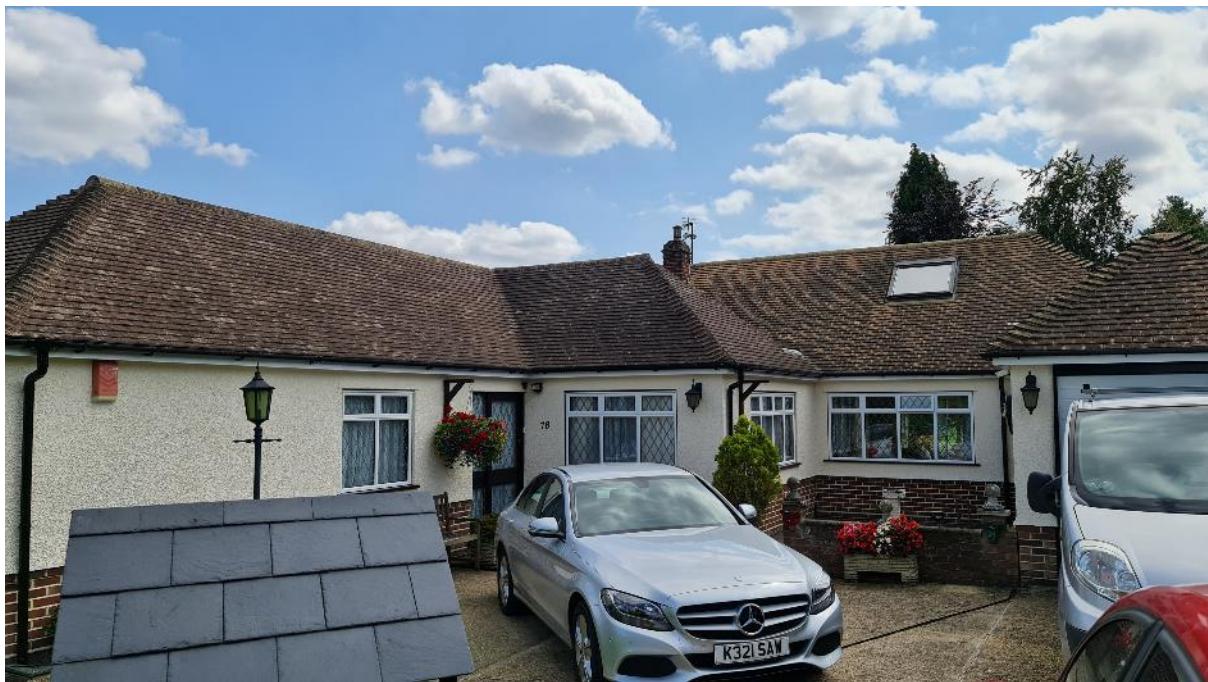
Figure 1: Northern elevation, facing south-east, with secure windows, doors and concrete tiled roof. Rendered brickwork appears in excellent condition.

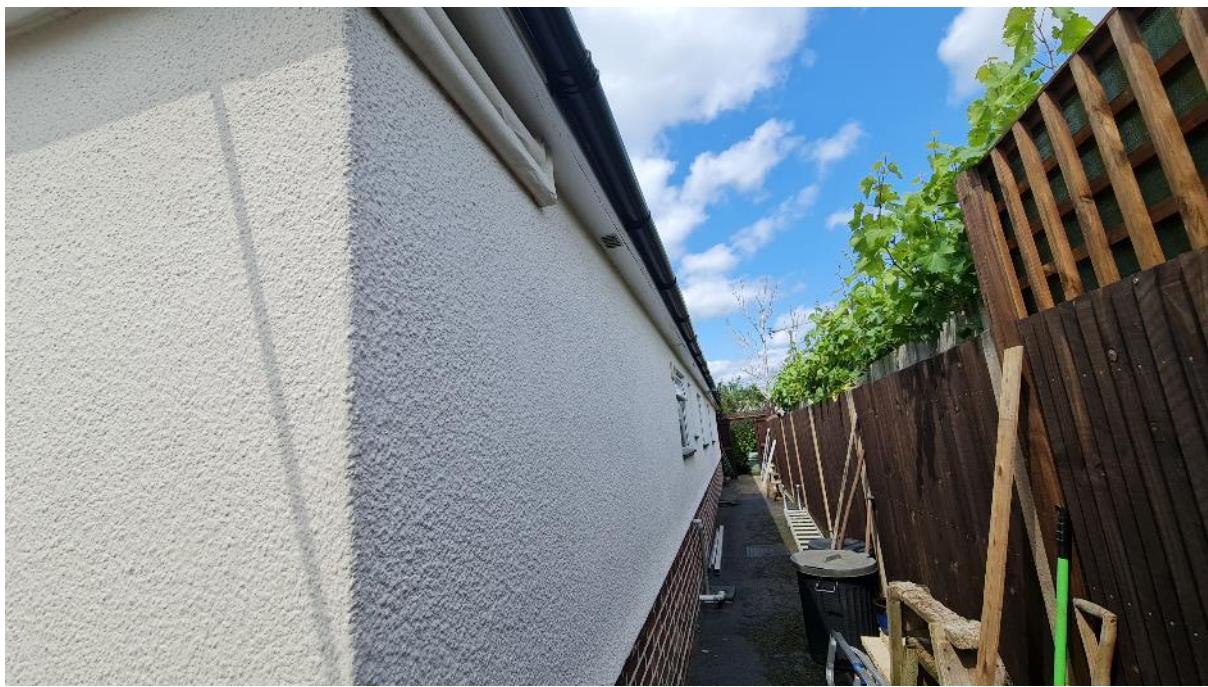
Figure 2: Eastern elevation with UPVC soffits and fascia in good condition, in addition to the rendered brickwork which appears to be in excellent condition with no gaps or cracks.

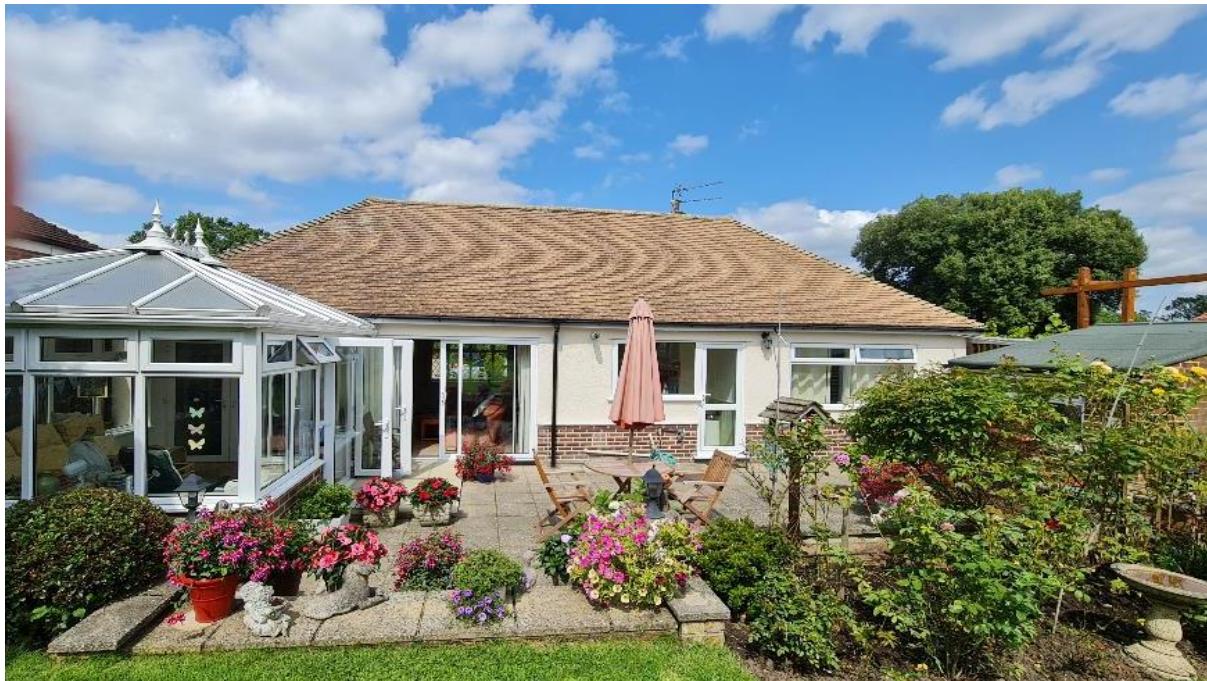
Figure 3: Southern elevation, with no damage to the rendering on the bricks, cracks or gaps. There soffits and fascia on the building are flush with no means of ingress and no evidence of bats. The roof tiles are in good condition, with no gaps, slipped or missing tiles. The conservatory is well-sealed too with no means of ingress.

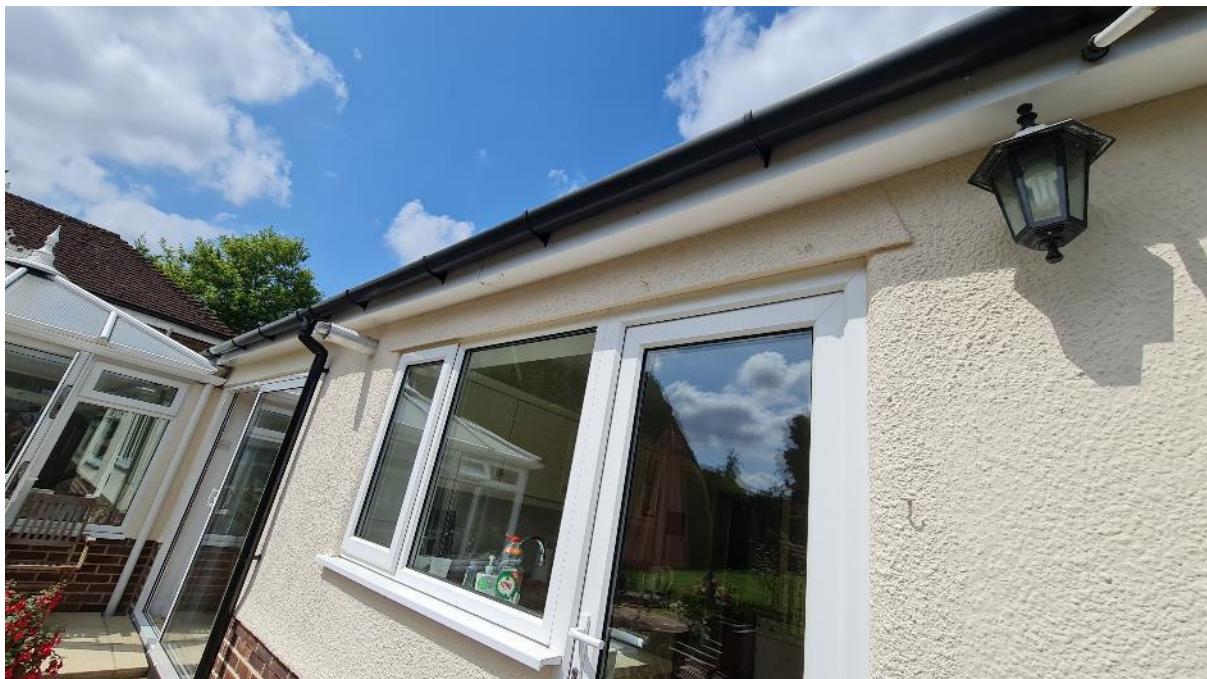
Figure 4: The UPVC windows, doors, soffits and fascia all appear to be in good condition with no gaps or means of ingress.

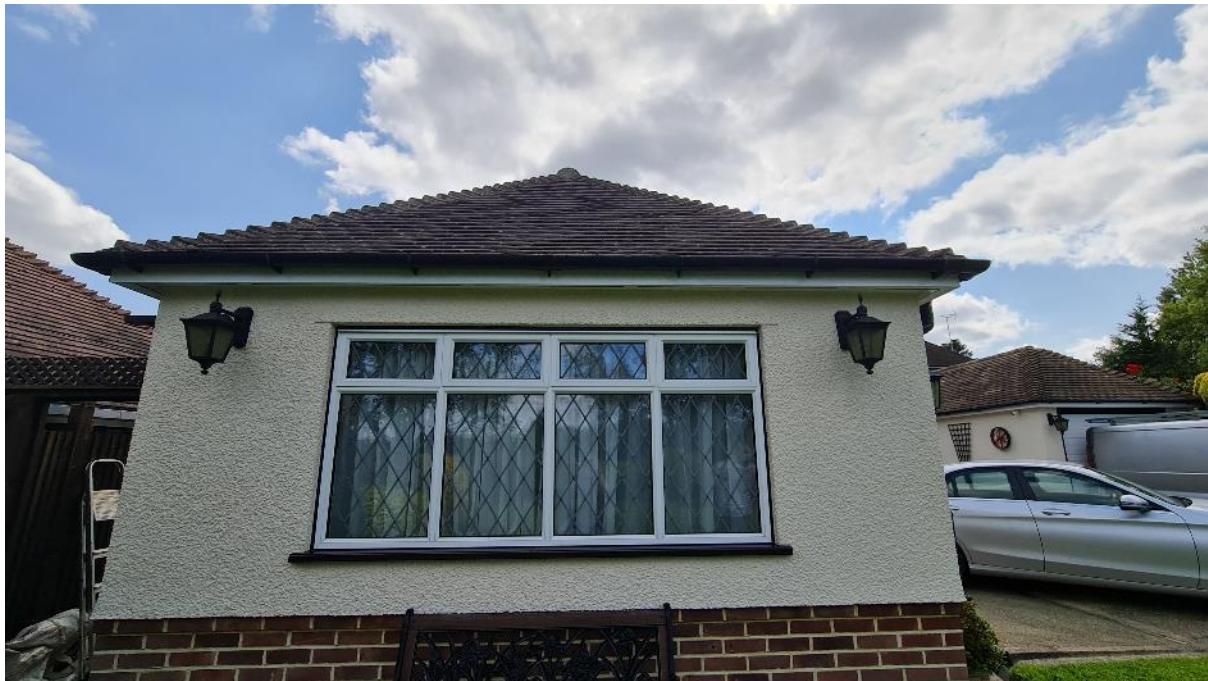
Figure 5: Northern elevation, with secure rendering on the brickwork, secure windows, and tiles all appear to be in good condition.

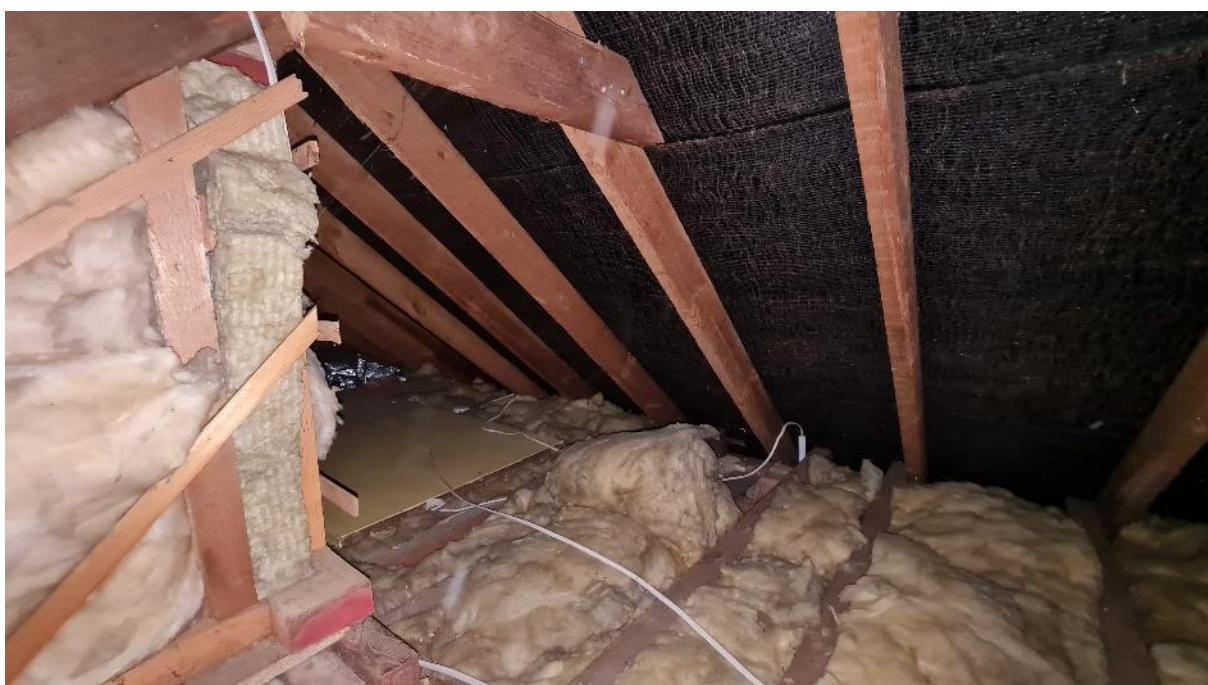
Figure 6: Loft space L1. Some boards for access and roll insulation across the loft space. Modern timbers present and black membrane lining the roof. There are cobwebs on the ridge of the loft space, no light entering from outside and no evidence of bats observed.

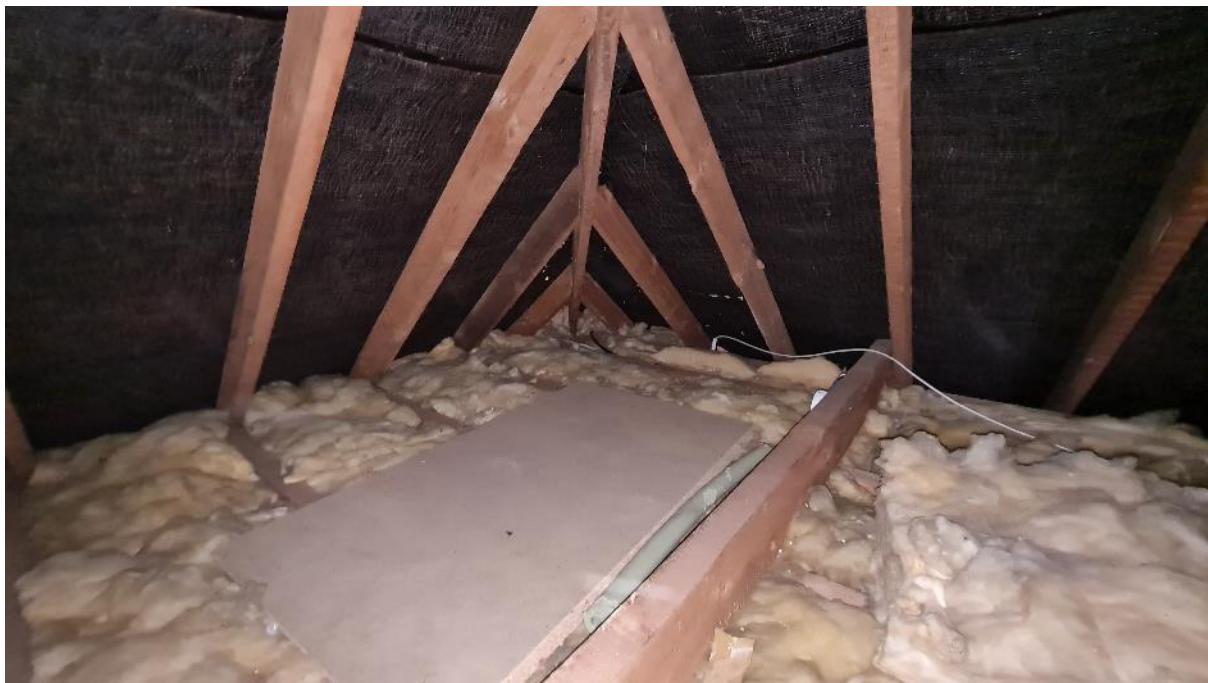
Figure 7: Loft space L1. Some boards for access and roll insulation across the loft space. Modern timbers present and black membrane lining the roof. There are cobwebs on the ridge of the loft space, no light entering from outside and no evidence of bats observed.

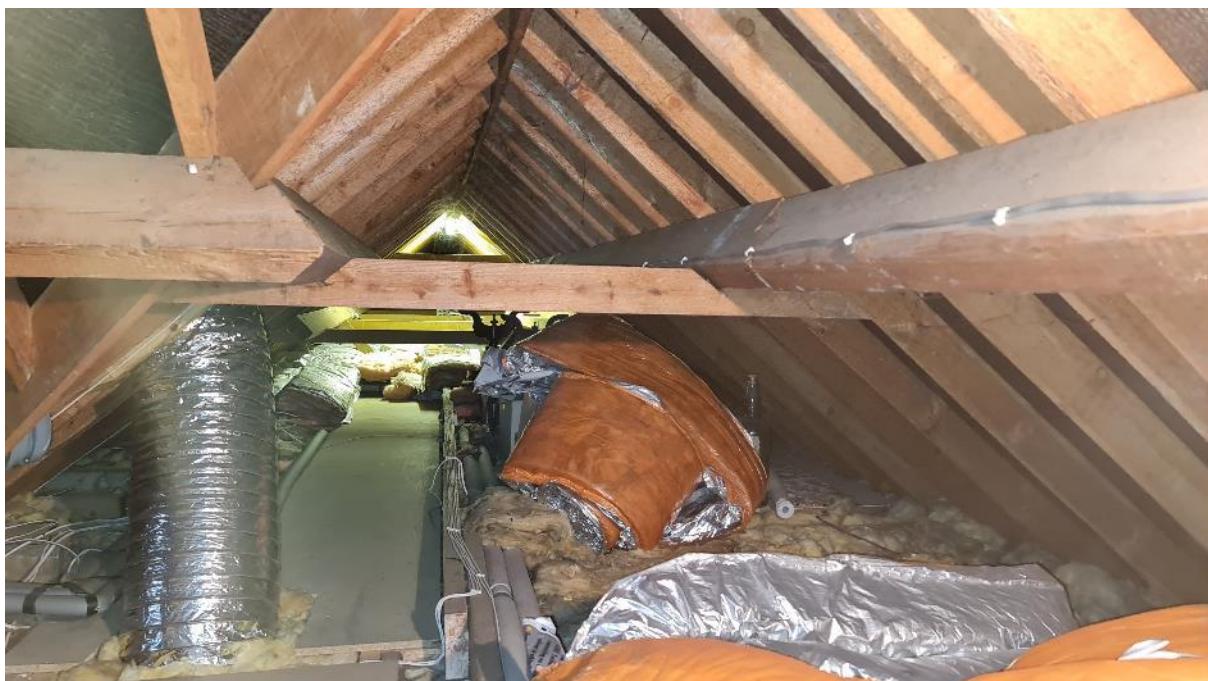
Figure 8: Loft space L2. Varying heights within this loft space. The longest length being at approximately 1-1.5m high. Cobwebs within the loft space from the ridge to the floor. Boarding across the loft to allow access within and no evidence of bats.

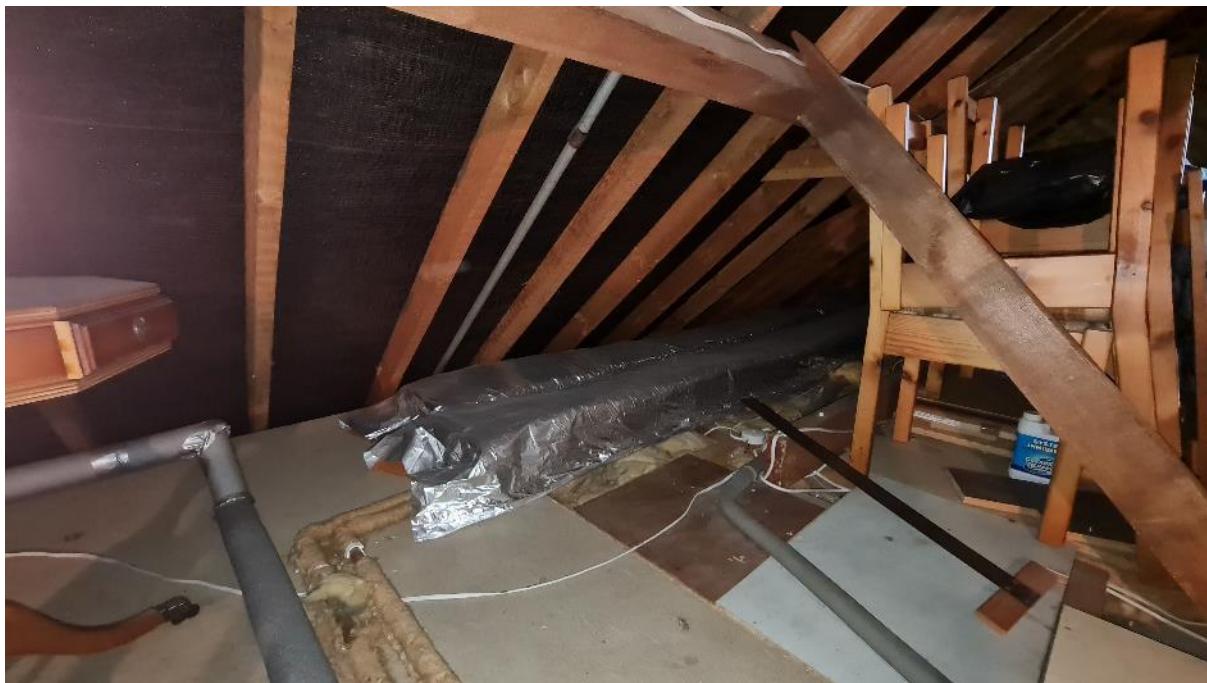
Figure 9: Loft space L2. Cobwebbing on the ridge beam and hanging from the modern timber beams. Black membrane lining the roof appeared to be in good condition with no gaps.

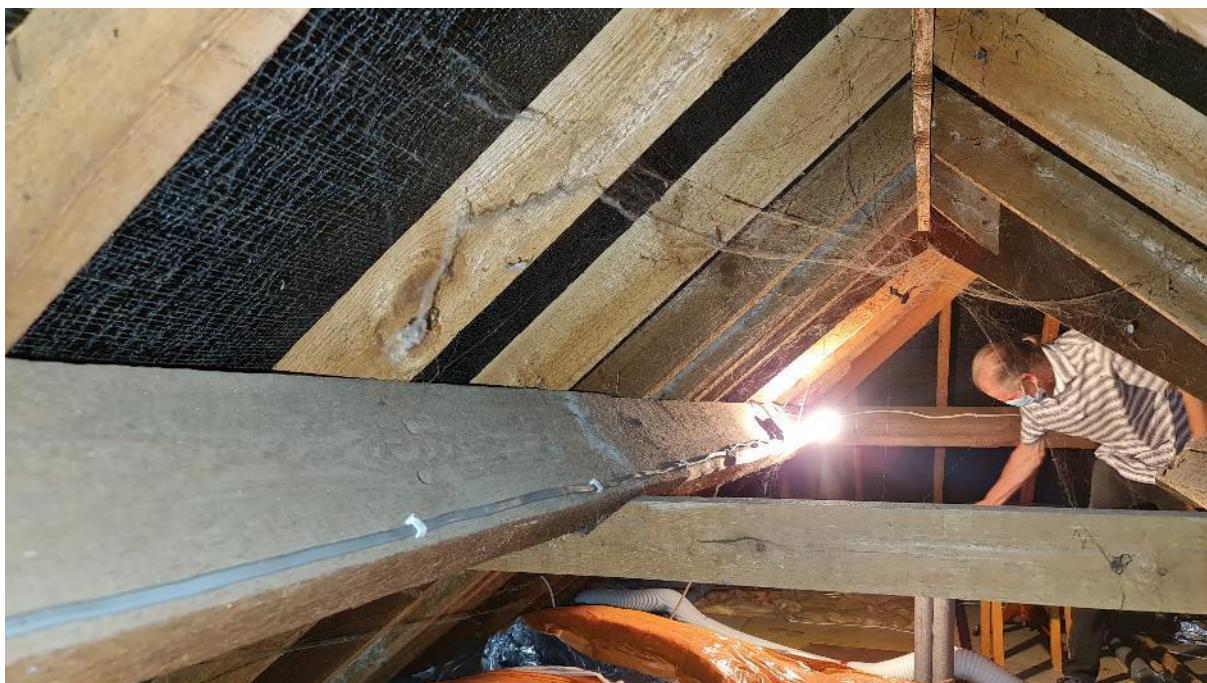
Figure 10: Loft space L2. Heavy cobwebbing present around the ridge of the loft space.

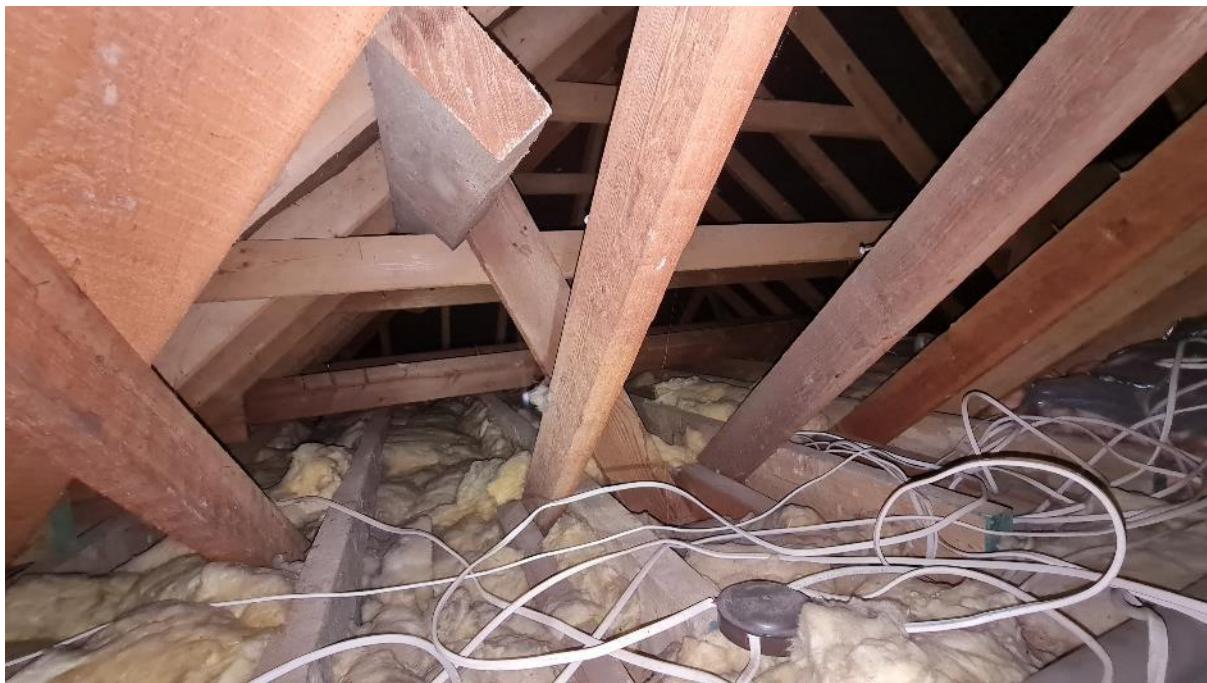
Figure 11: Loft space L2. No boards present in this section of the loft space with roll insulation. This was checked for accumulation of bat droppings or feeding remains. No evidence of bats was observed within the loft space.

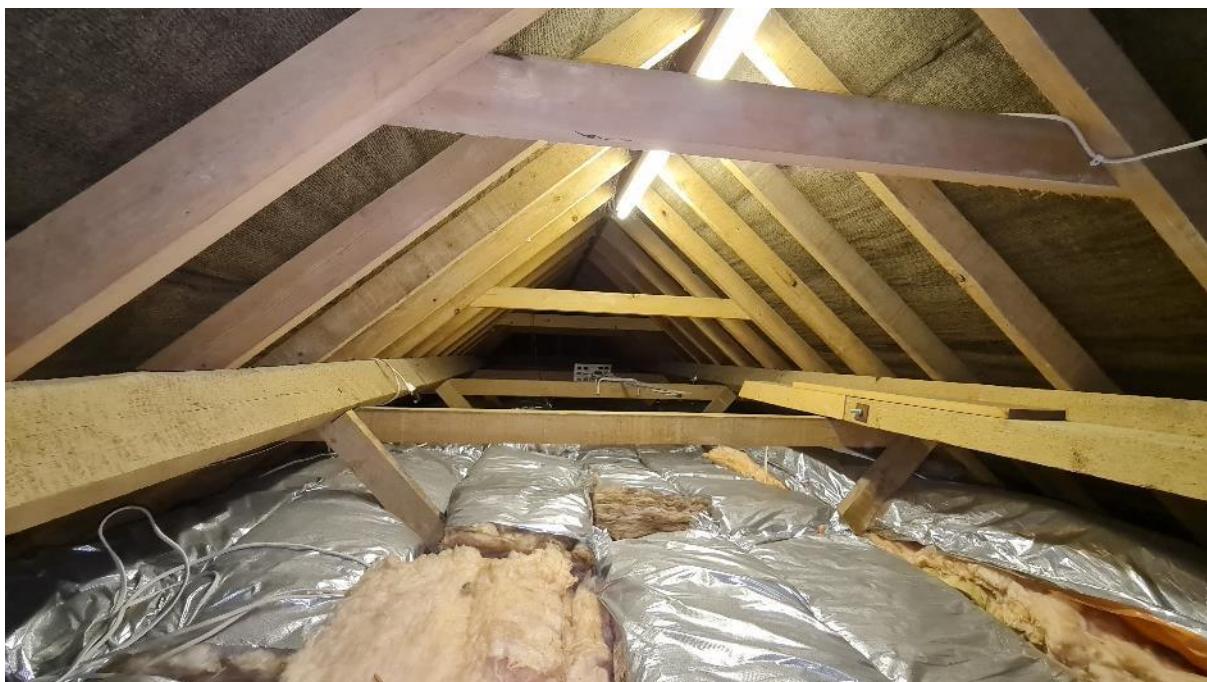
Figure 12: Loft space L2. This section of the loft (the most north-eastern section of the building) is the most modern with new timbers, unripped lining and new insulation present. There was no evidence of bats present within the loft.
