GEO-ENVIRONMENTAL & GEOTECHNICAL ASSESSMENT (GROUND INVESTIGATION) REPORT

546 SIPSON ROAD,
SIPSON,
HILLINGDON
UB7 0JB

Report Title: Geo-environmental & Geotechnical Assessment Ground Investigation Report for 546 Sipson Road, Sipson, Hillingdon UB7 0JB

Job No: P5040J2780/JRO

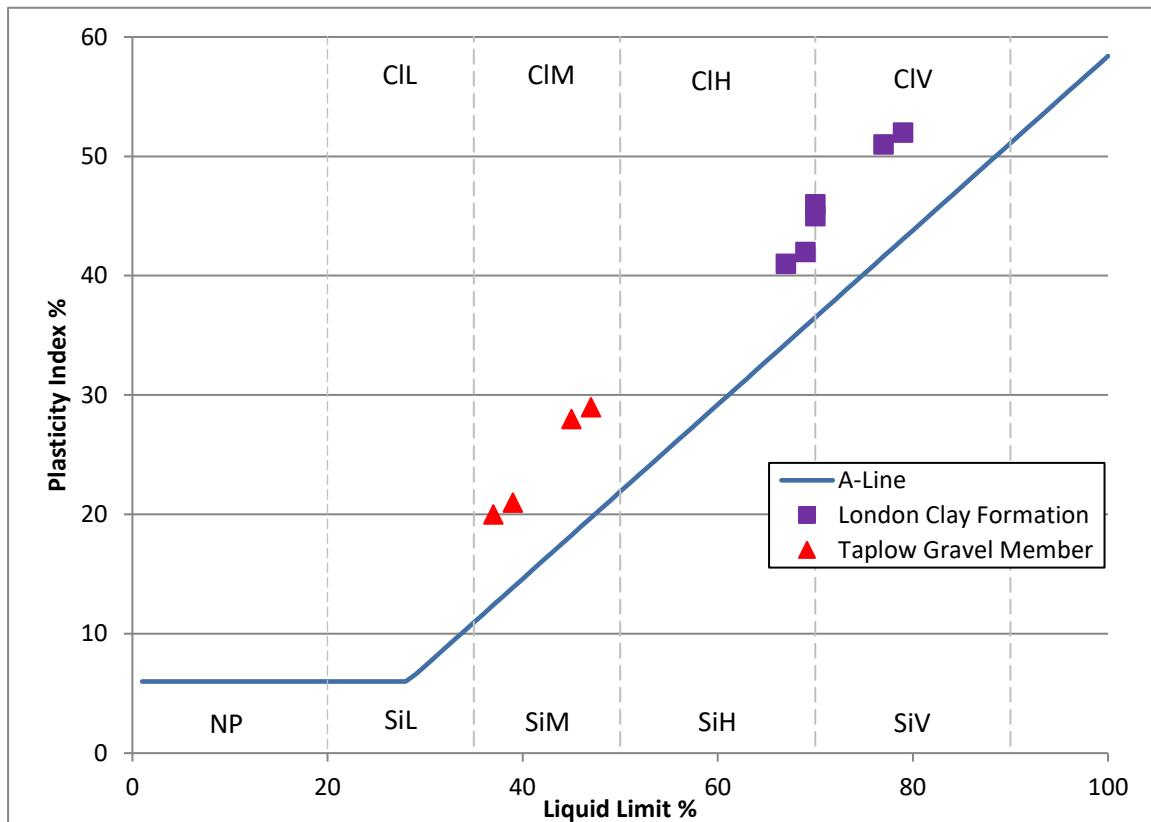
Figure 11.1: Plasticity Chart

11.2.5 Modified Plasticity Index values ranged from 39.1% to 52.0% in the London Clay Formation, indicating soils with medium to high volume change potential.

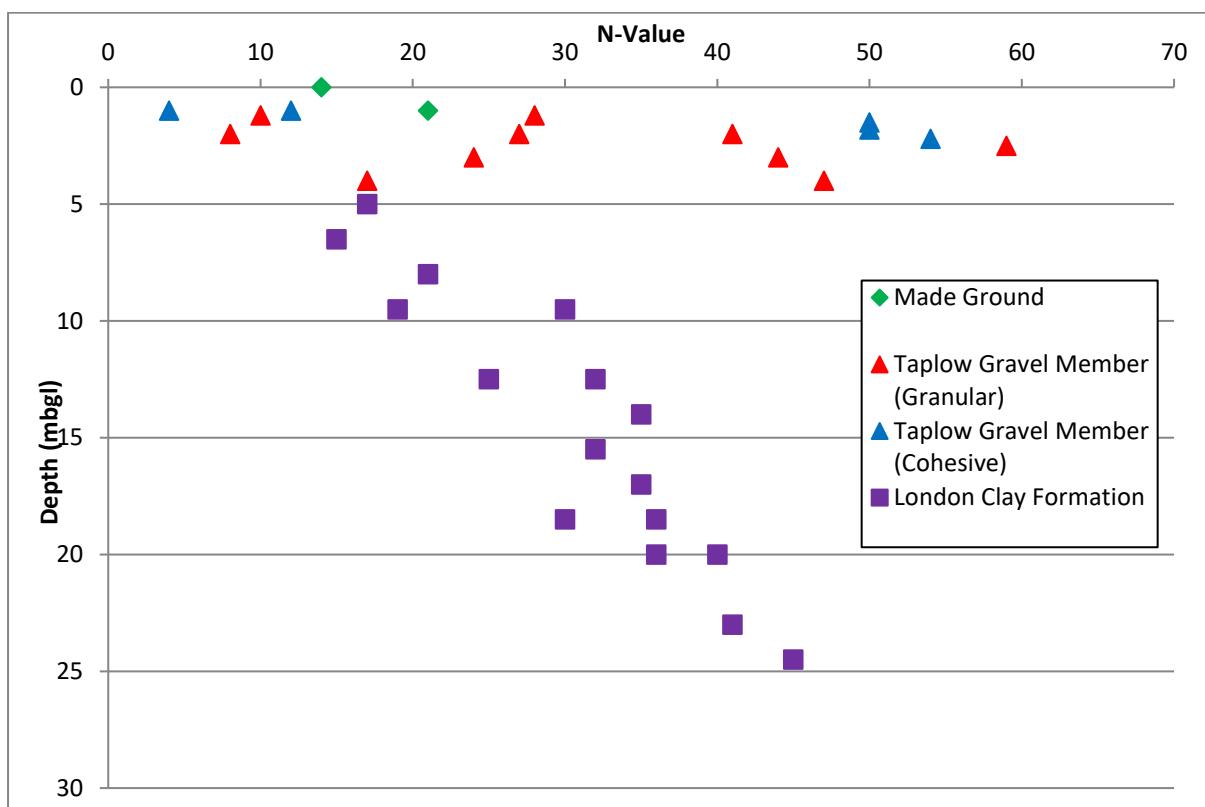
Figure 11.2: SPT 'N' Value v Depth

11.3.1 Standard Penetration Tests were undertaken at regular intervals throughout the windowless sample boreholes and cable percussive borehole. The results of the SPTs are plotted against depth in Figure 11.2 below.

11.3.4 The results show a degree of scatter in the shallow Made Ground and Taplow Gravel Member strata. The London Clay Formation results show a clear trend of increasing N-value number with depth.

11.3.3 N_{equi} results have been calculated for both strata where the SPT crossed strata boundaries or where the full 300mm of penetration could not be achieved for 50 or more blows. Where only minimal penetration was achieved, the test was recorded as a ‘refusal’ and an N_{equi} result was not calculated.

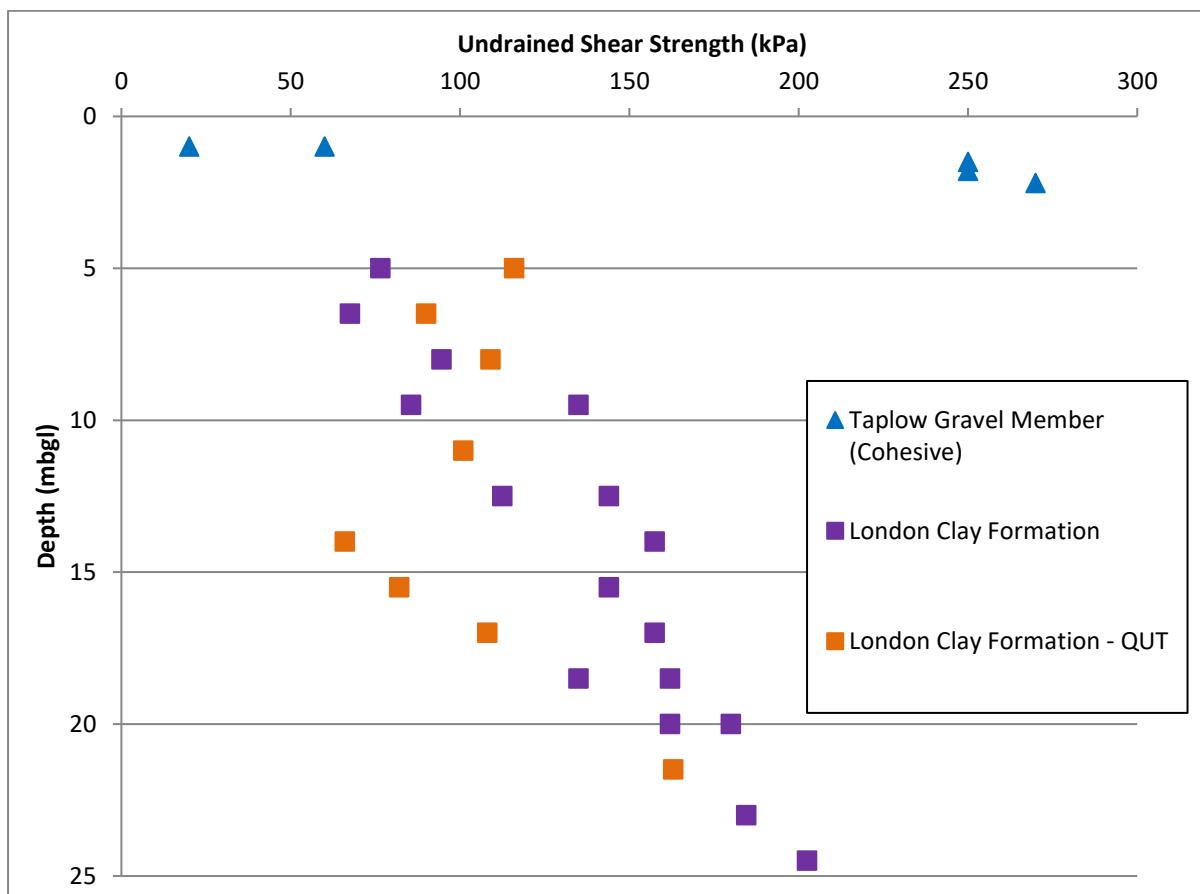
Figure 11.3: Undrained Shear Strength v Depth

11.4.3 The graph below shows the shear strength profile of the encountered cohesive materials at the site, based on the SPT to shear strength correlation described above, as well as the results of undrained triaxial tests on undisturbed samples taken from the borehole.

11.4.4 Although the results are quite variable, there is a clear trend of increasing shear strength with depth within the London Clay Formation, with both measured QUT results and correlated SPT results being broadly comparable. most of the strata. The Taplow Gravel Member deposits show a greater degree of variation.

11.4.5 In addition, three of the SPT 'N' results in the Cohesive Taplow Gravel Member were very high (equal to or in excess of 50). It would appear likely that these high results were due to the presence of obstructions over the length of the test, rather than a representation of the true strength of the clay. However, this could not be proved as the boreholes could not be progressed beyond this point. Due to the boreholes being able to progress at this point, it could not be proved if the high re

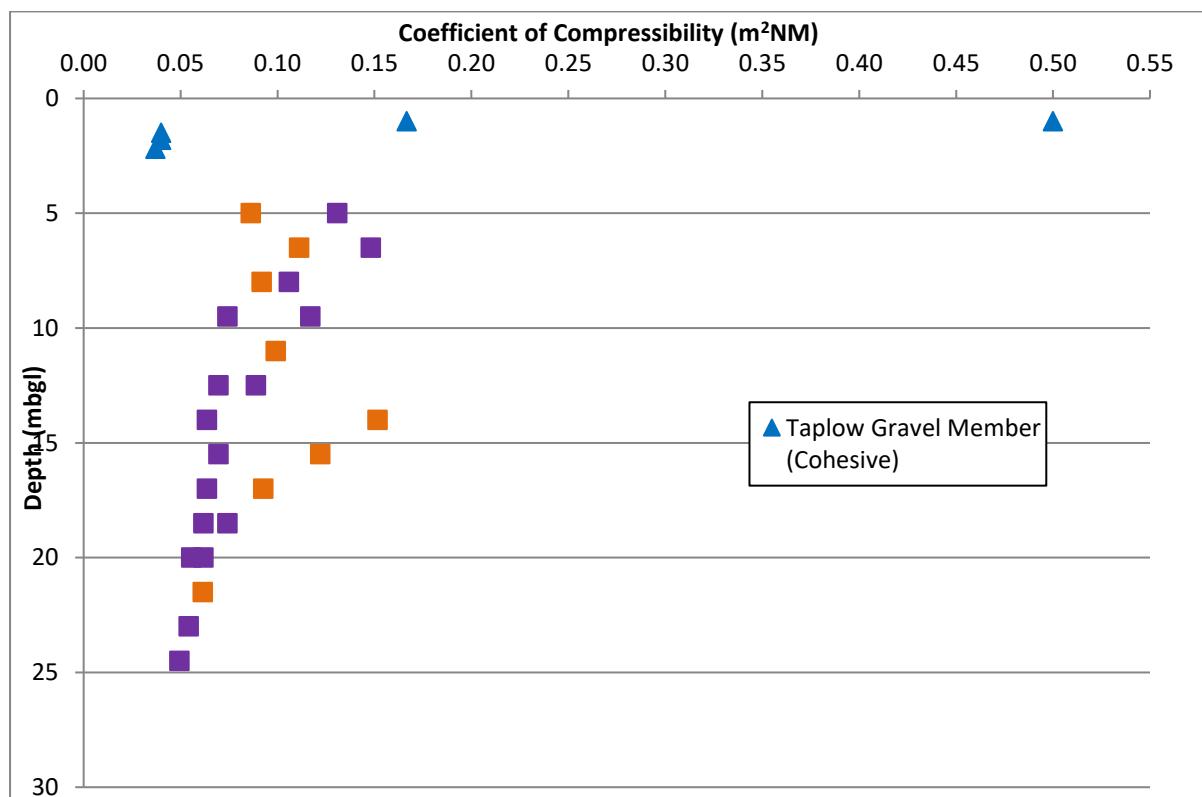
Figure 11.4: Coefficient of Volume Compressibility (m_v) v Depth

11.5.3 Where the undrained shear strength of the clays was measured using the quick undrained triaxial methodology, the m_v value was calculated by rearranging the equations for f_1 and f_2 and substituting in the measured undrained shear strength.

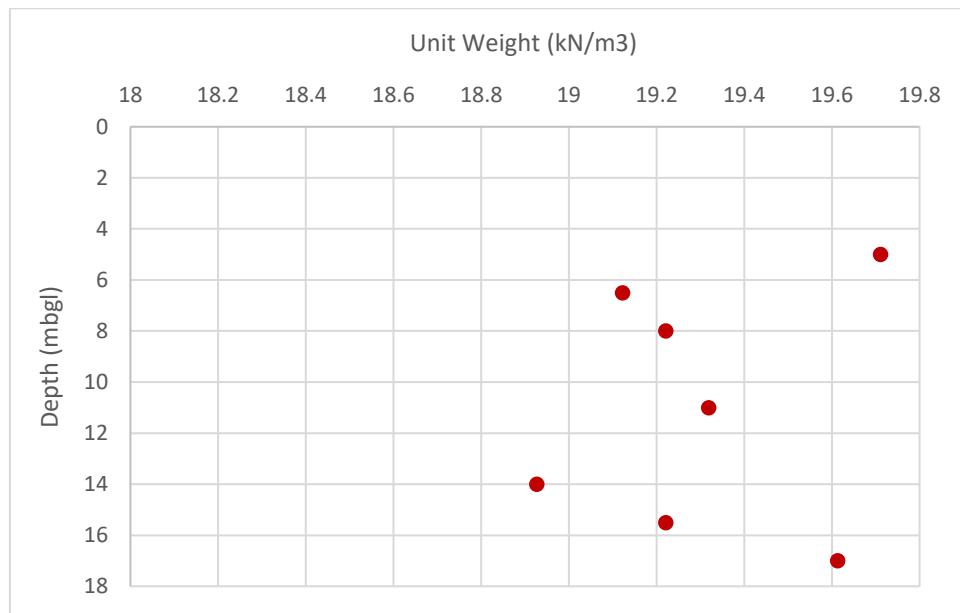
Figure 11.5: Unit Weight v Depth – London Clay

11.6.1 In order to calculate the undrained shear strength using the quick undrained triaxial methodology the bulk density of the materials has to be calculated. These values are provided on the quick undrained triaxial testing certificates provided in Appendix 4. These can be converted to a Unit Weight in kN/m³.

Unit Weight values for other strata have been derived based on correlations and suggested values given in BS8004:2015. These are summarised in Table 11.1 below.
