**Arboricultural Impact Assessment
Arboricultural Method Statement
Tree Constraints Plan,
Tree Removal Plan
&
Tree Protection Plan**

546 Sipson Road, Sipson, Hillingdon.

Job No: P5040J2780

Date: 12/09/2023

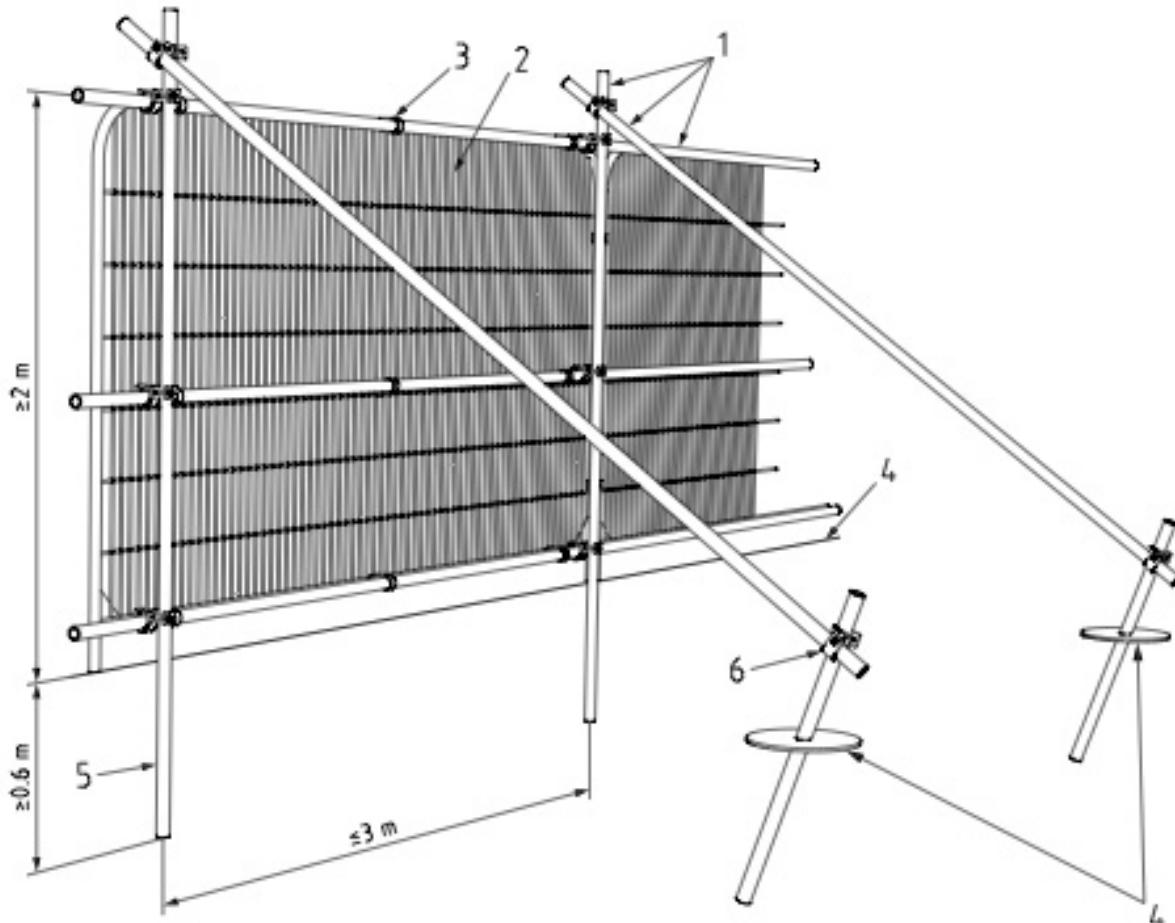
The Tree Protective fencing will be 2.4m Heras fencing as specified in the BS. The fencing will be supported by a scaffold framework with supporting struts firmed into the ground on the side of the trees. The purpose of the supports is to prevent the fencing being moved during the development. Clear signs will be attached to the fencing (e.g. Tree Protective Fencing – Keep Out).

- 1 Standard scaffold poles
- 2 Heavy gauge 2 m tall galvanized tube and welded mesh infill panels
- 3 Panels secured to uprights and cross-members with wire ties
- 4 Ground level
- 5 Uprights driven into the ground until secure (minimum depth 0.6 m)
- 6 Standard scaffold clamps

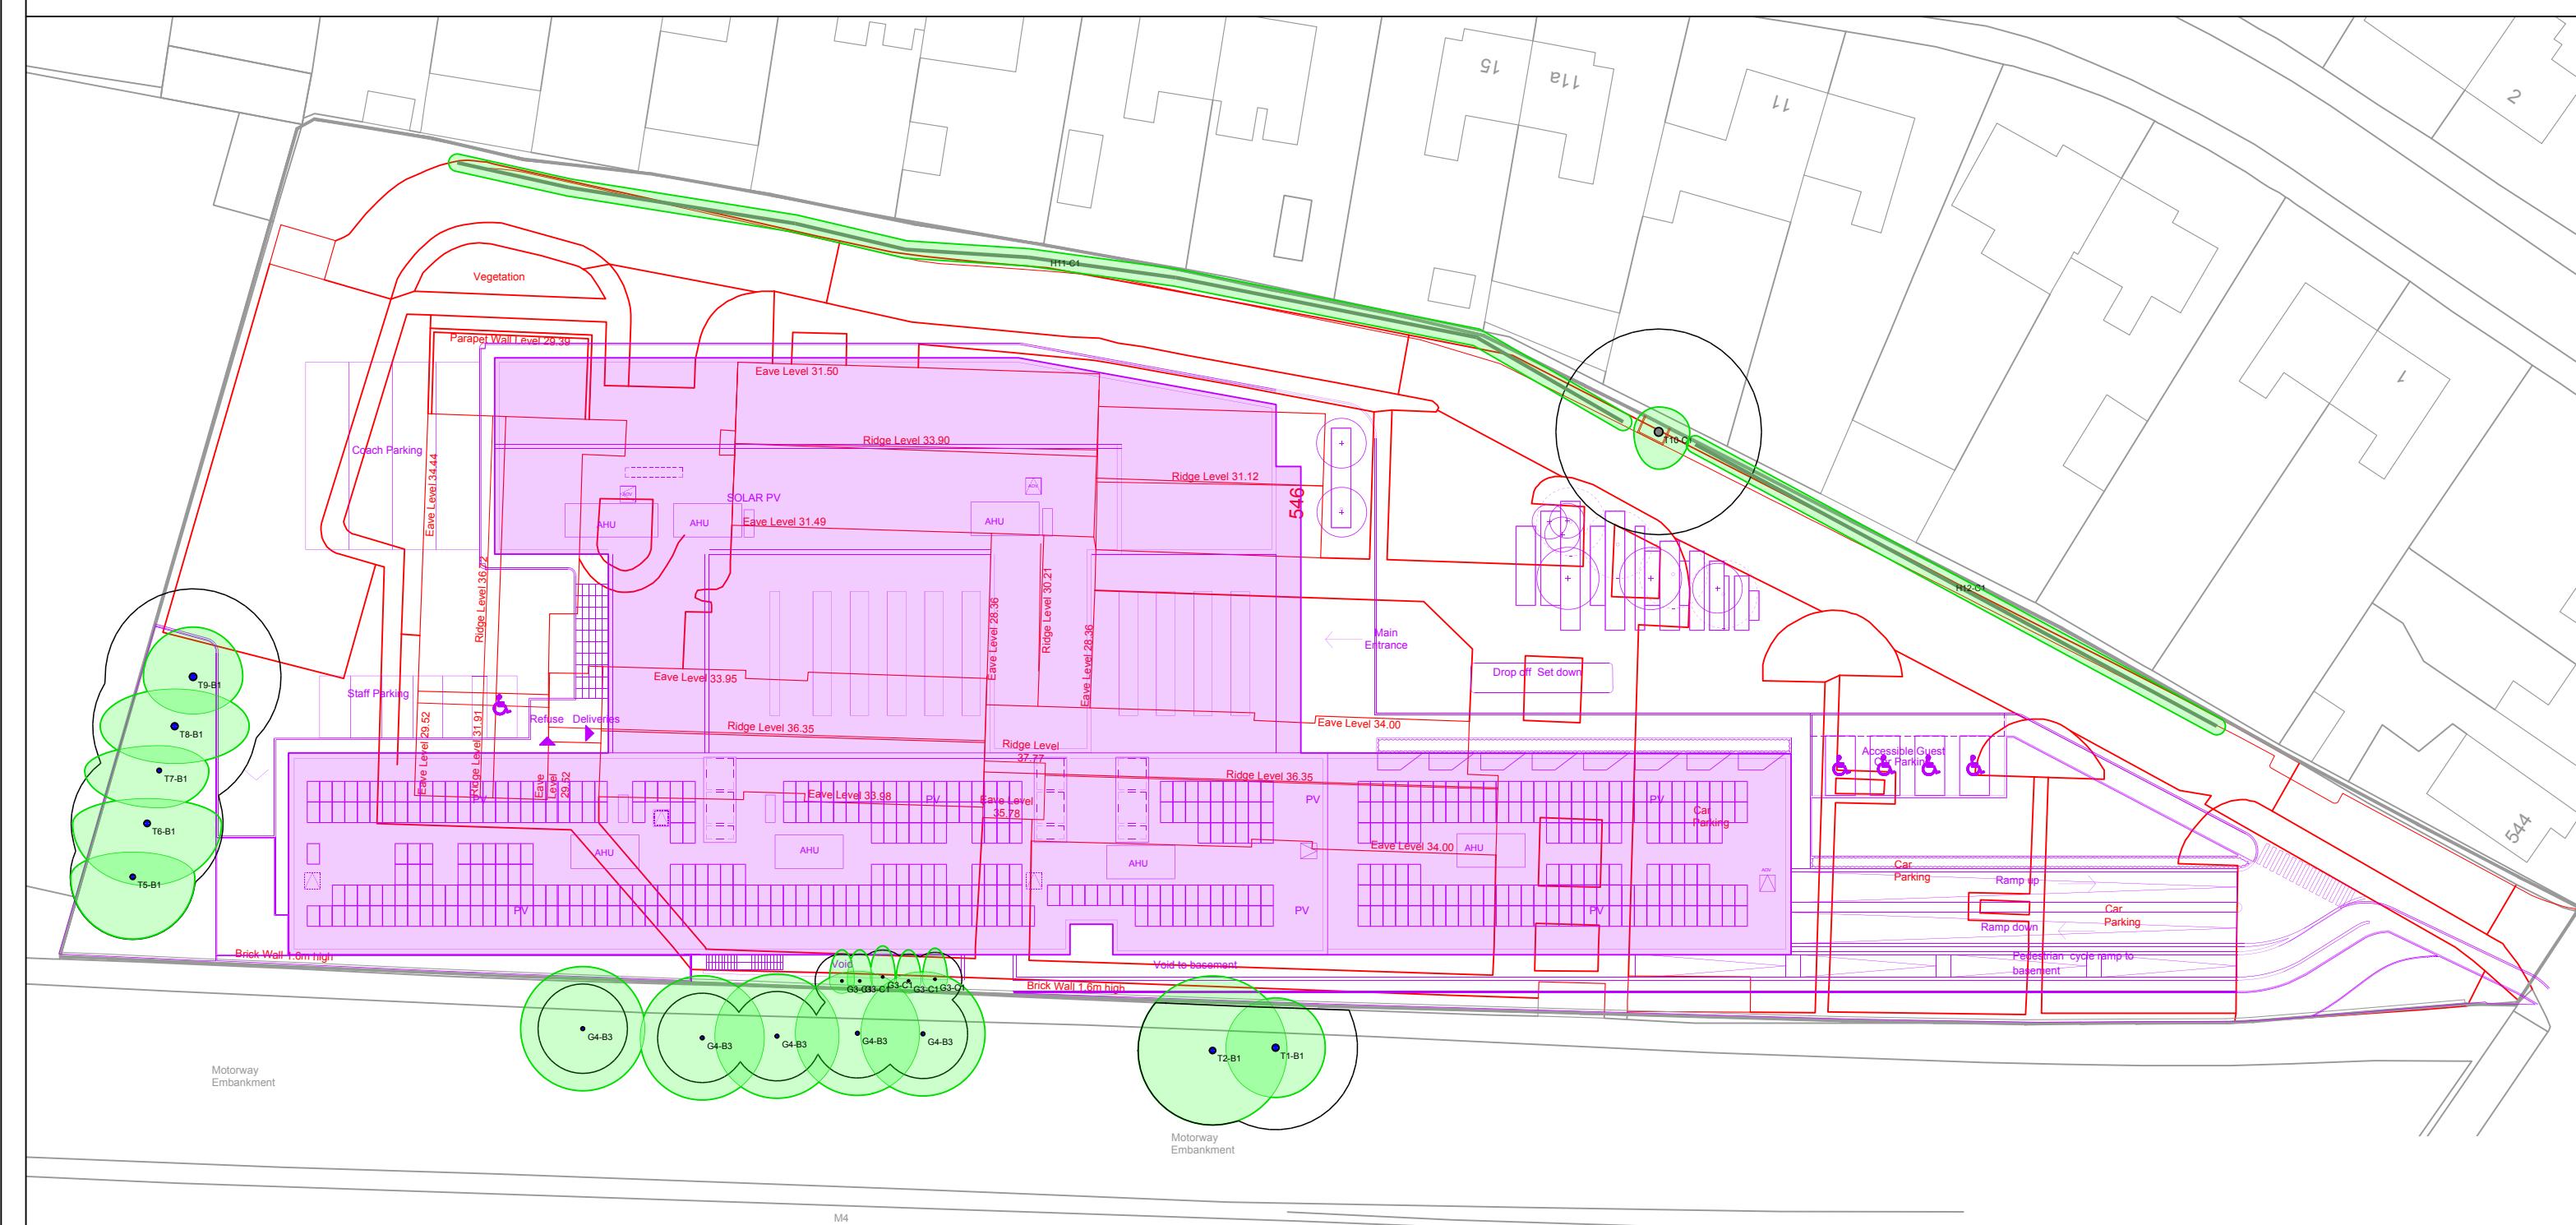
TREE CONSTRAINTS PLAN (Figure 1)

The proposal, in this instance, is to demolish the existing buildings on site shown in red on the tree and demolition plan (Figure 2). Then to construct a new hotel complex with the associated access and parking areas as shown using the purple colour on the tree constraints plan (Figure 1).

In our survey schedule, the RPA for each tree is indicated as the radius of a circle as well as in M². This is also plotted on the tree constraints plan and tree protection plan denoted by a heavy black line which merges the individual RPAs together where there is more than one tree.

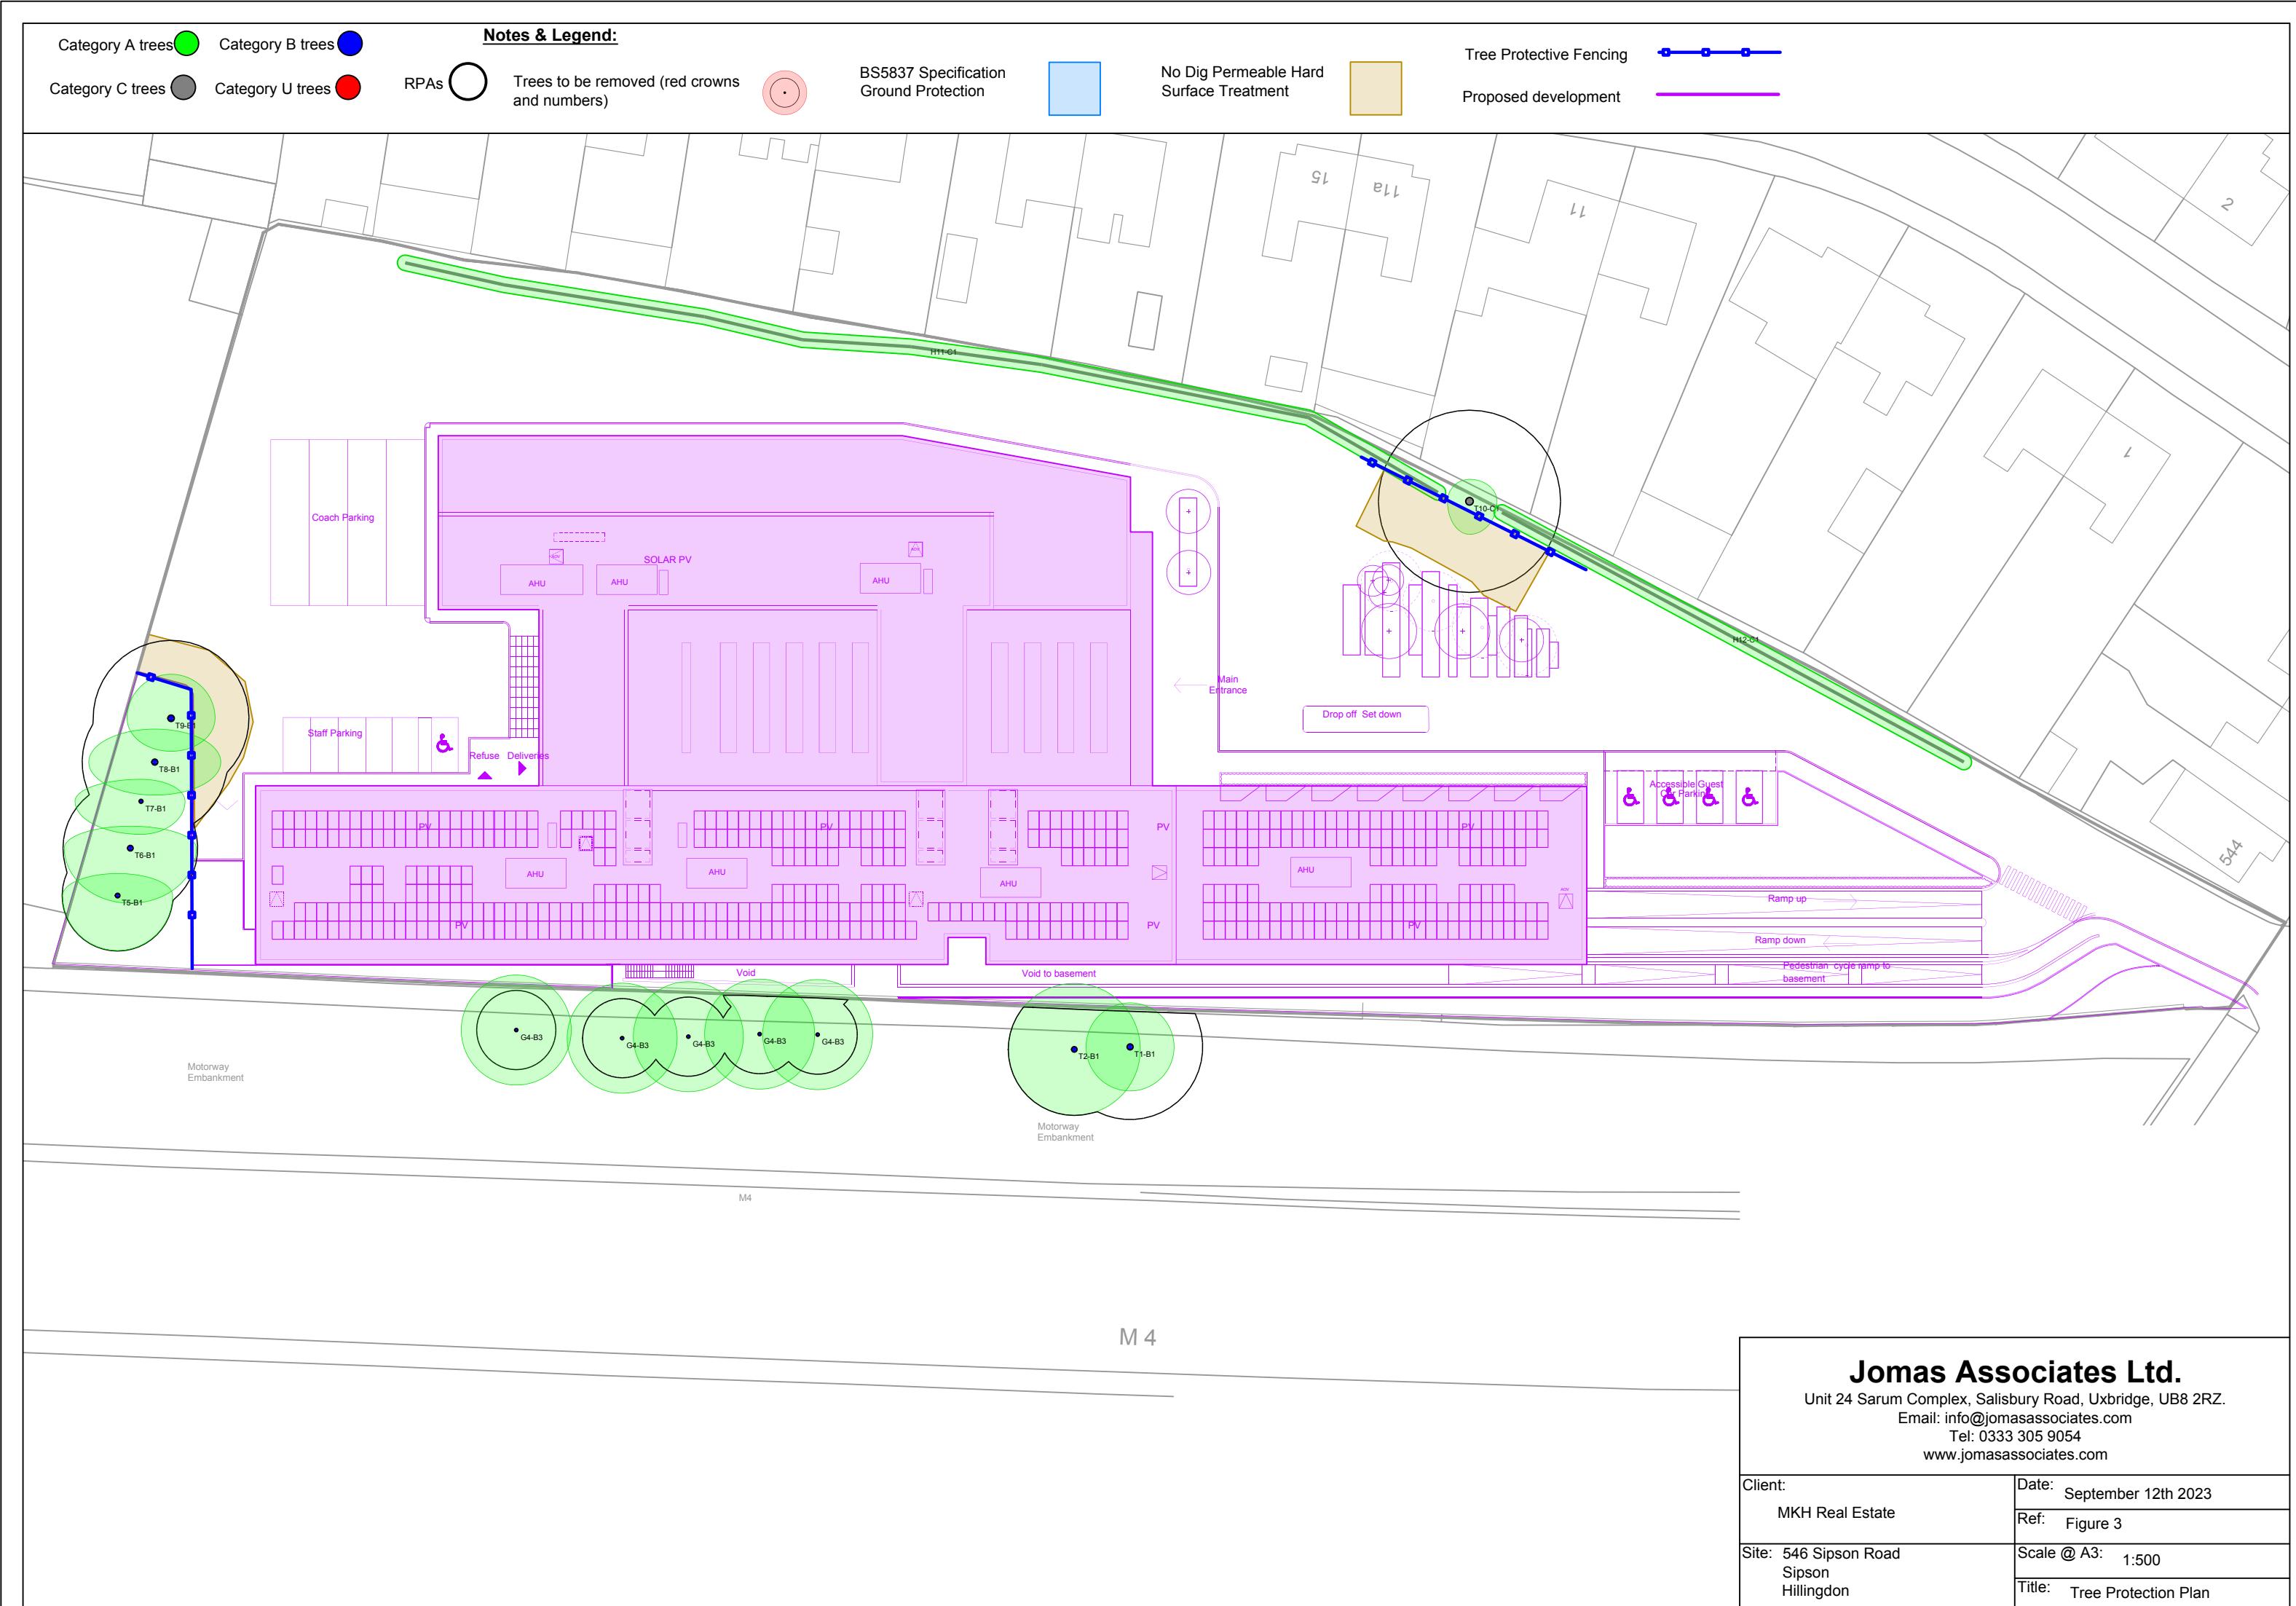
TREE PROTECTION PLAN (Figure 3)

The required tree protective fencing should be installed to fence off the construction exclusion zone(s), or CEZ, shown on the tree protection plan (Figure 2). This must only be altered or moved as agreed in writing by the Local Planning Authority following advice from a competent Arboricultural Consultant.
