**Queensmead School  
Queens Walk  
London HA4 0LS**

**Level 2 Archaeological Building Record**

Site Code: QMS20  
National Grid Reference: 511718 185502  
OASIS reference: molas1-399262

Level 2 Archaeological Building Survey

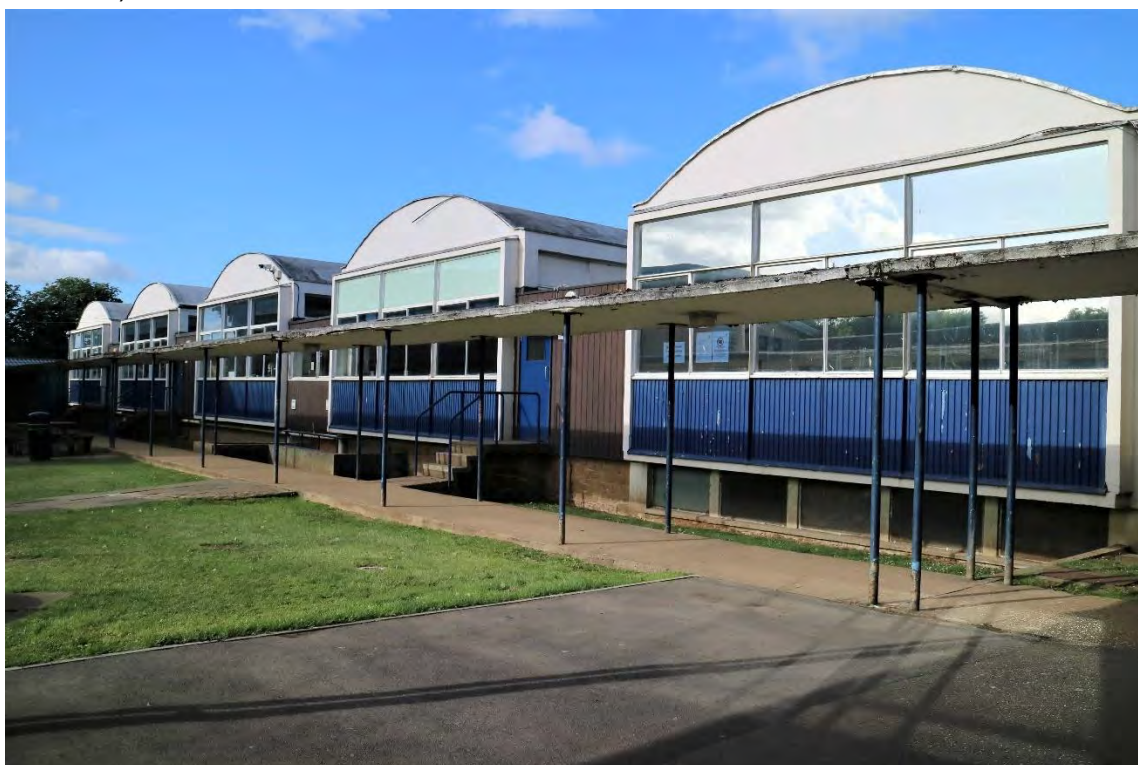
- 4.1.1 Block B (1953) was formed of five single storey prefabricated and symmetrical rectangular structures aligned east-west (Fig 13). They had domed roofs and were constructed in brick with prefabricated reinforced concrete beams and steel windows. Block B formed the western end of a courtyard to the south of the school grounds and were set in rows from north (Building 1) to south (Building 5). The other school building opposing B block across the courtyard were also constructed by Yorke, Rosenberg and Mardall in 1953. These remain unaffected by the current proposed works (Fig 14).

*Fig 13 Block B, looking south-west*

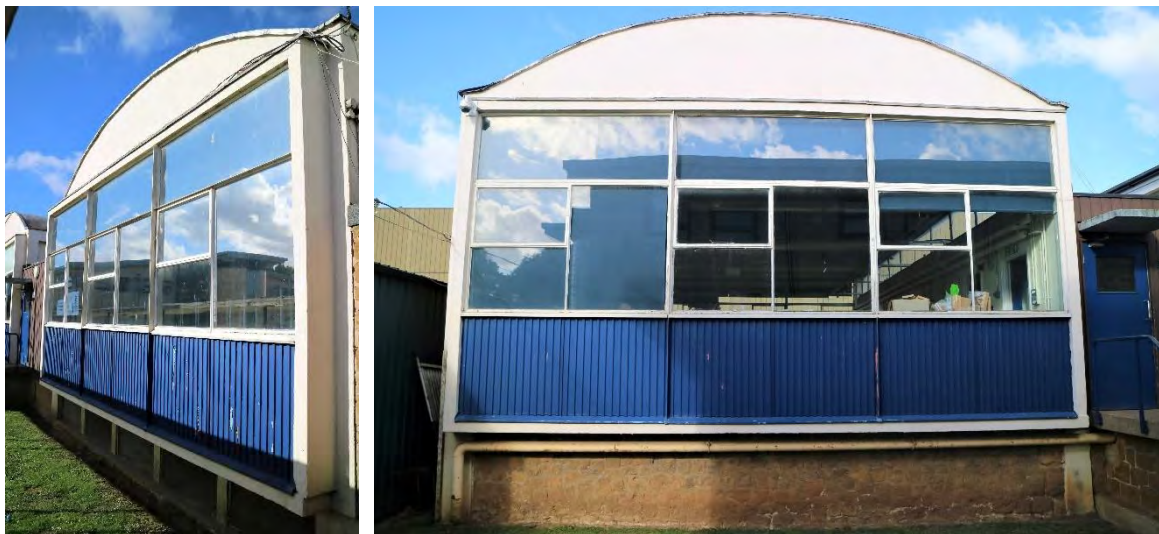
- 4.2.1 The east elevation formed the western end of the school courtyard (Fig 13). Each of the buildings contained a large steel casement window which projected slightly forward from rest of the elevation which was clad in cementitious render above and stone masonry below (Fig 15). Blue painted corrugated metal cladding lined the projected elevation underneath the windows (Fig 16). Each building had a doomed roof and was adjoined to one another with a low flat roofed brick partition clad with tongue and groove timber boards (Fig 17). Stone steps capped with concrete led to each adjoining section except between Buildings 2 and 3 which contained a window and no door (Fig 18).

*Fig 15 The glazed facades as seen from the east elevation. (Left) Looking south-west. (Right) Looking west*

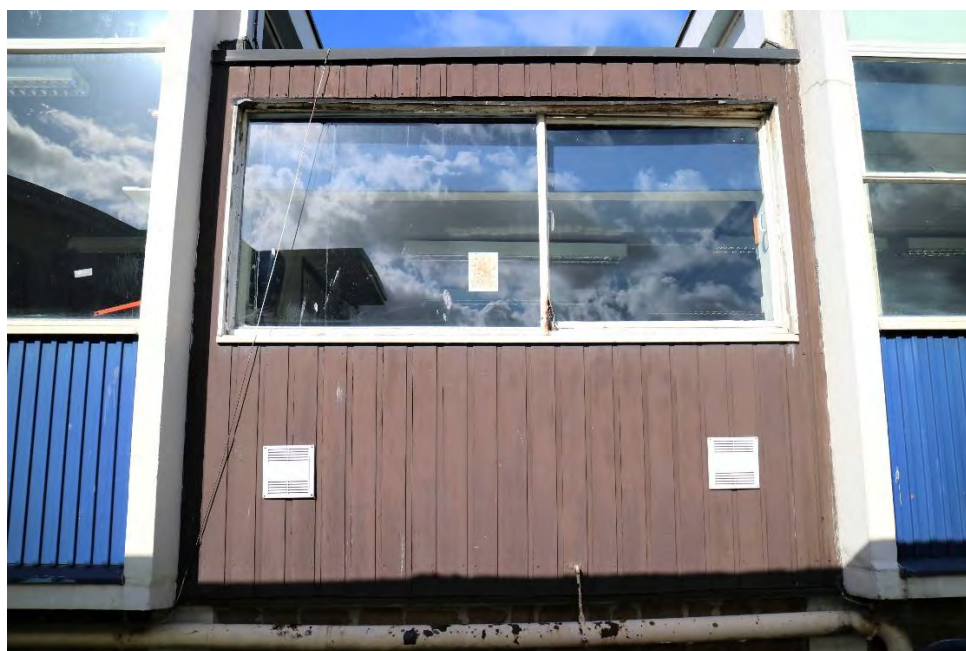
*Fig 18 The adjoining partitions between buildings 2 and 3, looking west*

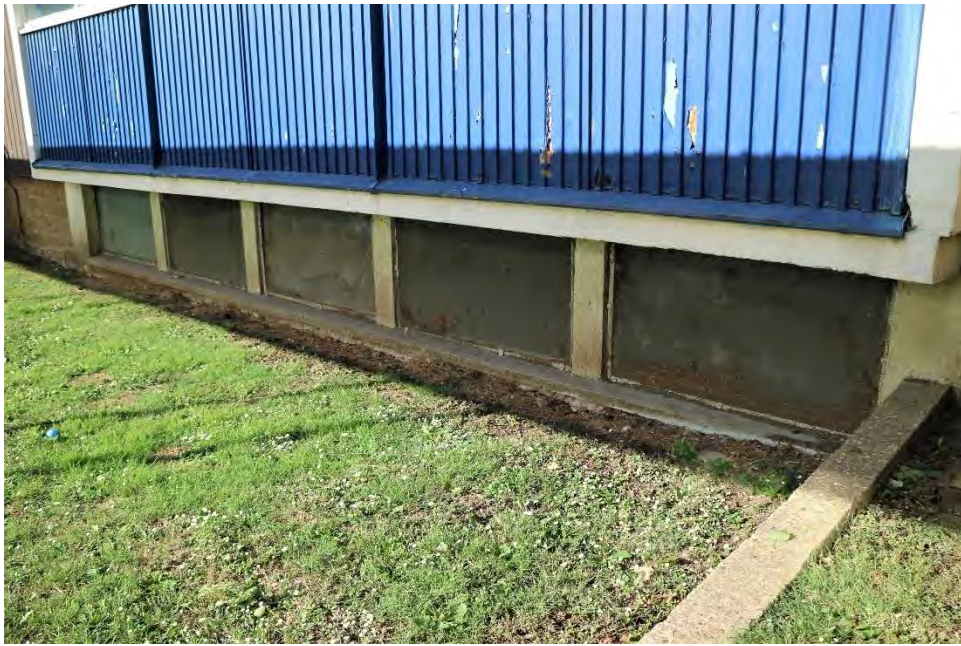
- 4.2.2 Each building was almost identical. However, a basement was located underneath Buildings 1 and 2 to the north. As such, Building 1 had basement windows at ground level (Fig 19) to the east of Building 2 were the concrete steps which led to the basement (Fig 20).
- 4.2.3 A concrete path and awning ran parallel with the east elevation east of Block B (Fig 21). The awning was also formed in concrete and was supported on metal poles.

*Fig 19 The basement windows underneath Building 1, looking south-west*

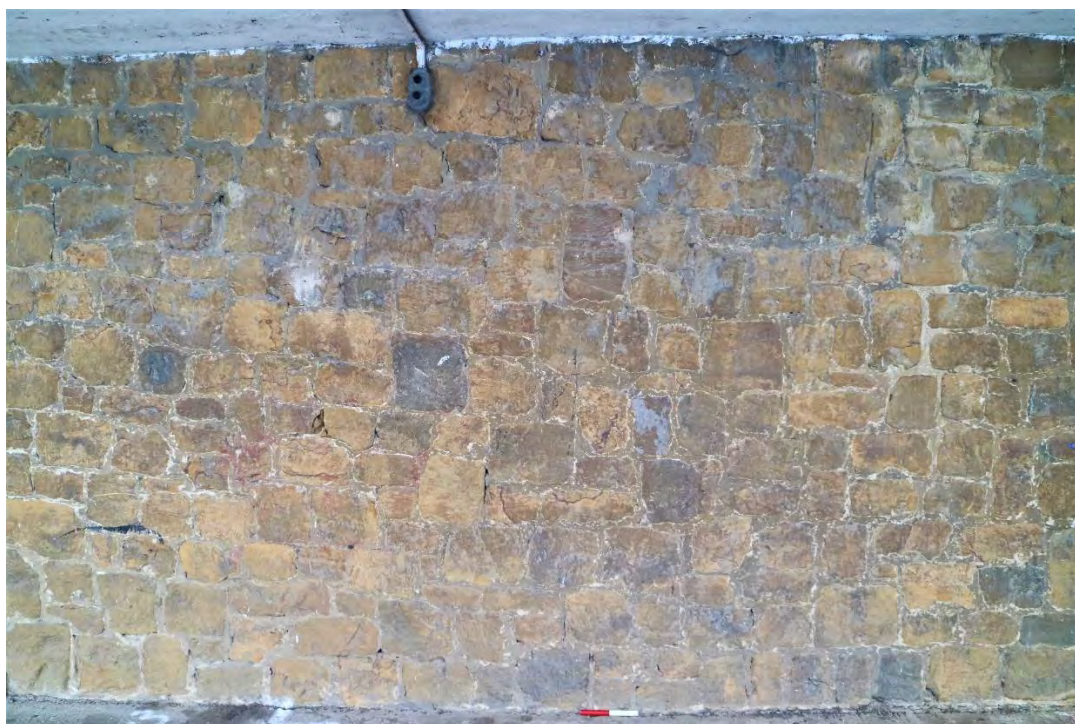
*Fig 23 Detail showing the masonry cladding along the north elevation, looking south*

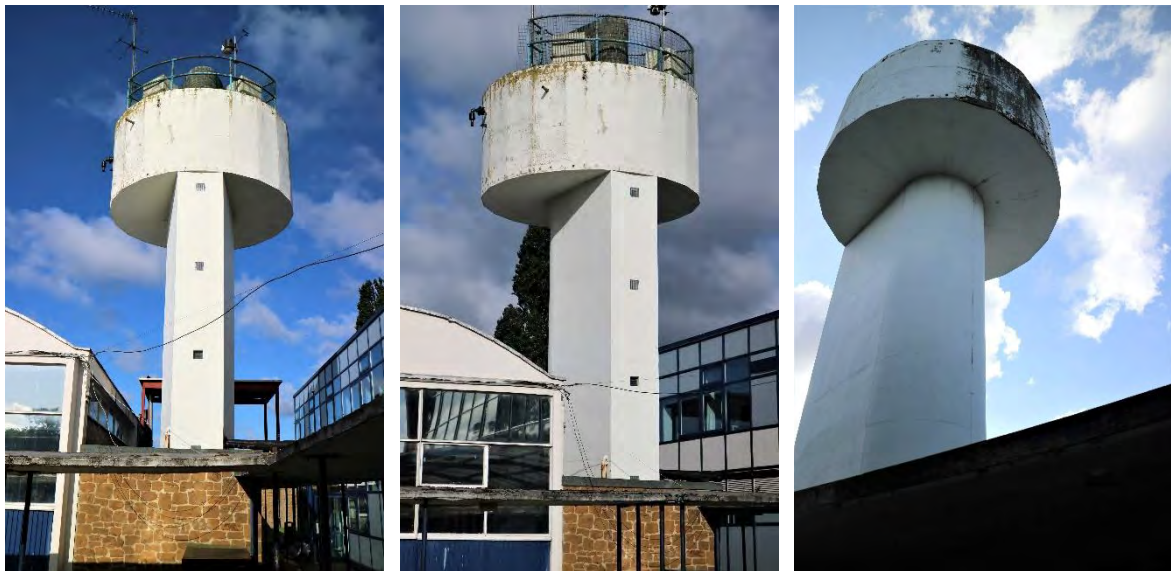
*Fig 25 The tower to the north-east of Block B. (Left) Looking west. (Middle) Looking north-west. (Right) Looking south-east*

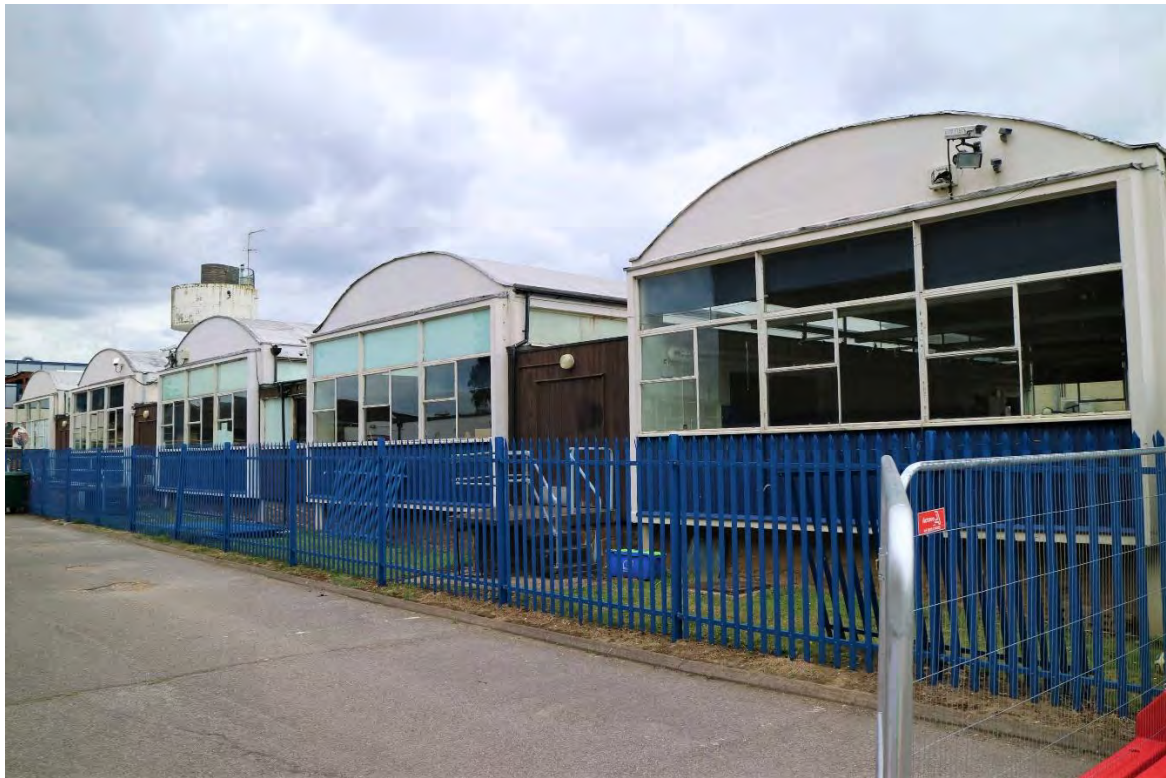
- 4.2.6 The western elevation closely resembled the east elevation (Fig 27). All windows were in the same style and in the same position as the east elevation but the window in Building 1 had been modified to include a modern fire door in the centre of the elevation (Fig 28). Like the east elevation, low flat partitions adjoined each of the buildings which were also clad in timber boards (Fig 29). All had double doors with steps constructed in masonry and concrete except the partition between buildings 3 and 4 which contained a window (Fig 30).
- 4.2.7 Basement access was located underneath Building 2 (Fig 31). Downpipes were located to the south-west of each of the buildings (Fig 32).

*Fig 27 The west elevation, looking north-east*

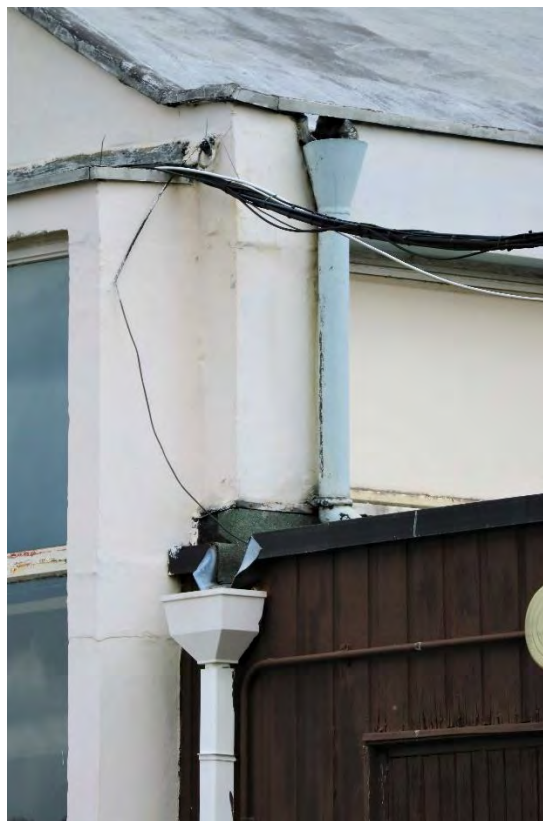
*Fig 32 Detail showing the downpipes to the south-west of the structures*

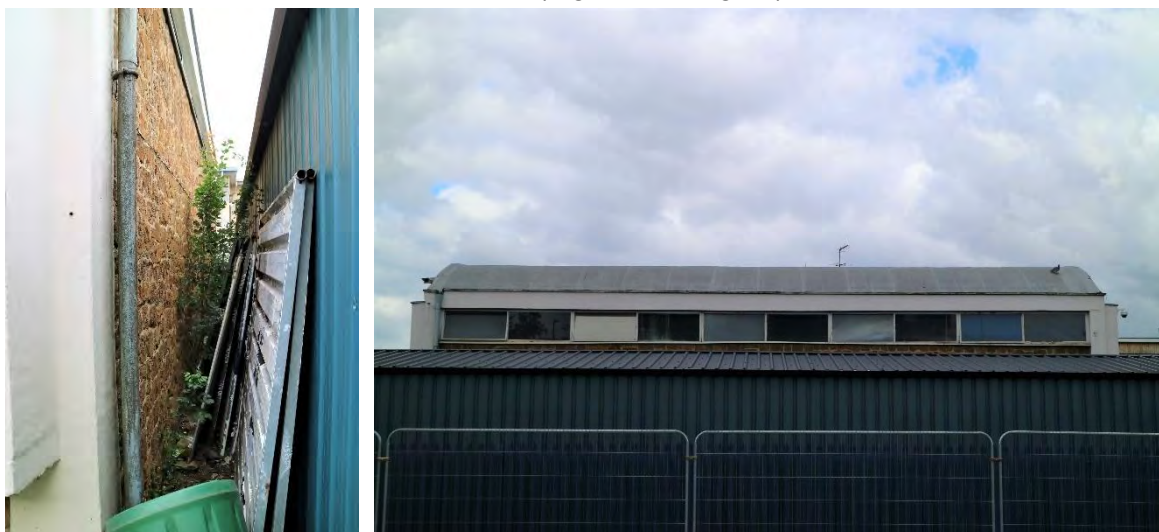
- 4.2.8 The south elevation was obscured by a more recent structure. It was formed in brick and contained one crittall window (Fig 33 and Fig 34).

*Fig 33 The south elevation. (Left) Looking east. (Right) Looking north*

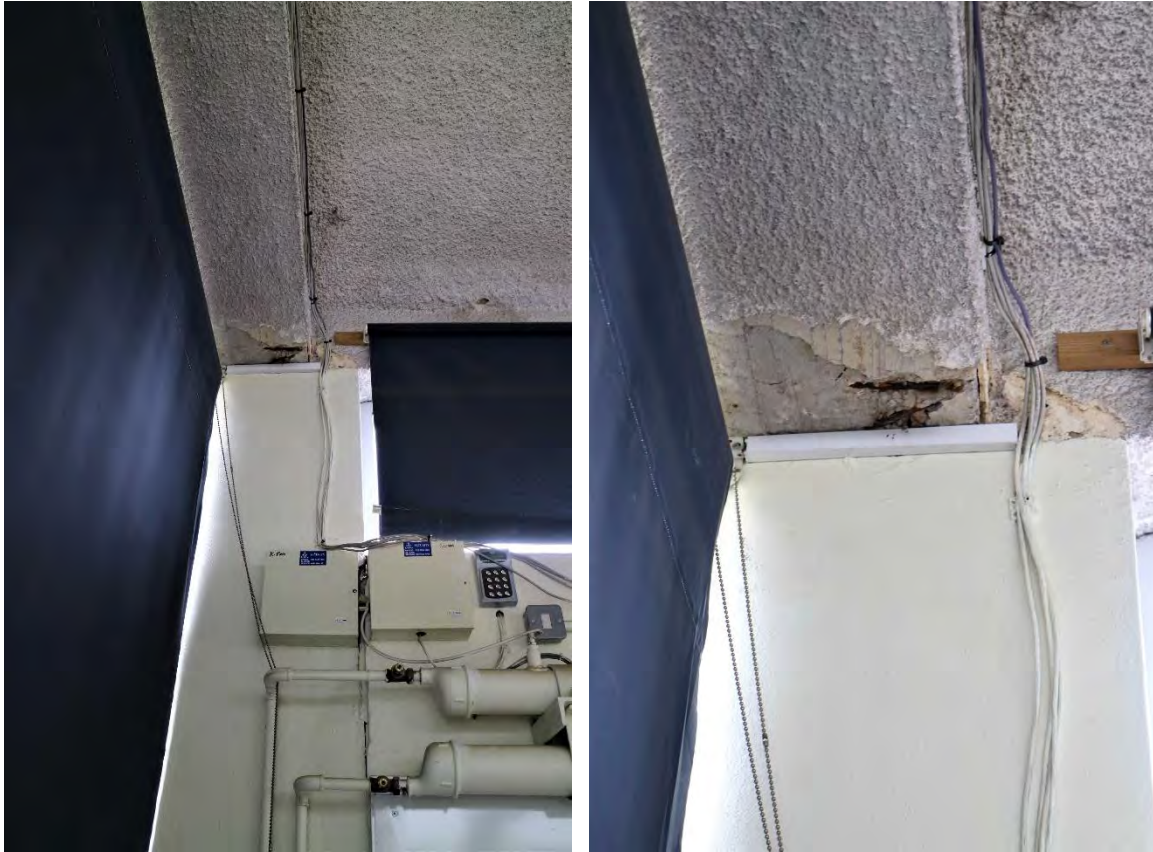
*Fig 40 Detail shots of an exposed reinforced concrete beam*

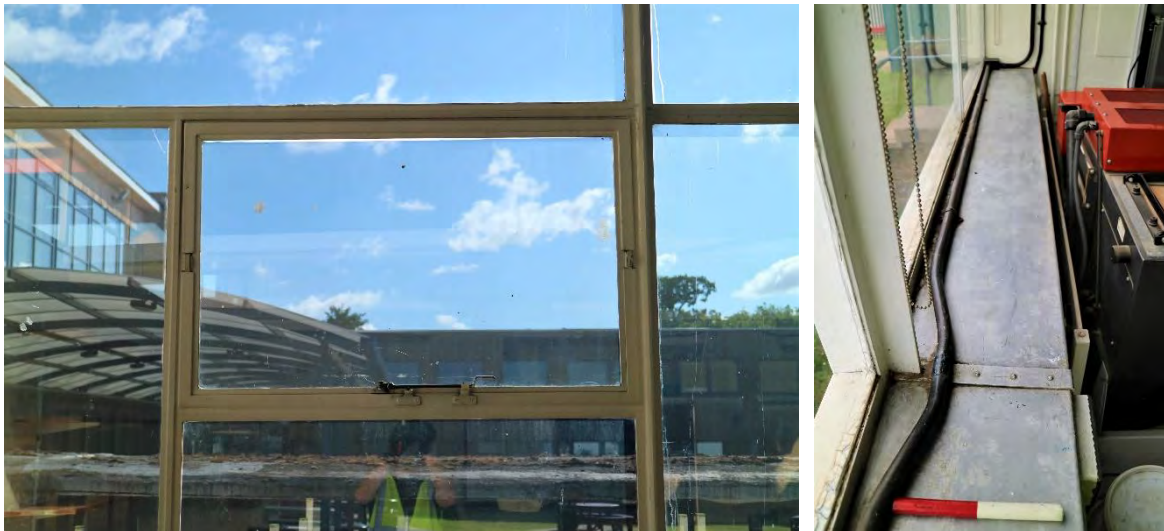
*Fig 41 (Left) Detail of a pivoting window on the east elevation. (Right) Detail of an internal window sill*

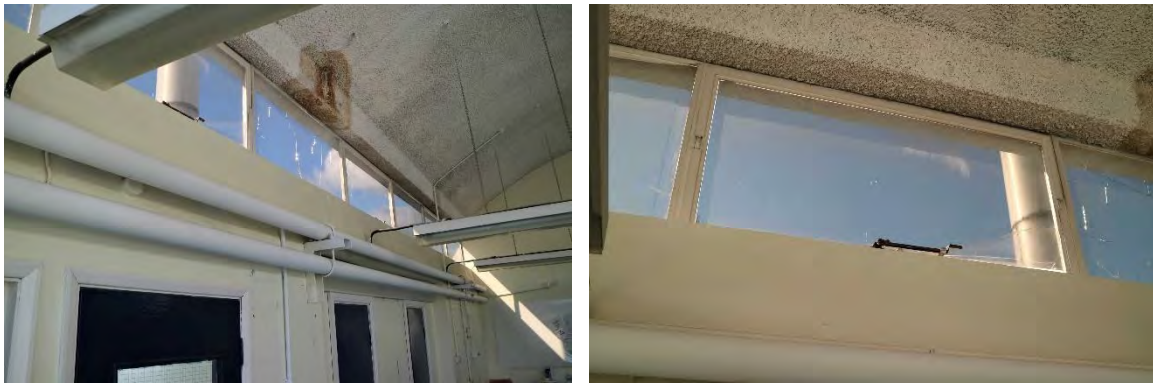
*Fig 42 (Left) An example of a crittall window. (Right) Detail of pivoting crittall window*

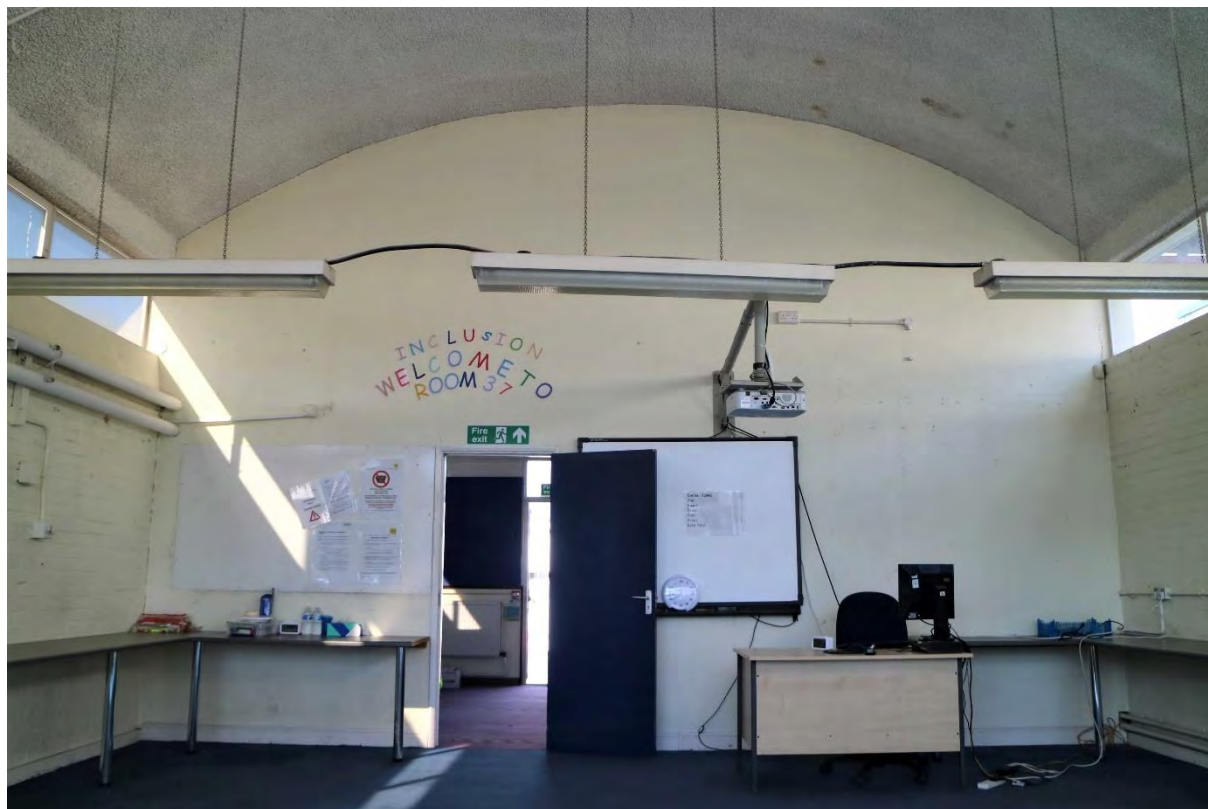
- 4.4.4 Building 1 had an internal partition to the west of the footprint that aligned north-south (Fig 45 and Fig 46). This had been inserted subsequent to initial construction sometime in the 20<sup>th</sup> century and had a different type of skirting. Of the four doors to the south of Building 1 (Fig 47), three led to office and storage spaces (Fig 48 and Fig 49) and one led to the eastern access corridor (Fig 50). The offices had skylights above with angular surrounds and reinforced glass (Fig 48).

*Fig 45 Building 1, looking west towards the inserted partition*

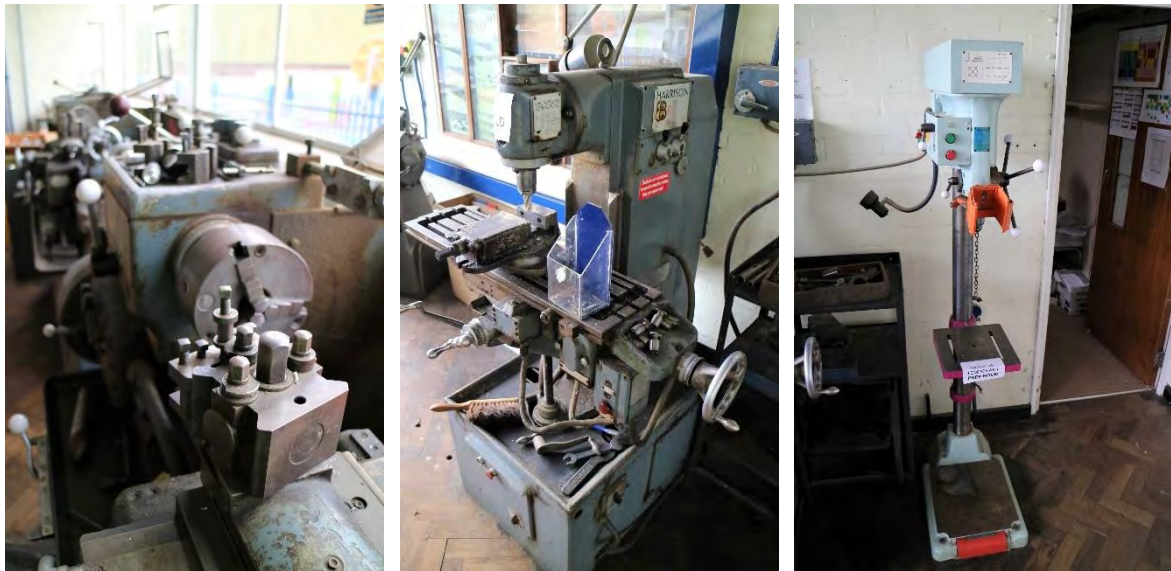
- 4.4.6 The western end was a full height space used as a workshop (Fig 55 and Fig 56). This contained several machines including a drill press, lath, vacuum packer and grinders (Fig 57) This had an office to the north which contained double doors to the exterior and an internal window to the south (Fig 58 and Fig 59). To the south was a storage area which also had double doors to the exterior (Fig 60).

*Fig 57 Detail shots of the machinery*

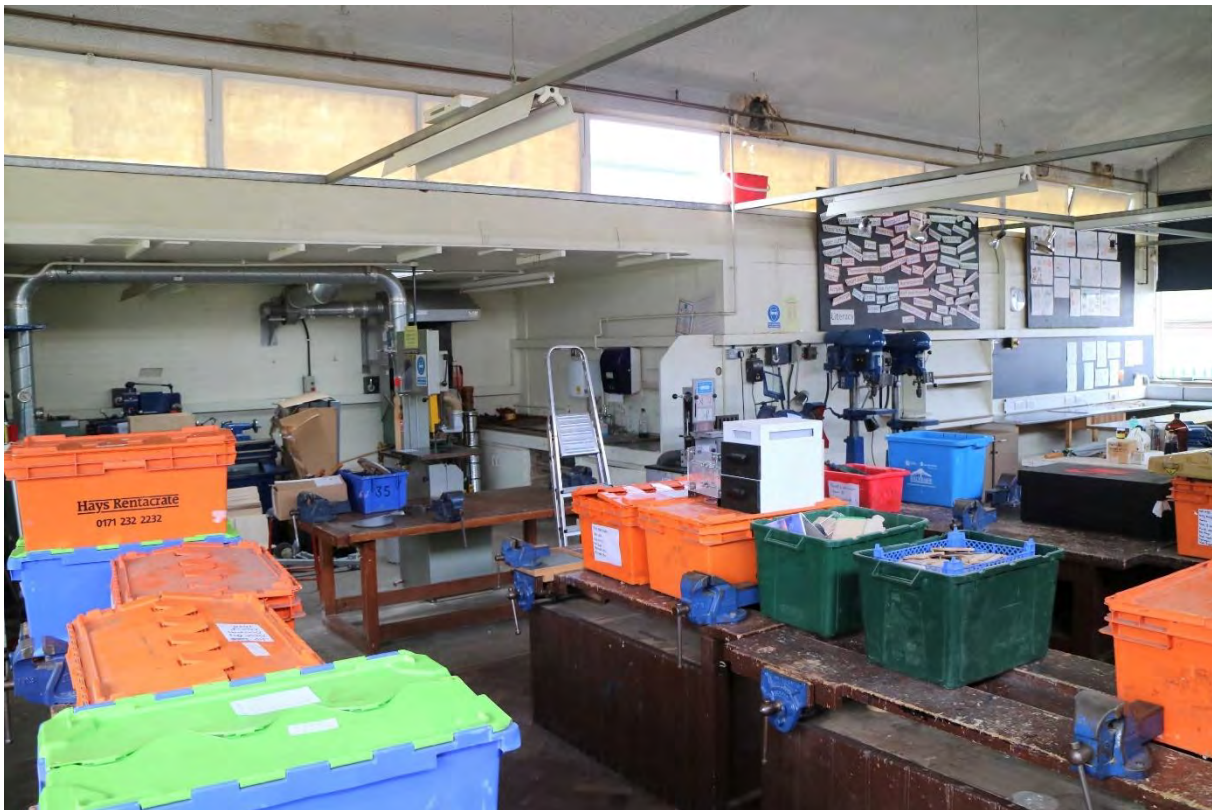
- 4.4.7 Building 3 was a large open space that did not contain any partitions (Fig 61 and Fig 62). The south facing crittall window had been painted over, presumably to limit the heat and glare here. Rows of vice benches filled the room and the narrow spaces between were lined with stools. These had left deep gouges in the parquet floor tiles (Fig 63) The adjoining partitions to the south-east had been broken through to Building 3. Workshop machinery was located here on top of a screed floor (Fig 64).

*Fig 61 Building 3, looking south-west*

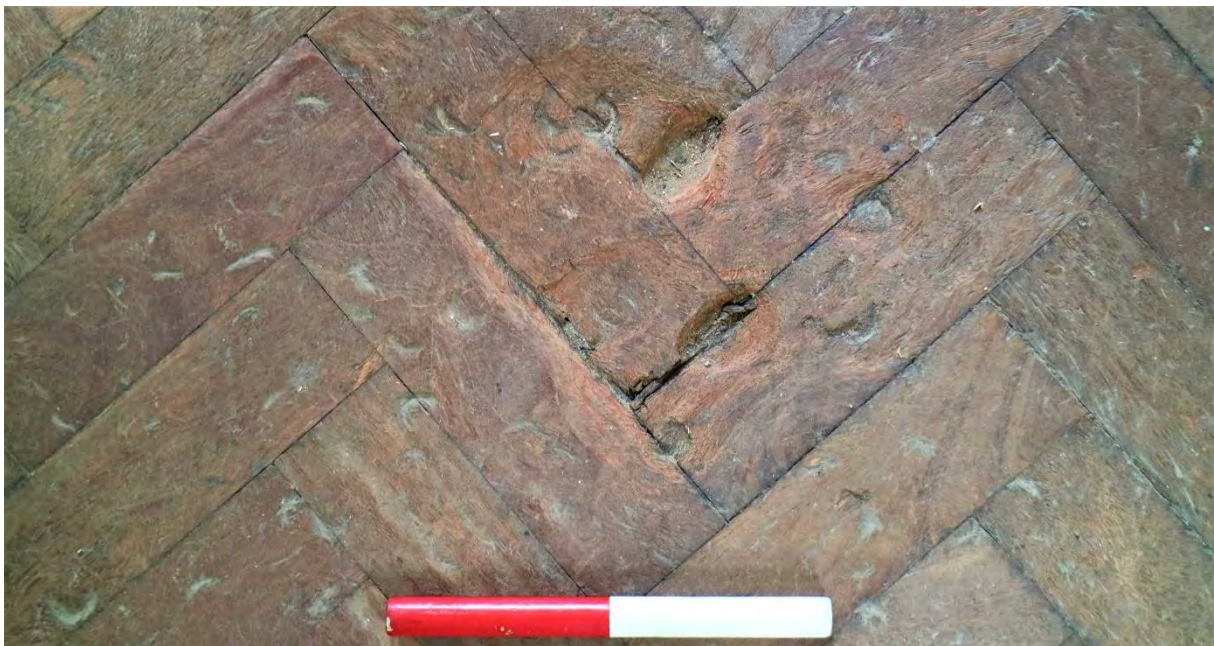
*Fig 63 Gouges in the parquet flooring caused by the stools*

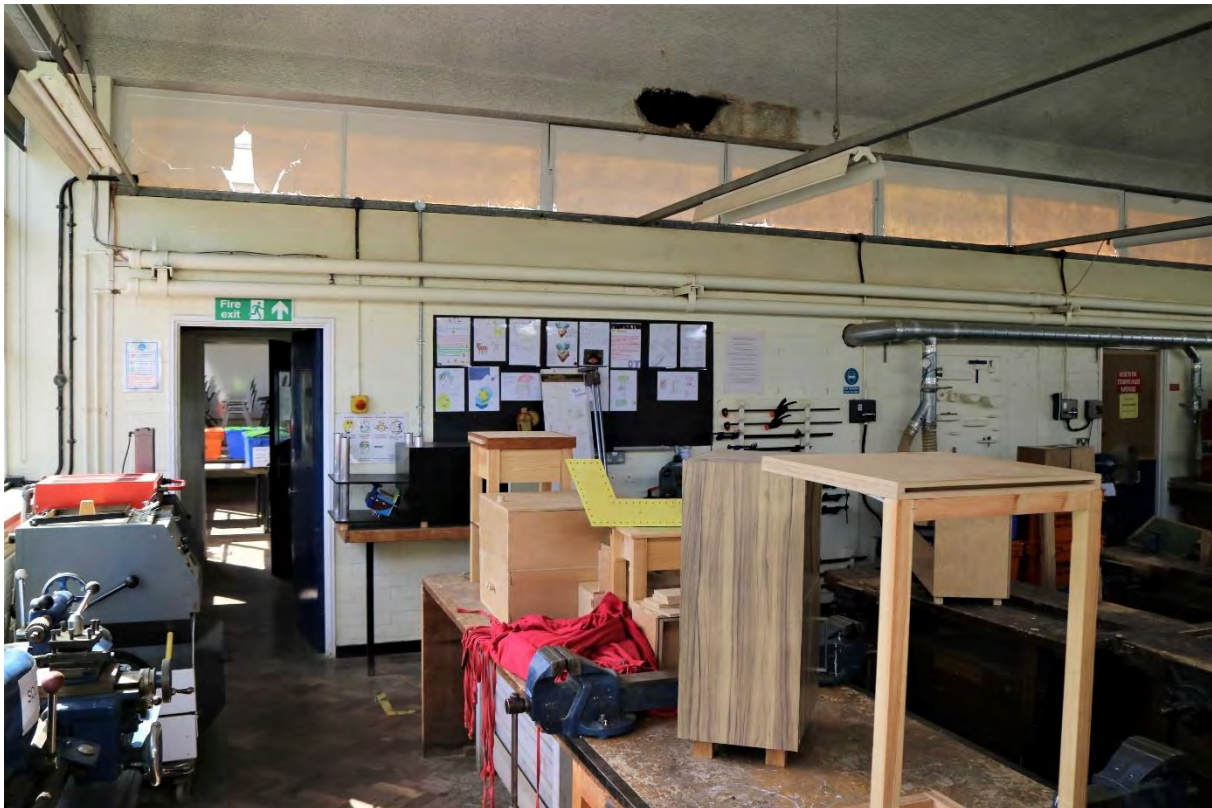
- 4.4.8 Building 4 was also one large open space occupied by rows of vice benches (Fig 65 and Fig 66). The adjoining partition to the north-west was broken through to form a small class area with sliding windows to the west (Fig 67 and Fig 68). A skylight with security bars above had been blocked by a sheet of mdf. The southern crittall window was painted over.

*Fig 65 Building 4, looking south*
