**PROJECT No. RML 8370**

**VERIFICATION REPORT**

**AT  
 FRAYS COURT, 71-73 COWLEY ROAD,  
 UXBRIDGE, LONDON, UB8 2AE**

**ON BEHALF OF  
 DHOLAK ESTATES LIMITED**

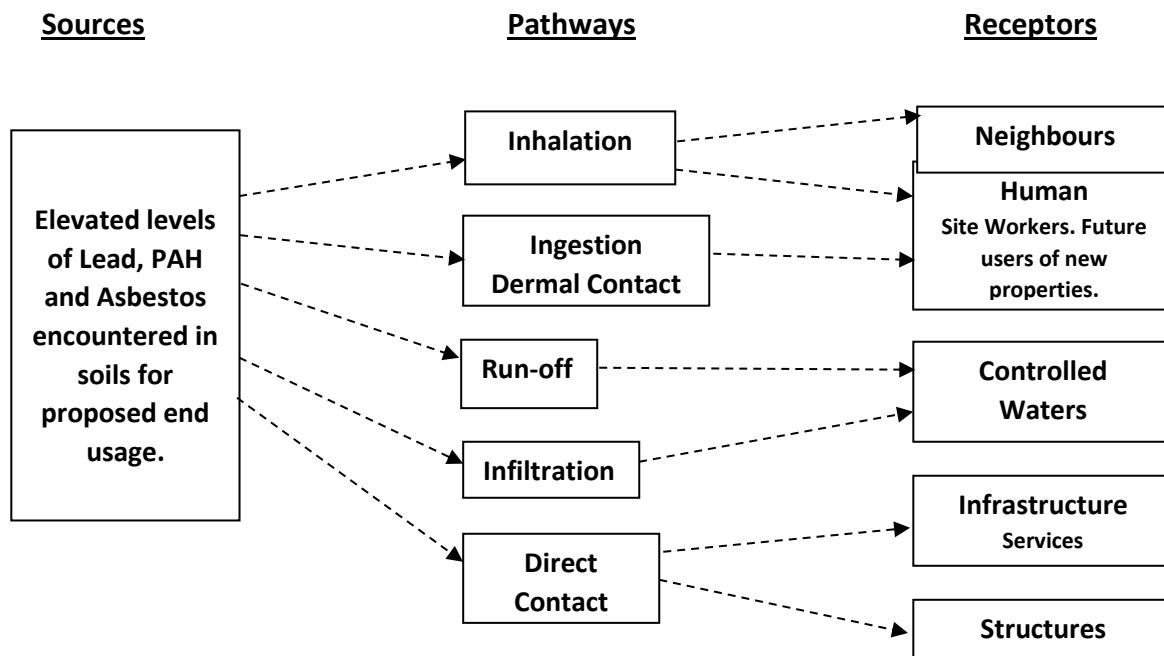
7.9 Report No. RML 7837 included the following Conceptual Site Model (CSM)

7.10 Report No. RML 7837 also included a risk assessment for each linkage identified in the CSM as shown in Table 5 below.

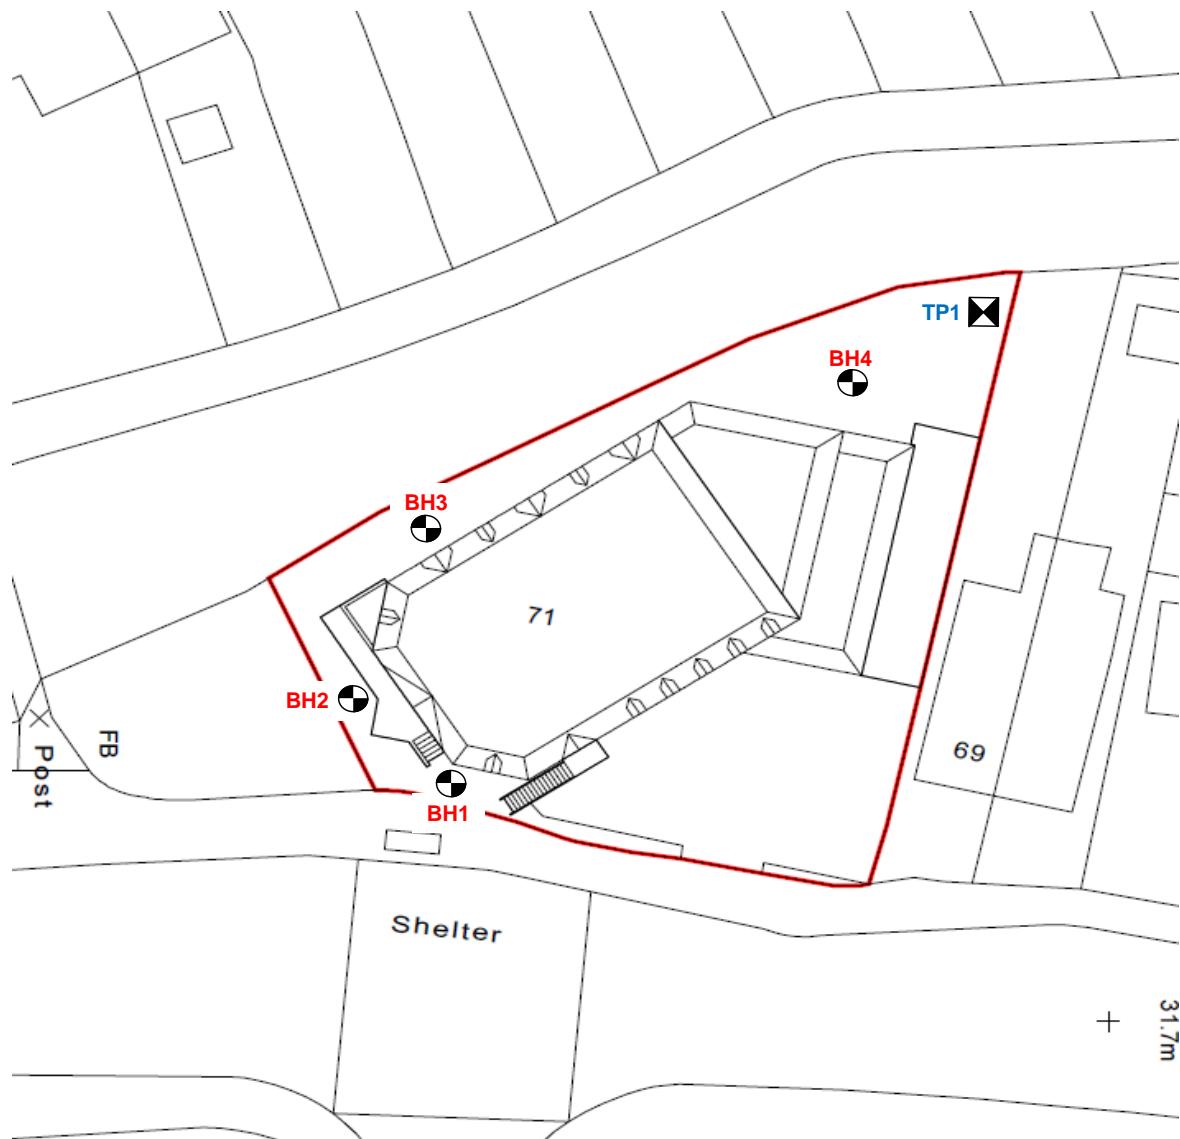
Drg. No. RML 7837 /1

- 4.9 Borehole locations are shown on the appended Figure 4, Drawing No. RML 7837/1, Sketch Fieldwork Location Plan.

**SKETCH FIELDWORK  
LOCATION PLAN**

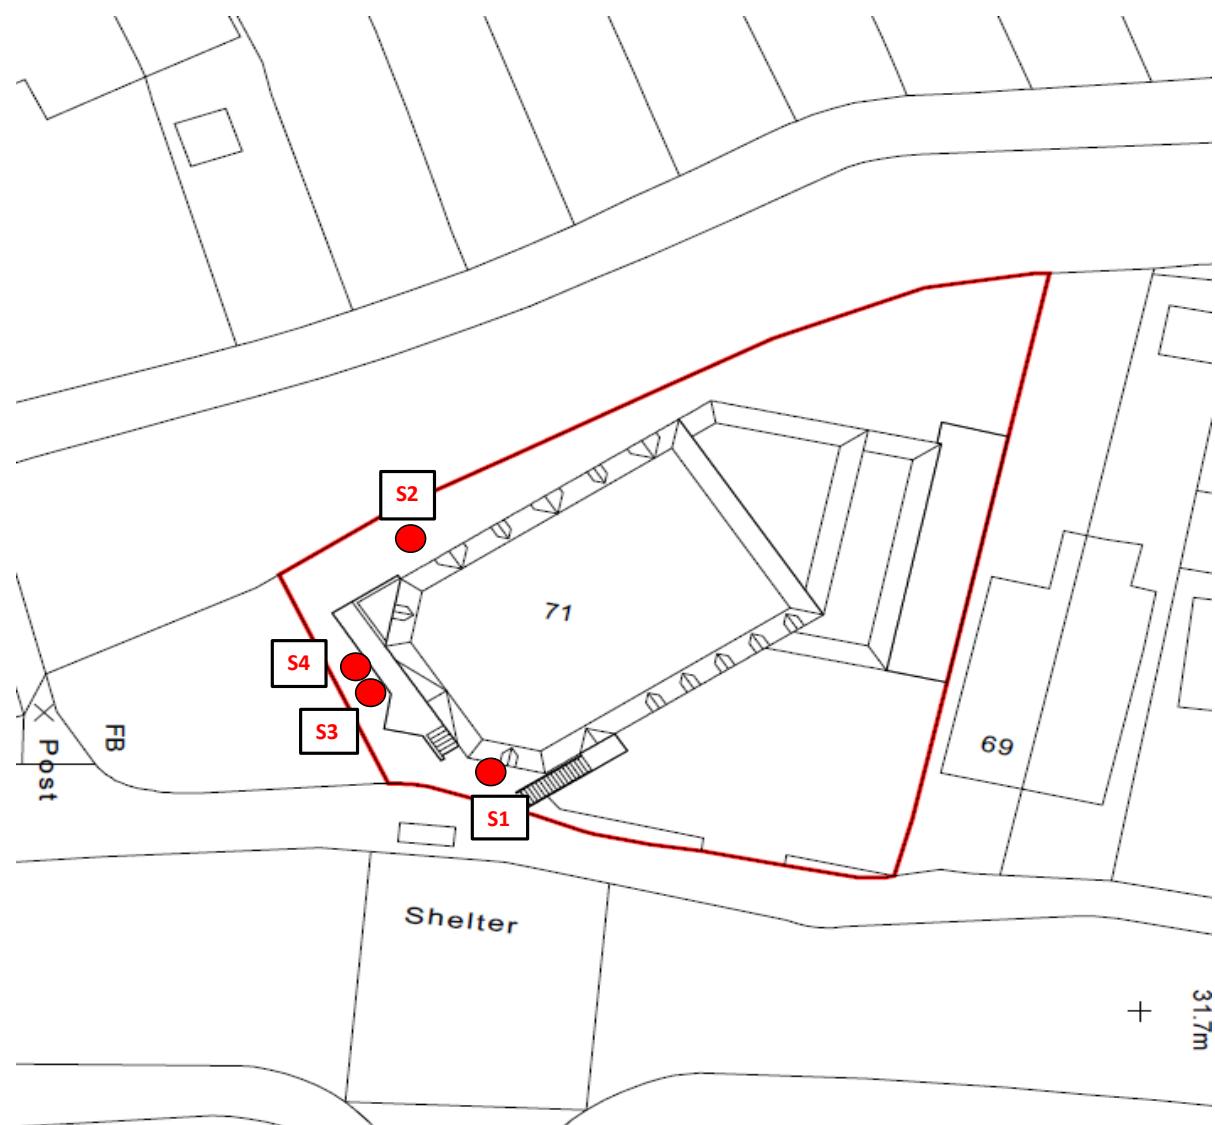
Drg. No. RML 8370 /1

## SKETCH FIELDWORK LOCATION PLAN

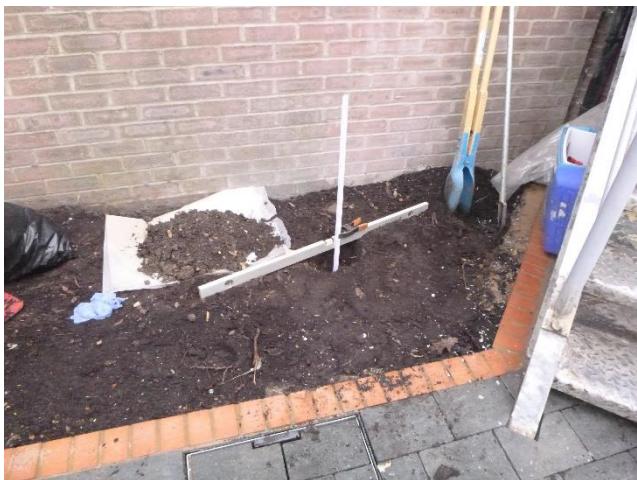
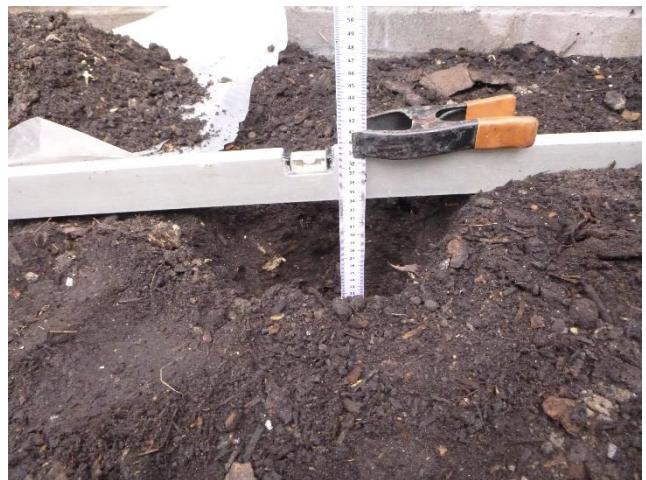
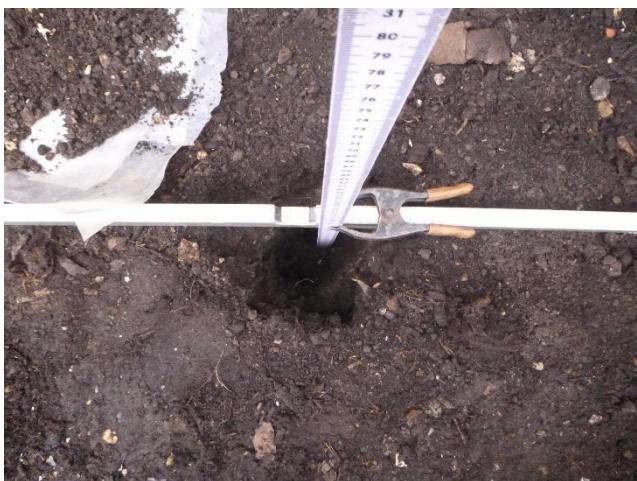
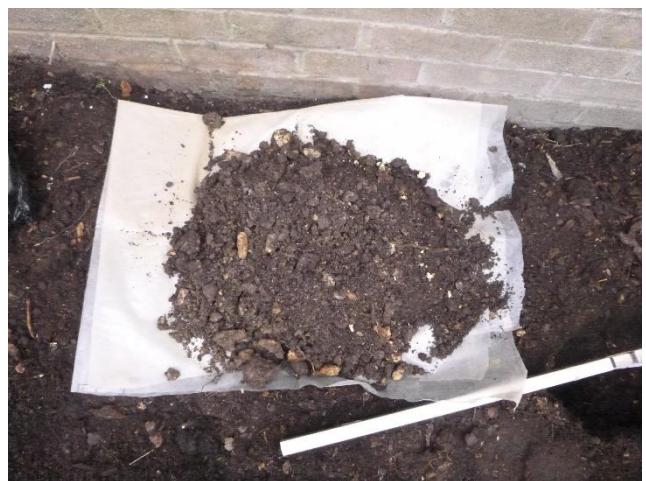
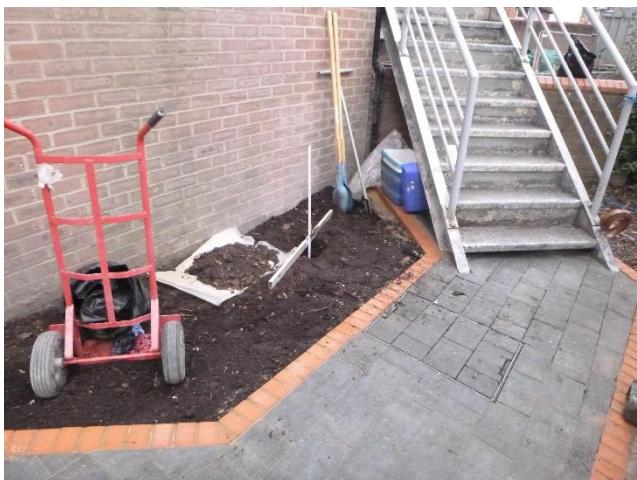
<b>Risk Management</b>	<b>Title : VERIFICATION PHOTOGRAPHS LOCATION S1</b>	<b>Report Date : March 2023</b>
<b>RISK MANAGEMENT LIMITED</b> Tel : 01883 343572	<b>Project Name : Frays Court, 71-73 Cowley Road, Uxbridge, UB8 2AE</b>	<b>Plate 1</b> <b>Job No : RML 8370</b>

**Location S1**

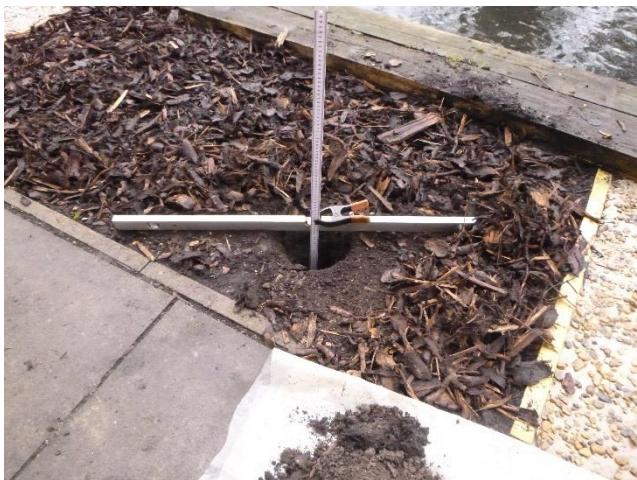
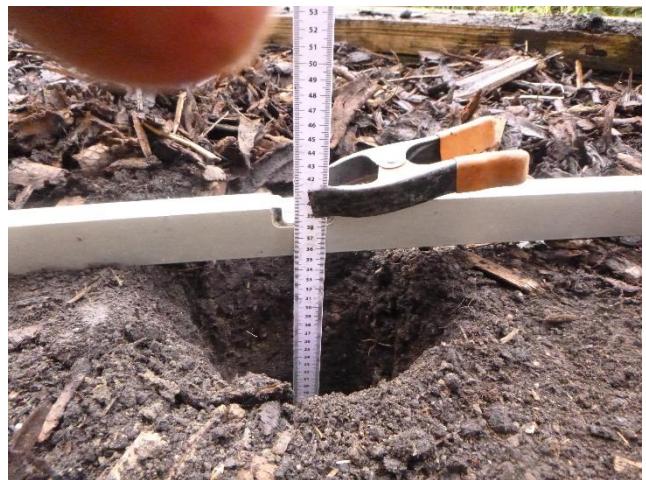
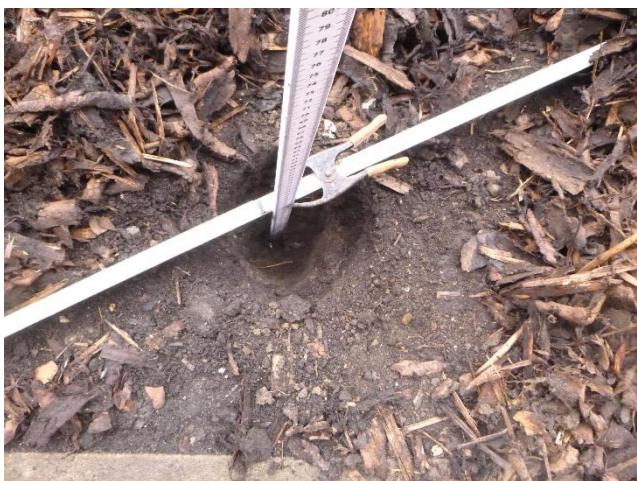
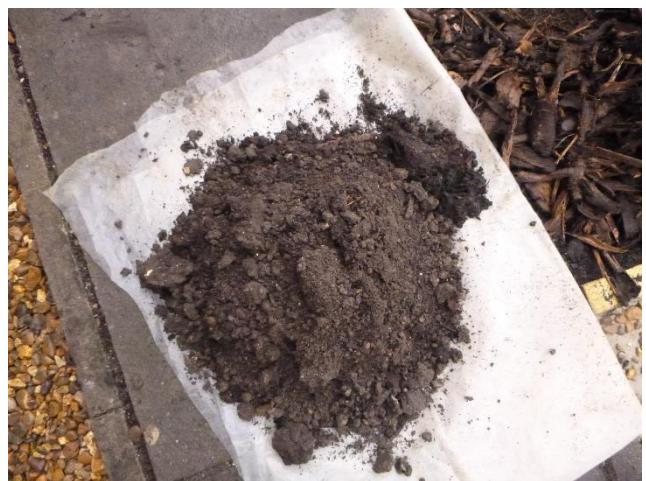
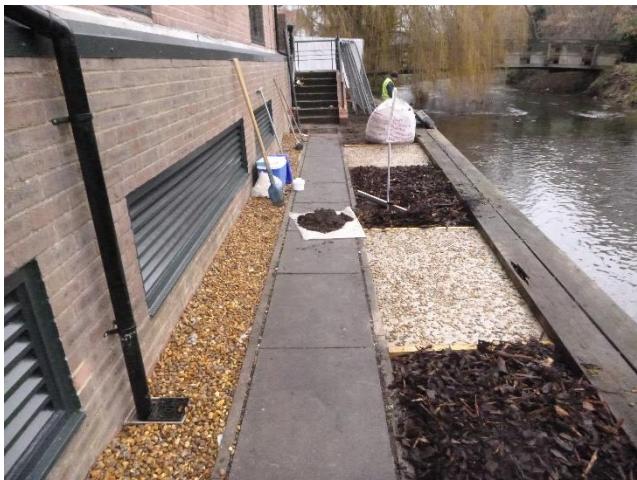
<b>Risk Management</b>	<b>Title : VERIFICATION PHOTOGRAPHS LOCATION S2</b>	<b>Report Date : March 2023</b>
<b>RISK MANAGEMENT LIMITED</b> Tel : 01883 343572	<b>Project Name : Frays Court, 71-73 Cowley Road, Uxbridge, UB8 2AE</b>	<b>Plate 2</b> <b>Job No : RML 8370</b>

**Location S2**

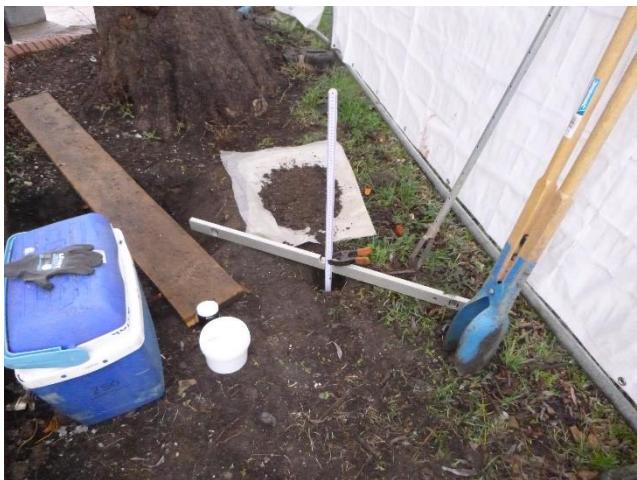
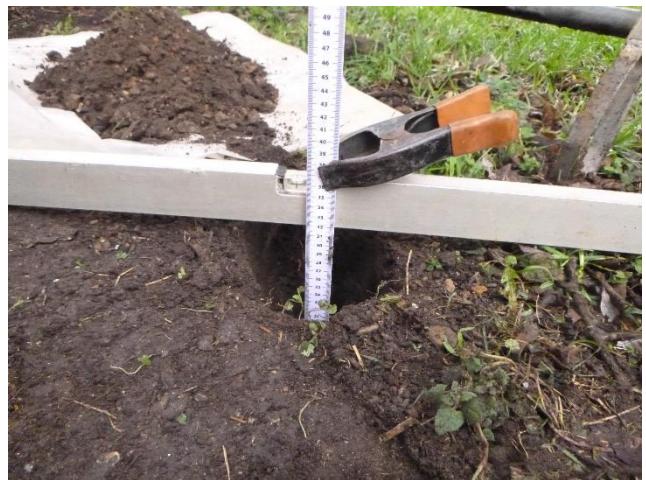
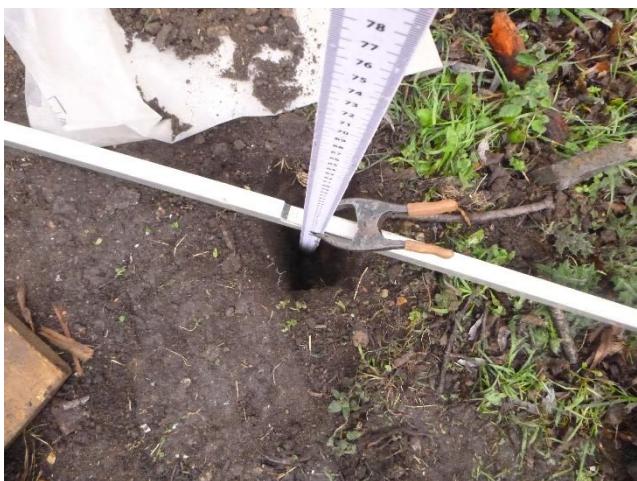
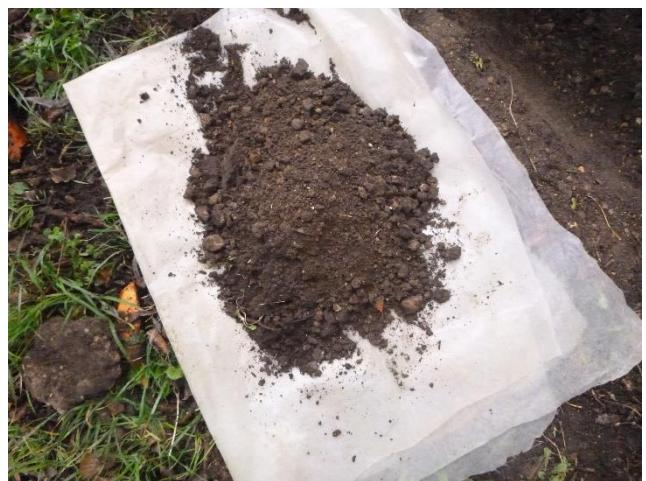
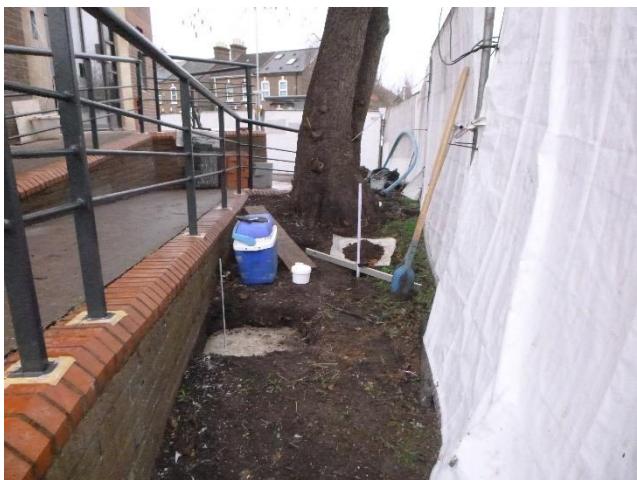
<b>Risk Management</b>	<b>Title : VERIFICATION PHOTOGRAPHS LOCATION S3</b>	<b>Report Date : March 2023</b>
<b>RISK MANAGEMENT LIMITED</b> Tel : 01883 343572	<b>Project Name : Frays Court, 71-73 Cowley Road, Uxbridge, UB8 2AE</b>	<b>Plate 3</b> <b>Job No : RML 8370</b>

9.24 One of the samples (S3) was found to contain a determinand with a concentration that exceeded the ATRISK Soil Screening Values (SSV) for **Residential without consumption of home-grown fruit and vegetables** usage.

10.1 In order to address the exceedance in the Lead concentration found in sample S3, the following additional remediation and verification activities were undertaken.

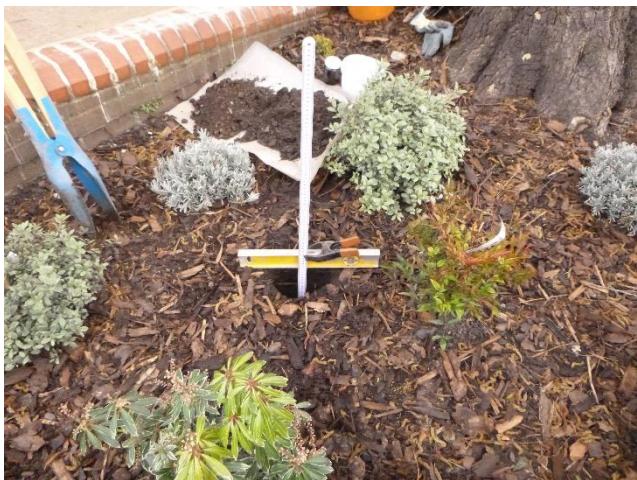
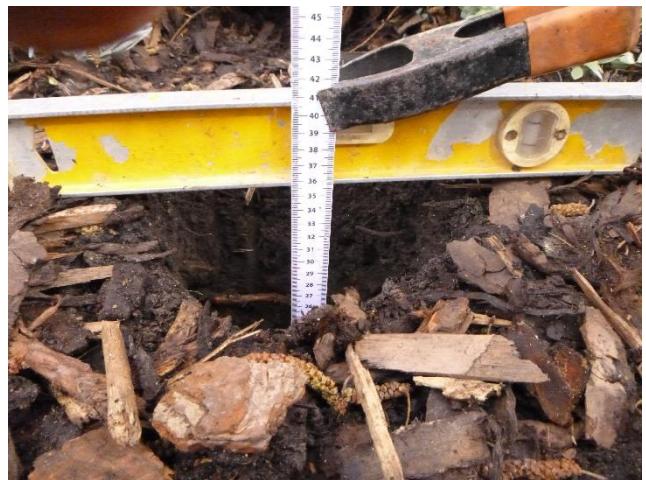
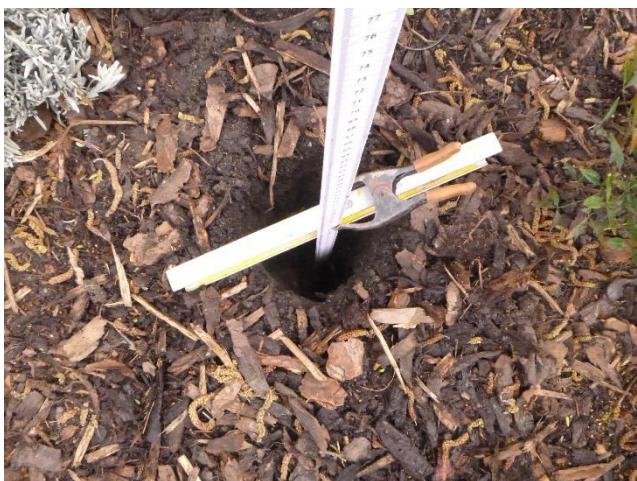
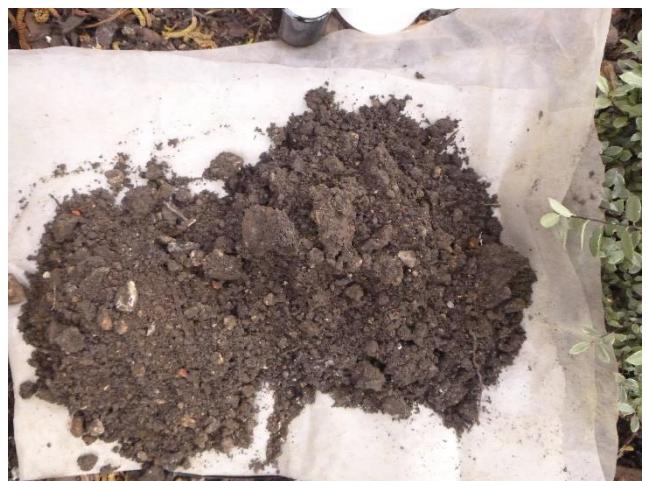
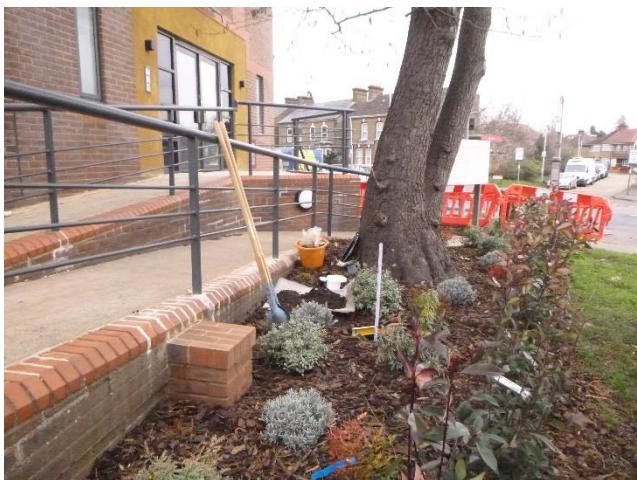
<b>Risk Management</b>	<b>Title : VERIFICATION PHOTOGRAPHS LOCATION S4</b>	<b>Report Date : March 2023</b>
<b>RISK MANAGEMENT LIMITED</b> Tel : 01883 343572	<b>Project Name : Frays Court, 71-73 Cowley Road, Uxbridge, UB8 2AE</b>	<b>Plate 4</b> <b>Job No : RML 8370</b>

10.10 From the results of the additional verification testing sample S4 was found to contain no determinants with concentrations that exceeded the CLEA Soil Guideline Values (SGV) for ***Residential without consumption of home-grown fruit and vegetables*** usage.

10.11 From the results of the additional verification testing sample S4 was found to contain one determinant with a concentration that exceeded the ATRISK Soil Screening Values (SSV) for ***Residential without consumption of home-grown fruit and vegetables*** usage.

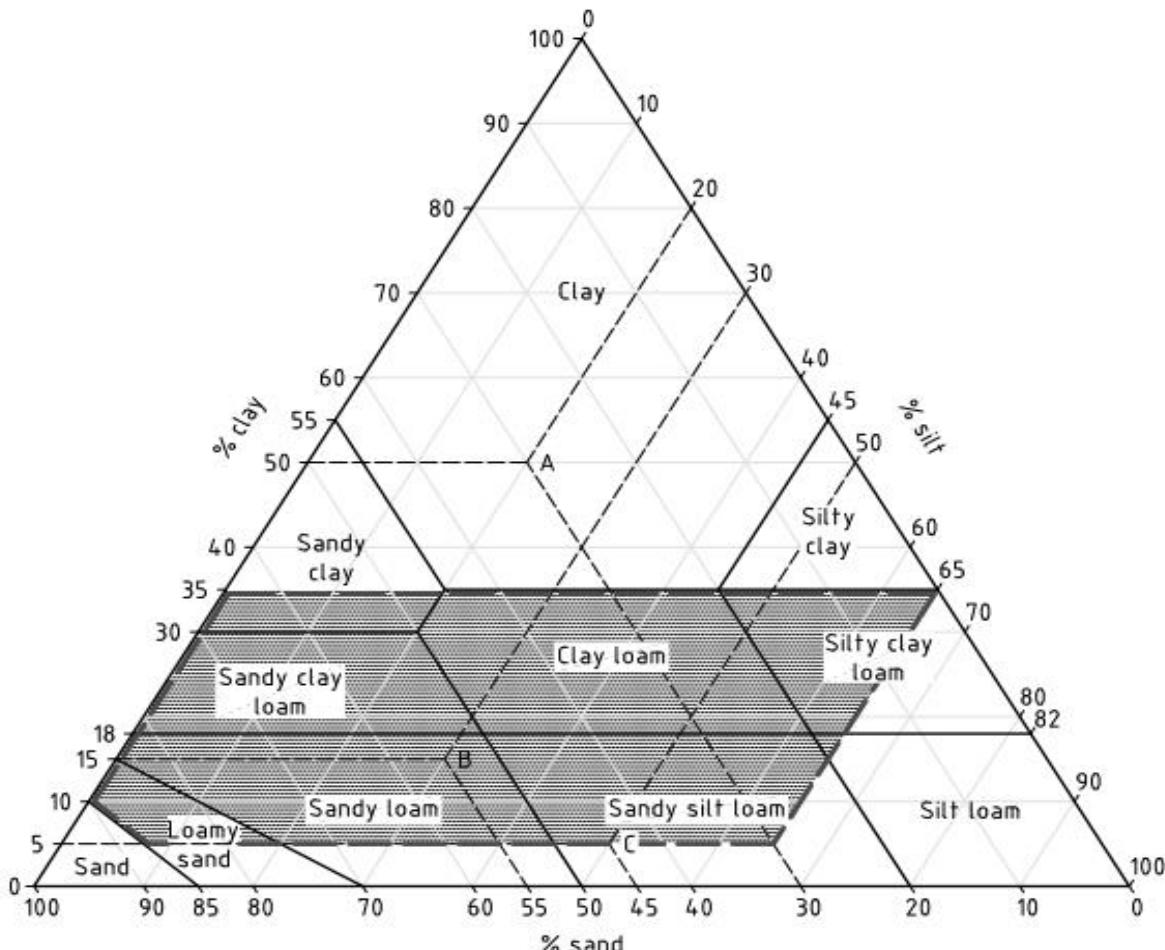
**Topsoil:  
Texture Classification Chart**

BS3882:2015
