## **Nestle Former Canteen Building, Hayes**

### **Report on the Investigation of a Two Storey Steel Framed Former Canteen Building**

**Final Report - 4689**

**Report No:** 4689

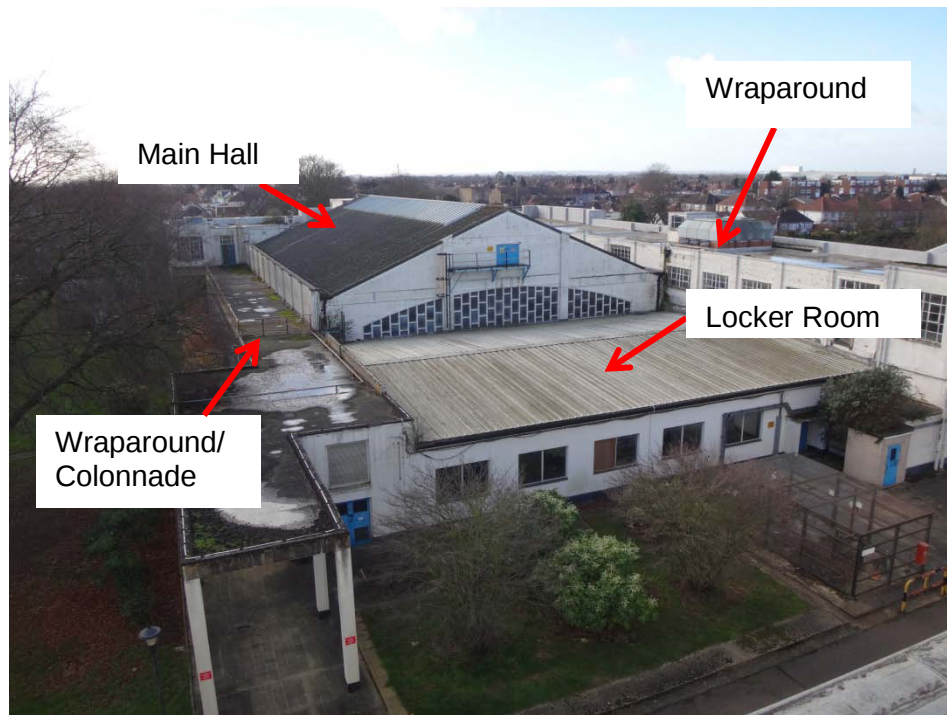
Aerial view of the former canteen building showing the northern elevation and various portions of the building

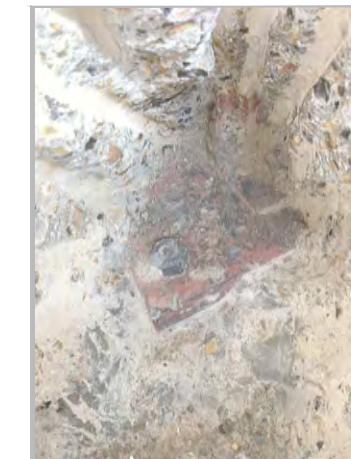
**P2b:** CLOSE UP VIEW OF BASE PLATE  
AT BOTTOM OF TRIAL PIT TP1

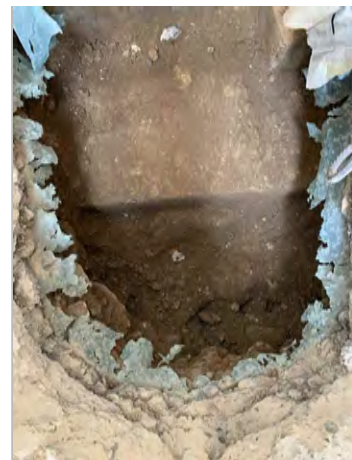
P5b: LOOKING DOWN AT FOUNDATION AT BASE OF TRIAL PIT TP2

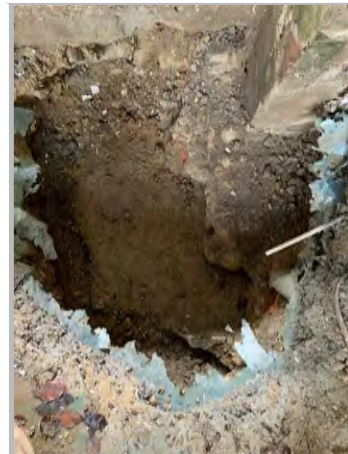
P8b: LOOKING DOWN AT FOUNDATION AT BASE OF TRIAL PIT TP3

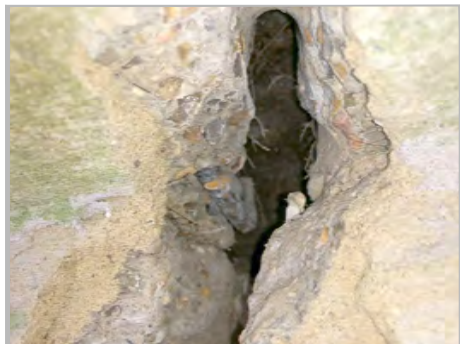
P11b: CLOSE UP VIEW OF BEAM N/2-3

STEELWORK EXHIBITS LIGHT SURFACE CORROSION WHERE EXPOSED

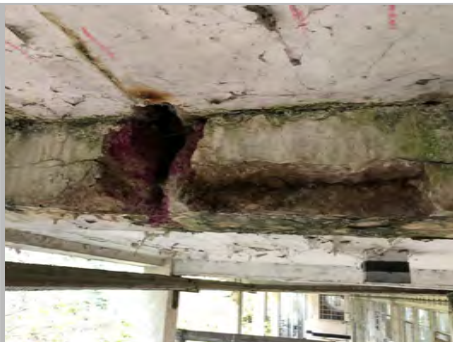
P8a: SURVEY AREA Q/10-11

FINISHES OMITTED FROM SKETCH FOR CLARITY.  
CONCRETE ENCASUREMENT TO BEAM AND PLANKS IN VISIBLY POOR CONDITION.  
RUST STAINS, MOSS, HISTORIC STAINING AND SPALLING PRESENT.

The application of an anti-carbonation coating to the exposed concrete elements will reduce the rate of carbonation and increase the durability of the structure, although it should be noted that manufacturers of such coatings normally advise re-application every c.10 years.

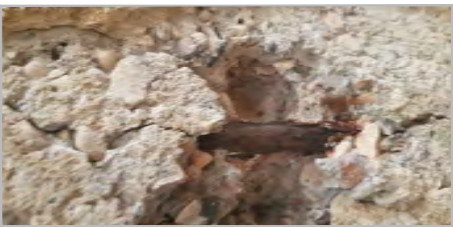
P8b: BAR EXPOSED AT BREAKOUT B/O C

12mmØ PLAIN ROUND BAR AT 20mm CONCRETE COVER.  
BAR EXHIBITS MODERATE TO HEAVY SURFACE CORROSION WHERE LOCALLY EXPOSED.

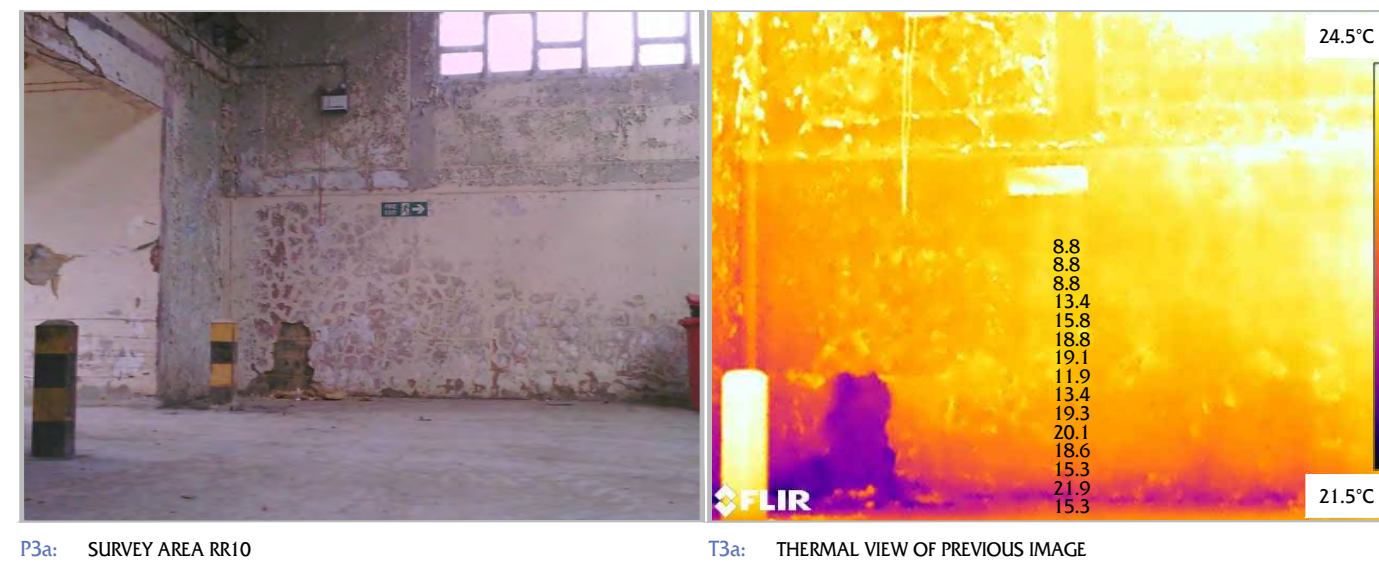
FIG.4: RESULTS OF THERMAL SURVEY - AREA RR11

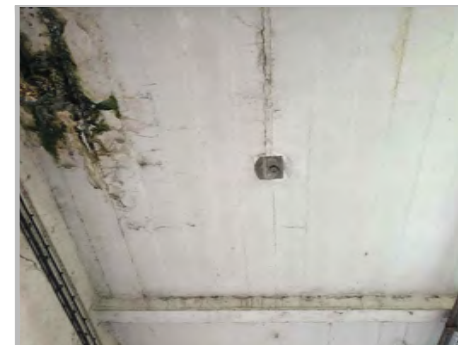
P1d: WATER SEEPAGE, CRACK AND MOSS GROWTH - GRID Q-P/10-11

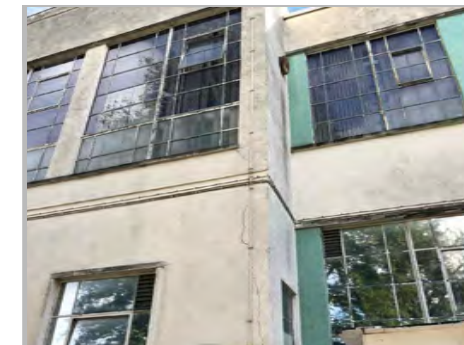
P1e: VERTICAL CRACK TO EXTERNAL COLUMN AB

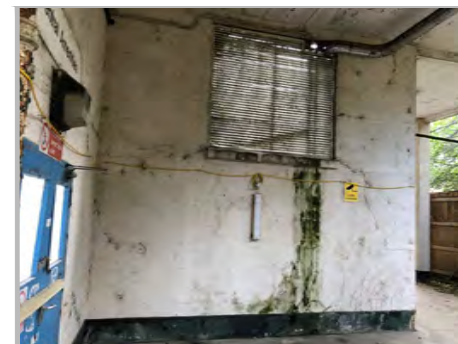
P1g: CRACK AND WATER INGRESS TO WALL R/10-11

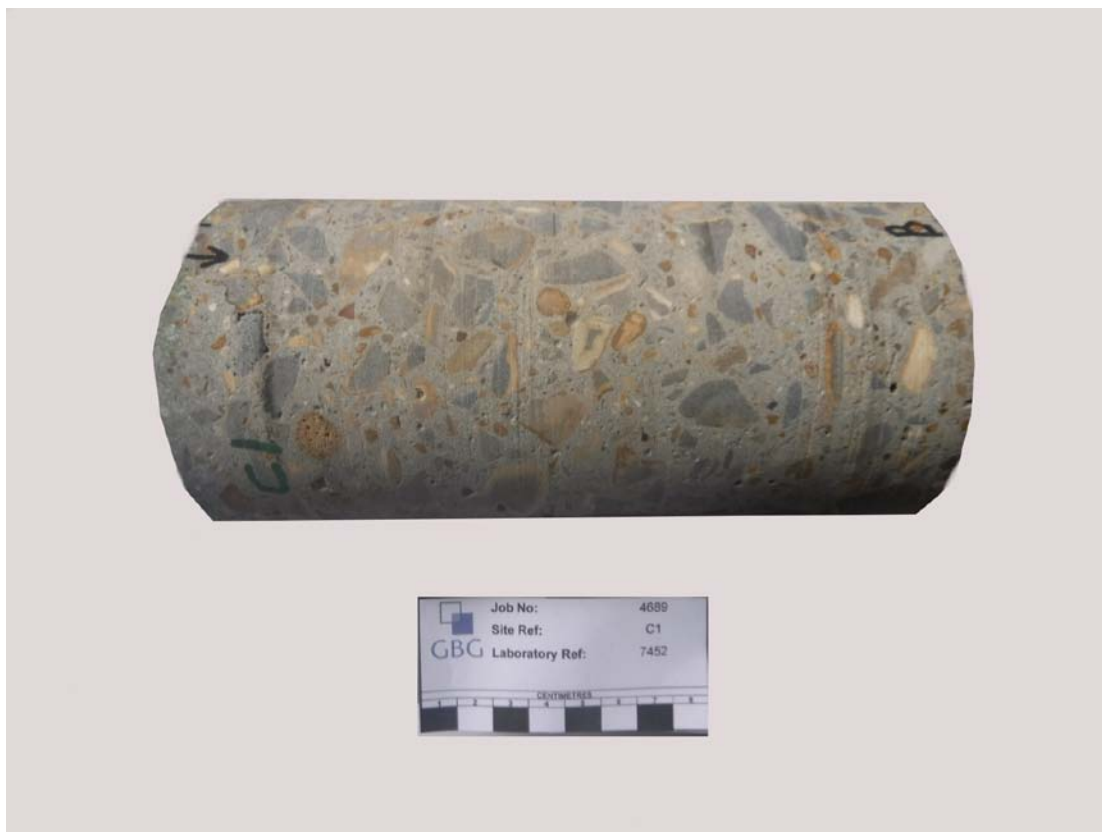
**Plate: SD1** (D7730\_001)

**Site Reference:** C1

The surface of the core was dry on receipt and the voids were empty. There were no cracks cutting the core. There was 1No. 8mm diameter steel bar present within the core at 25mm from the top surface of the core.

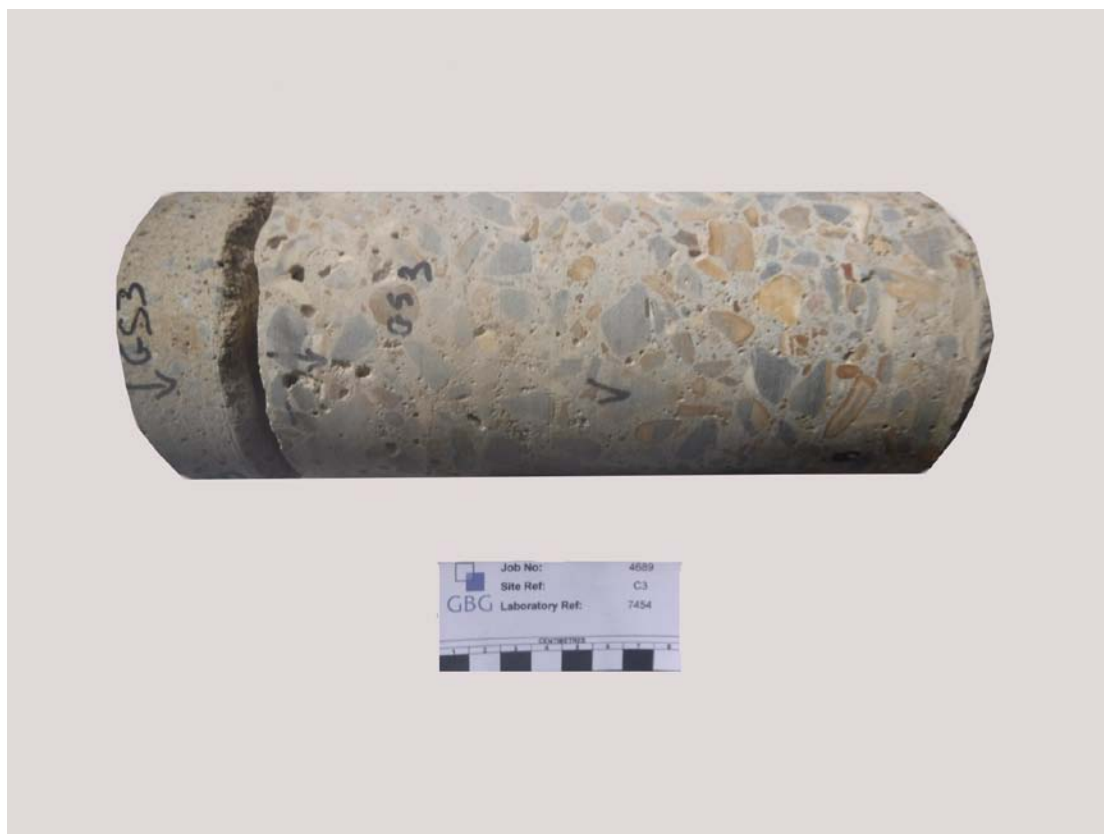
**Plate: SD3** (D7730\_049)

**Site Reference:** C3

The surface of the core was dry on receipt and the voids were empty. There were no cracks cutting the core. There were no steel bars present in the core. Minor honeycombing was observed at the bottom of the core.

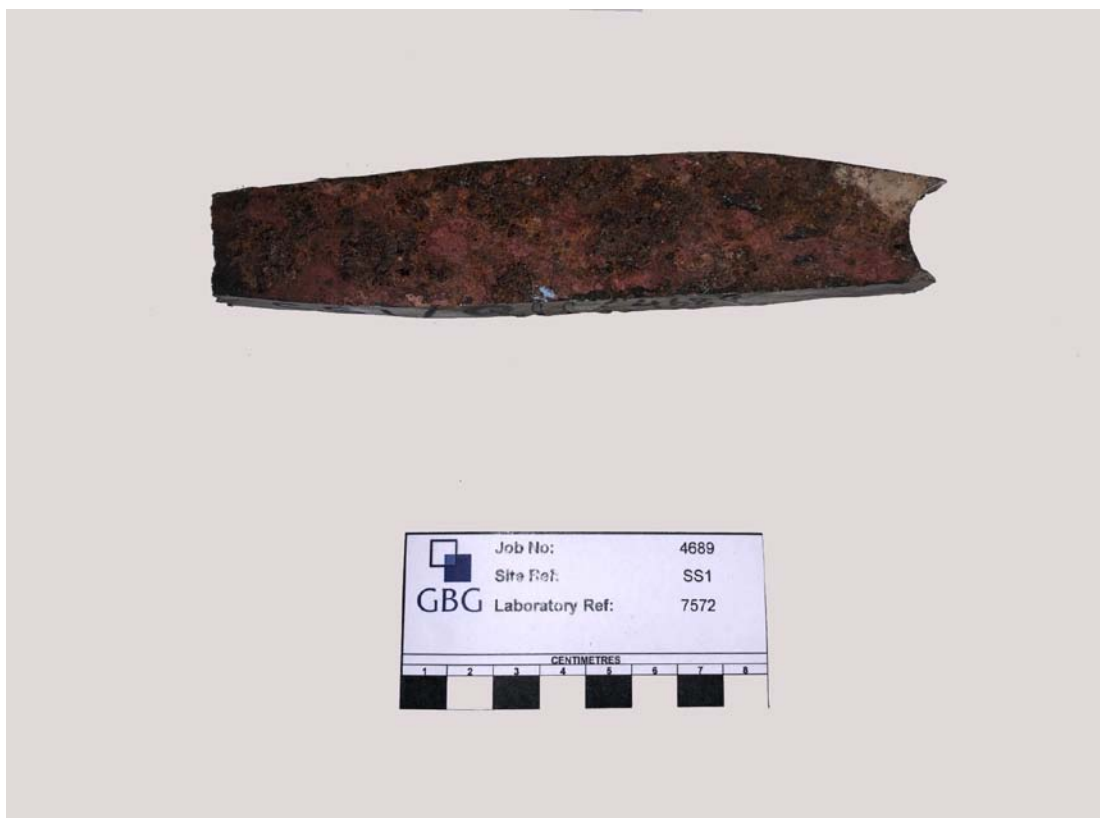
**Plate:** SD5 (D7736\_003)

**Site Reference:** SS1

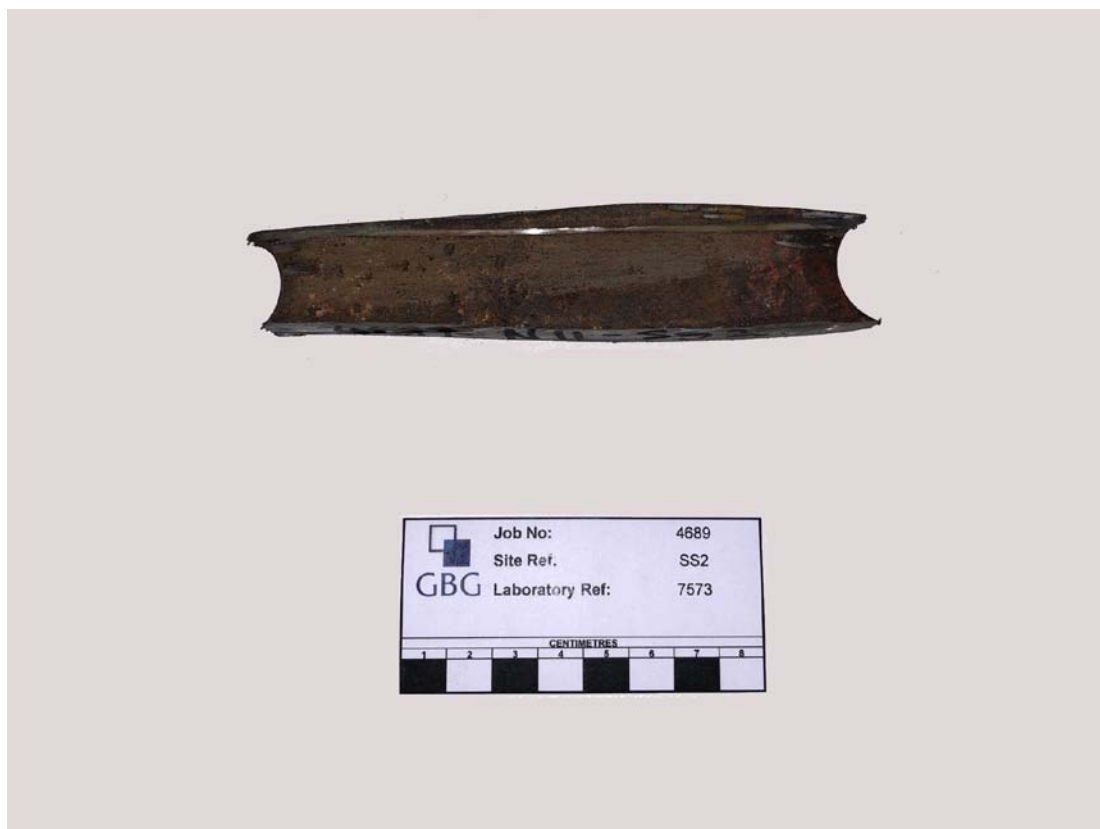
**Plate: SD6** (D7736\_005)

**Site Reference:** SS2  
**Laboratory Ref:** 7573

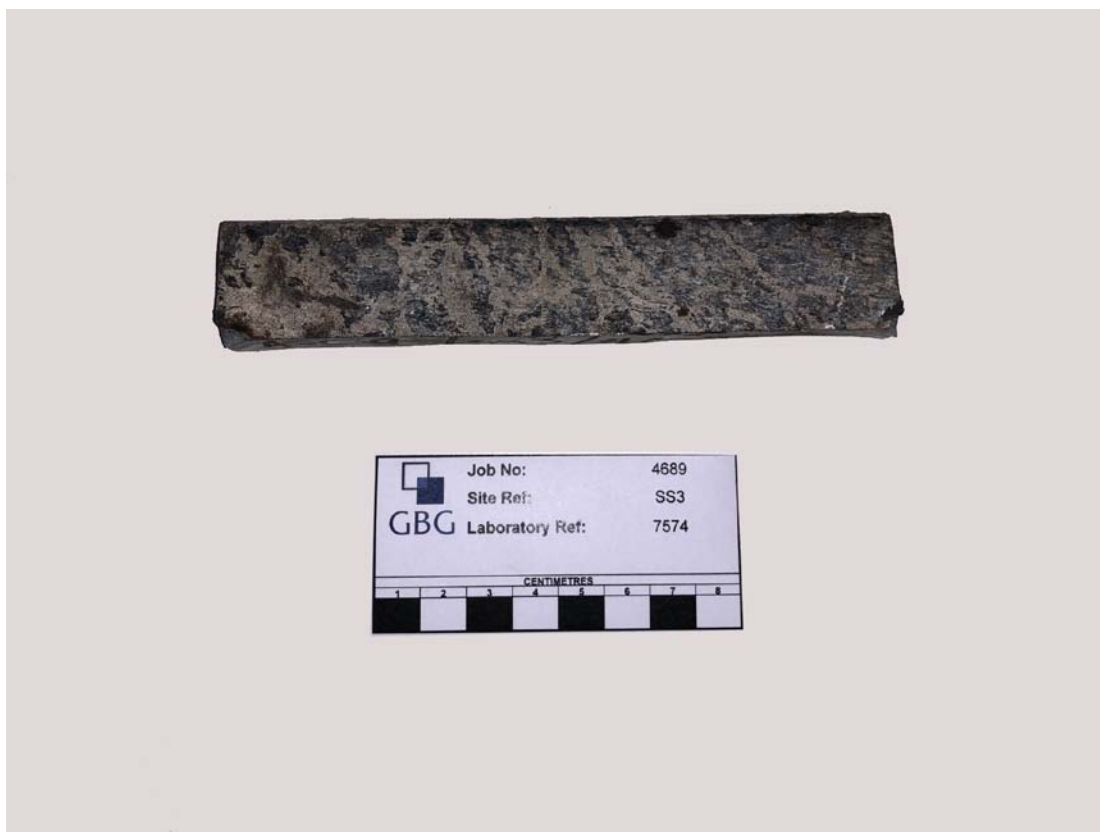
**Plate: SD7** (D7736\_007)  
**Site Reference:** SS3  
**Laboratory Ref:** 7574  
**Location:** Grid A-B/9 – Steel Beam – First Floor Level

A 150mm long x 25mm wide steel coupon sample cut from the steel beam flange.

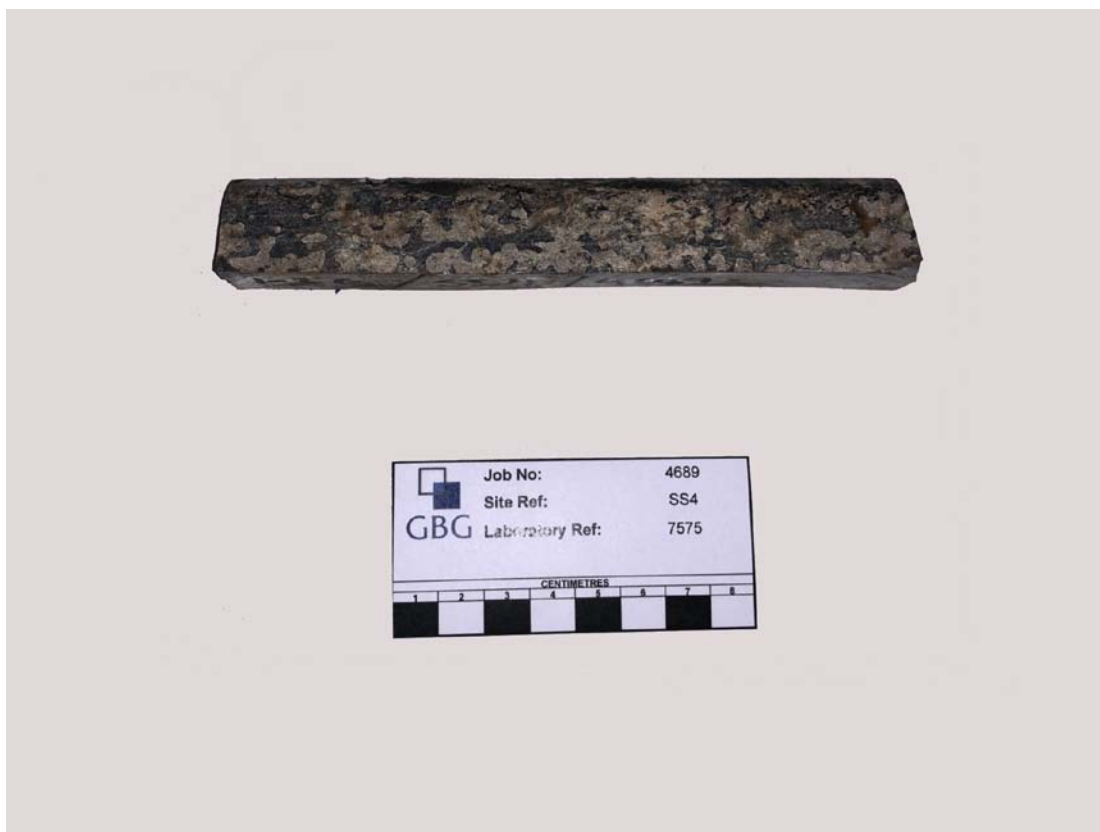
**Plate:** SD8 (D7736\_009)

**Site Reference:** SS4

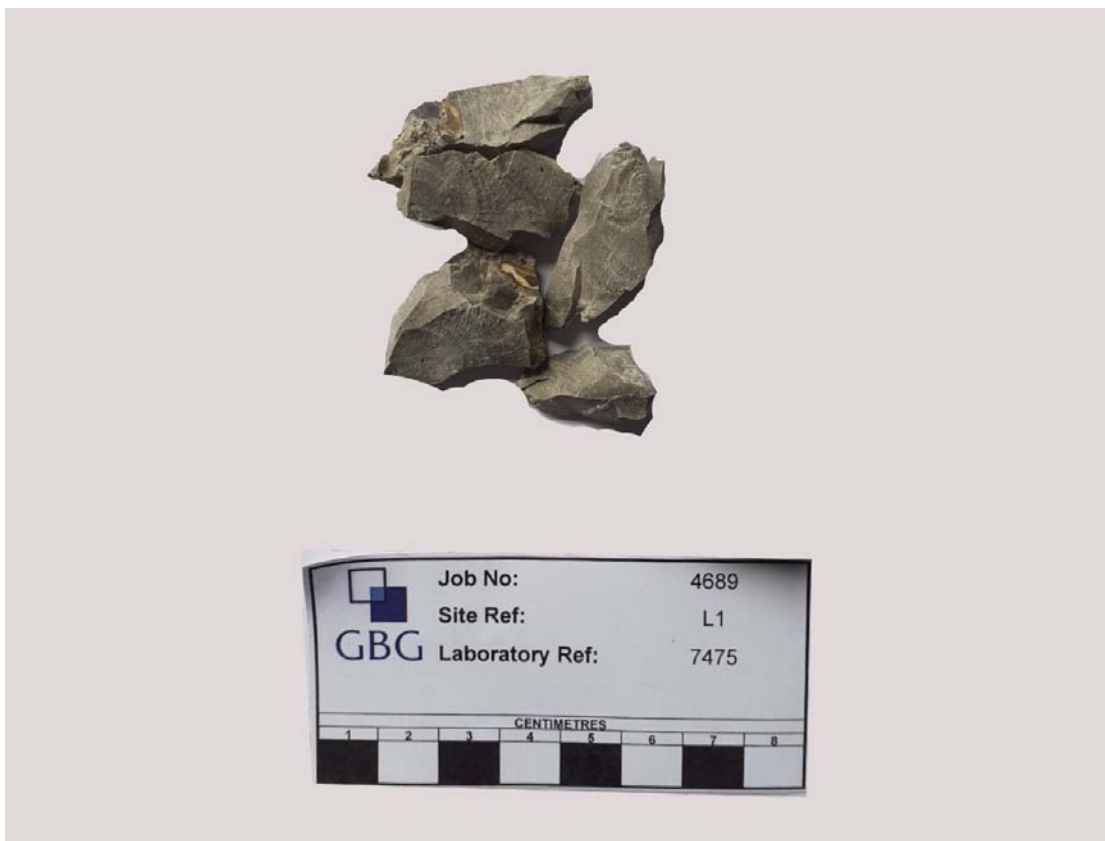
**Plate: SD9** (D7729\_001)

**Site Reference:** L1

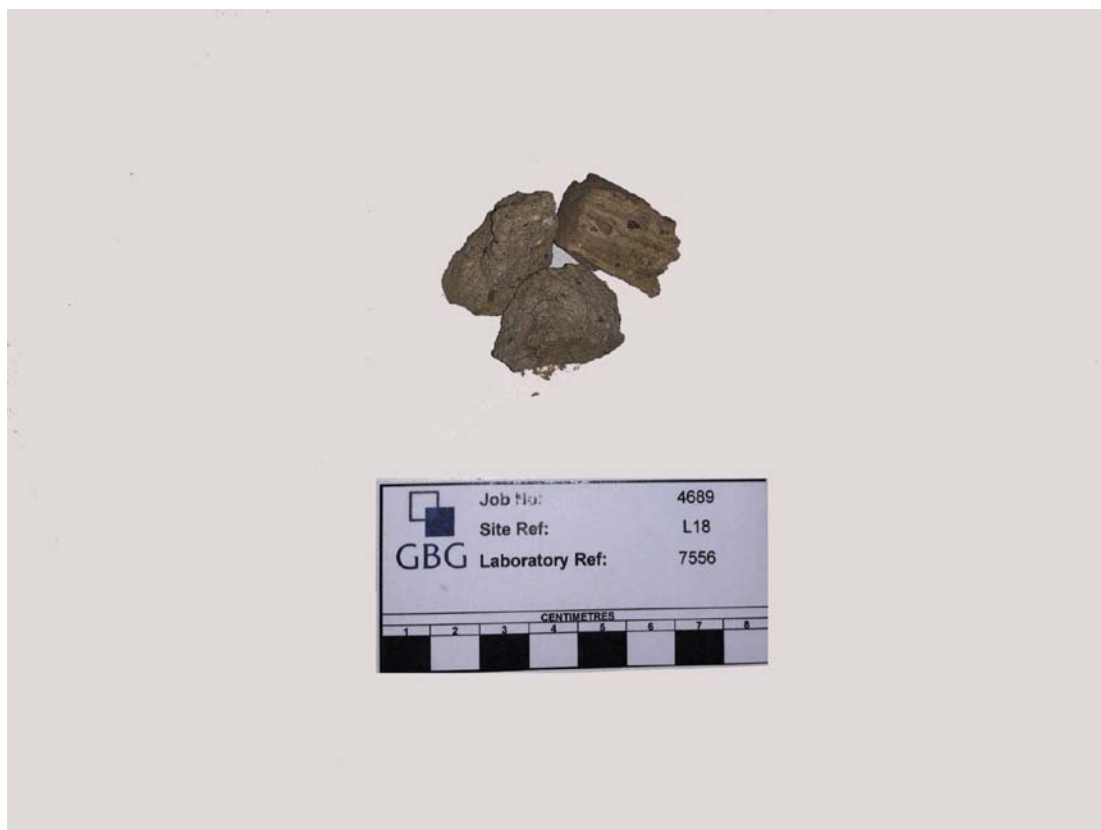
**Plate: SD12** (D7736\_001)

**Site Reference:** L18
