DETAILS OF ROOF TRUSS CONNECTIONS - SHEET 4 OF 8
NESTLE FORMER CANTEEN BUILDING, HAYES

PROJECT DETAILS
GBG REPORT No. 4698 ACCOMPANIES THIS DRAWING.

STRUCTURE INVESTIGATED TWO STOREY STEEL FRAMED FORMER CANTEEN BUILDING

PURPOSE OF INVESTIGATION TO DETERMINE CERTAIN STRUCTURAL DETAILS AND MATERIAL PROPERTIES AS REQUIRED BY THE CLIENT'S DESIGN TEAM

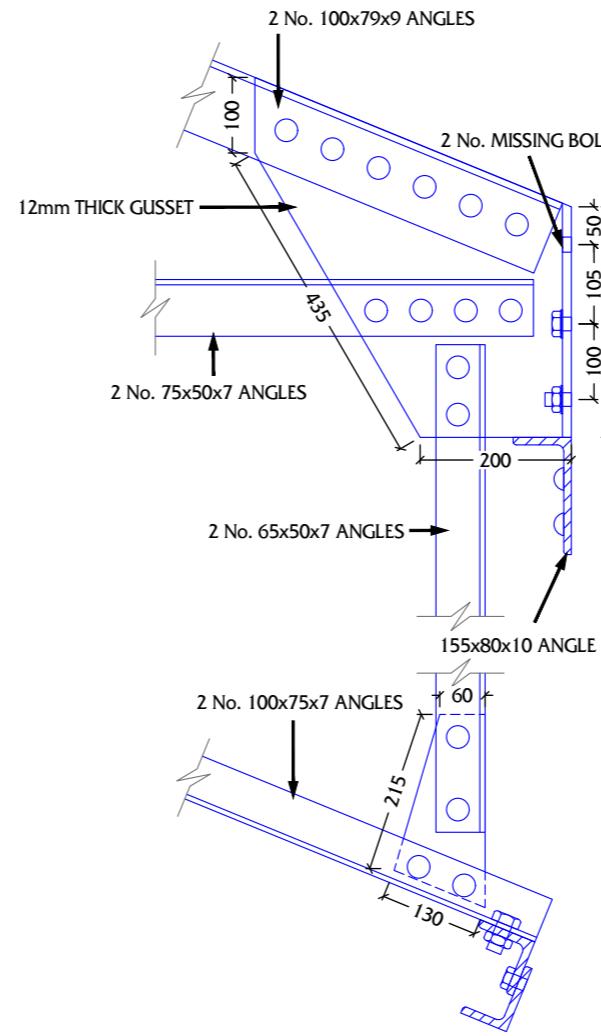
FIG.11: PART ELEVATION LOOKING SOUTH SHOWING DETAILS OF PARTIALLY EXPOSED ROOF TRUSS END CONNECTION - SURVEY AREA K3 SCALE 1:10

STEELWORK GENERALLY EXHIBITS LIGHT SURFACE CORROSION WHERE EXPOSED.
GUSSET PLATE BELOW TOP CHORD EXHIBITS MODERATE SURFACE CORROSION WHERE EXPOSED.
RIVETS APPEAR TO BE IN POOR CONDITION COMPARED TO ELSEWHERE.
LOSS OF SECTION TO ANGLE SUPPORTING TOP GUSSET.
LOTS OF VEGETATION GROWING THROUGH BRICKWORK.
BRICKWORK MORTAR IS SOFT AND EASILY BROKEN OUT.

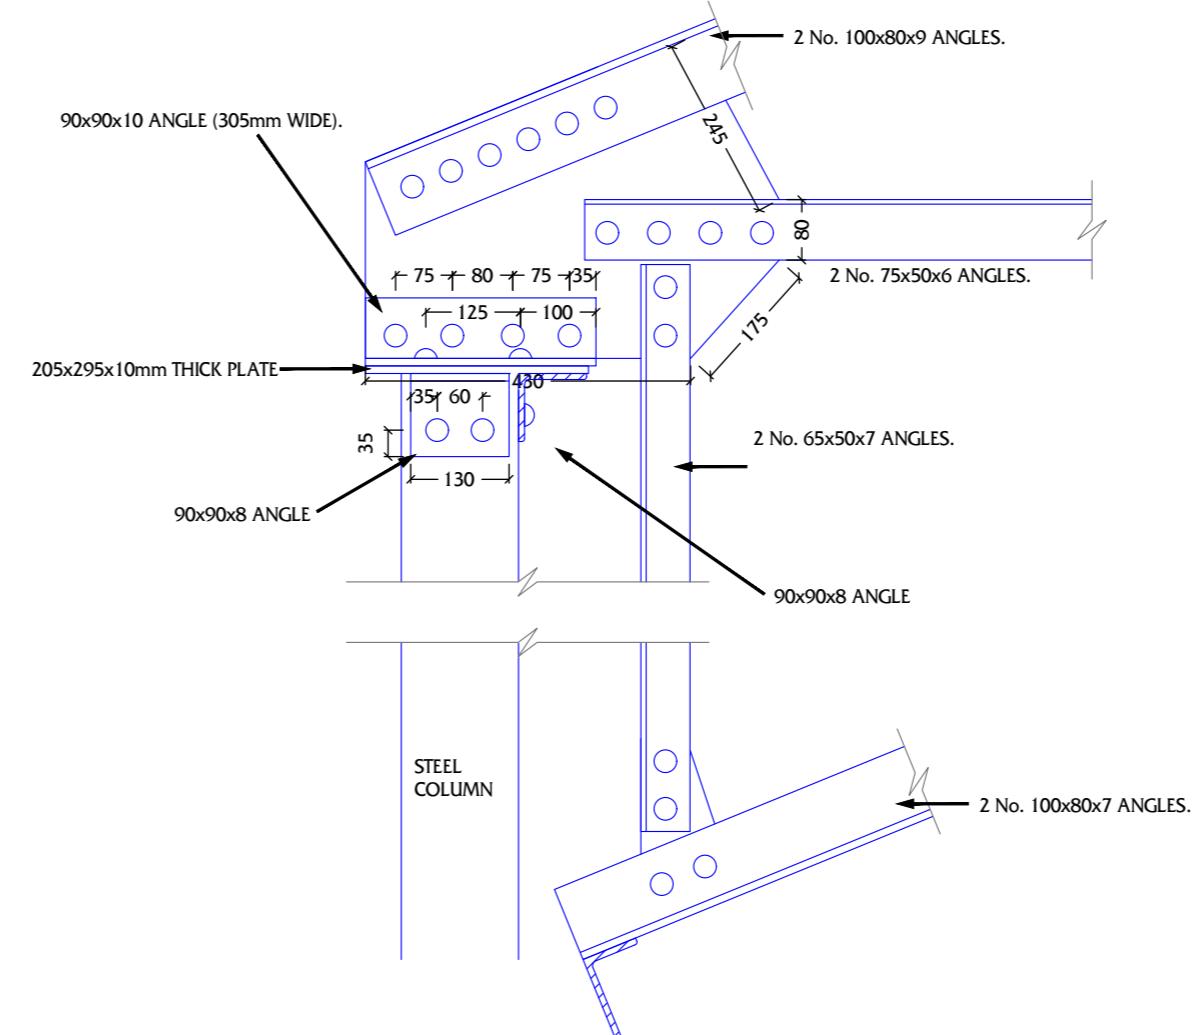
FIG.21: PART ELEVATION LOOKING SOUTH SHOWING DETAILS OF PARTIALLY EXPOSED ROOF TRUSS END CONNECTION - SURVEY AREA G10 SCALE 1:10

STEELWORK GENERALLY EXHIBITS LIGHT SURFACE CORROSION WHERE EXPOSED.
EVIDENCE OF WATER INGRESS.
CORROSION WHERE EXPOSED IS HEAVIER ALONG TOP OF TOP CHORD AND EDGES OF GUSSET.
EVIDENCE OF PREVIOUS BOLT WITH CORROSION WHERE EXPOSED AROUND WASHER.

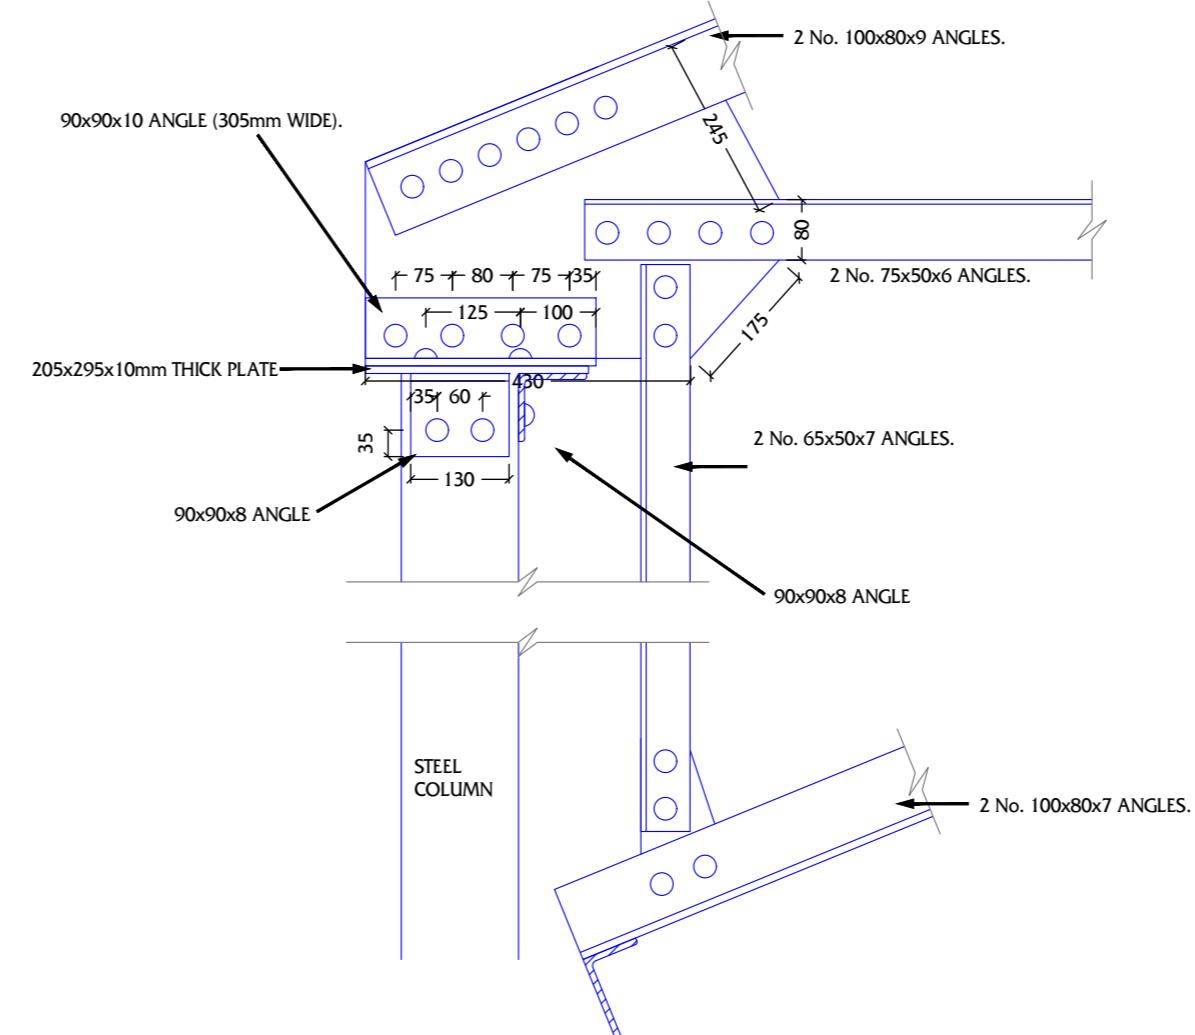
FIG.24: PART ELEVATION LOOKING SOUTH SHOWING DETAILS OF PARTIALLY EXPOSED ROOF TRUSS END CONNECTION - SURVEY AREA H10 SCALE 1:10

STEELWORK GENERALLY EXHIBITS LIGHT SURFACE CORROSION WHERE EXPOSED. SOME AREAS OF ORIGINAL PAINT STILL PRESENT.

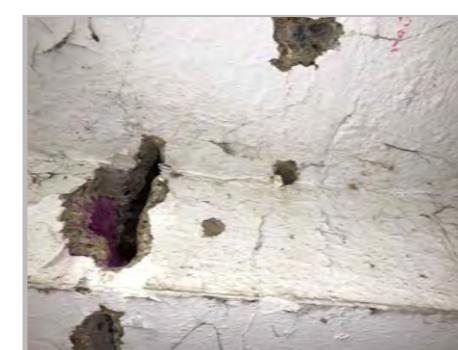
P2a: SURVEY AREA F/10-11

STEELWORK EXHIBITS LIGHT SURFACE CORROSION WHERE EXPOSED

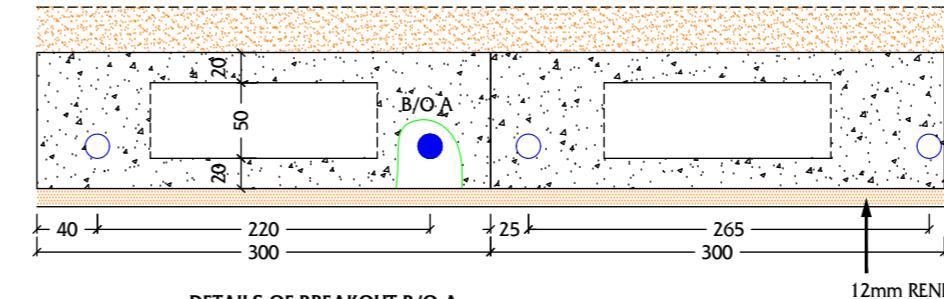
FIG.2: PART SECTION LOOKING SOUTH THROUGH 1ST FLOOR SLAB SHOWING
PRECAST CONCRETE PLANK CONSTRUCTION DETAIL - SURVEY AREA L-K/2-3

DETAILS OF BREAKOUT B/O A

16mmØ PLAIN ROUND BAR AT 20mm CONCRETE COVER.
BAR IS IN VISIBLY GOOD CONDITION WHERE EXPOSED.

CRACKING BETWEEN PLANKS (AT PLANK JOINTS) THROUGH RENDER ONLY

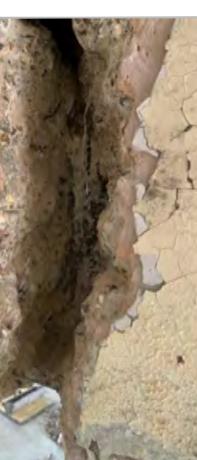
P3a: PRIMARY BEAM AT SURVEY AREA L-K/2-3

STEELWORK EXHIBITS LIGHT SURFACE CORROSION ONLY WHERE EXPOSED

CRACKS DO NOT EXTEND BEYOND RENDER

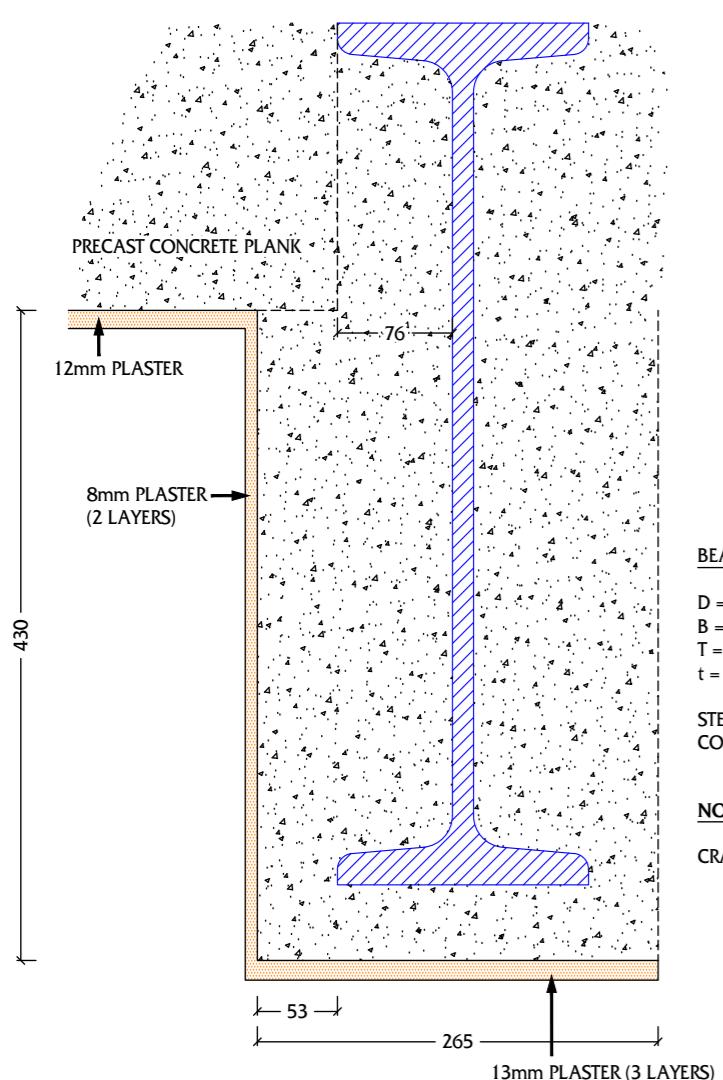
FIG.3: PART SECTION LOOKING EAST THROUGH 1ST FLOOR PRIMARY BEAM - SURVEY AREA L-K/2-3

D = 570mm
B = 166mm
T = 23.2mm
t = 14mm

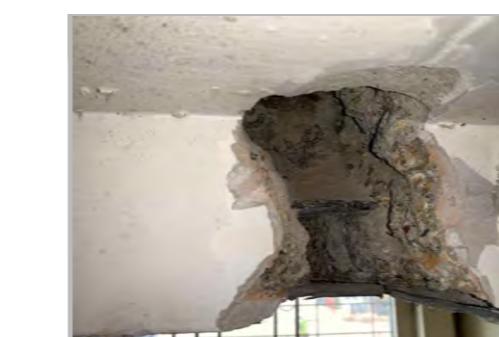
P4a: SECONDARY BEAM AT SURVEY AREA L-K/2-3

D = 172mm
B = 96mm
T = NOT MEASURED
t = NOT MEASURED

STEELWORK EXHIBITS LIGHT SURFACE CORROSION ONLY WHERE EXPOSED

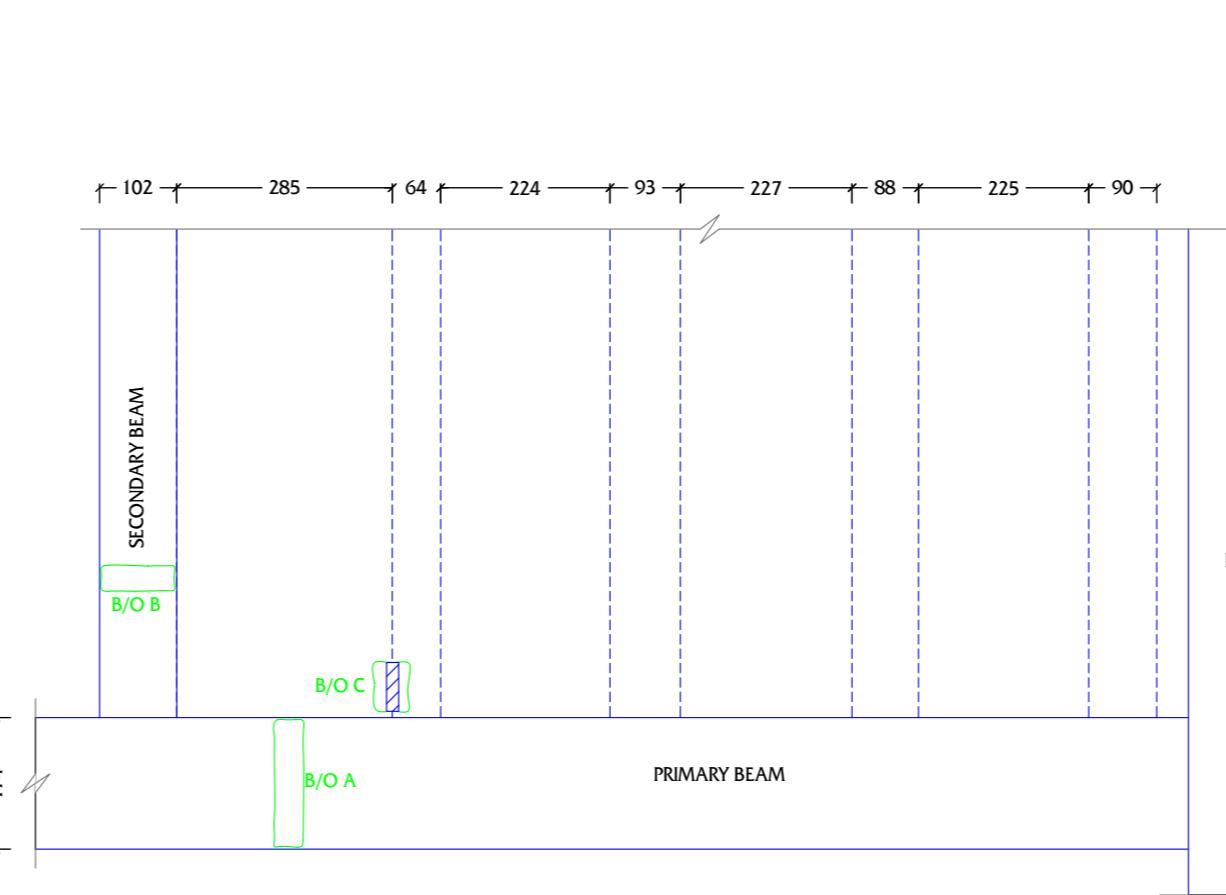
FIG.2: PART REFLECTED 1ST FLOOR SLAB SOFFIT PLAN SHOWING DETAILS OF BEAM AND PRECAST CONCRETE PLANKS - SURVEY AREA H/1-3 SCALE 1:10

PRIMARY BEAM DETAILS (B/O A)

D = 505mm
B = 174mm
T = 16mm
t = 12.8mm

STEELWORK EXHIBITS LIGHT SURFACE CORROSION WHERE EXPOSED

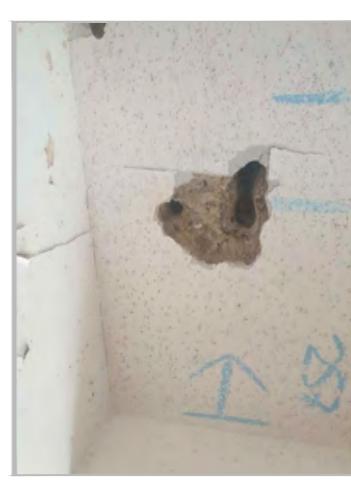
P2e: PRECAST PLANK AT SURVEY AREA H/1-3

BAR OBSERVED TO BE IN VISUALLY GOOD CONDITION WHERE EXPOSED

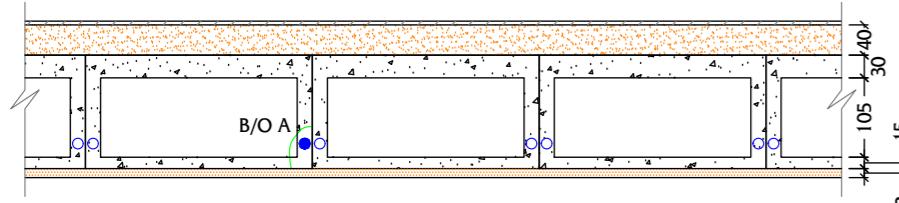
FIG.3: PART SECTION LOOKING SOUTH THROUGH ROOF SLAB SHOWING DETAILS OF PRECAST CONCRETE PLANK - SURVEY AREA RS1 SCALE 1:5

DETAILS OF BREAKOUT B/O A

14mmØ PLAIN ROUND BAR AT 26mm CONCRETE COVER.
BAR EXHIBITS VERY LIGHT SURFACE CORROSION WHERE EXPOSED.

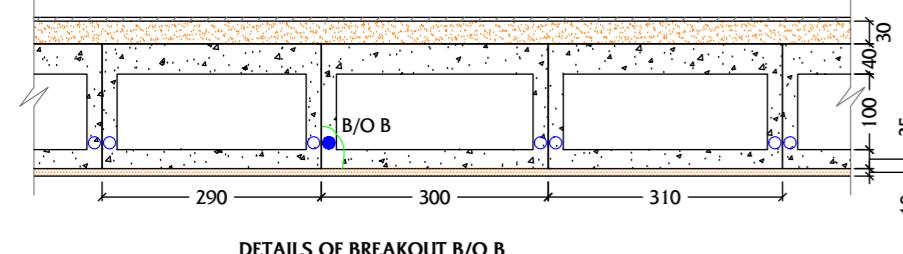
FIG.6: PART SECTION LOOKING EAST THROUGH ROOF SLAB SHOWING DETAILS OF PRECAST CONCRETE PLANK - SURVEY AREA RS2 SCALE 1:5

DETAILS OF BREAKOUT B/O B

16mmØ PLAIN ROUND BAR AT 26mm CONCRETE COVER.
BAR EXHIBITS VERY LIGHT SURFACE CORROSION WHERE EXPOSED.

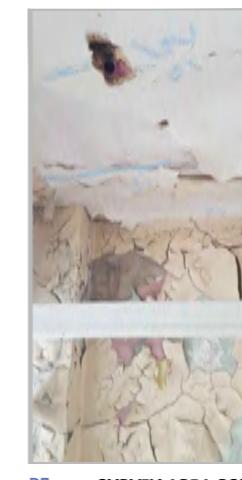
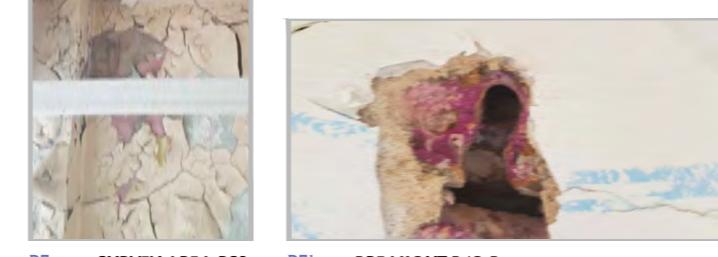
FIG.5: PART REFLECTED SOFFIT PLAN OF ROOF SLAB SHOWING DOWNSTAND BEAM AND PRECAST CONCRETE PLANK - SURVEY AREA RS2 SCALE 1:20

P5a: SURVEY AREA RS2

P5b: BREAKOUT B/O B

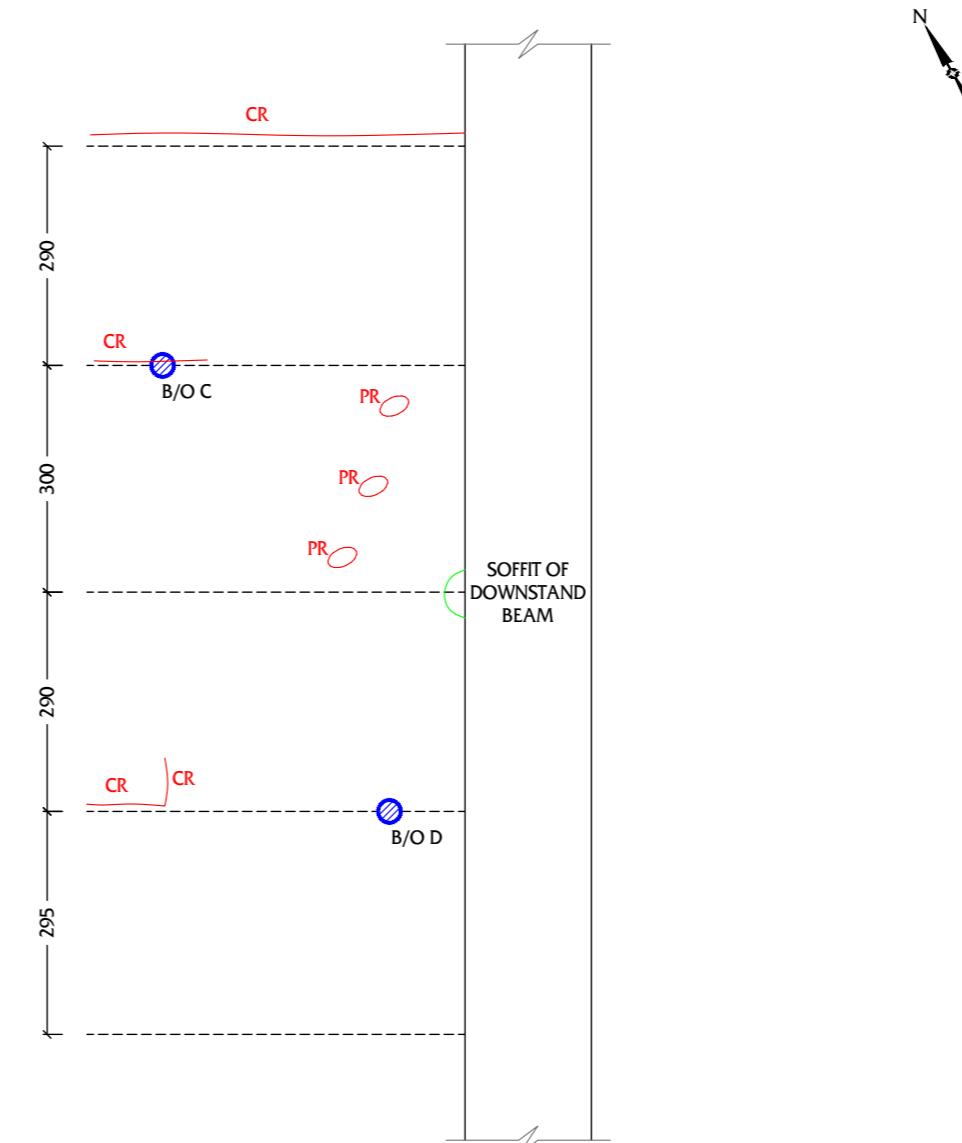
FIG.8: PART REFLECTED SOFFIT PLAN OF ROOF SLAB SHOWING DOWNSTAND BEAM, PRECAST CONCRETE PLANK AND LOCALISED DEFECTS - SURVEY AREA RS3 SCALE 1:20

12mmØ PLAIN ROUND BAR AT 20mm CONCRETE COVER.
BAR EXHIBITS MODERATE TO HEAVY SURFACE CORROSION WHERE LOCALLY EXPOSED.

12mmØ PLAIN ROUND BAR AT 15mm CONCRETE COVER.
BAR EXHIBITS LIGHT SURFACE CORROSION WHERE EXPOSED.

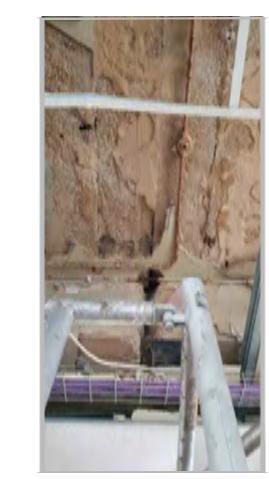
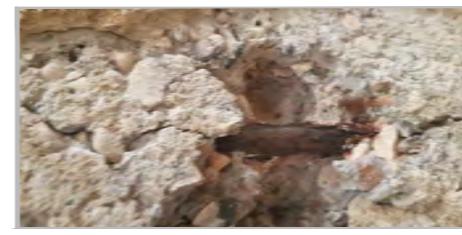
P8a: SURVEY AREA RS3

P8b: BAR EXPOSED AT BREAKOUT B/O C

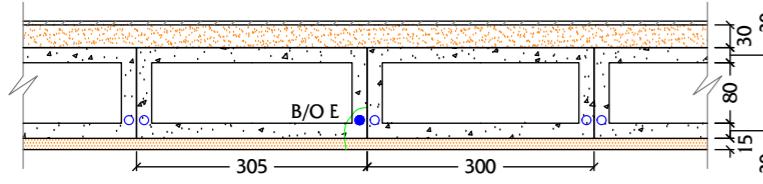
FIG.12: PART SECTION LOOKING EAST THROUGH ROOF SLAB SHOWING DETAILS OF PRECAST CONCRETE PLANK - SURVEY AREA RS4 SCALE 1:5

DETAILS OF BREAKOUT B/O E
12mmØ PLAIN ROUND BAR AT 18mm CONCRETE COVER.
BAR EXHIBITS VERY LIGHT SURFACE CORROSION WHERE LOCALLY EXPOSED.

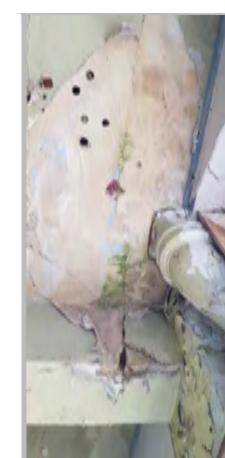
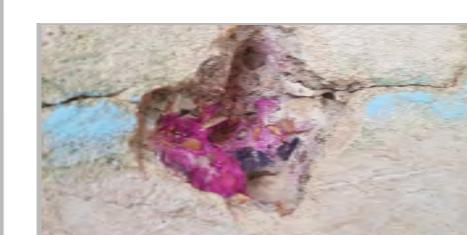
FIG.11: PART REFLECTED SOFFIT PLAN OF ROOF SLAB SHOWING DOWNSTAND BEAM, PRECAST CONCRETE PLANK AND LOCALISED DEFECTS - SURVEY AREA RS4 SCALE 1:20

P11a: SURVEY AREA RS4

P11b: BAR EXPOSED AT BREAKOUT B/O D

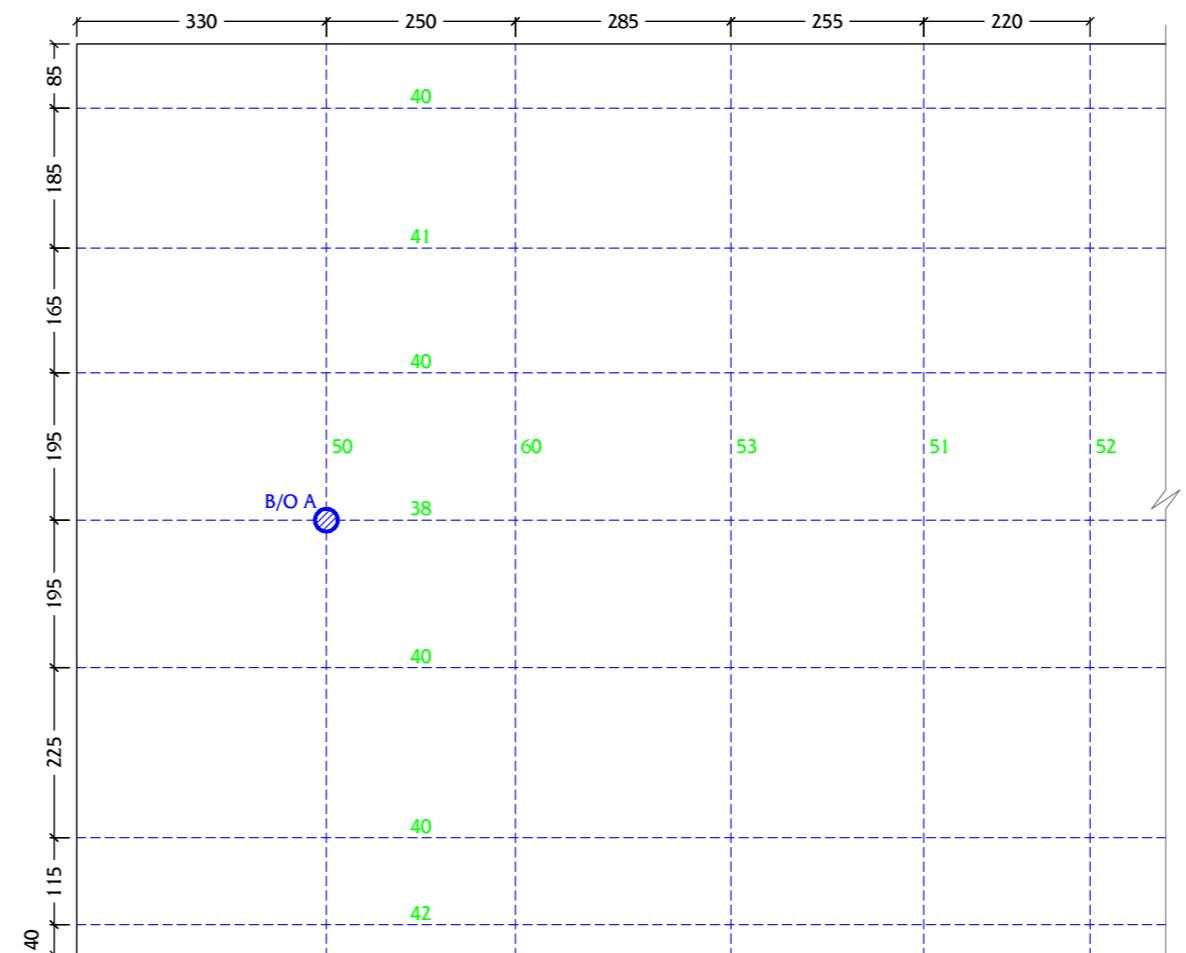
FIG.2: PART REFLECTED SOFFIT PLAN OF 1ST FLOOR STAIR LANDING SHOWING BREAKOUT AND NEAR SURFACE STEEL REINFORCEMENT ARRANGEMENT - SURVEY AREA S-T/1-2 SCALE 1:20

DETAILS OF BREAKOUT B/O A

10mmØ N-S BAR AT 36mm CONCRETE COVER.
16mmØ E-W BAR AT 20mm CONCRETE COVER.
BOTH BARS EXHIBIT LIGHT SURFACE CORROSION ONLY.

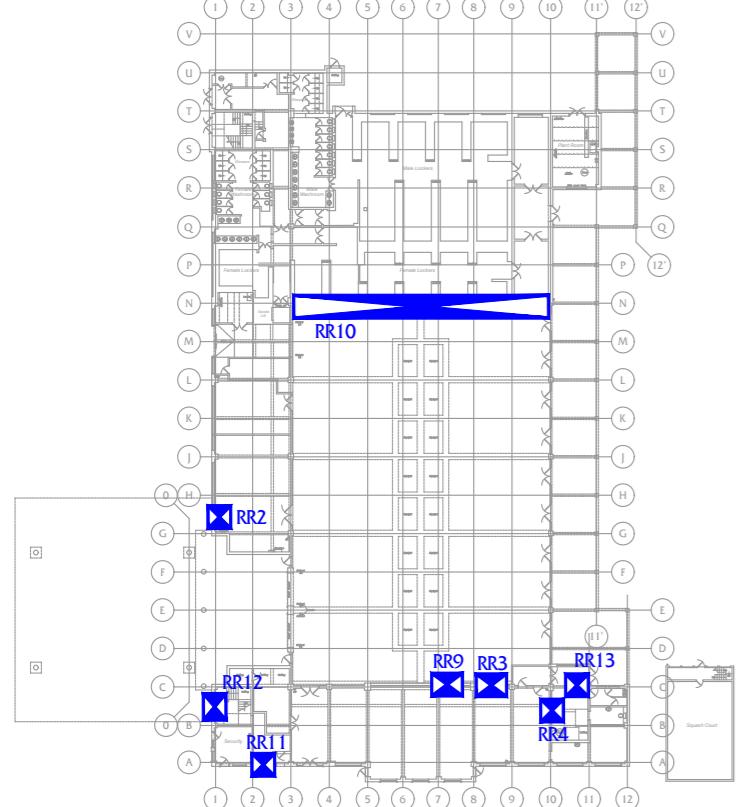
FIG.1: PLAN OF GROUND FLOOR SHOWING LOCATIONS OF SURVEY AREAS NOT TO SCALE

DAMP PROOF COURSE WAS LOCATED AT SURVEY AREAS RR9 AND RR12 AT LOW LEVEL. NO OTHER DAMP PROOF COURSE WAS FOUND AT THE REMAINING GROUND FLOOR SURVEY AREAS. CRACKS TO WALL FINISHES DID NOT EXTEND INTO THE BRICKWORK MASONRY WHERE INVESTIGATED.

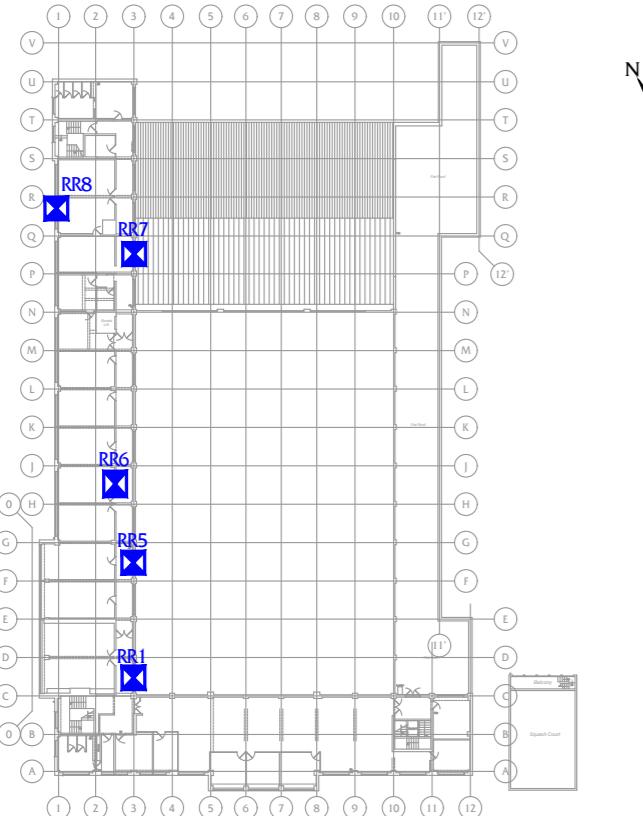
FIG.2: PLAN OF 1ST FLOOR SHOWING LOCATIONS OF WALLS SURVEYED NOT TO SCALE

CRACKS TO WALL FINISHES DID NOT EXTEND INTO THE BRICKWORK MASONRY WHERE INVESTIGATED.

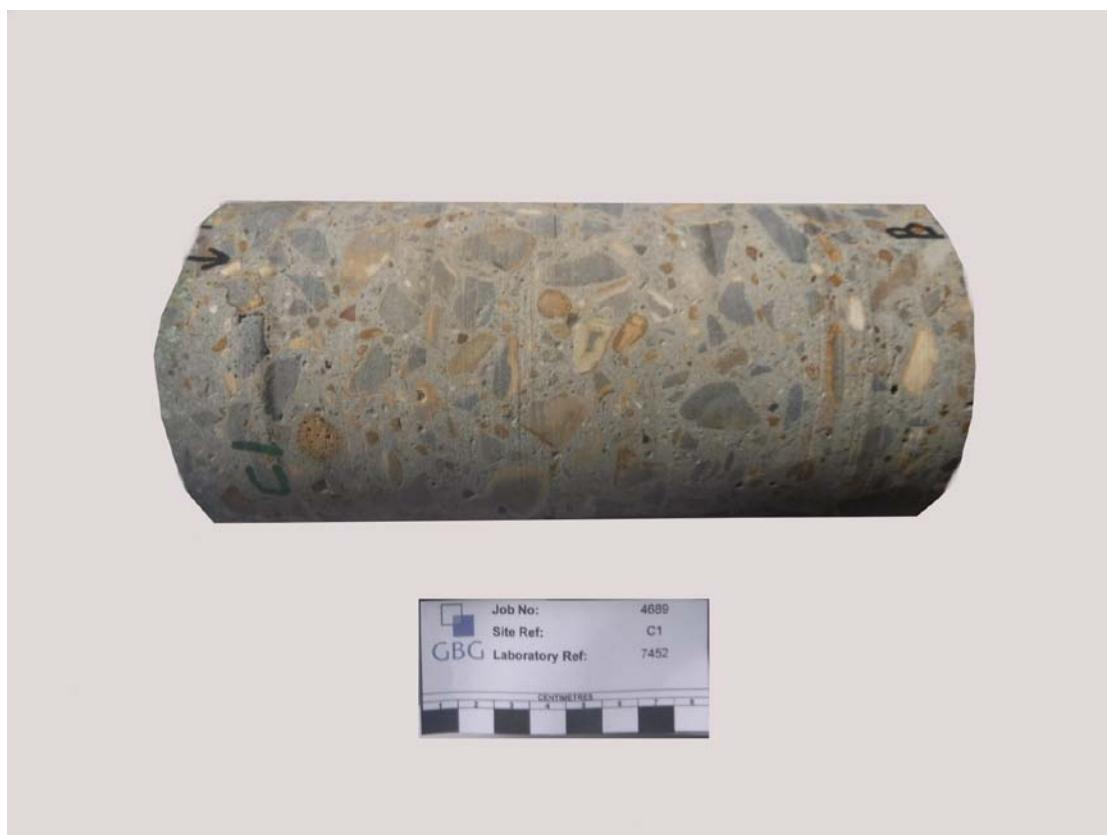
Plate: SD1 (D7730_001)

The surface of the core was dry on receipt and the voids were empty. There were no cracks cutting the core. There was 1No. 8mm diameter steel bar present within the core at 25mm from the top surface of the core.

Other Information: The top surface of the screed has a smooth surface finish. The bottom surface of the core was uneven but smooth, with the impression of a damp proof membrane.

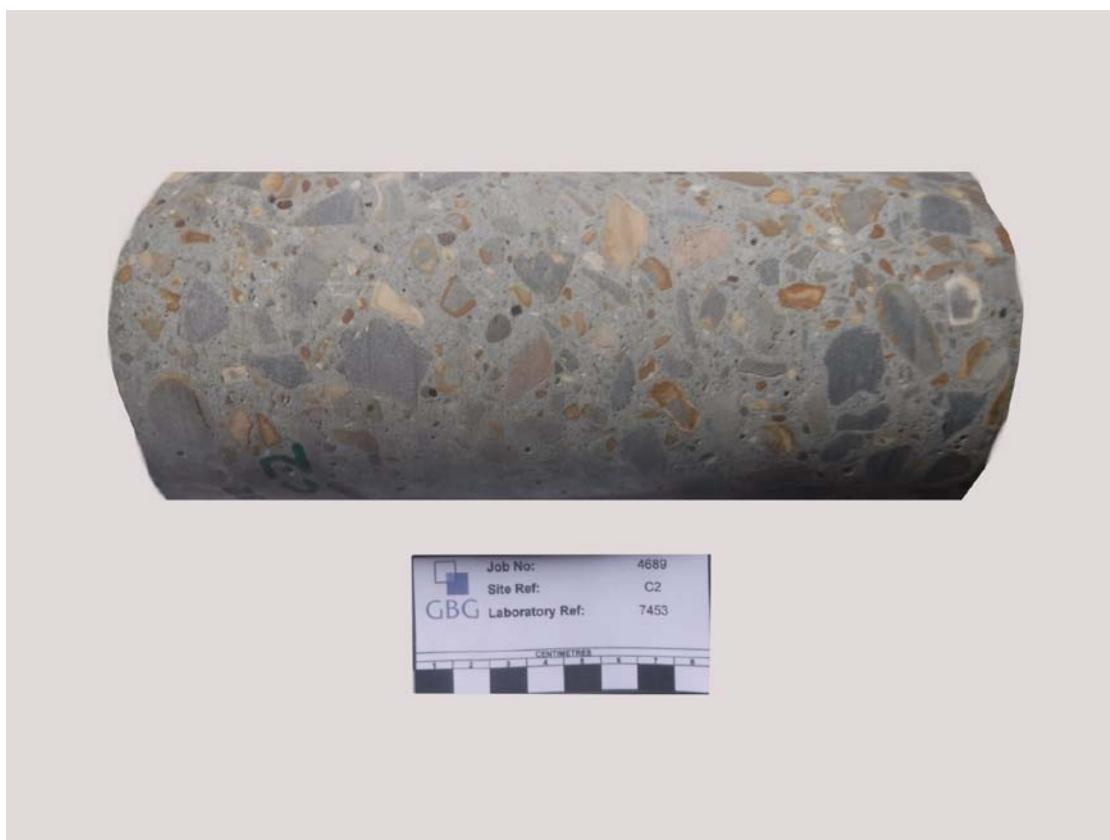
Plate: SD2 (D7730_014)

The surface of the core was dry on receipt and the voids were empty. There were no cracks cutting the core. There were no steel bars present in the core.

Other Information: The top surface of the concrete has a smooth surface finish. The bottom surface of the core was uneven but smooth, with the impression of a damp proof membrane.

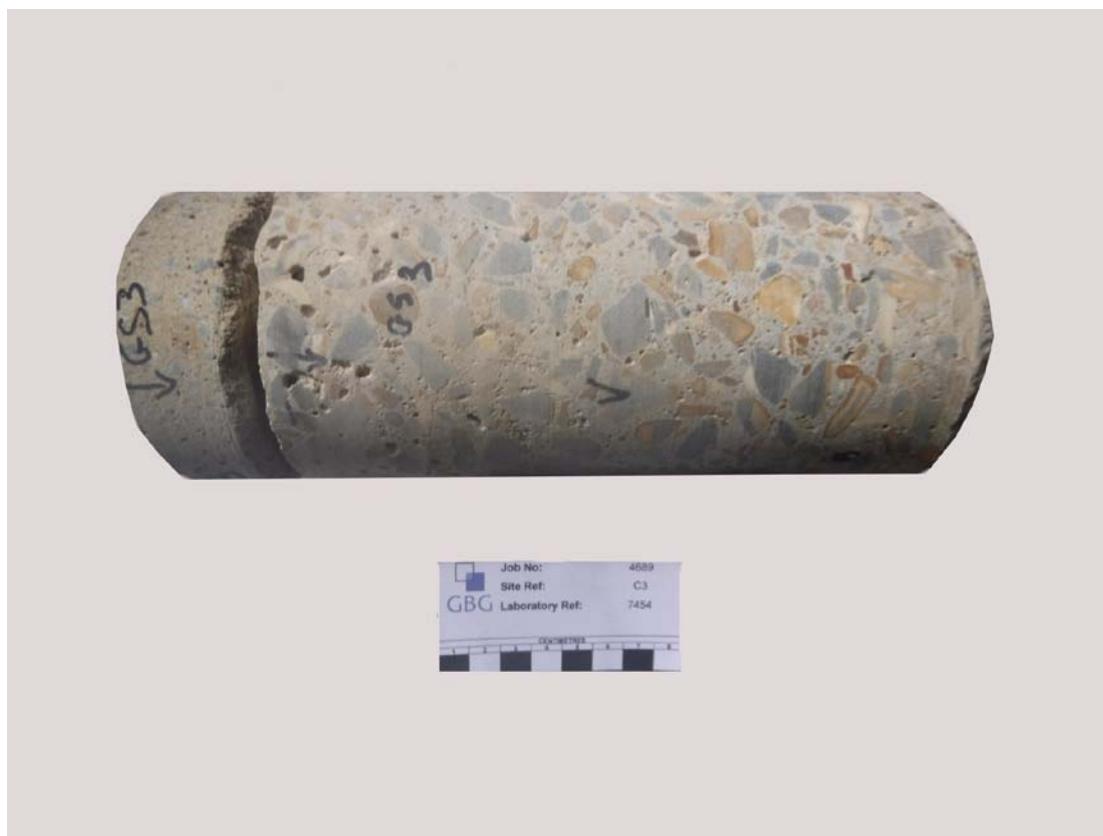
Plate: SD3 (D7730_049)

The surface of the core was dry on receipt and the voids were empty. There were no cracks cutting the core. There were no steel bars present in the core. Minor honeycombing was observed at the bottom of the core.

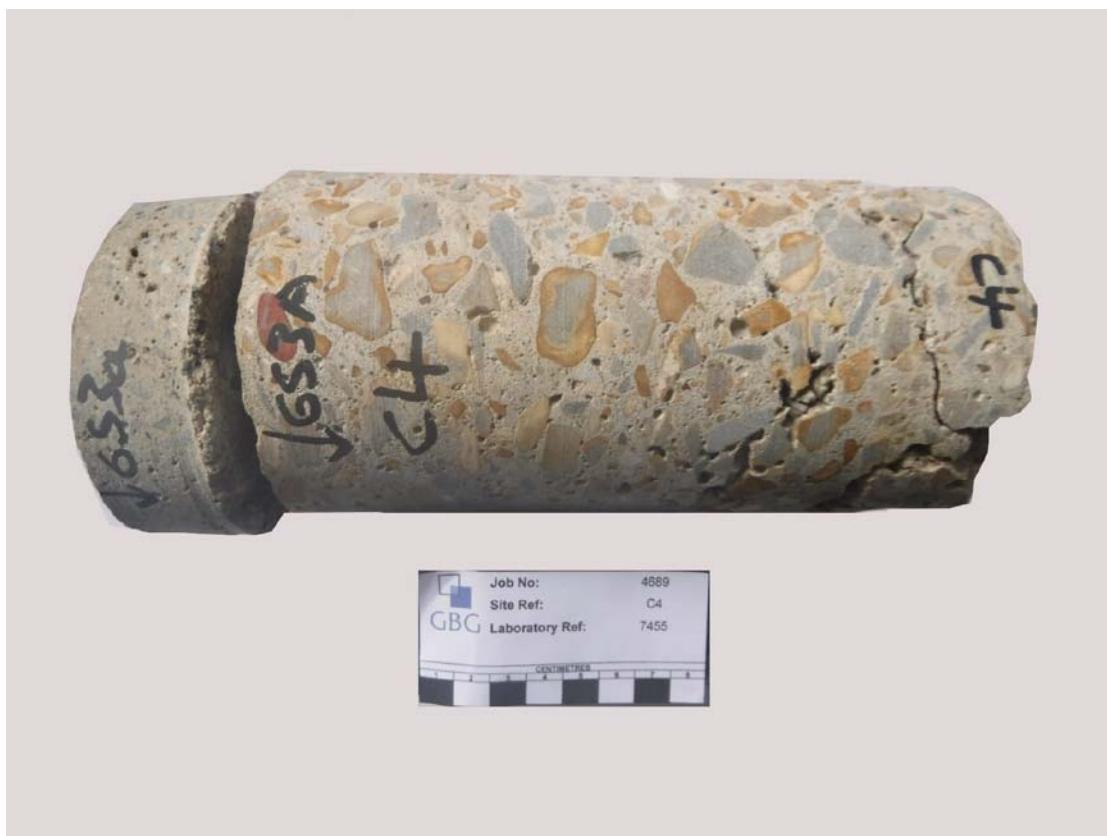
Plate: SD4 (D7730_062)

The concrete contained approximately 45-55% mixed flint-gravel as the coarse aggregate, which was sub-rounded to sub-angular and equant to elongate in shape, generally well graded and evenly distributed, with a maximum nominal size of 20mm. The cement paste within the core sample was light grey in colour and generally of good compaction, with excess voidage judged at 1.5%. However, honeycombing was evident towards the bottom of the core and the maximum void size observed was 8mm x 9mm x 6mm deep (honeycombed area).

The surface of the core was dry on receipt and the voids were empty. A cracks was observed cutting a portion of the bottom of the core within the honeycombed area. There were no steel bars present in the core.

Other Information: The top surface of the concrete has a roughly cast surface finish. The bottom surface of the core was roughly cast and uneven. There was no damp proof membrane at the bottom of the core.

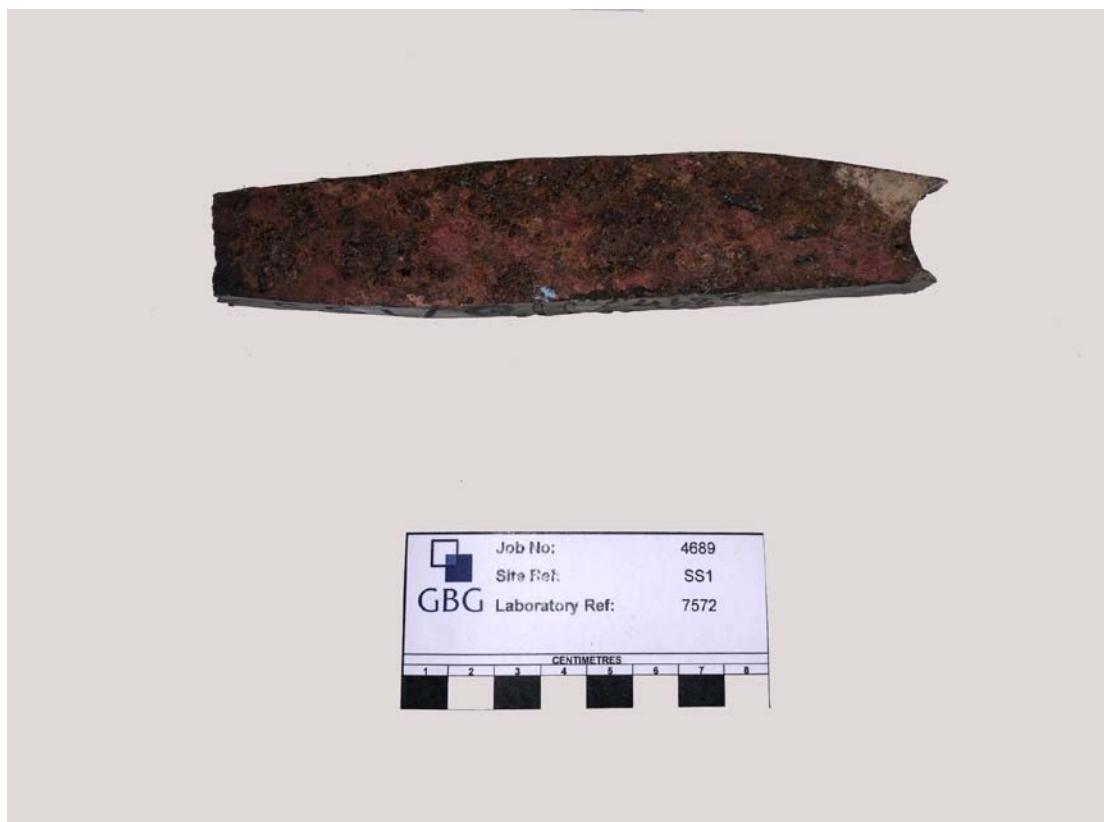
Plate: SD5 (D7736_003)

A 150mm long x 25mm wide steel coupon sample cut from the steel column web.

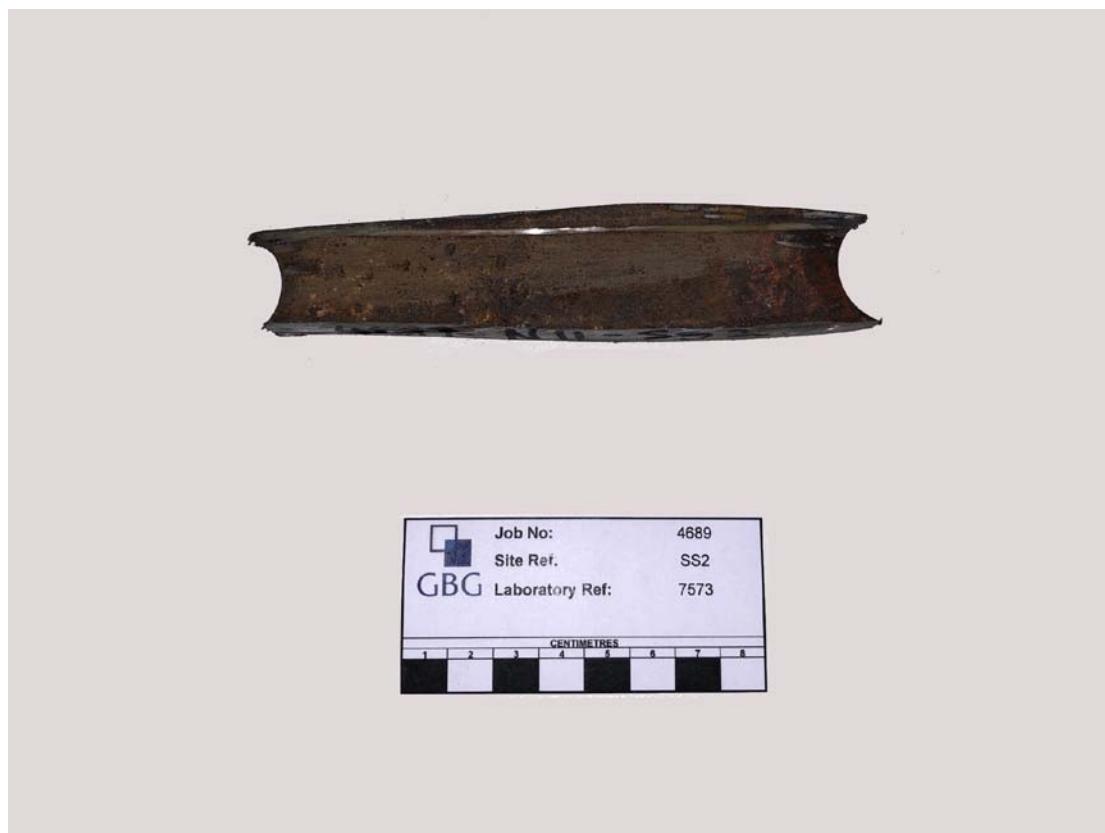
Plate: SD6 (D7736_005)

A 150mm long x 25mm wide steel coupon sample cut from the steel column web.

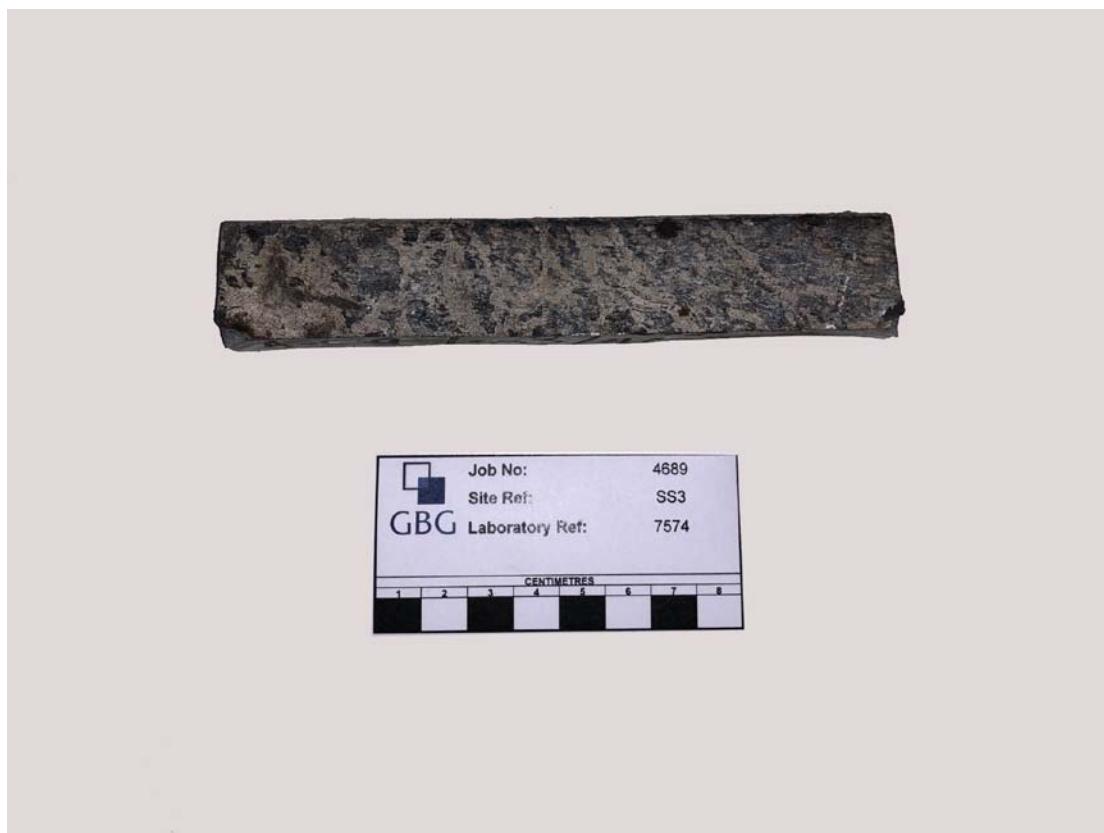
Plate: SD7 (D7736_007)

A 150mm long x 25mm wide steel coupon sample cut from the steel beam flange.

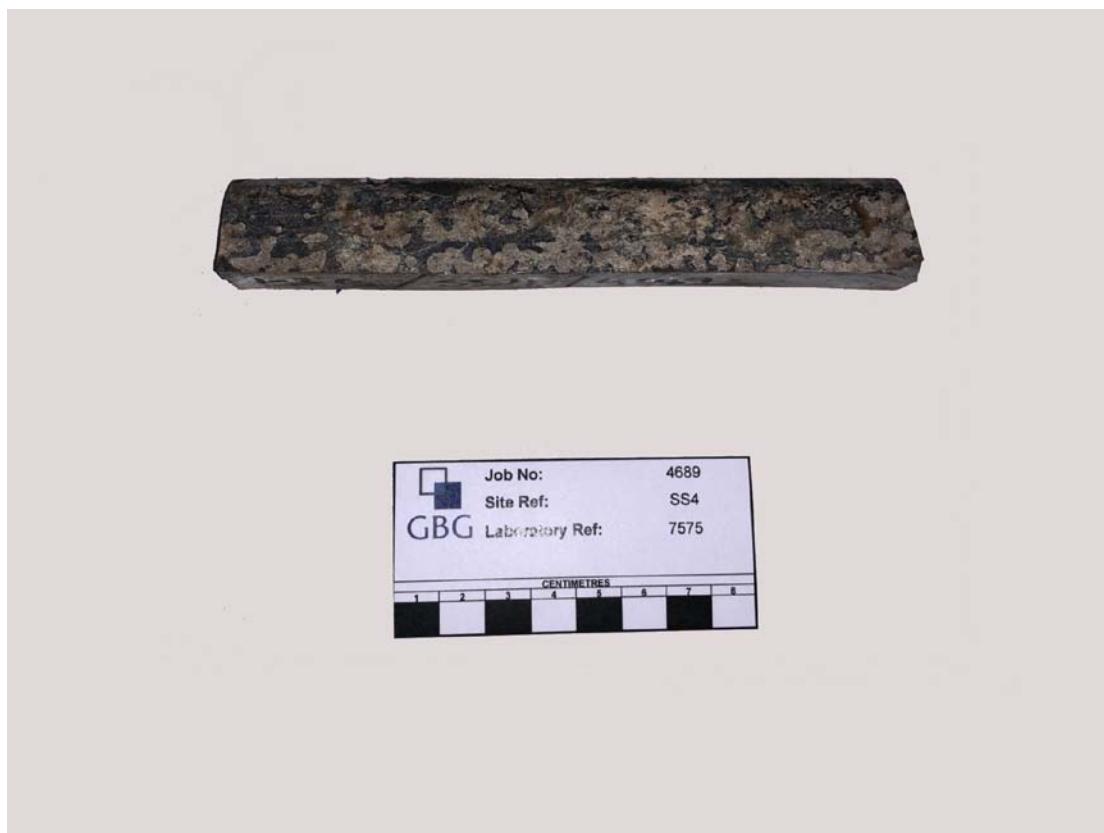
Plate: SD8 (D7736_009)

A 150mm long x 25mm wide steel coupon sample cut from the steel beam flange.

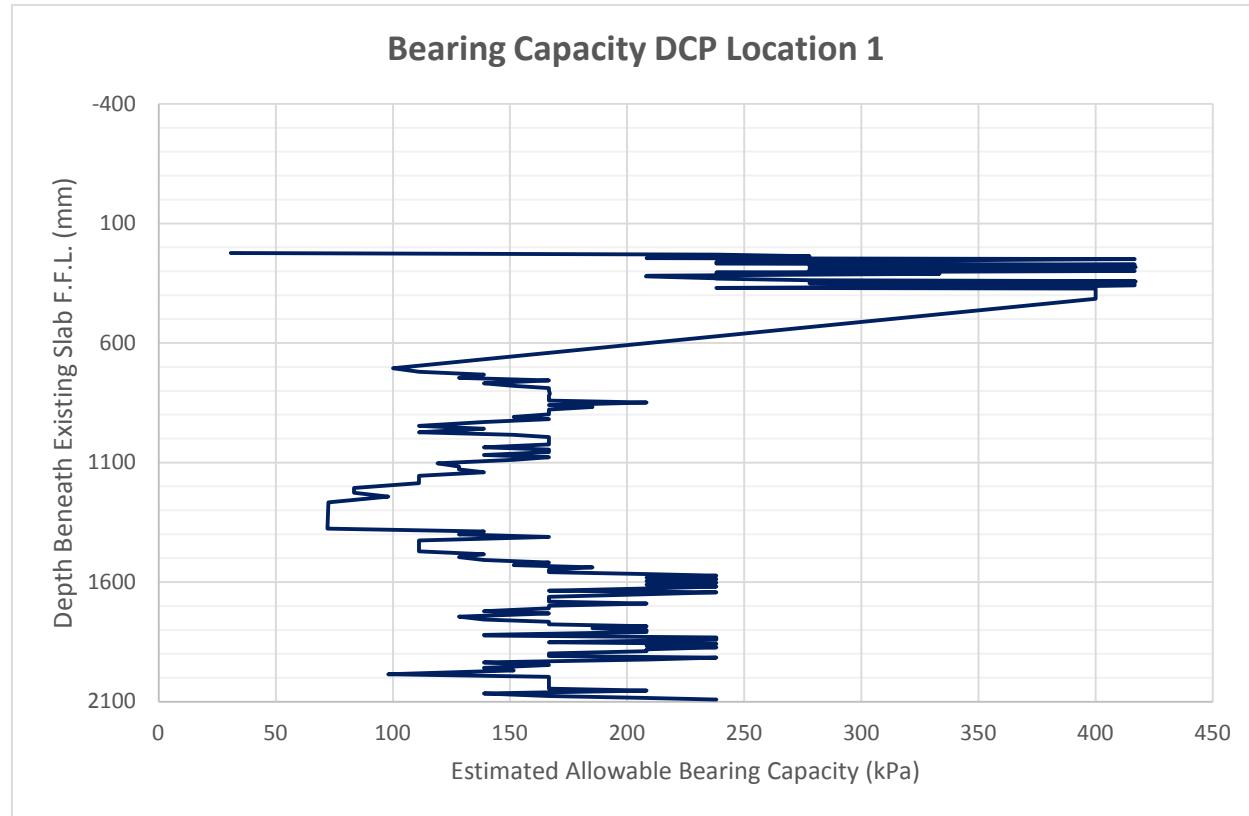
Job No.	4689
Fig No.	A4.1

DCP TEST RESULTS
