Former Nestle Factory
Conditions 41, 42, 54 – S96 update
August 2023

This document relates to block F1 conditions 41, 42, & 54 (previously approved together under a shared application with reference 1331/APP/2019/2386), outlining the relevant amendments which have since been made as part of the approved S96 application (reference 1331/APP/2021/4497).

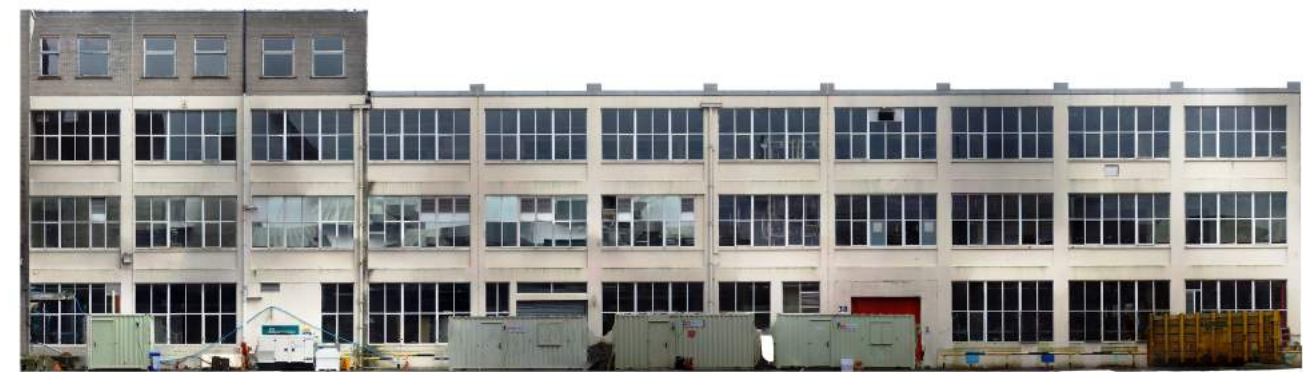
West elevation

Rectified photography undertaken by Mola in July 2018, providing a detailed record of the existing building prior to site clearance.

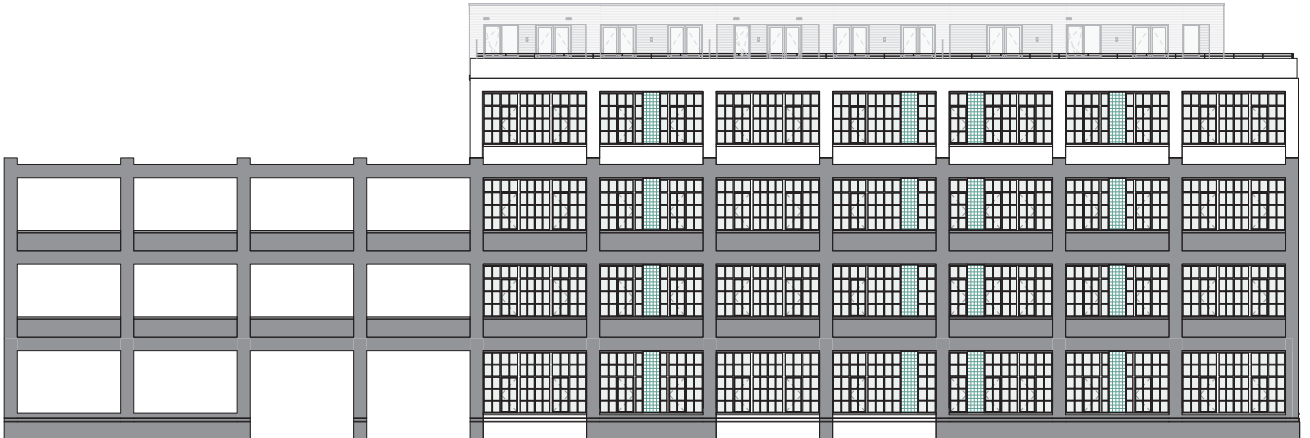
West elevation

External render finish
To existing & new concrete facades

Product: Sikagard 550W Elastic
Colour: RAL 9016, Traffic White
(as approved to Segro warehouse U4)

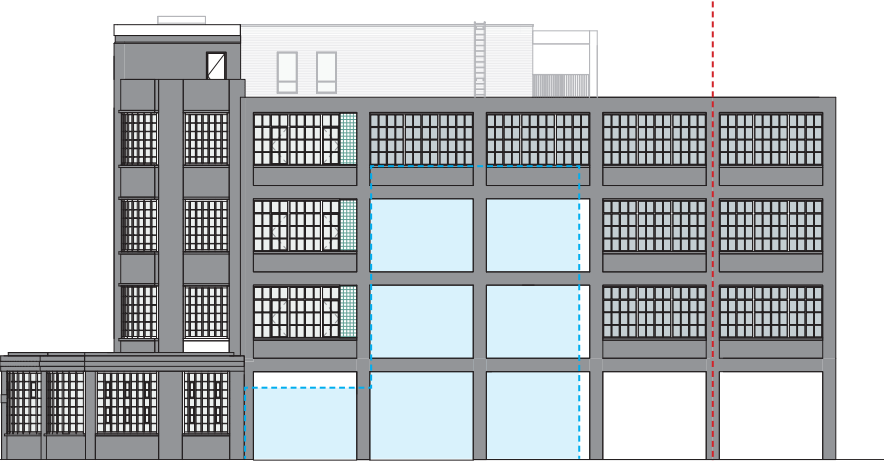
Refer to condition 75 application for approved East elevation of Segro warehouse U4. Drawing referenced: MS202 Illustrative Elevations Unit 4 P6.
