**Building Recording (Level 2):  
Written Record (Volume 1)**  
Former Nestlé Factory Canteen Building,  
Nestles Avenue, Hayes

March 2026

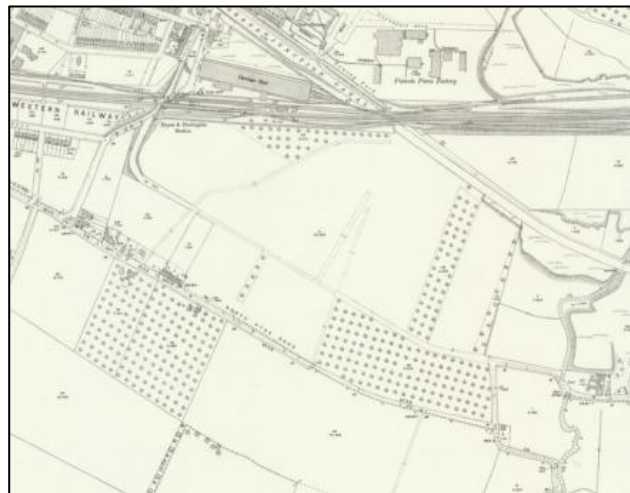
**Figure 2.2: Extract from the 1914 Ordnance Survey ('OS') Map (Surveyed 1913)**

- 2.5 The area, which became occupied by the Nestlé Works remained undeveloped until the early 20<sup>th</sup> century and comprised open agricultural land, with the Grand Union Canal forming the north east boundary from 1807 (**Figure 2.2**). By the 1860s, the Great Western Railway tracks formed part of the northern boundary.

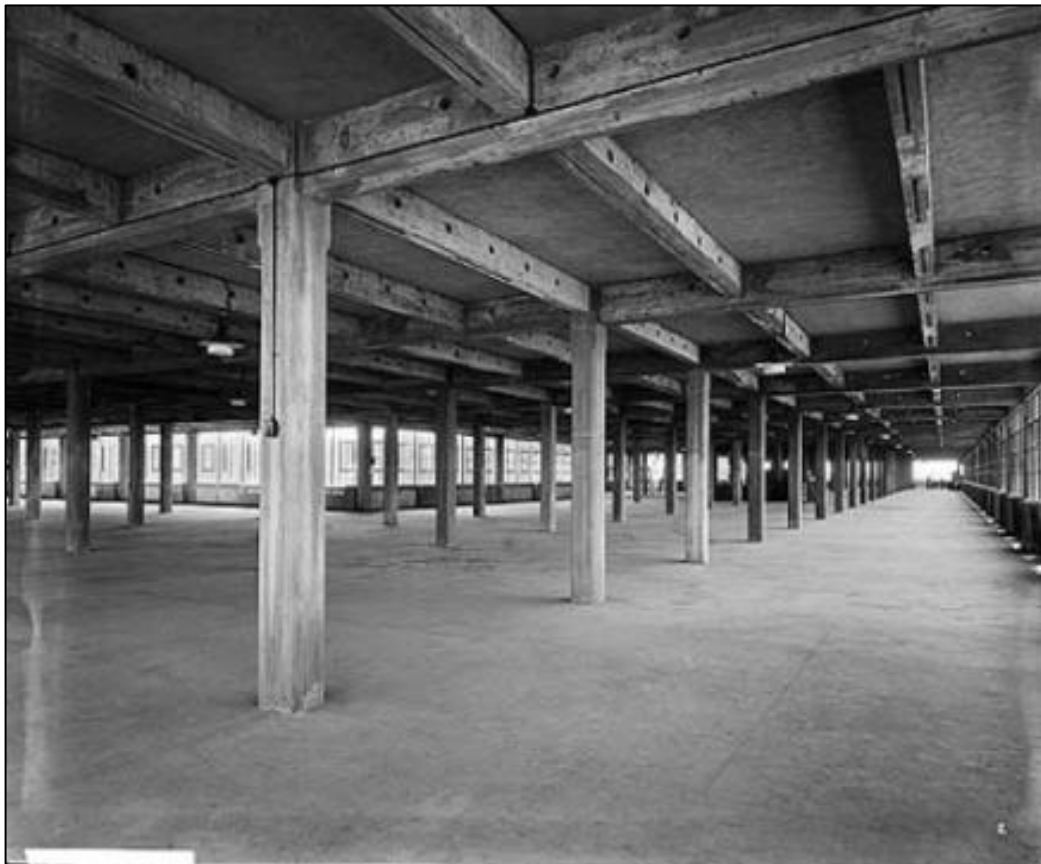
**Figure 2.5: Image from 1921 showing the construction of the extension at Hayes Cocoa Factory with exposed concrete beams and posts (Historic England Archives)**

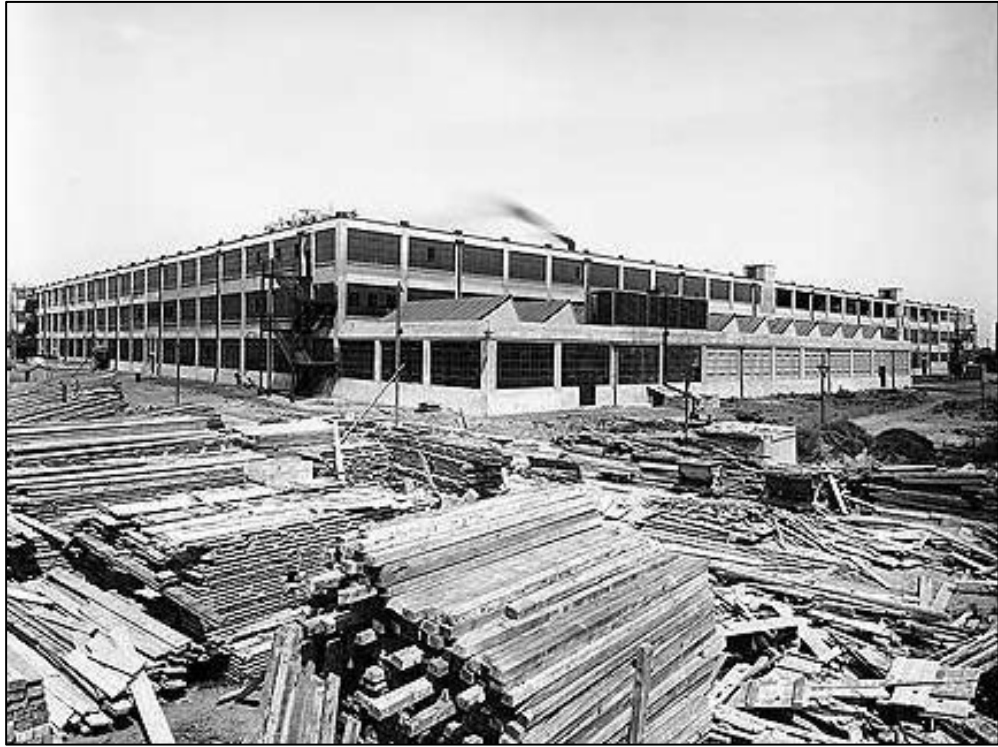
Figure 2.6: Hayes Cocoa Factory viewed from the south east (1921, Historic England Archives)

and 1930s. The extension (**Figures 2.5 and 2.6**) had a Kahn Daylight pattern, comprising a “reinforced concrete frame infilled with large areas of small-paned glazing in narrow metal bars.”<sup>16</sup> The extension had a four-storey square shaped arrangement with four inner courtyards to allow natural light into the factory interiors, set around the existing 1914 factory building (**Figure 2.7**). The new extension was intended to provide a “bright, cleaner, healthier” factory environment; this principal came to dominate interwar factory design and was also reflected in the landscaping of the grounds. As illustrated in the 1935 OS Map and aerial photographs of the same period (**Figures 2.7-2.8**), to the south of the factory were orchards and open landscape, separating the Site from its newly constructed residential neighbours to the south, as well as a sports ground, tennis courts, and bowling green to the north west. The original red brick factory was apparently painted white to provide a more unified appearance with the new extension, which was completed in 1921.

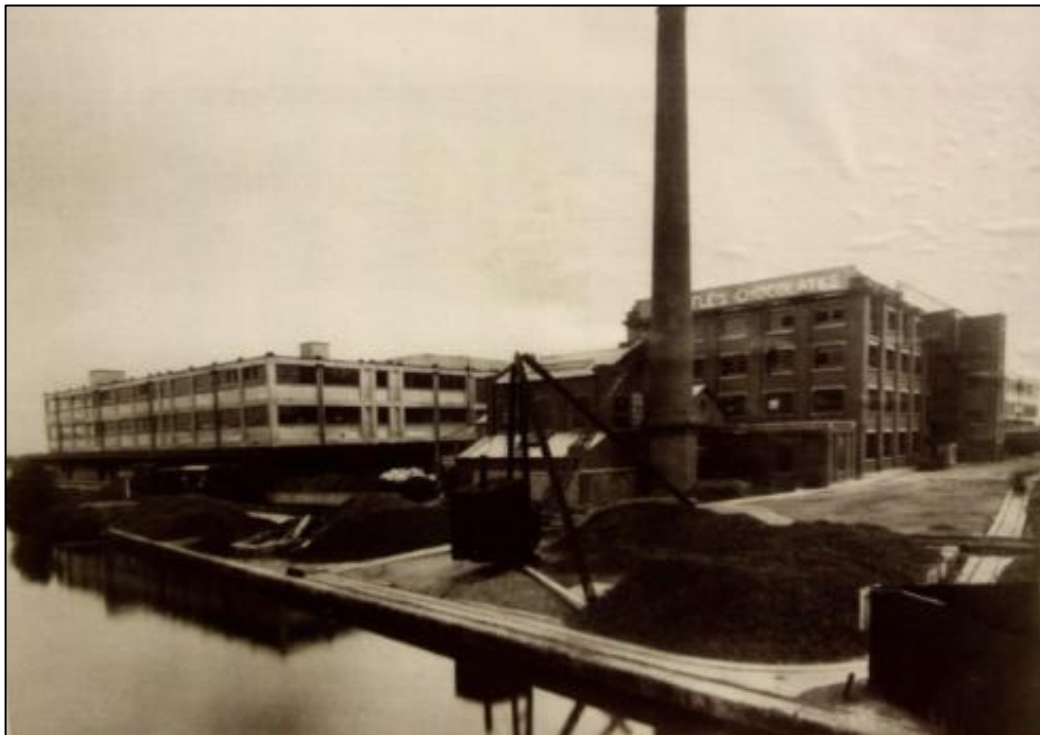
**Figure 2.9: View of the factory from the Grand Union Canal during the early 1930s**

- 2.11 Early 1930s images of the Site and its surroundings show little change except for the alteration of the signage on the chimney and 1914 factory, which remained prominent features in views from the canal and railway (**Figure 2.9**)

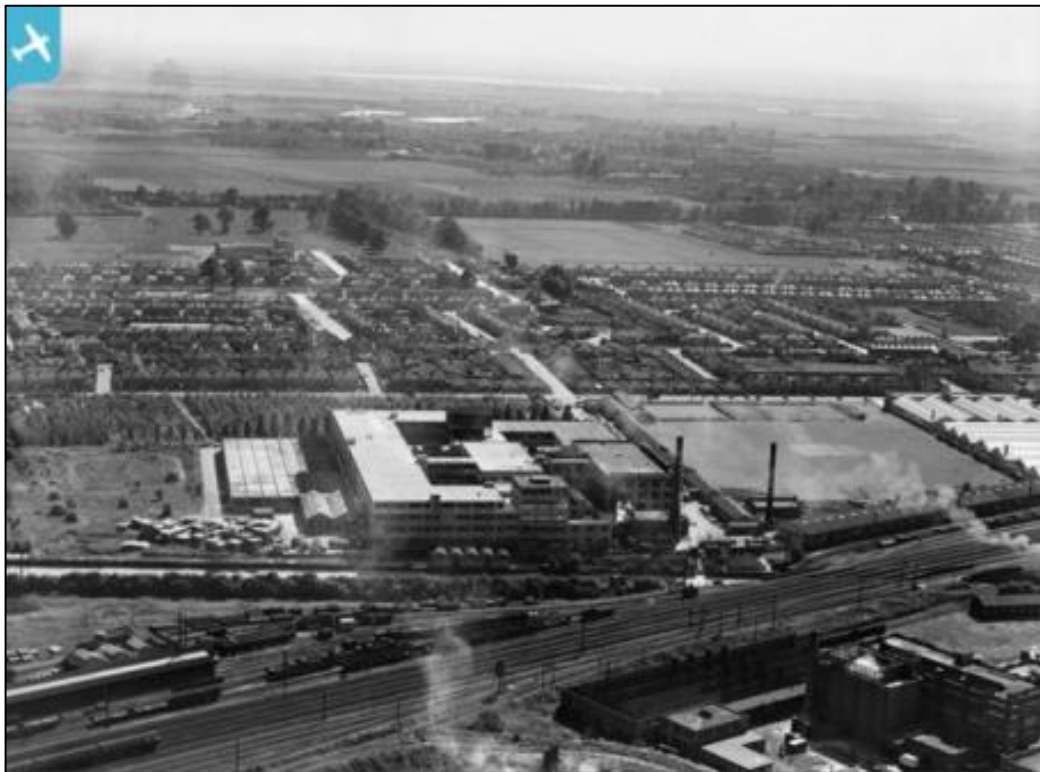
**Figure 2.10: Aerial photograph of the Nestlé Factory at Hayes, taken 1939 (Britain from Above)**

- 2.12 In the mid-1930s, the company undertook alterations to the factory site, including the introduction of a further storey to the eastern portion of the factory, as evidenced in the 1939 aerial photograph, likely designed by Truscon (**Figure 2.10**). The aerial photograph shows the original 1914 factory remained as an 11-bay structure and likely formed the principal entrance to the factory. Other changes to the factory complex included the extension of the single storey elements to the east. Nestlé also sold part of the open sports ground to the west, likely to fund those alterations to the factory, as illustrated by the presence of newly constructed industrial buildings to the west.

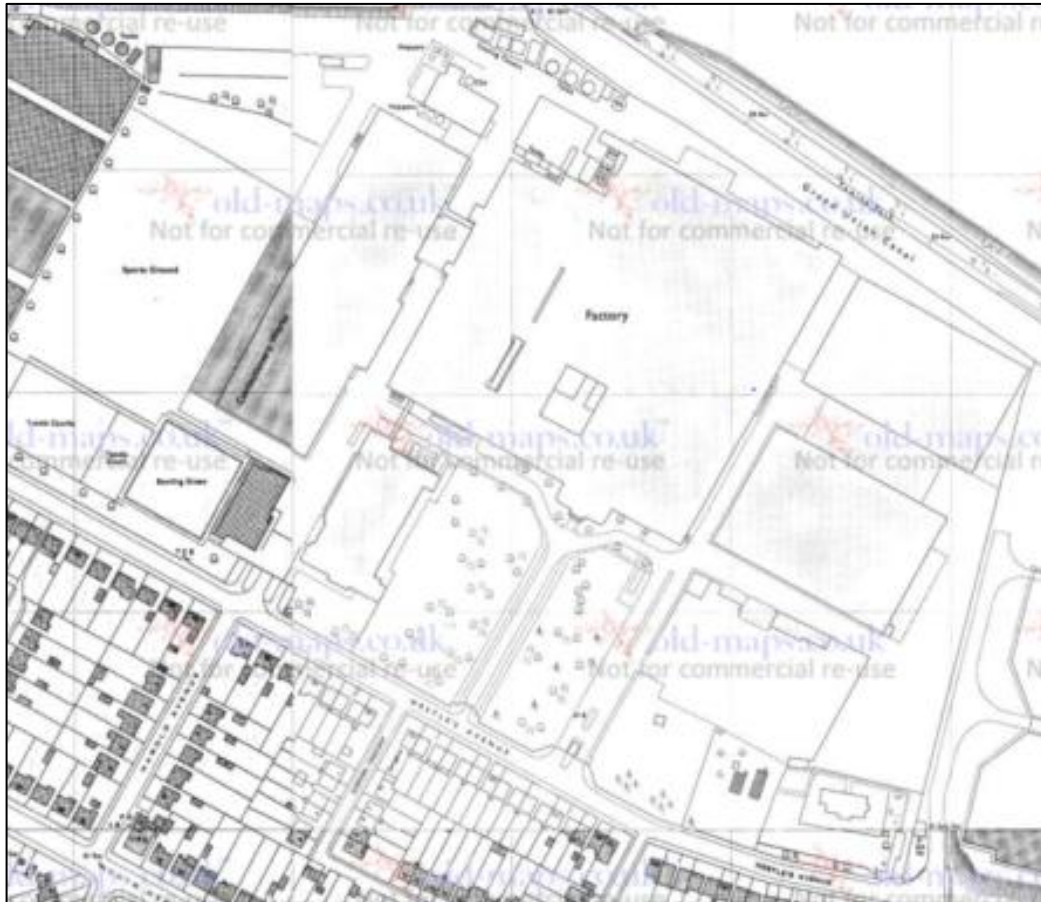
**Figure 2.12: Extract from the 1964 OS Map (surveyed in 1963)**

- 2.15 Further ad-hoc additions to the factory complex were constructed in the 1970s, including a series of buildings along the west side of the original entrance drive, with a small link from the original 1914 element of the factory. A large rectangular extension to the east was also constructed in this period (**Figure 2.12**).

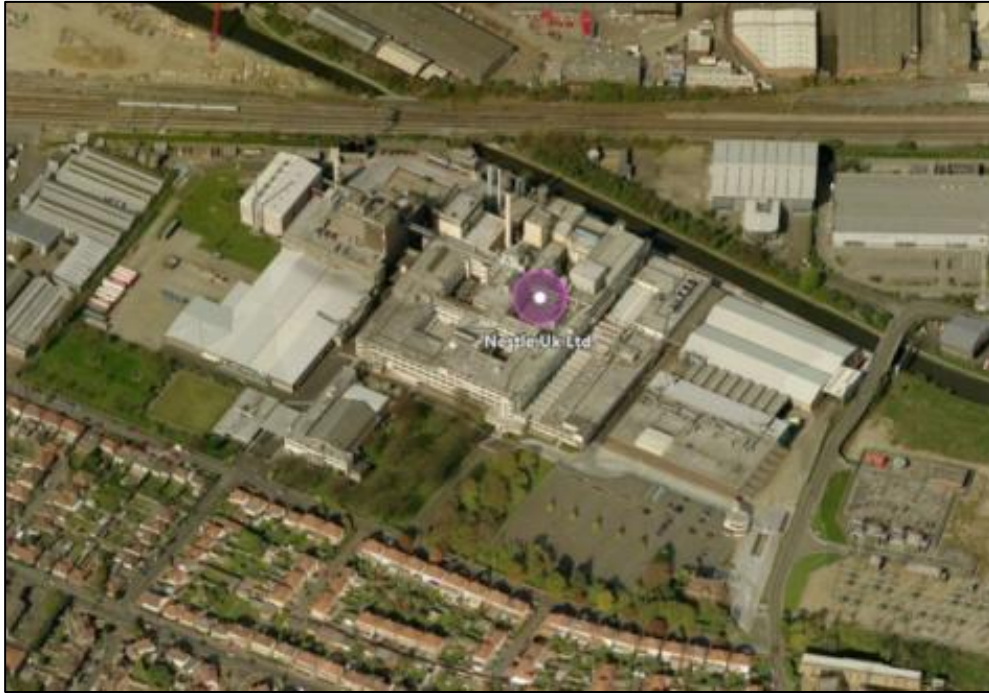
**Figure 2.13: Aerial view of the former Nestlé Factory (2016, BING)**

- 2.16 The 1970s saw significant change at the site, through the ad-hoc extension of the factory building, and the introduction of large sheds, reducing the complex's visual relationship with the canal. A large extent of the sports ground to the north west were also developed, reducing the open spacious character of the factory's former surroundings. At some point during this period, four bays of the original 1914 Sandow building were demolished and much of what remained of the original front façade was masked by later additions. Part of the former woodland area to the south and south east was also removed to allow for the introduction of a large area of hardstanding to be used as a car park (**Figure 2.13**). The Hayes site remained in operation until 2012, though some manufacturing processes were undertaken up to 2014. The factory complex was decommissioned in 2015.

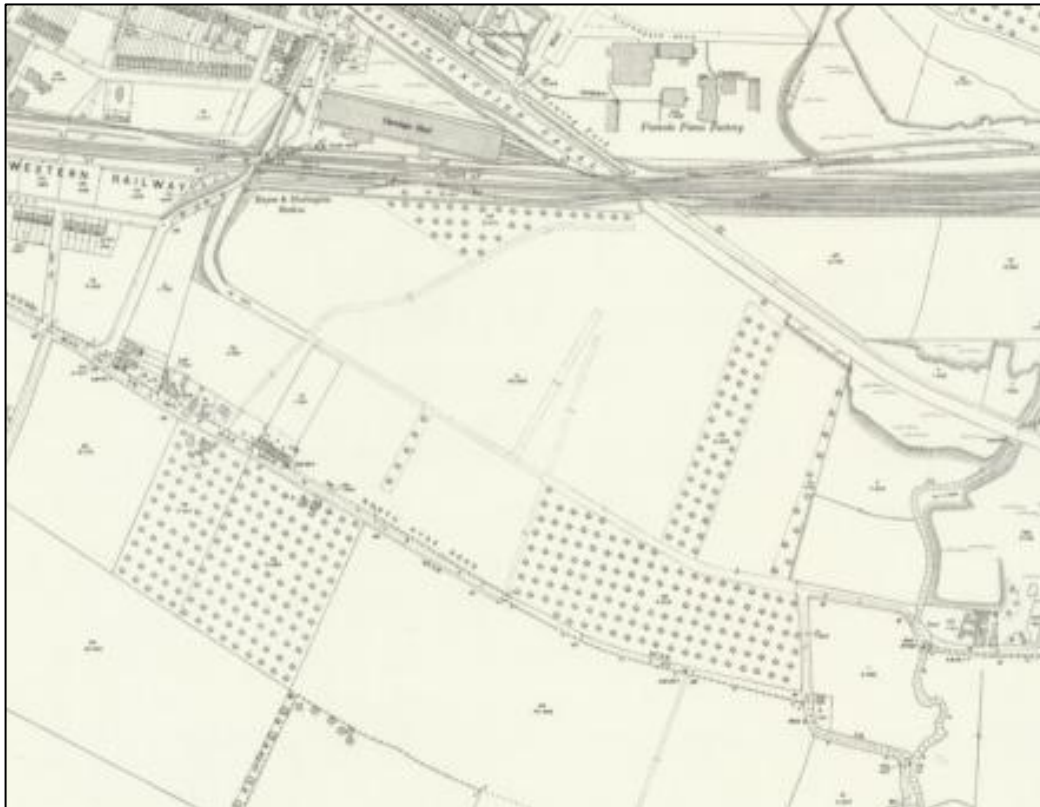
**Figure 2.1: Extract from the 1914 Ordnance Survey ('OS') Map (Surveyed 1913)**

- 2.1 The area, which became occupied by the Nestlé Works remained undeveloped until the early 20<sup>th</sup> century and comprised open agricultural land, with the Grand Union Canal forming the north east boundary from 1807 (**Figure 2.1**). By the 1860s, the Great Western Railway tracks formed part of the northern boundary.

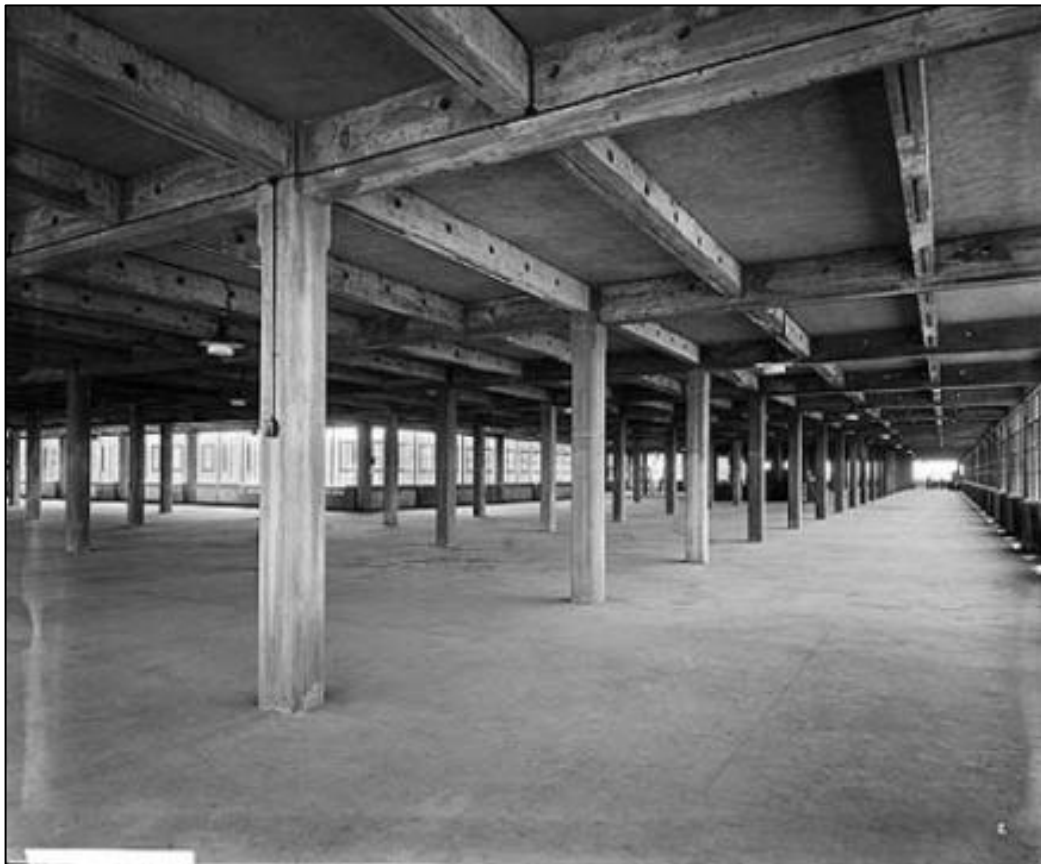
**Figure 2.4: Image from 1921 showing the construction of the extension at Hayes Cocoa Factory with exposed concrete beams and posts (Historic England Archives)**

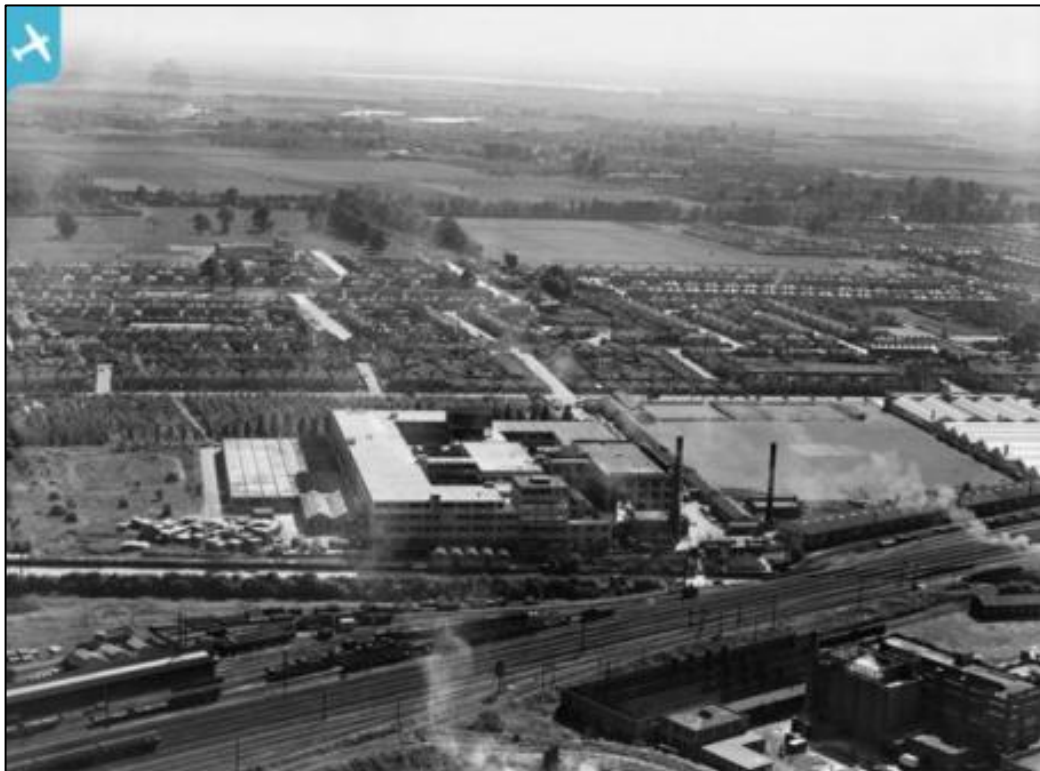
**Figure 2.9: Aerial photograph of the Nestlé Factory at Hayes, taken 1939 (Britain from Above)**

- 2.8 In the mid-1930s, the company undertook alterations to the factory site, including the introduction of a further storey to the eastern portion of the factory, as evidenced in the 1939 aerial photograph, likely designed by Truscon (**Figure 2.9**). The aerial photograph shows the original 1914 factory remained as an 11-bay structure and likely formed the principal entrance to the factory. Other changes to the factory complex included the extension of the single storey elements to the east. Nestlé also sold part of the open sports ground to the west, likely to fund those alterations to the factory, as illustrated by the presence of newly constructed industrial buildings to the west.

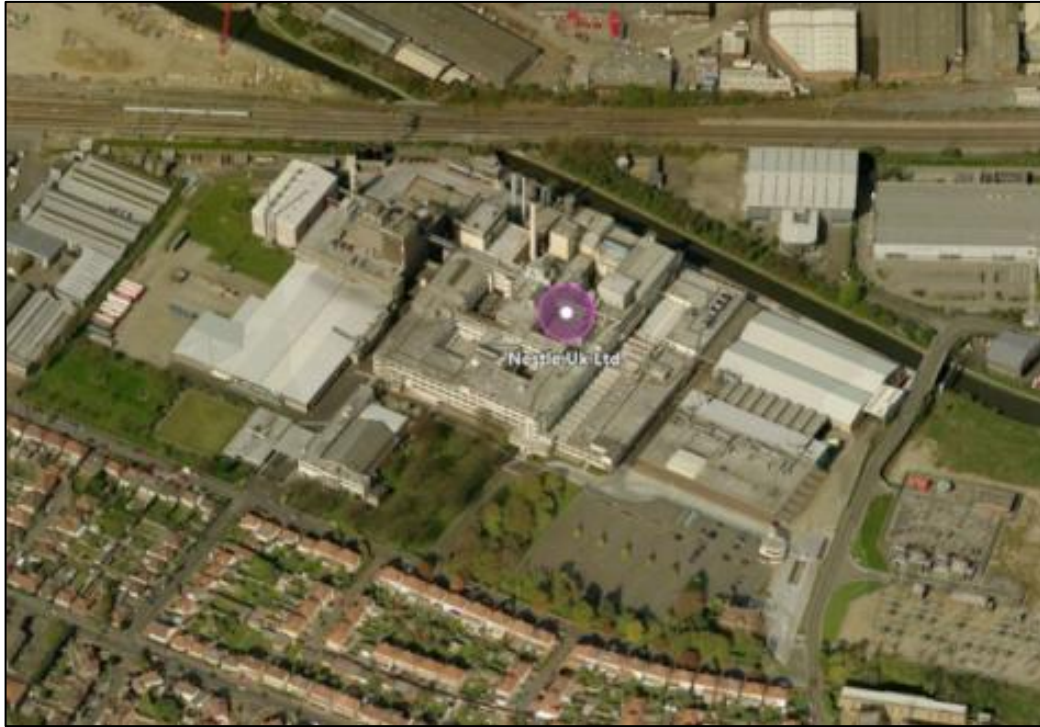
**Figure 2.12: Aerial view of the former Nestlé Factory (2016, BING)**

- 2.12 The 1970s saw significant change at the site, through the ad-hoc extension of the factory building, and the introduction of large sheds, reducing the complex's visual relationship with the canal (**Figure 2.12**). A large extent of the sports ground to the north west were also developed, reducing the open spacious character of the factory's former surroundings. At some point during this period, four bays of the original 1914 Sandow building were demolished and much of what remained of the original front façade was masked by later additions. Part of the former woodland area to the south and south east was also removed to allow for the introduction of a large area of hardstanding to be used as a car park (**Figure 2.12**). The Hayes site remained in operation until 2012, though some manufacturing processes were undertaken up to 2014. The factory complex was decommissioned in 2015.
