Plant Noise Assessment

Block B1 and Car Park Fan

Carried out for
BDW Trading Limited (Barratt West London)

Report 107362/2

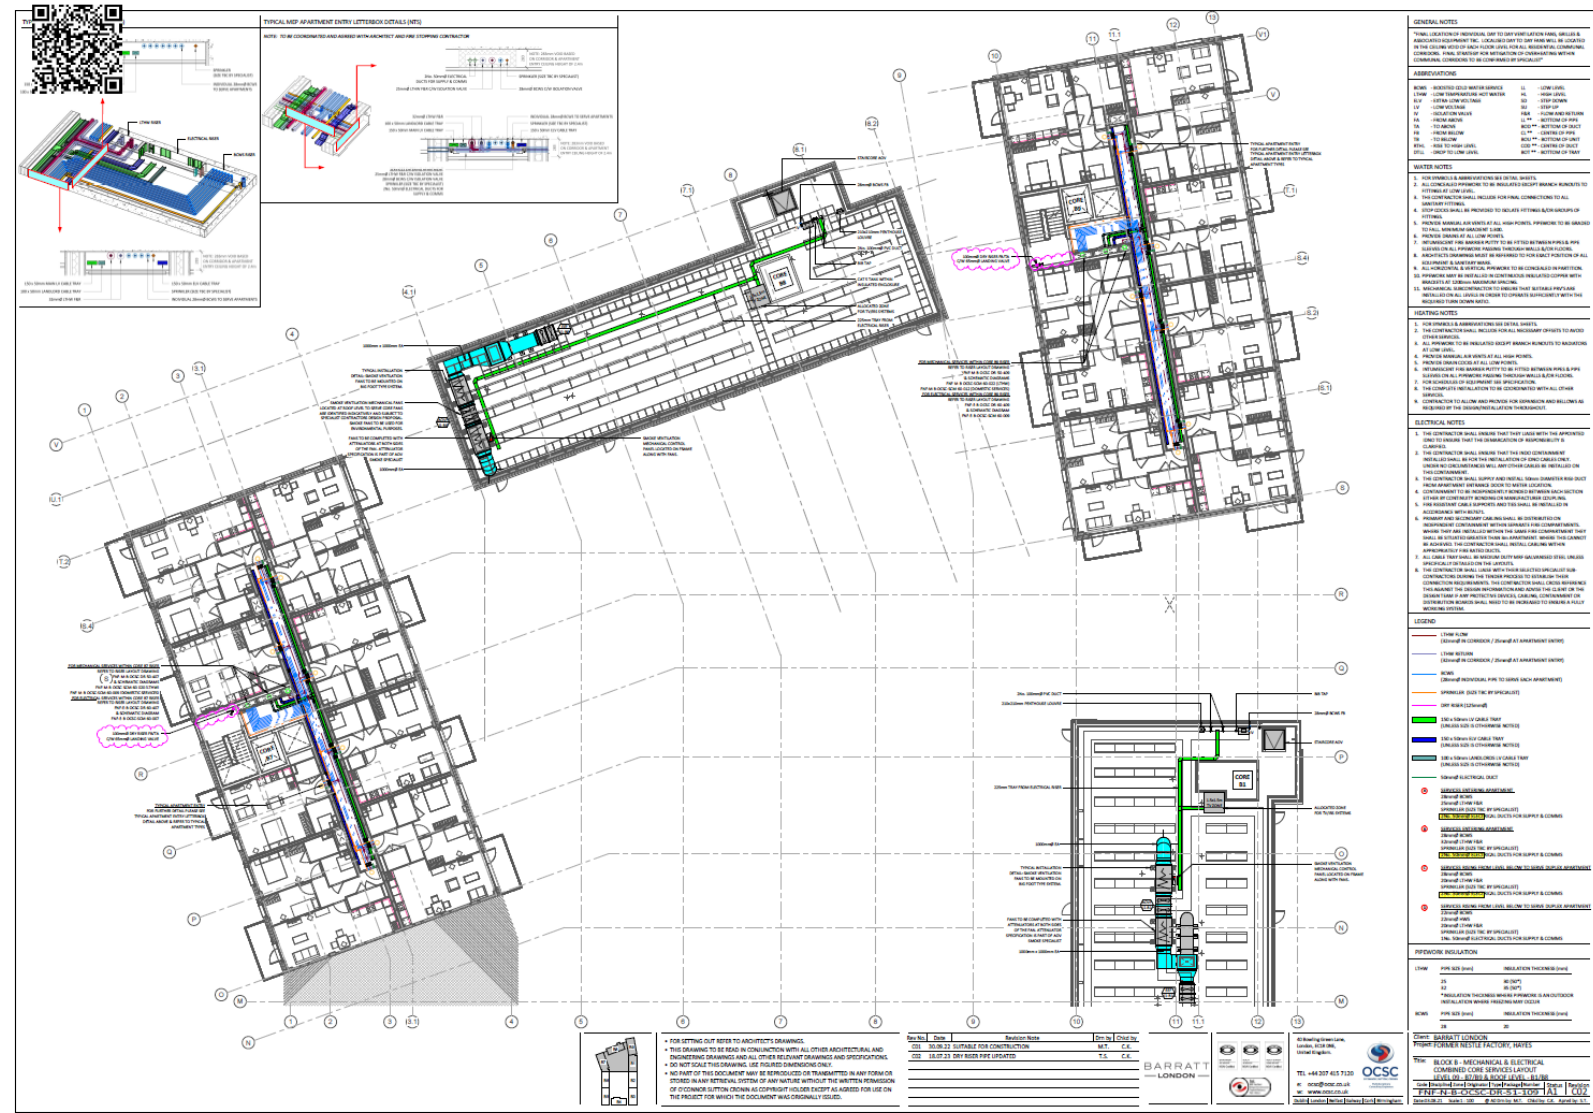
APPENDIX A: DRAWINGS

The objective of the plant noise assessment was to determine compliance, or otherwise, with Planning Condition 21. The client provided drawings of the plant locations which are given in Appendix A. Photographs are given in Appendix B.

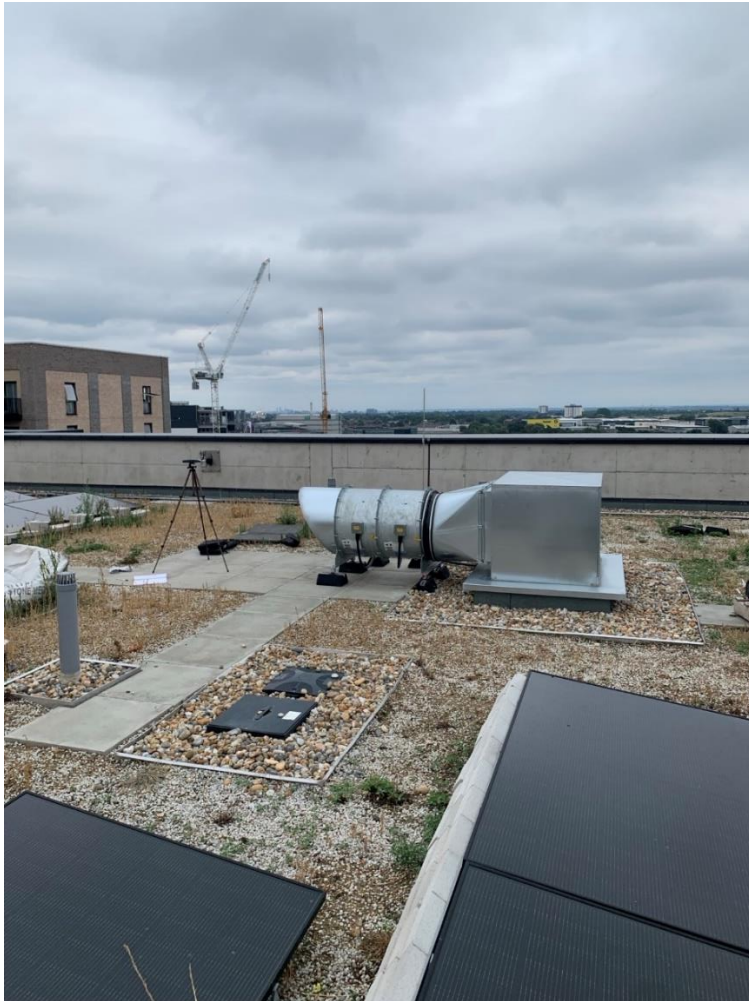
Figure 1 Plant on Roof of Block B1

The results of the noise monitoring on Block B1 are given in Table 3. The fan was slightly audible at the measurement location during the measurement period.

Operating Conditions	Location	Noise Level
Ambient noise levels - no plant	Roof of Block B1	48.3
Plant operating	Roof of Block B1 – 1m from fan extract	51.8
Plant operating	Nearest residential property	31.8 (predicted)

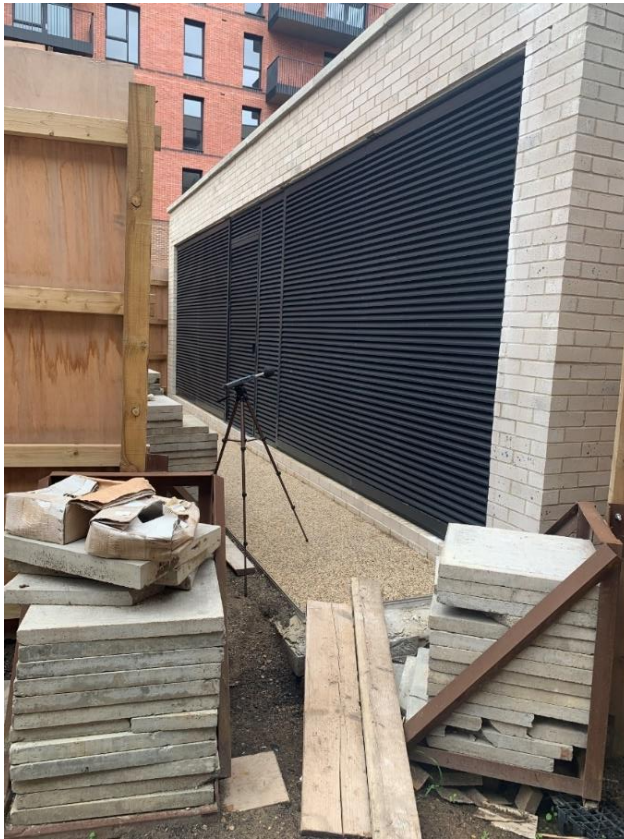
Figure 2 Ground Floor Exhaust of Car Park Fan

The results of the noise monitoring on the Car Park Fan are given in Table 4. The plant fan was very audible at the measurement locations during the measurement period.

Operating Conditions	Location	Noise Level
Ambient noise levels – no plant	Ground floor nearby car park fan	49.4
Plant operating	Ground floor – 1m from fan extract	79.3
Plant operating	Ground floor outside Plot 124 – 26m from fan extract	58.8

The client has stated the car park fan only operates when there is an excess of car fumes in the car park below and there are no set times for operation. It is estimated it may operate for approximately 3 hours per day, but not consecutive hours.

In order to comply with the criteria, it has been estimated the car park fan should only operate for a maximum of 1.5 hours during the daytime and a maximum of 15 mins during the night-time.
