Preliminary Roost Assessment

| Site Location | 75 Roseville Road, Hayes, UB3 4QY |

The findings of this study are valid for a period of 24 months from the date of survey. If works have not commenced by this date, it may be necessary to undertake an updated survey to allow any changes in the status of bats on site to be assessed, and to inform a review of the conclusions and recommendations made.

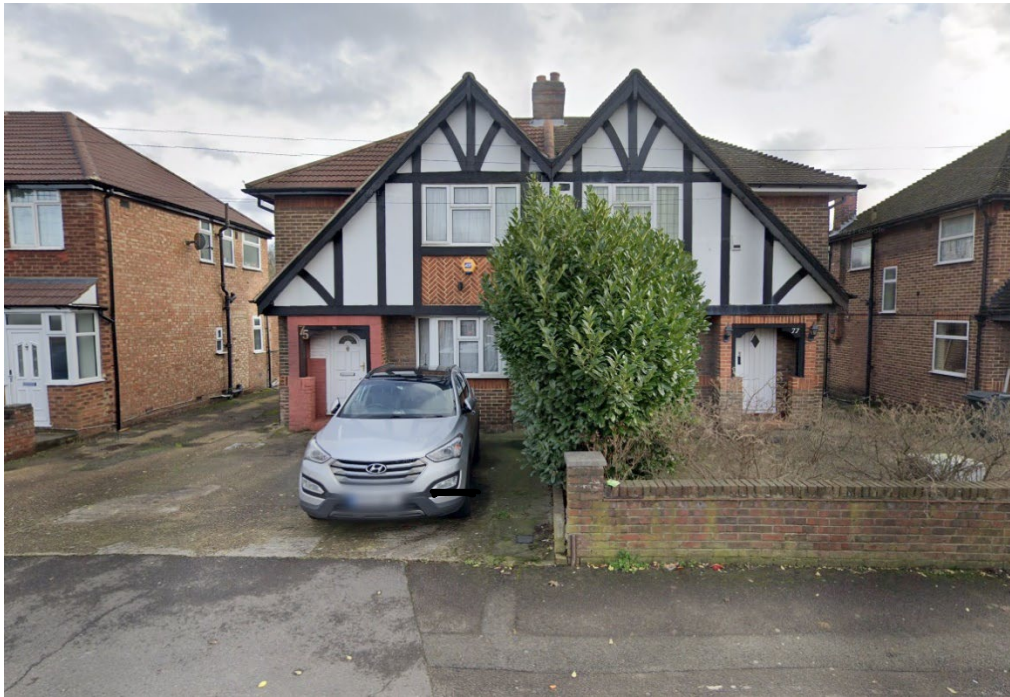
5.0 Photographs

| External | Features of value to bats | Notes |
| External brickwork | No | The brickwork, pointing and render coverings across all facing elevation of the building have demonstrated a good level of condition with no observed features of value to bat. |
| Window/door frames | No | No gaps or features of value to |

| Eaves coverings | No | The eaves demonstrated a sealed covering with no observed features of value to bats. |
| Roof coverings | No | <p>The tiled roof coverings have demonstrated a fair level of condition throughout each elevation with no slipped/missing /damaged tiles.</p> <p>The hip & ridge tiles also demonstrated no features of access value to bats.</p> <p>The vertical tiles to the sides of each dormer have also demonstrated a well-maintained coverings with no gaps or deterioration.</p> |

6.6 In line with current accepted guidelines no further survey requirements for bats or nesting birds have been identified or required. However, a level of protection must be implemented during development to protect wildlife during such works and to limit disturbance caused.
