Historic Building Recording of

# **6A HIGH STREET UXBRIDGE**

| Doc Ref: | LP3139L-HBR-v.1.3 |

A Level 2 Historic Building Recording was carried out at 6A High Street, Uxbridge. This report has been prepared by Michael Johnson of L - P : Archaeology on behalf of Bayar Enterprises Ltd.

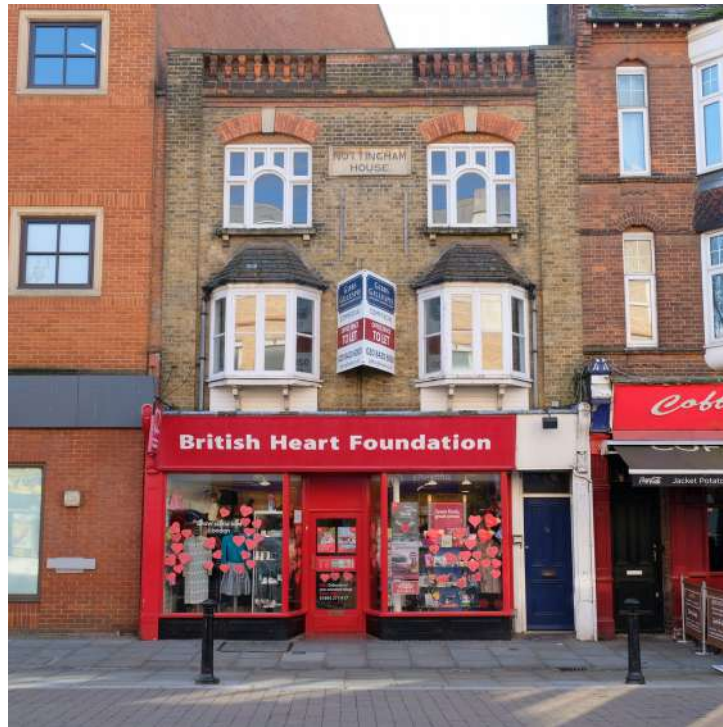
Plate 1 - High Street Façade

- 4.2.1. At the time of the survey the façade stood to 10.5m. The pitch of the hip roof behind the façade is approximately half a metre higher (PLATE 1). The ground floor shop front of 6 High Street is not included in this survey. There were two oriel windows on the first floor of the building and two casement windows on the second floor. The parapet has two blind brick banister details, one above each bay. This form of architecture is typical of the Regency period, however documentary evidence suggests a later build date for this structure.
- 4.2.2. Each of the first floor oriel windows had a tiled roof and two unadorned brackets, these were painted white at the time of the survey and the material was uncertain but likely wooden.

4.2.3. The second floor windows have brick arched architrave with a Cotswold stone keystone. The space between the arch and the square casement windows is adorned with a red and black diamond tile or glazed brick design. In the centre of the second floor there was a carved and painted stone inscribed “NOTTINGHAM HOUSE”. There is no record of this building name in the local archive.

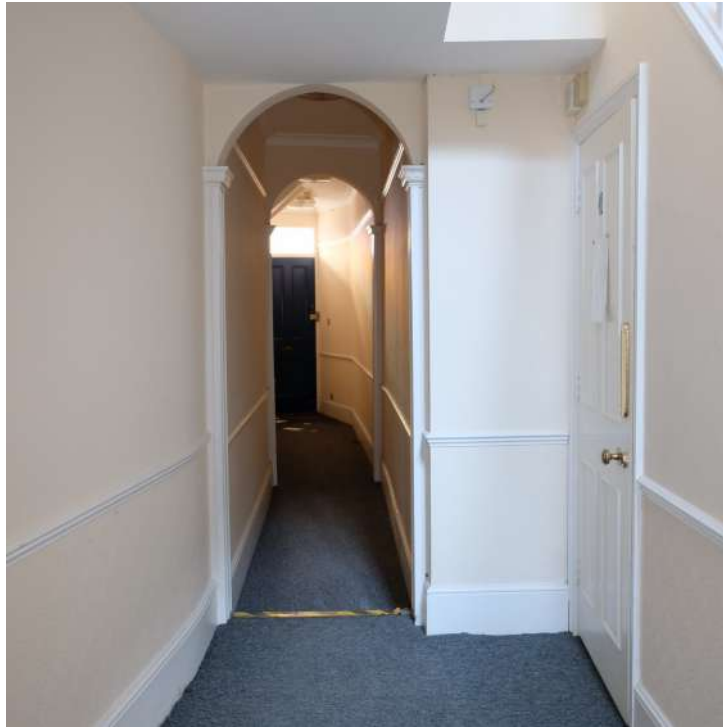
Plate 2 - Room A from Room B

4.4.1. The door from the High Street opens in to the corridor Room A. There was a slight bend to the right, marked by an arch, supported by a fluted pilaster with a dentil design on the capital (PLATE 5). Another arch with an identical pair of engaged columns separated rooms A and B, there was no door (PLATE 2, PLATE 5, FIGURE 3).

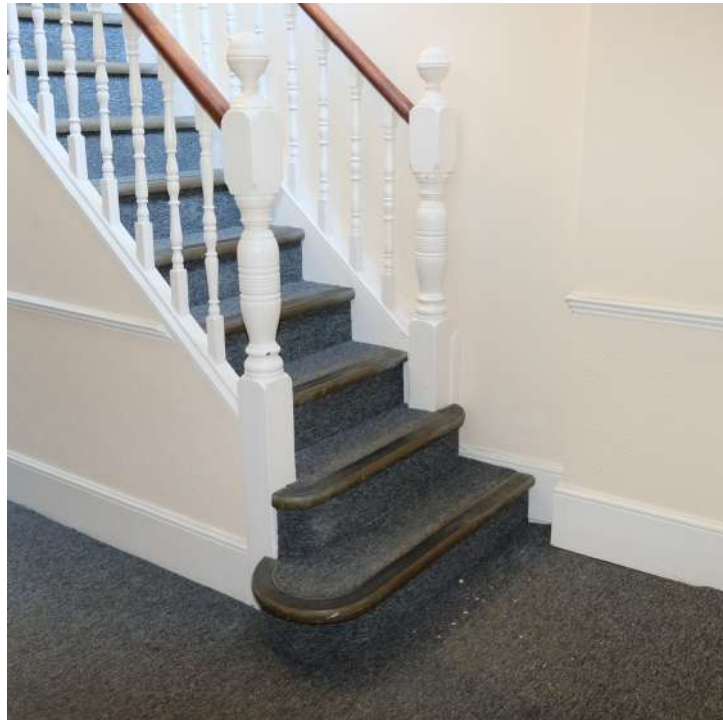
Plate 3 - Stairs in room B

4.4.2. Room B had one door to the rear, a stair to the first floor, and a cupboard under the stairs. (FIGURE 3, Room B). The stairs had a rounded acorn finial. The banister was wooden and stairs carpeted with a plastic nose guard and had a run of 0.22m and rise of 0.18m. The stairs were a single straight run to the first floor, up to the northeast (PLATE 3).

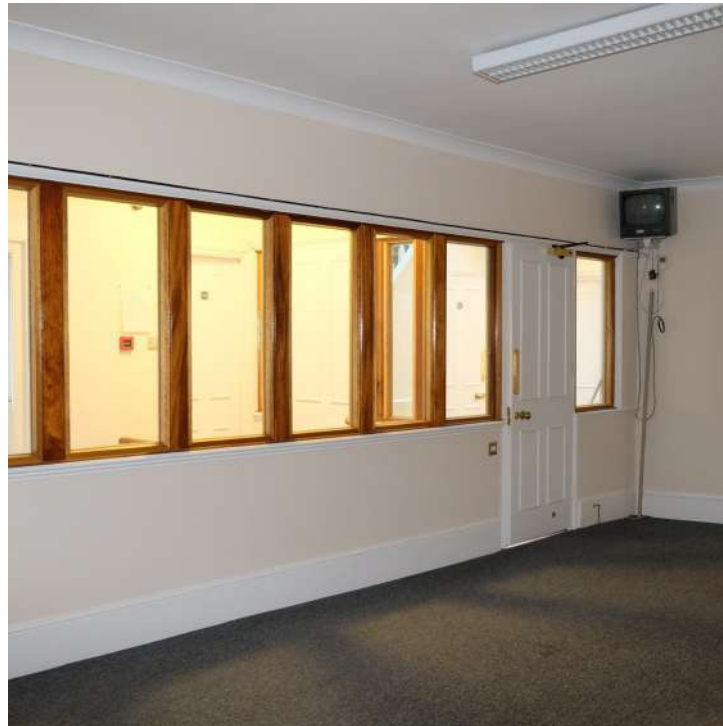
Plate 4 - Windows to room O and room J and door to room J from room M

4.5.2. To the southeast there was an eight light window to room M. The frames were unpainted and square. The frame is shaped as a T where the rooms M, O and J meet. There is a single narrow light from room O to room J.

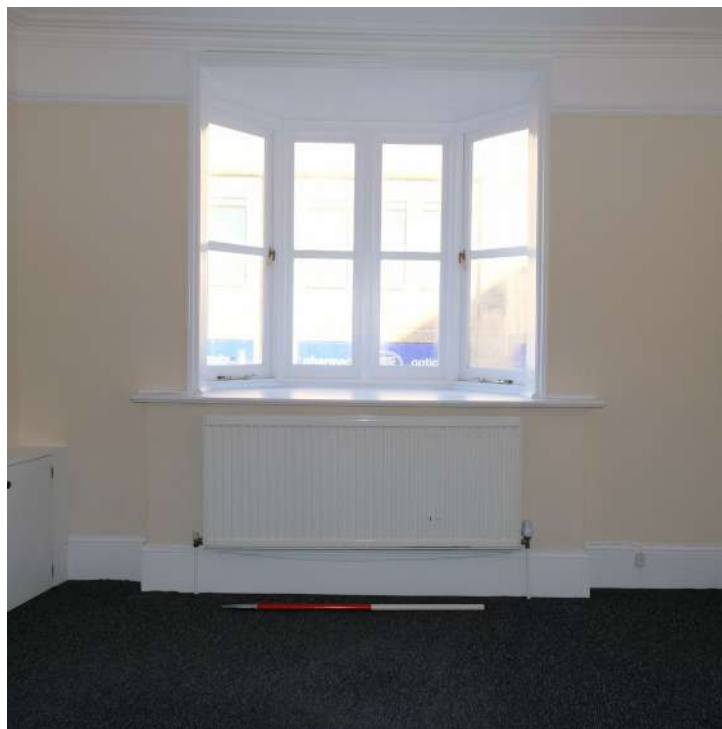
Plate 5 - Oriel window in room L

4.5.4. Rooms K, and L were rectangular rooms on the northeast facing of the building, viewing onto High Street. (FIGURE 4, Room K). Both rooms have oriel windows with four panels, eight lights. The surrounding frame of the bay has an ogee moulding, within the bay the frames were half round at the base and beaded at the top and square on the vertical. The sill was edged with an ogee mould, with a bead and return beneath (PLATE 5).

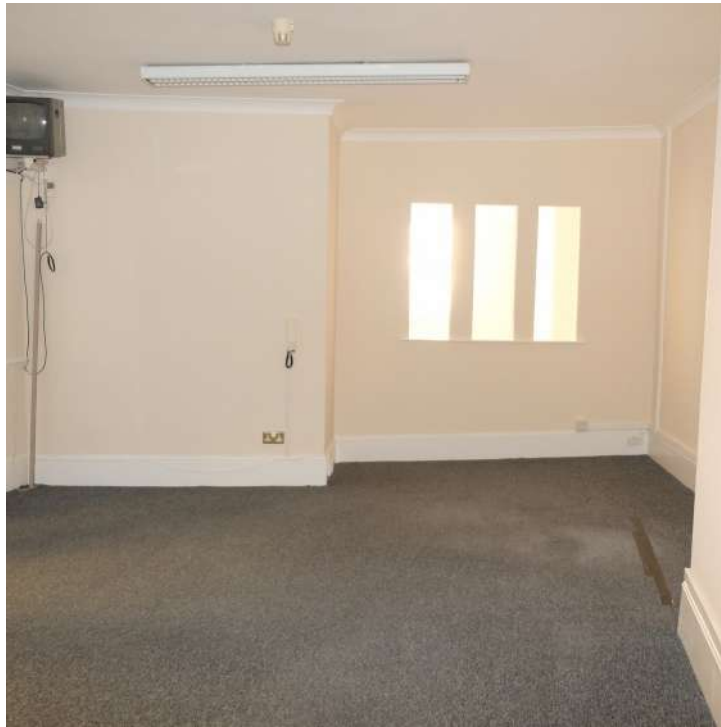
Plate 6 - Room M looking northeast, window to room L and irregular east wall visible

4.5.5. Room K had a chimney breast to the northwest. The fireplace was covered at the time of the survey, with a vent fitted near the base of the wall. Room L had a similar feature on its southeast wall, also with a covered fireplace and a small vent set low in the covered breast. Room L had an unglazed three panel window to Room M (PLATE 6).

4.5.6. Room M was irregularly shaped, the southeast wall was stepped in, and the angle changes to accommodate the buildings 1-4 (FIGURE 4, Room M). The windows on its northeast wall are described in rooms J and O above. At the southwest of the room there a three steps down to room N and a single light unglazed window to room N.

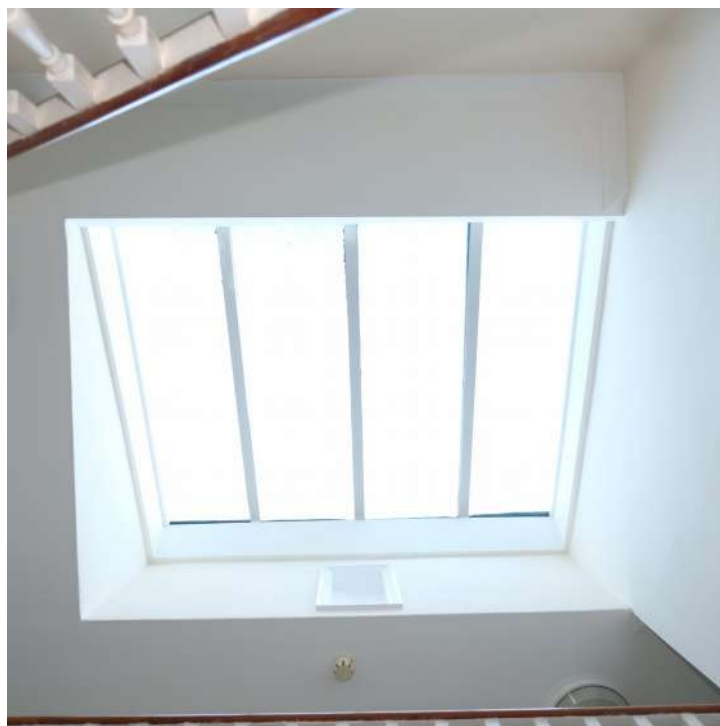
Plate 7 - Rooflight in room C, facing west from room J

- 4.6.2. At the south of the room there was a ceiling the stair in room C there is a vertical hatch to the roof space. Above the stair there was a roof light, the wall between this and the roof space had a door to the roof space. This space was inaccessible at the time of the survey (PLATE 7).

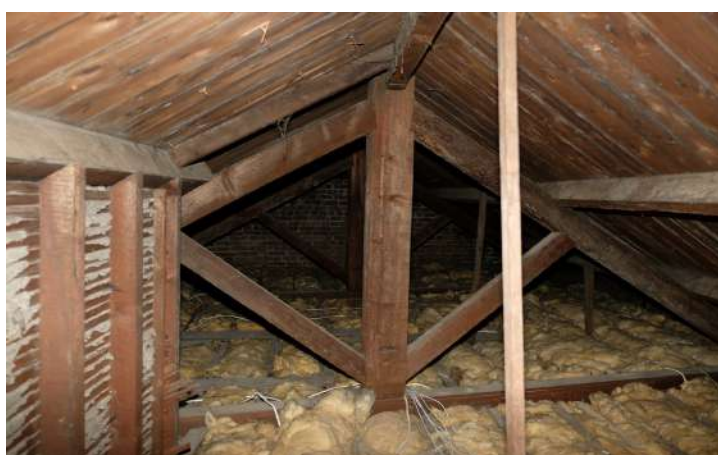
Plate 9 - Attic, facing west

- 4.6.5. Room F has a chimney breast on the northwest wall and room E had one on the southeast. The chimney breast in room E deviated from vertical towards the rear of the building, see PLATE 9.

- 4.7.1. The roof was supported by an unfinished wooden king-post frame. The floor was uncovered insulation with occasional walking boards. One of the boards had painted text suggesting it was a reused sign.

- 4.7.2. There was no access to the exterior roof, which was obscured from street by the parapet. The interior of the light well above the stair is lath and plaster. At the rear of the building some of the wall bricks in a recess were blackened - potentially by soot. The consistency suggests the discolouration occurred in-situ, and that there was a source of burning in this area.

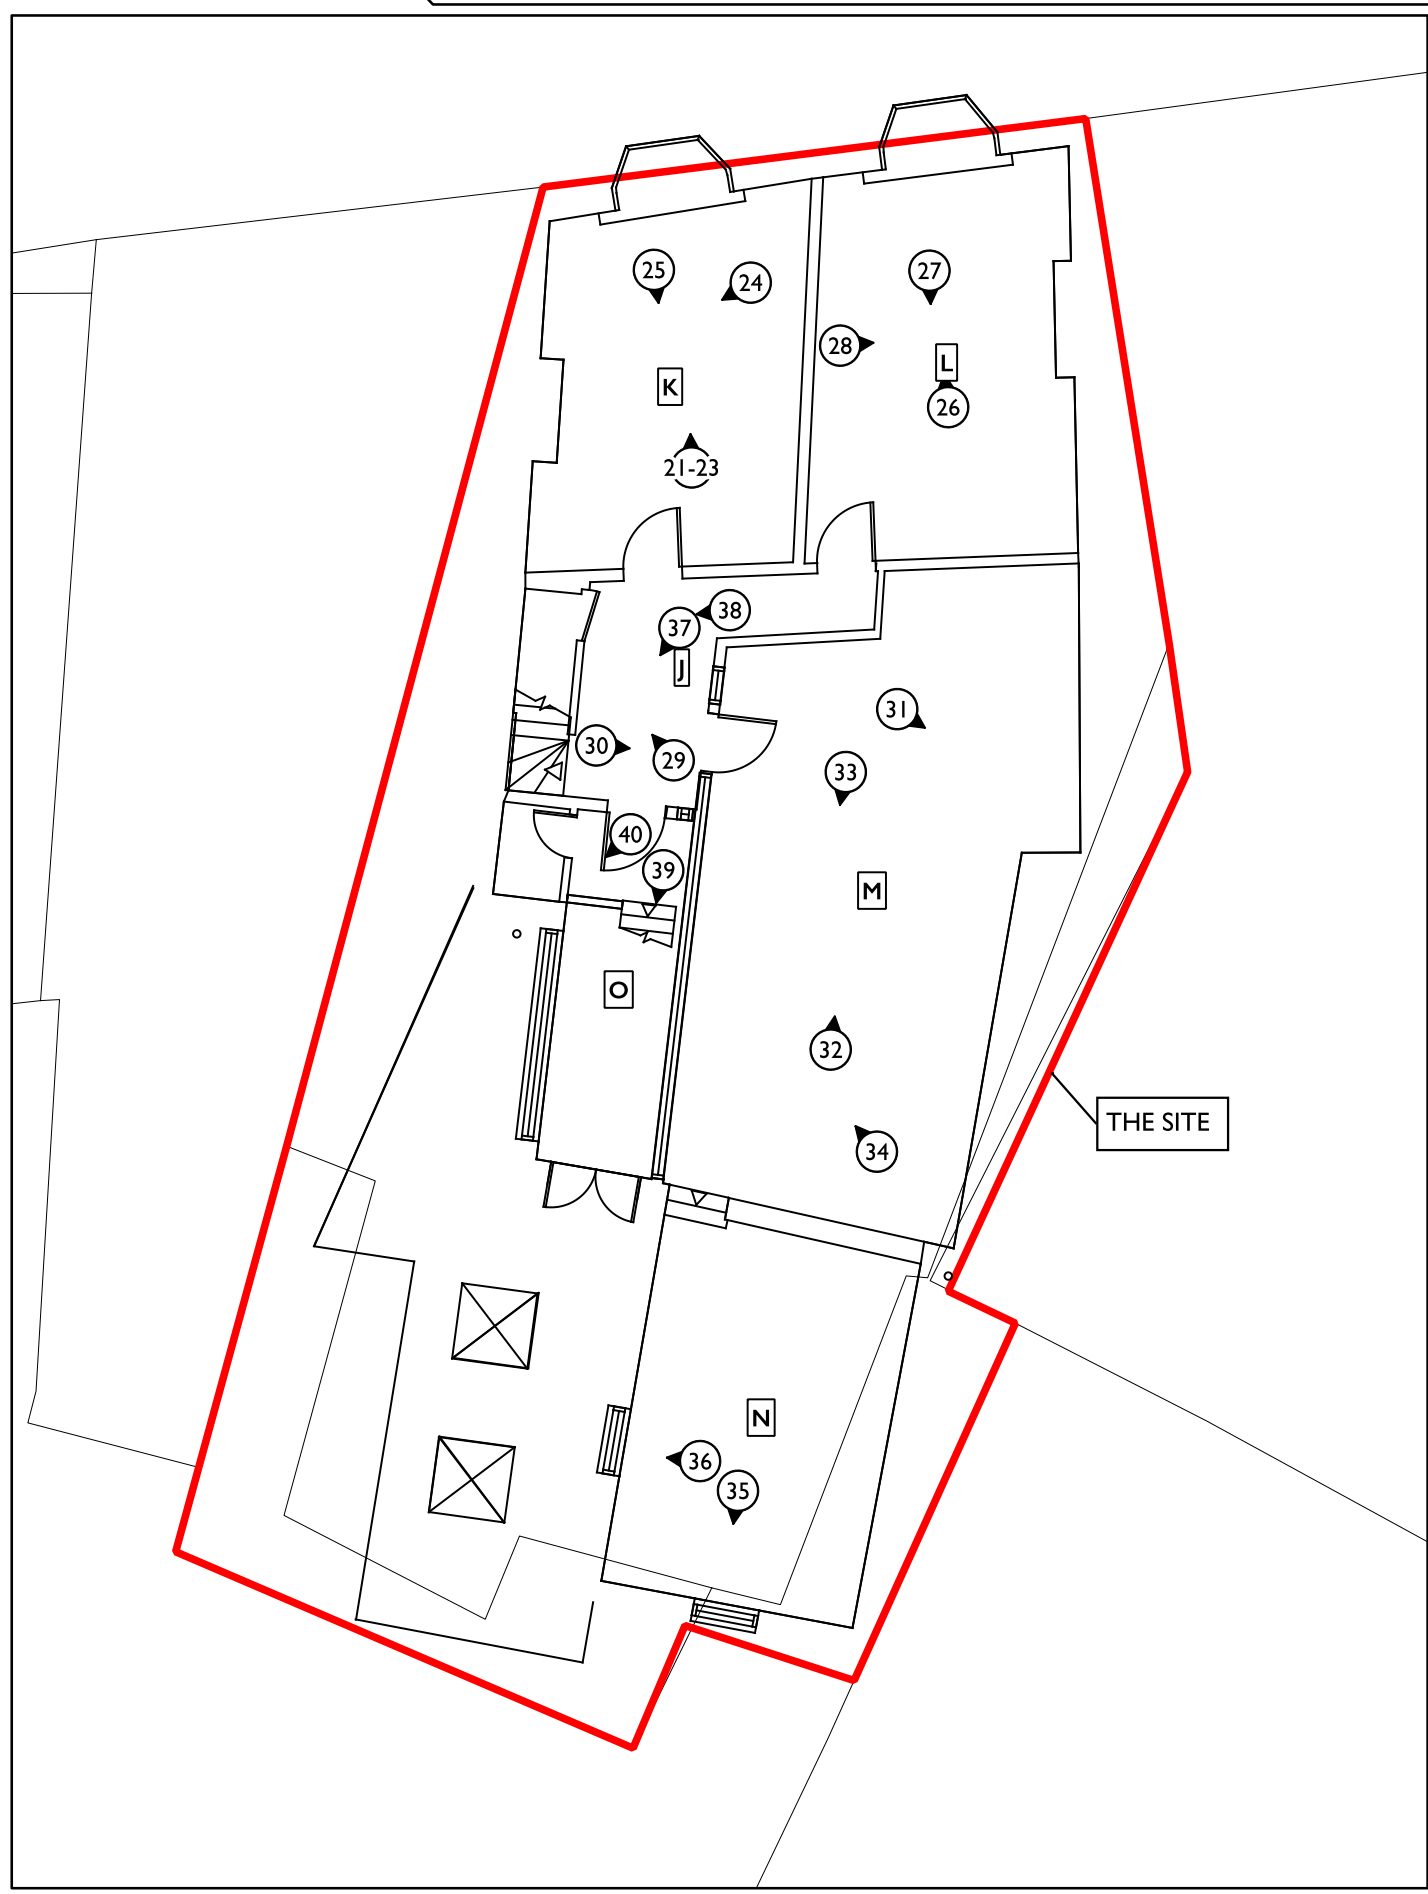
FIGURE 4 // First Floor

4.5.1. The landing on the first floor (Room O, FIGURE 4) is separated from the rest of the first floor space, accessed via hallway Room J, by a four panel wooden door. There is a cupboard to the northwest from the landing. To the west, south and east the walls of room O were almost entirely glazed. The northeast wall has three wooden sash windows, to the southeast there was a wooden door to the roof space beyond. The door frame was quarter round at the top, those of the sash windows were square. The door was directly above the stair, and therefore inaccessible. The roof space beyond had roof lights, and the blocked window.

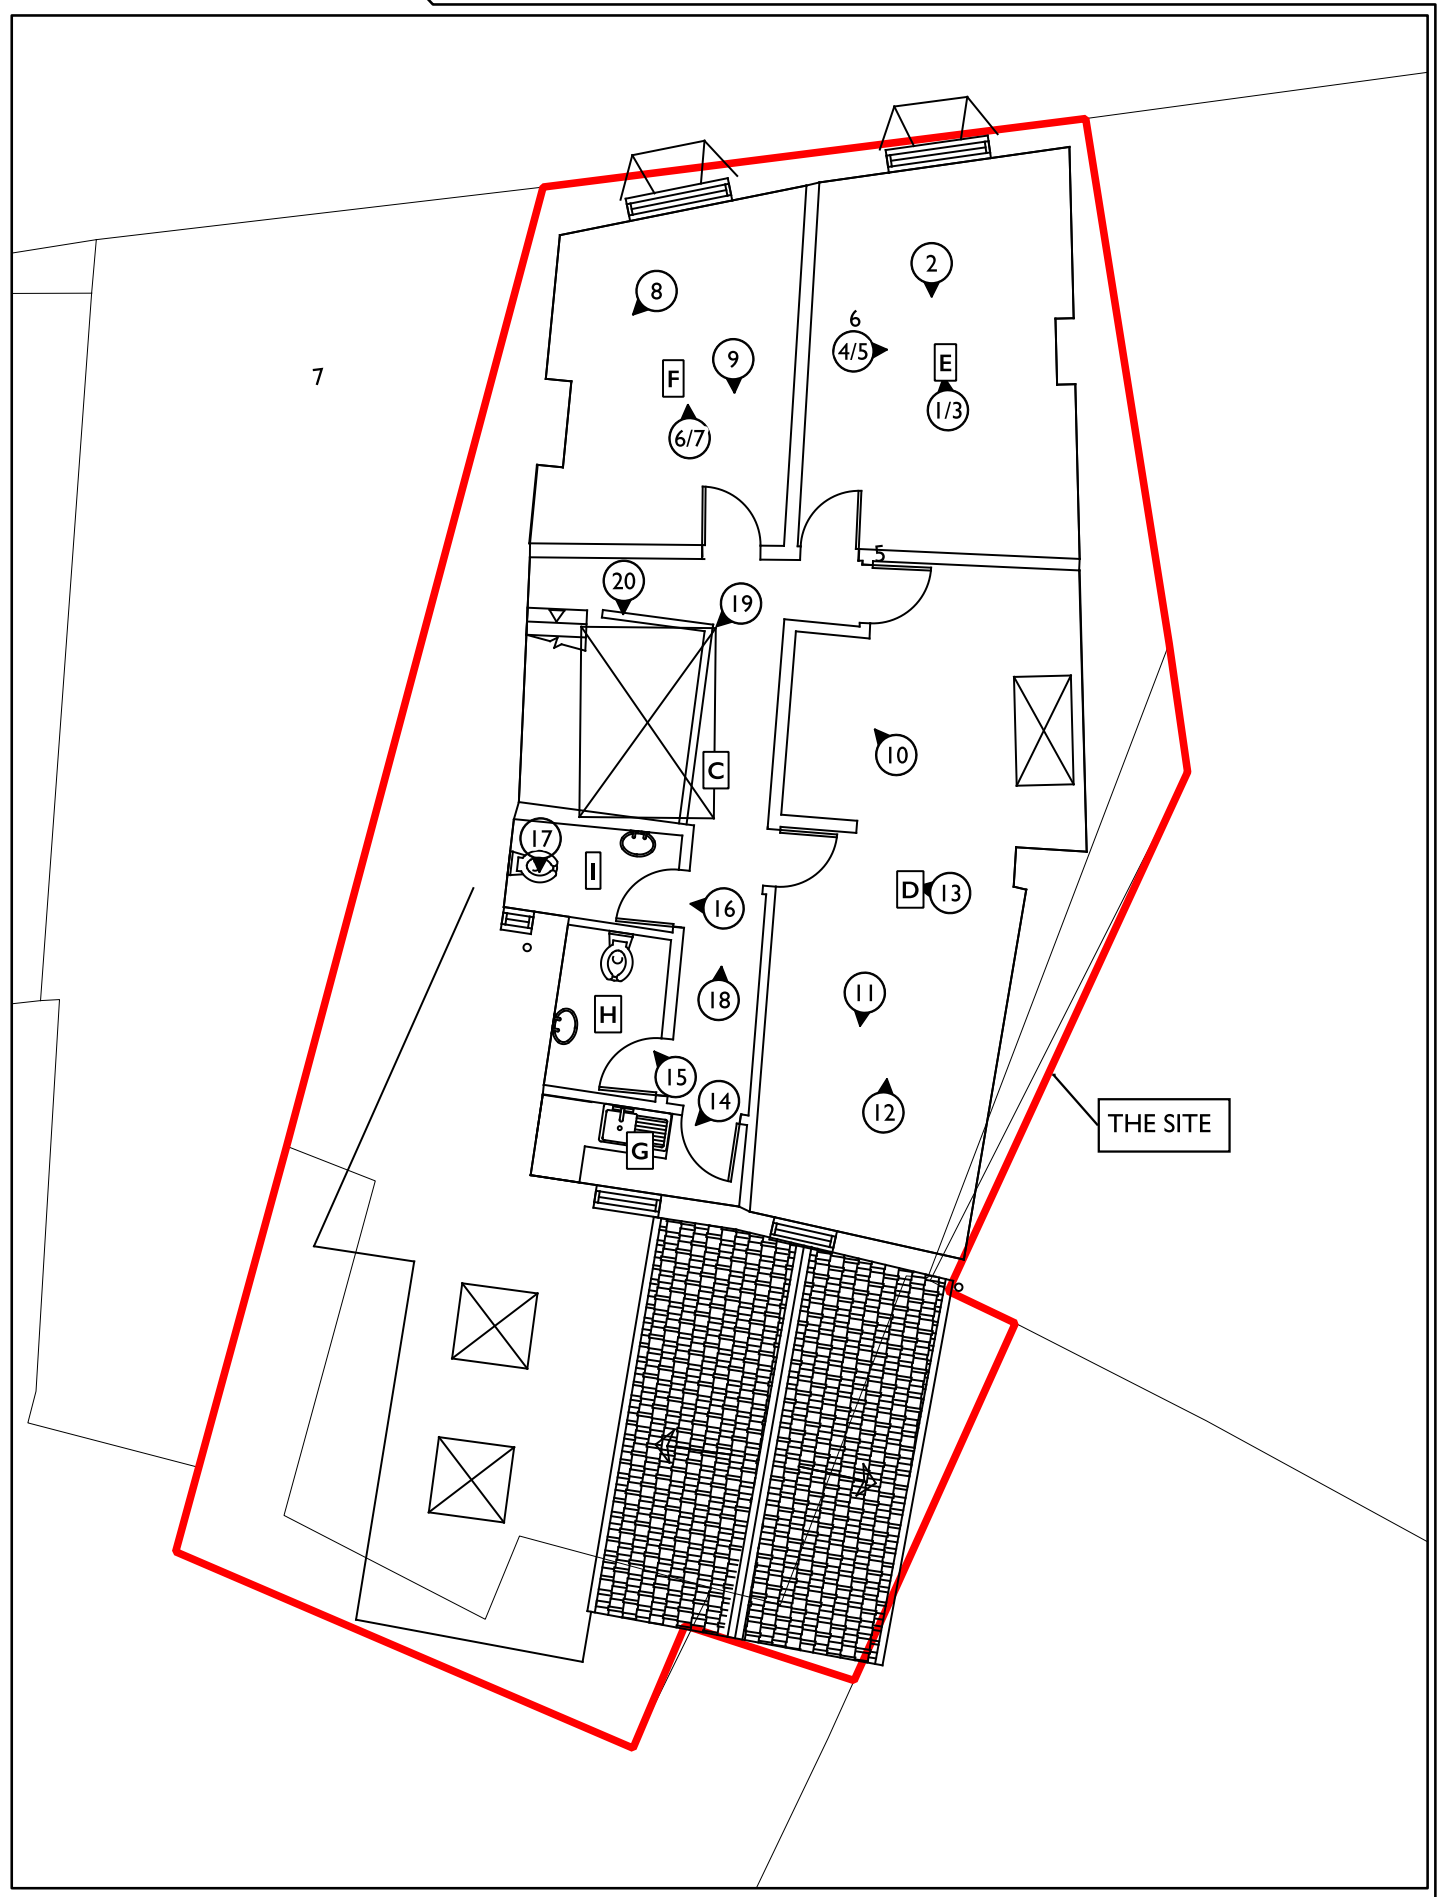
FIGURE 5 // Second Floor

- 4.6.1. The landing on the second floor (room C, FIGURE 5) had seven doors, two to the northeast to the storage/office spaces on the front of the building rooms E and F, two to room D, to the southeast, one to a kitchen (room G) in the southwest and two to toilets on the northwest elevation.

- 4.6.3. Room D to the southeast had two doors to room C (FIGURE 5, Room D). It is irregularly shaped, with the southeast wall changing angle at a step, the same as room M below. There is an external casement window to the southwest, which is the same as the windows in room N. The northwest corner of the room contained fittings for a server, suggesting the room was used previously as an office. There is a roof light in the east of the room, and three double tube fluorescent lights.

- 4.6.4. Rooms E and F face the High Street (FIGURE 5) both rooms have the same

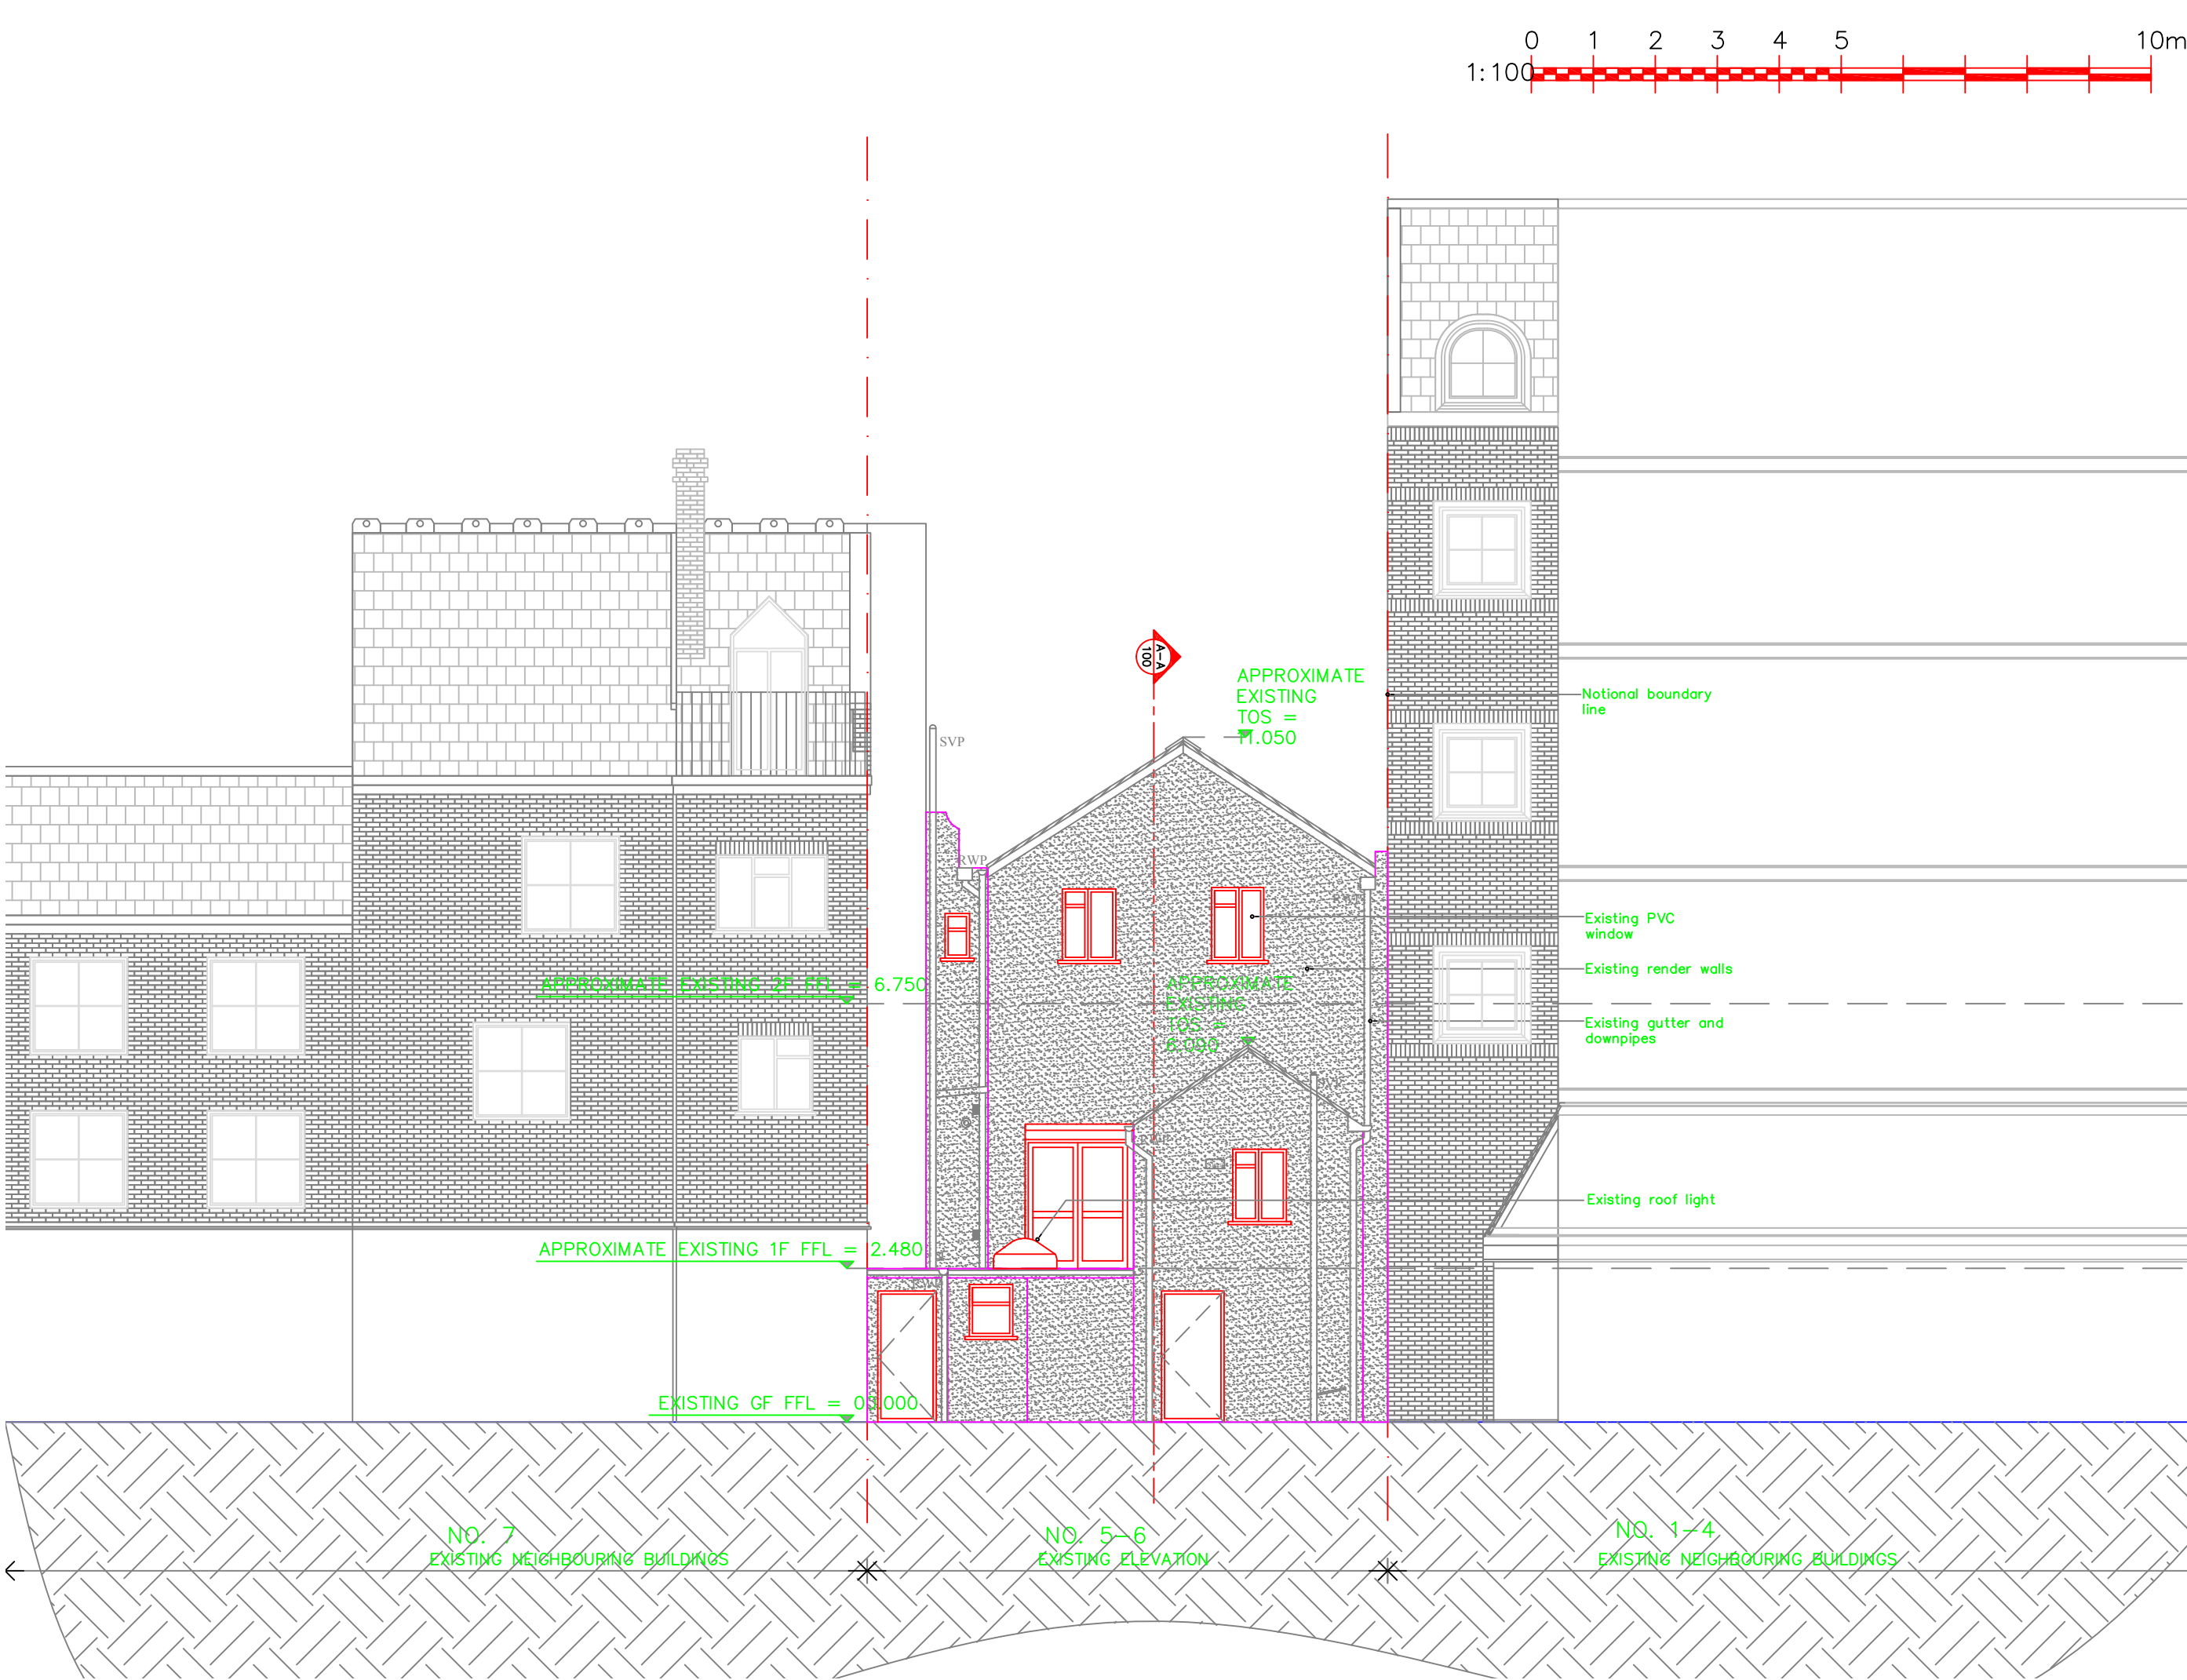
EXISTING REAR ELEVATION

4.3.1. The rear elevation featured two gable ends, the principle roof of the building and that above the rear room N.. The brickwork was obscured by a textured plaster finish. The second floor featured two square topped windows described in rooms D and G. The first floor featured the doorway above the stair in room C which opened onto the flat roof of the ground floor of 6 High Street, the exterior of room N was plastered in the same way as the gable end of the second floor, with no visible interface to the ground floor of 6 High Street below it.

4.3.2. The style of the windows and the difference between the floor level in rooms N and M suggest that the rear elevation of the building was a later addition.
