BS5837 Arboricultural Impact Assessment & Method Statement

29 Sweetcroft Lane, Uxbridge, UB10 9LE

Job Reference: 05490Rv2

March 2026

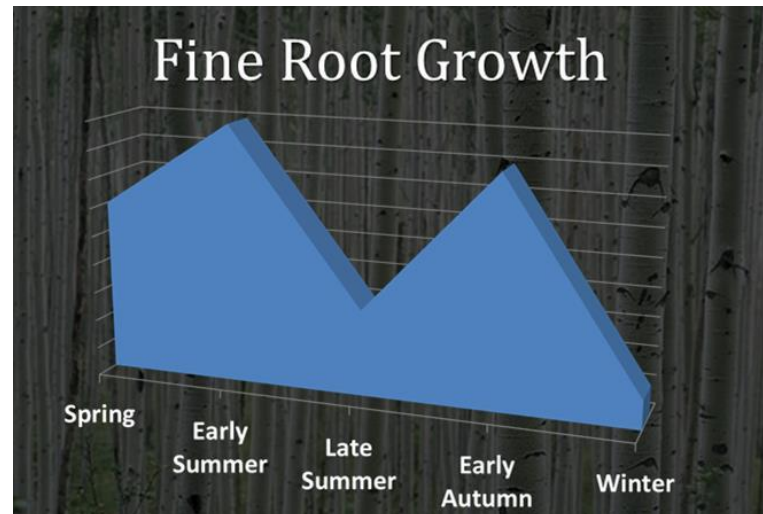
Fig 3 – Fine root growth is (generally) seasonal peaking in late spring and again in early autumn but dying back in winter dormant periods when photosynthetic production ceases. This is an important part of the soil nutrient cycle and demonstrates that a static RPA as calculated by BS5837 is a ‘simplistic’ view of the tree rooting dynamic. (Image Source: Tamla Trees)

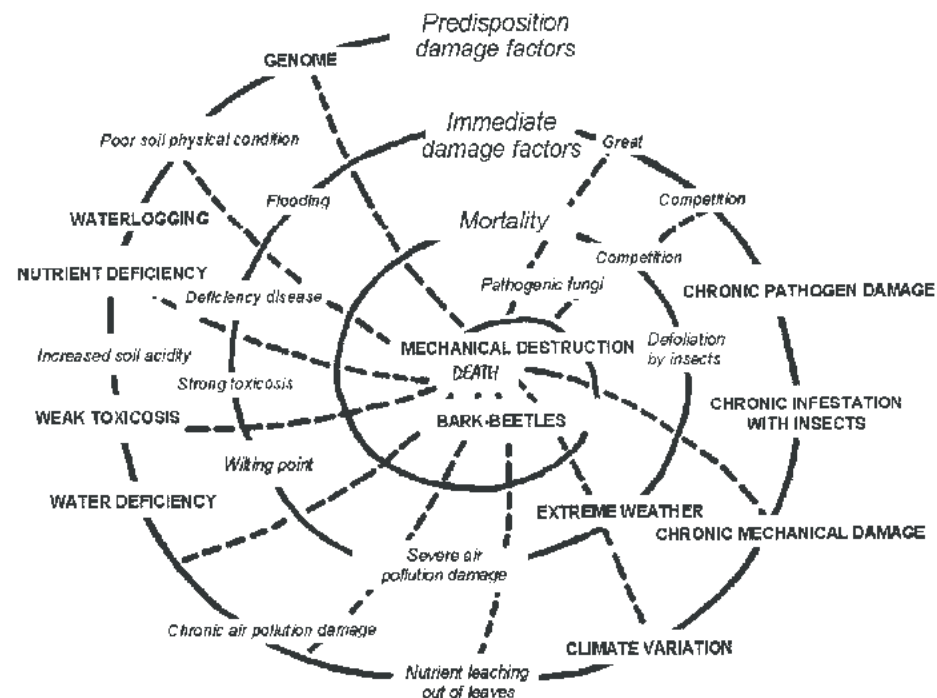
Fig 5 - Manion's spiral of tree decline for Norway Spruce (modified by Mrkva 1993)

5.1.9 Against this backdrop rooting information seeking to manipulate RPA shapes to account for the presence of houses, garages etc outside of the immediate zone of structural rooting (3-4m) is not considered appropriate. Unless ground obstructions are present within the immediate structural rooting area or to such a depth as to nullify potential fine root growth (below basements or retaining wall step changes in levels for example) Tamlata Trees Ltd will show RPA's in a circular fashion but seek to maximise the quality and positioning of specified tree protection measures and encourage ground treatments (such as mulching – see Section 5.7). **Clients and developers must implement these measures for them to be effective. A failure to protect trees during the development process adversely affects soil and roots. Symptoms may not present themselves for a number of years following the development as the tree(s) enter a spiral of potentially irreversible decline.**

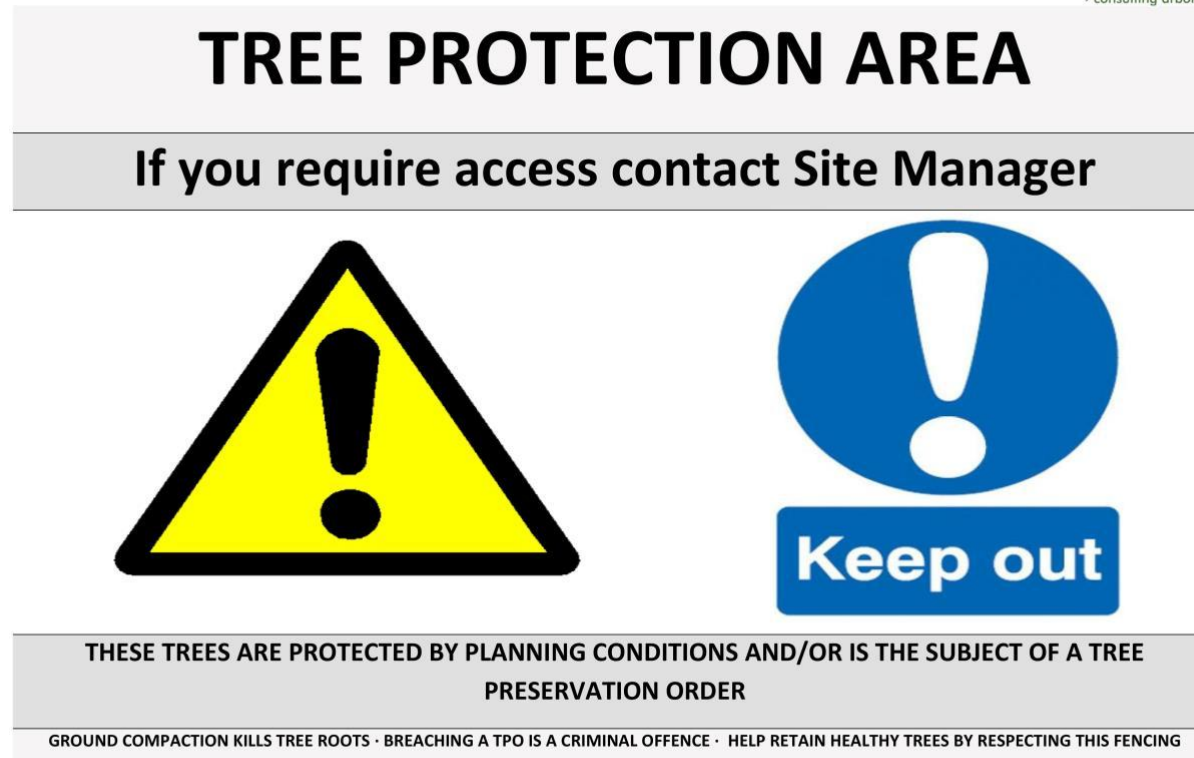
Fig 8 – Professional grade weatherproof tree protection signs no smaller than 297 x 420 mm (A3) should be placed on protective fencing.

5.4.4 All internal tree protection must be appropriately signed to ensure that all site operatives know its purpose.

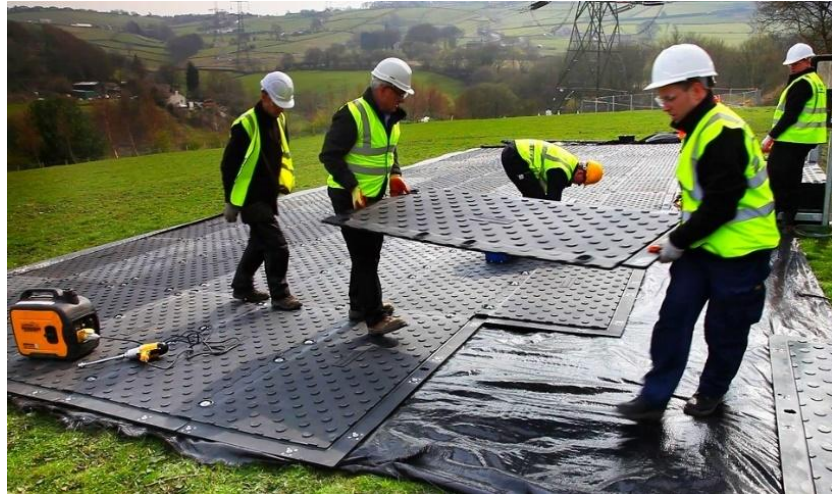
Fig 9 – Overview of ground protection. This is for information only as there does not appear a current project requirement.

5.4.5 Temporary ground protection is not specified on this project as there appears no requirement for access or material storage within the RPA of retained trees (unless this is already a driveway area). This will be kept under review and should a requirements arise the specification of ground protection should reflect the movements across it. An overview of this is provided below:

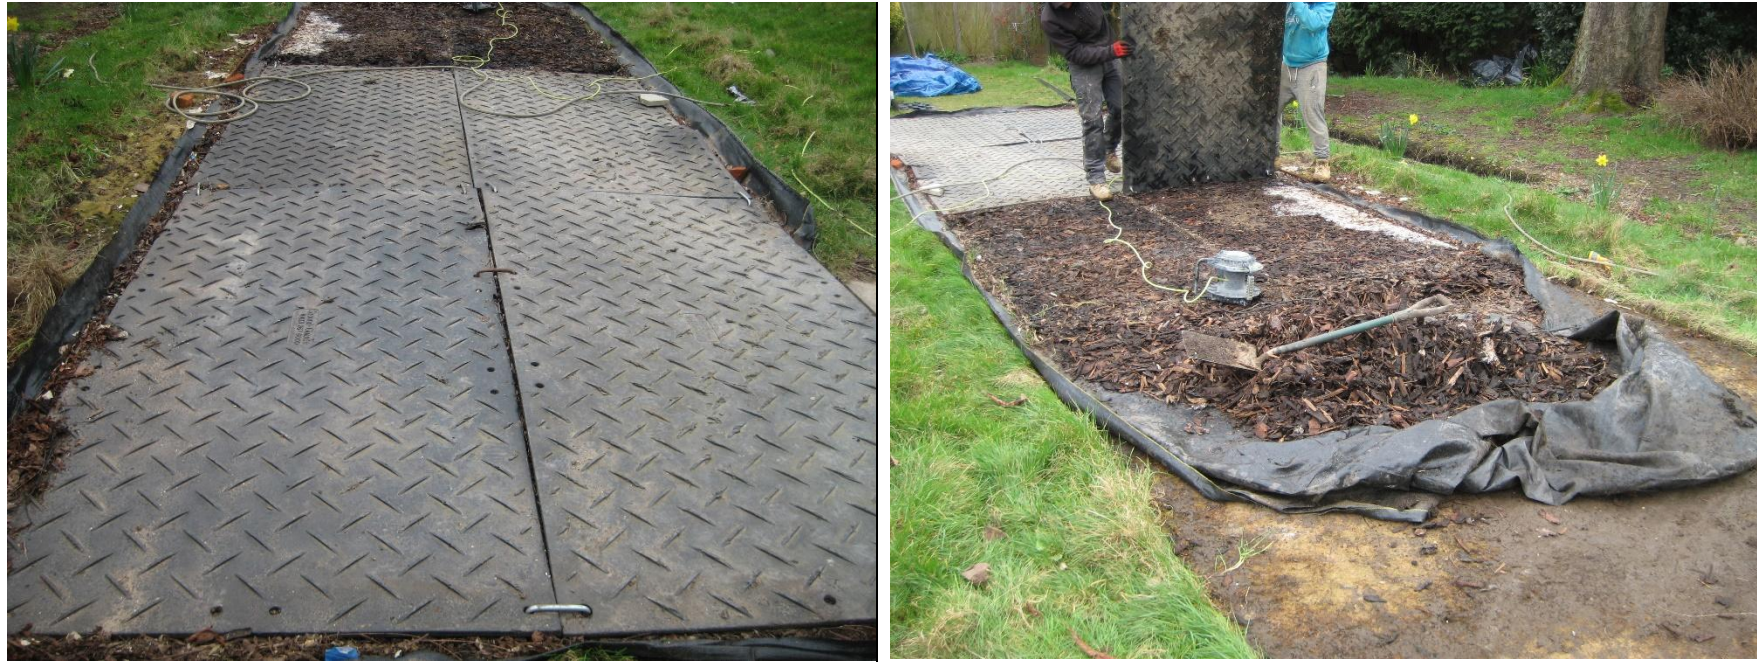
Fig 10 – Temporary ground protection is an effective way of allowing access through the RPA of retained trees. It must be installed prior to any on site activity and maintained for the duration of all works to be effective. Above left Tamla Trees project ground protection in place and above right being removed following the completion of site works. (Note: depending on the length of time it is in place it will adversely affect underlying grass ground cover which will need reseeded/ turfed accordingly)

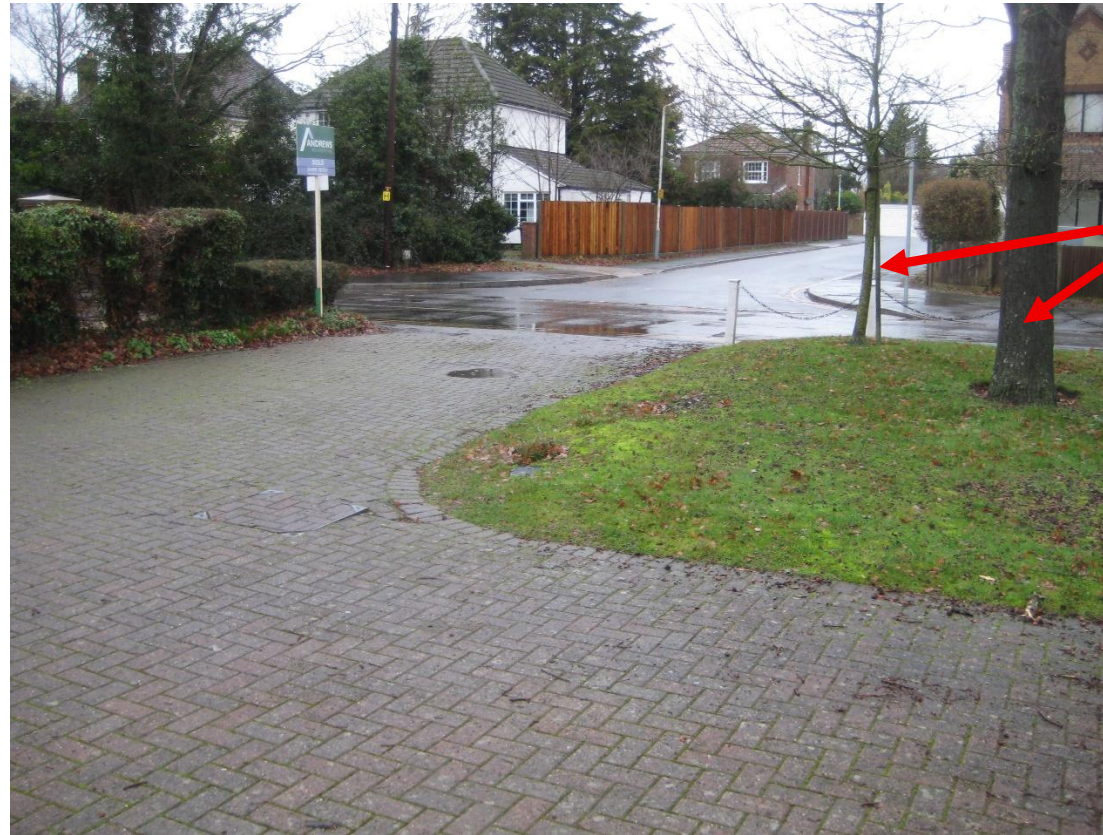
Fig 11 – The existing driveway is retained. T1 and T2 are highlighted.

5.5.1 There are no new surfaces proposed within the RPA of retained trees. The existing driveway to the front of the site is retained.

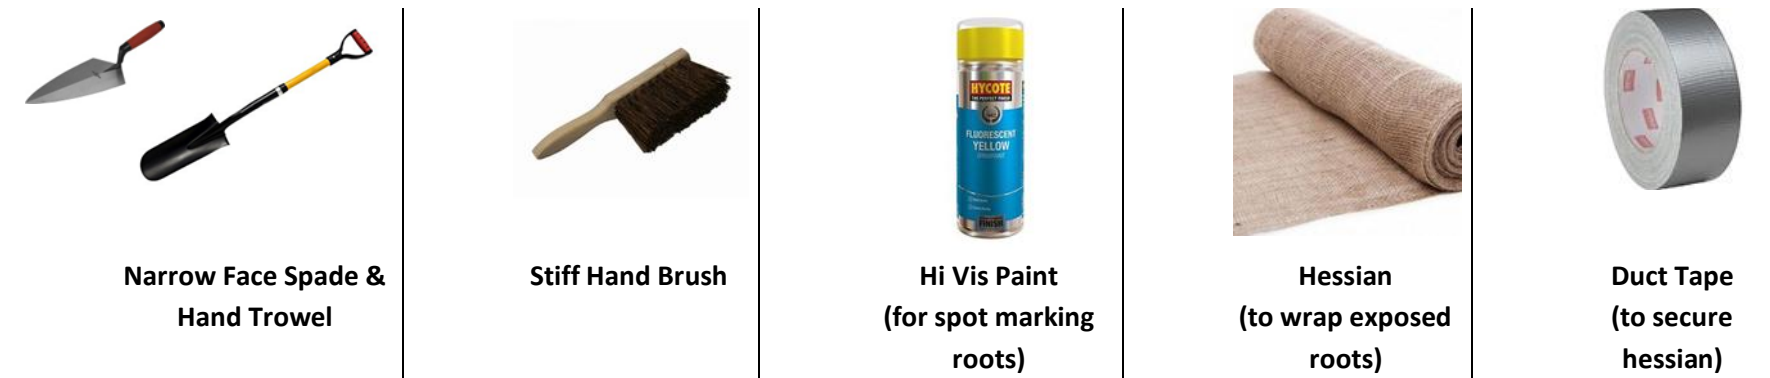
Fig 13 – Advised tools/ materials which should be available for all excavation works within RPA.

5.6.2 **Planning the excavation:** A ‘toolbox talk’ will spot mark and agree the locations and working practices. All excavation by hand retaining roots larger than 10mm. This will only be required where excavation works are within retained tree RPA’s.

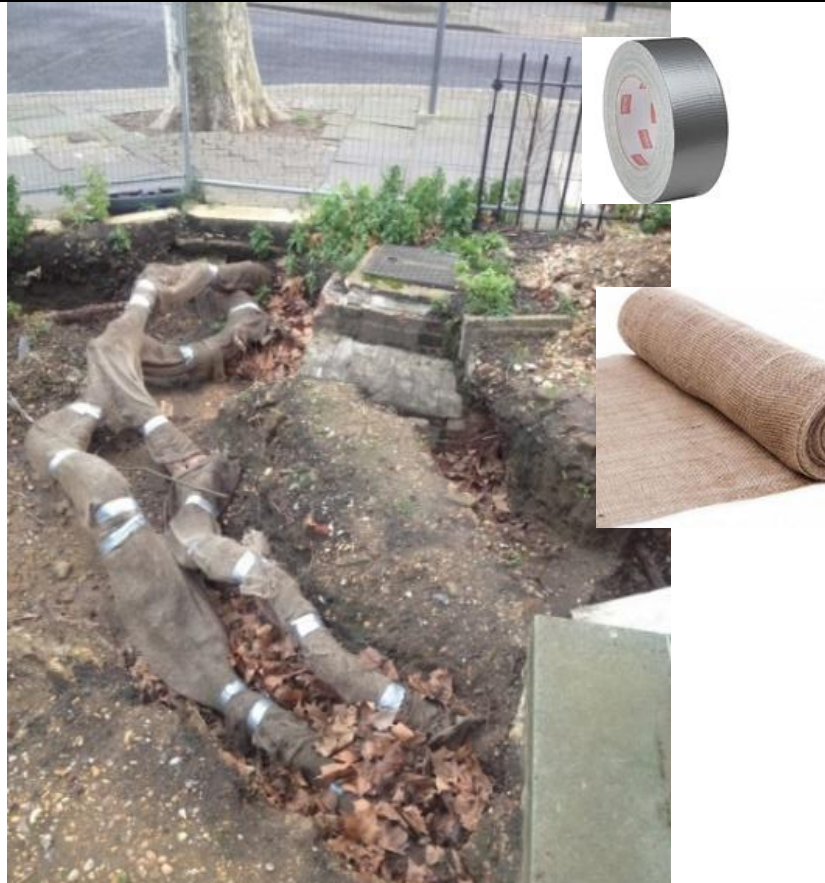
Root Wrapping

- Any exposed roots >25mm should be wrapped in hessian (example left) if exposed overnight or for any 4-hour period.
- Spot marking with spray paint to highlight locations also advised.
- Alternatively, roots can be covered over with topsoil to maintain moisture retention.
- Example Tamla Trees project on London Plane (left).

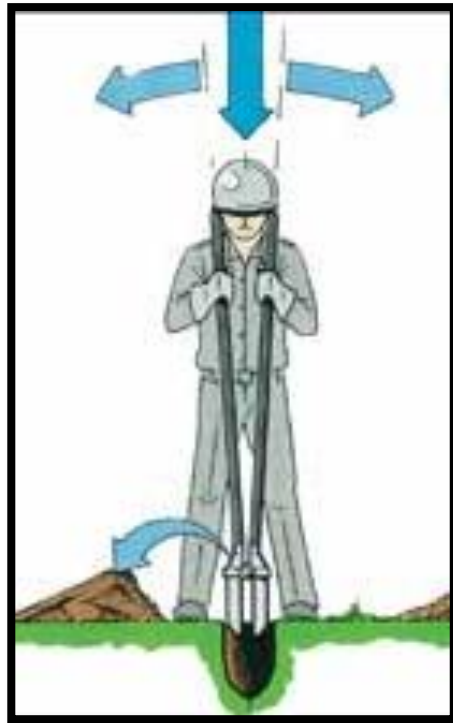
Post Hole Excavation

- *Post holes excavated by hand.*
- *Repositioned in the event any roots >25mm encountered.*

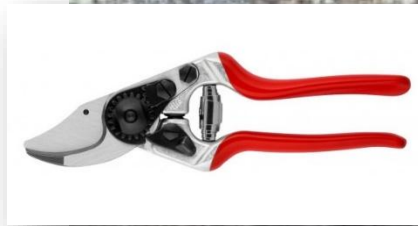
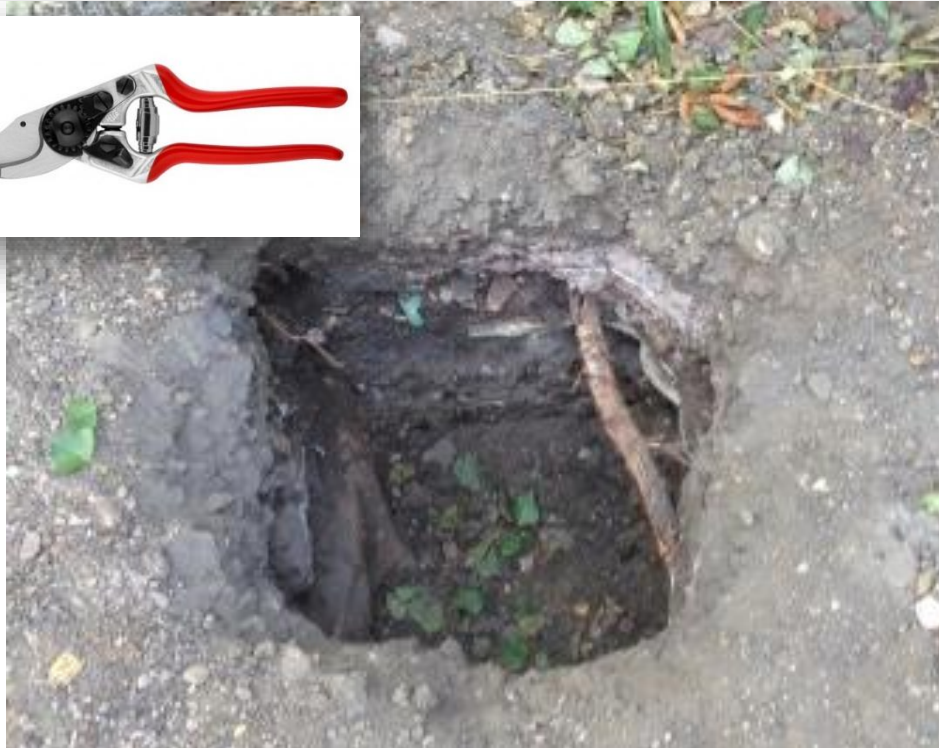
Root Pruning

- All roots >25mm retained (see left for example).
- Fin fibrous roots <25mm cleanly cut with secateurs or similar (inset).

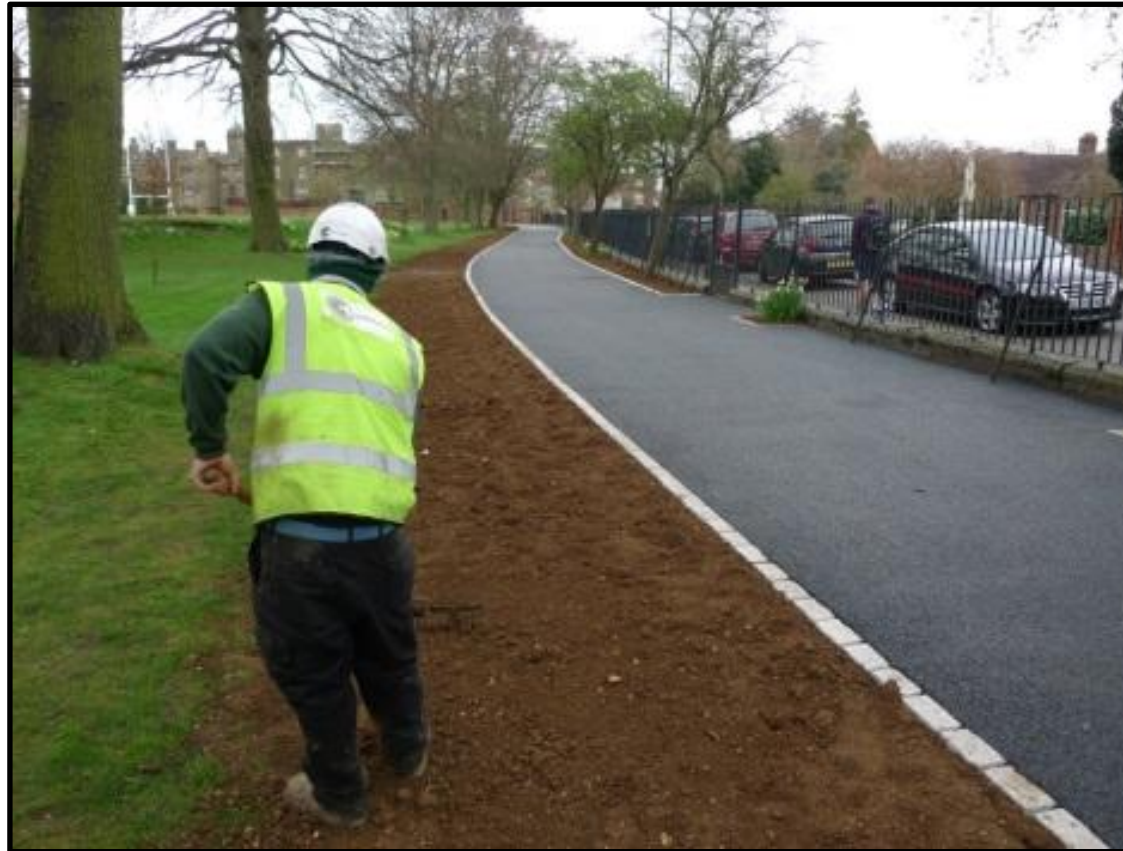
Fig 14 – All 'making good' topsoil will be BS3882 compliant and raked out by hand to no greater depth than 100mm.

5.7.2 All 'making good' will be with BS3882 compliant topsoil raked out by hand (to no more than 100mm depth within any tree RPA) and then seeded/planted as appropriate. No remediation proposed on this project. Further comments on full landscaping details are beyond the scope of this report.

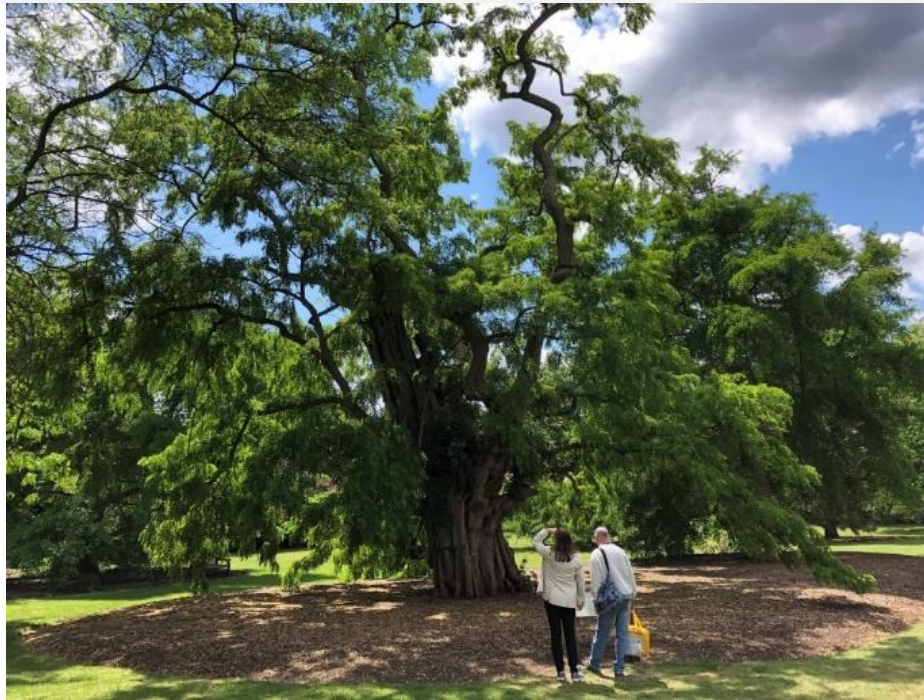
Mulching

- *Circular area edged to 50-100mm depth to stop mulch from 'creeping' on to surround lawn.*
- *Composted mulch then spread around below tree by hand – no need to lift or remove underlying grass.*
- *Mulch topped up annually/ as required.*
- *Positive benefits for mulched trees.*
- *Scope exists to mulch below T2 within the front garden area.*

5.7.3 We encourage the use of composted bark mulch below tree canopies where possible to aid water retention and increase soil microbial activity. This is particularly relevant to mature retained trees. Mulch is recommended below the canopy of trees T2 & T3 (Oak) on the basis of their current condition.

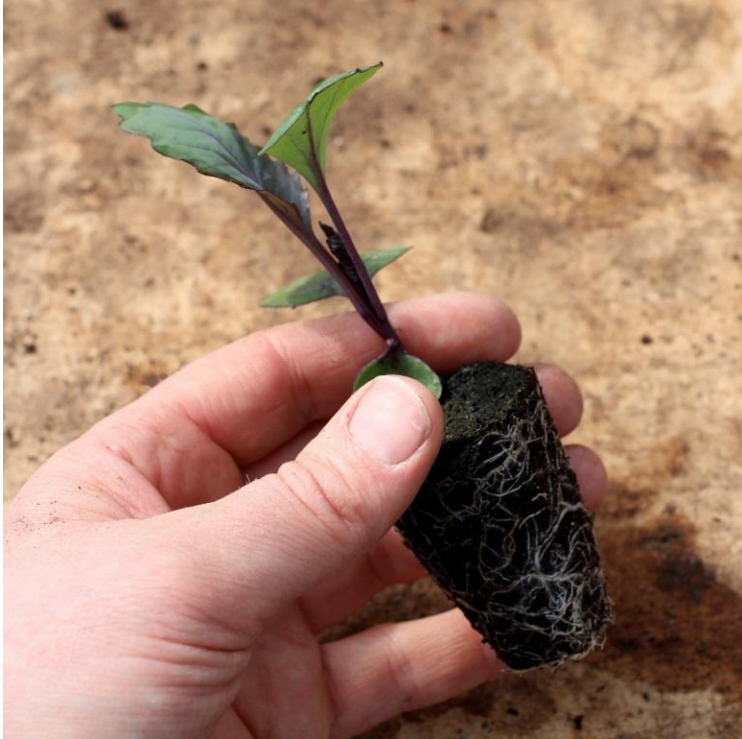
Plug and Pot Planting

<p>Overview</p> <ul style="list-style-type: none"> • <i>Within 1.5m of retained trees planting should be with plug stock (left)</i> • <i>Small plant pot sizes <3l utilised for new planting in further areas.</i> • <i>Hand dug planting holes.</i> • <i>Top dressed in compacted bark mulch/ soil as appropriate.</i> • <i>Watered weekly May – September during season 1 & 2.</i>
Threat Level to Retained Trees	LOW

5.7.4 Where soft landscape planting occurs within the RPA of retained trees, we advise the use of small pot sizes and plug planting where possible to minimize the risk of root disturbance.

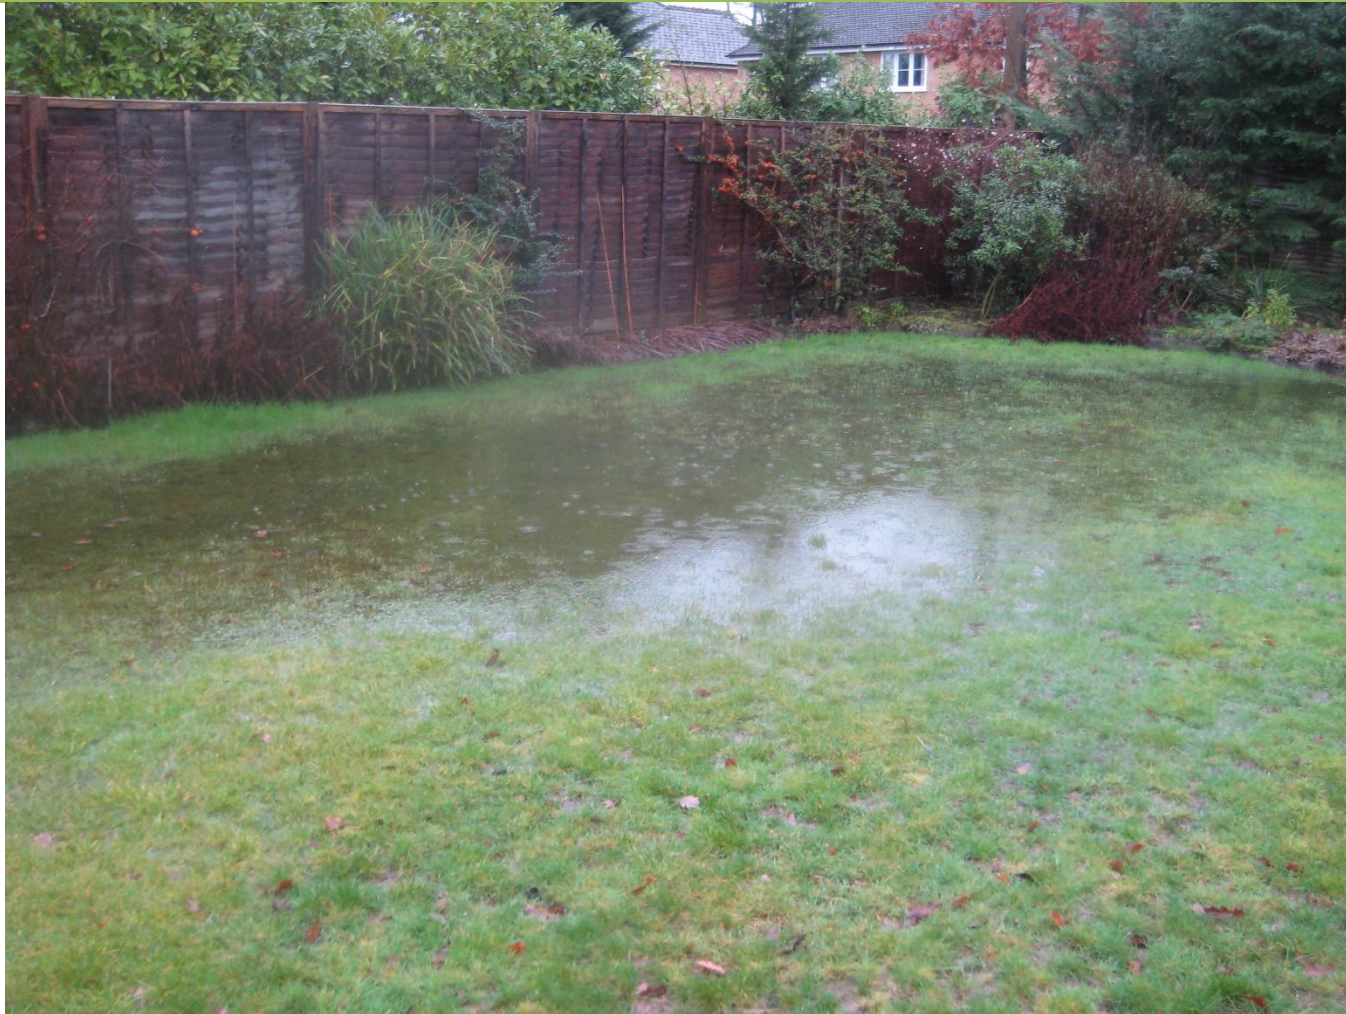
Image 3 – Some standing water was evident within the rear garden.

4.6.3.(b)	<i>topography and drainage;</i>	<ul style="list-style-type: none"> The site is generally level. There was no evidence of standing water pooling in areas near trees, but standing water was noted to the eastern side of the rear garden.
