**44 WATERLOO ROAD  
UXBRIDGE UB8 2QX**

**PHASE 1 PRELIMINARY RISK ASSESSMENT  
FOR  
*UXBRIDGE PROPERTY LIMITED***

**Our Ref:** HLEI52937/001R

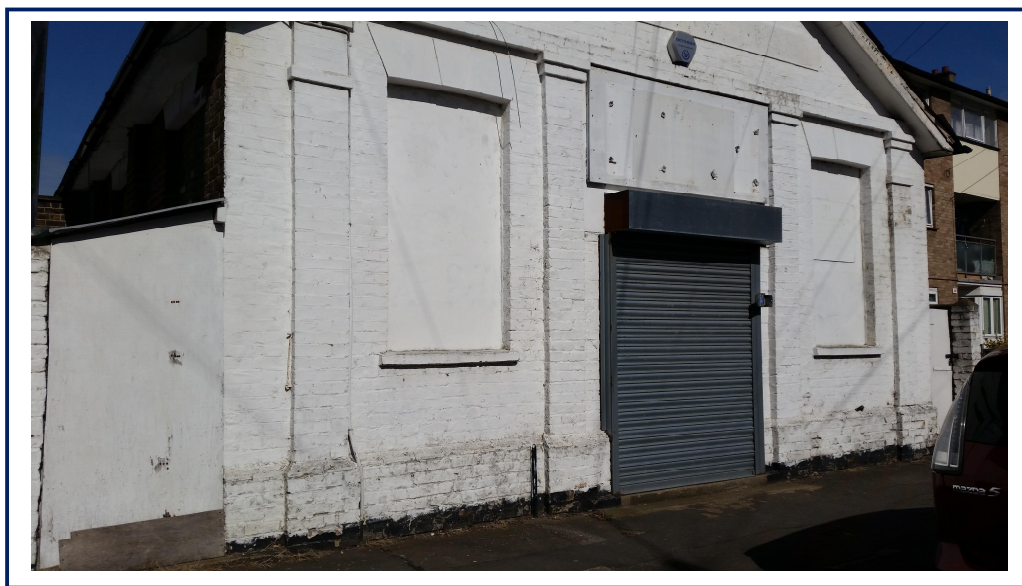
*General view of the site. For further photos see Appendix B.*

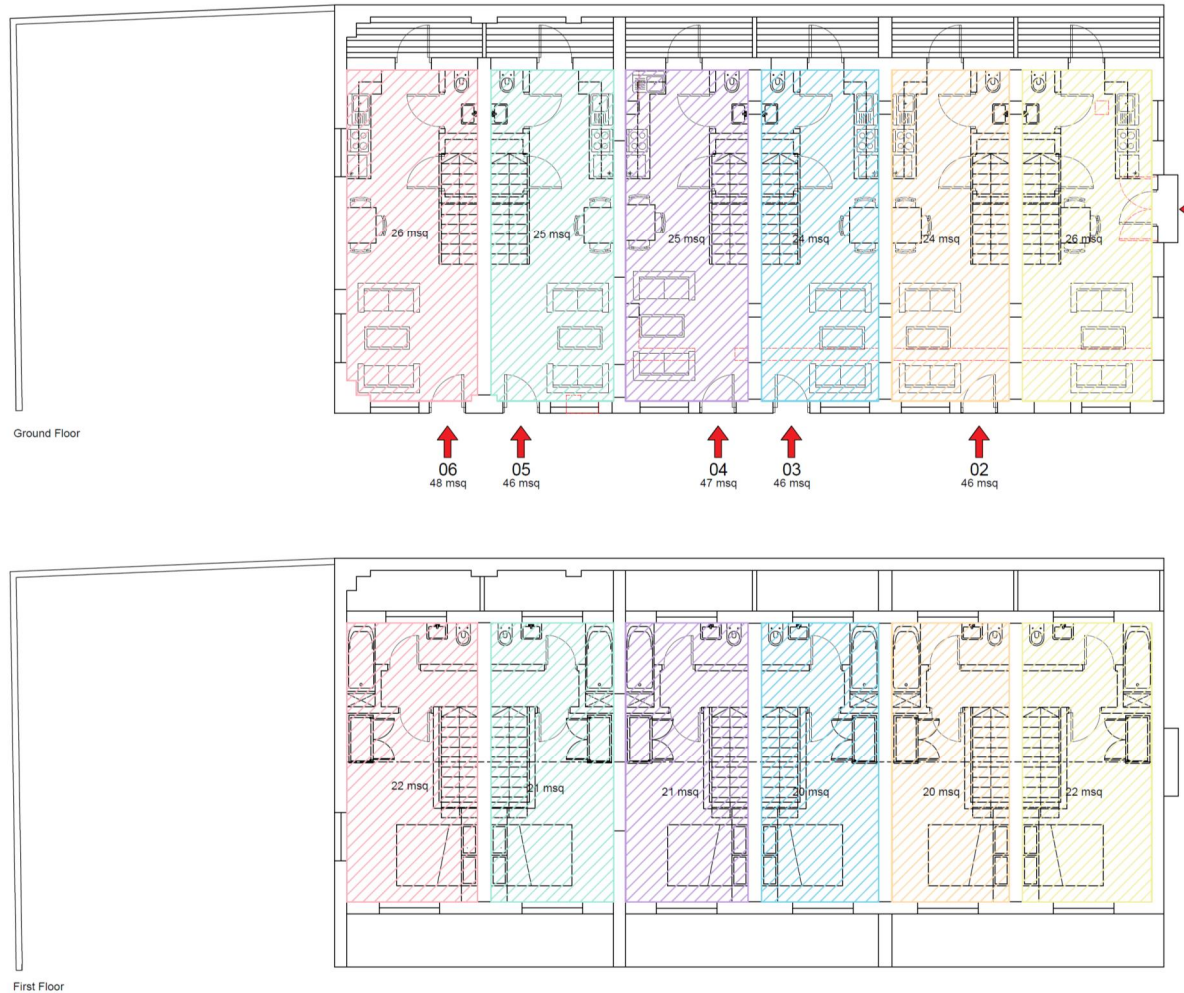
**Figure 3:** Proposed Development Plan

The existing building is proposed to be converted into six residential dwellings. Small areas of decking are proposed on the ground floor of each of the properties with pocket gardens on the roof level.

It is understood that the existing rear yard area will remain as an area of hardstanding.

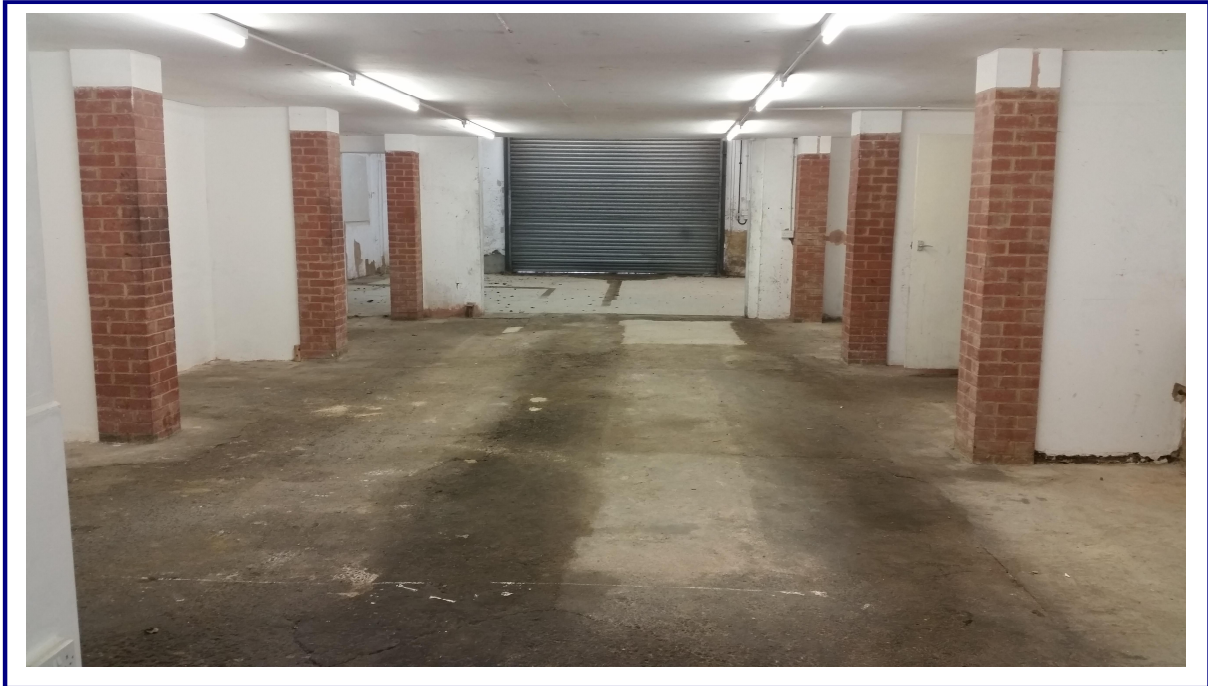
| Section | Description |
|---|---|
| <i>Activity Operations:</i> | The site was vacant at the time of the walkover (see Appendix B, Photo 1). The site representative advised RPS that the site had previously been used as a church hall and, more recently, to store vehicle parts. |

Photo 1: Internal area of building.

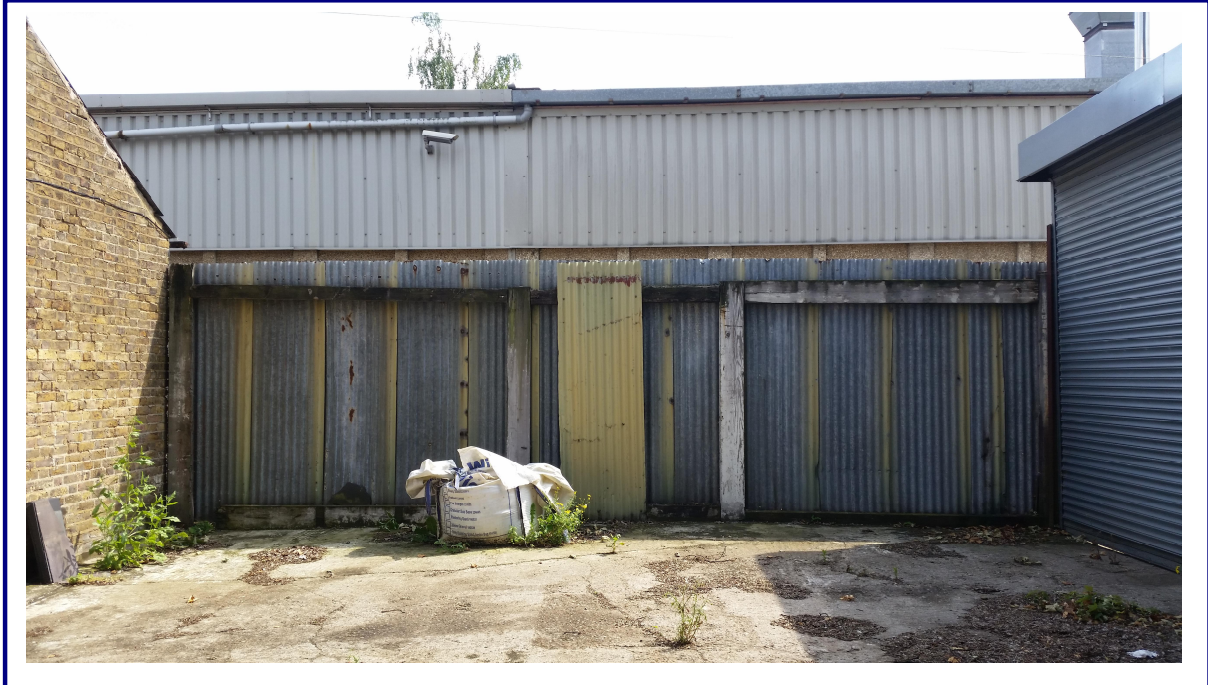
| Section | Description |
|---|---|
| <i>Waste:</i> | The building was vacant at the time of the walkover and no waste streams associated with the site were observed to be present. A one ton bag containing sand was present in the south of the yard area (see Appendix B, Photo 2). |

Photo 2: Yard area to the west of the building.
