**STAGE 1 TIER 1 PRELIMINARY GEO-ENVIRONMENTAL RISK ASSESSMENT**

**PROPOSED REDEVELOPMENT:**

**ASHBY FARM, DUCKS HILL ROAD, NORTHWOOD HA6 2SS**

**Report ref:** **11079/JW(Rev1)**

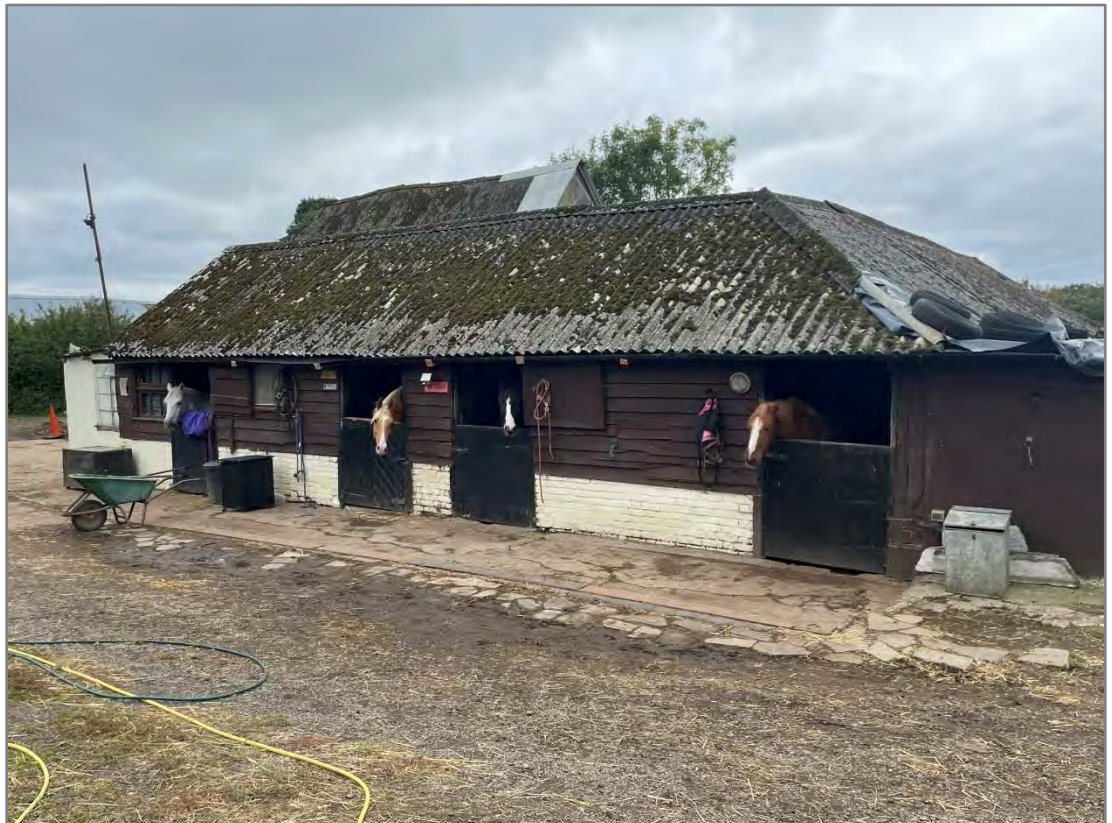
**Photo No 6**

**Description:**  
Stables

Waste storage	✚ Skip within south-western corner containing unidentified burnt waste (Photo 18). other items present within a heap adjacent including carpets, wood and corrugated asbestos-cement roof panels (Photo 19).
ACMs	✚ All the buildings on site are of pre-2000 construction, and the majority are observed to contain ACM in the form of corrugated asbestos-cement roof panels (Photos 6 to 12).

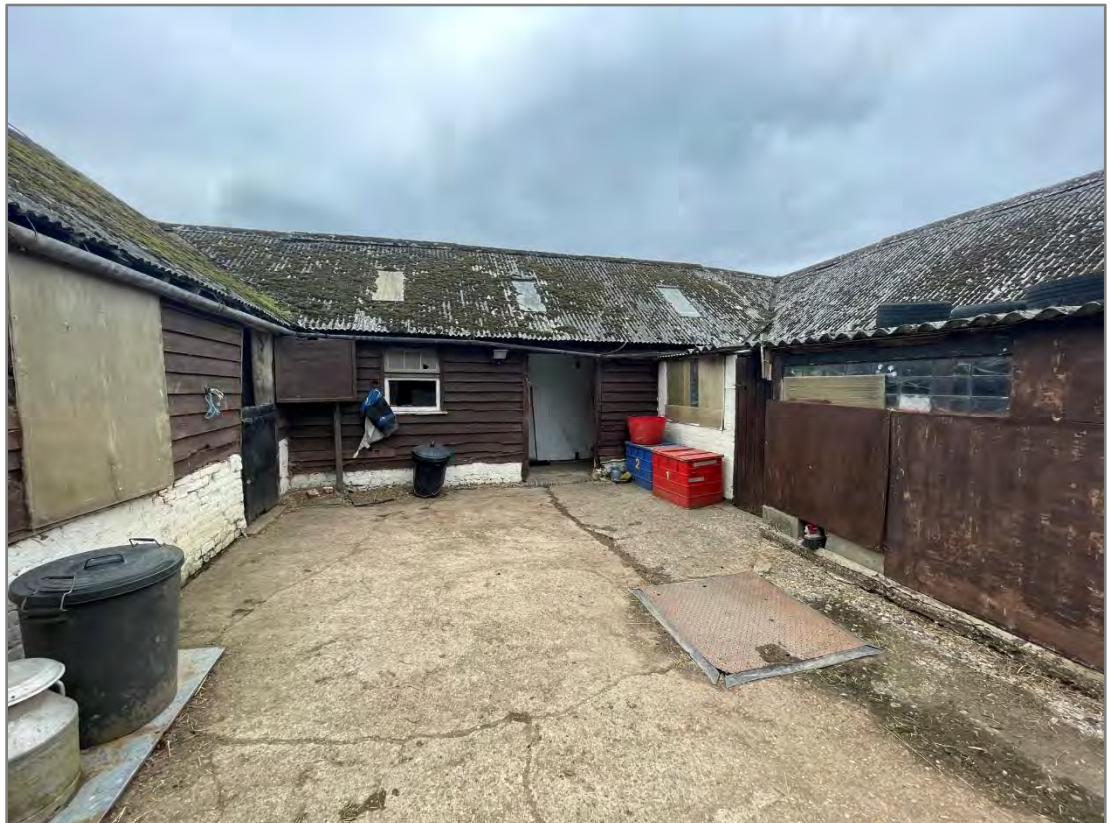
**Photo No 8**

**Description:**  
**Stables**

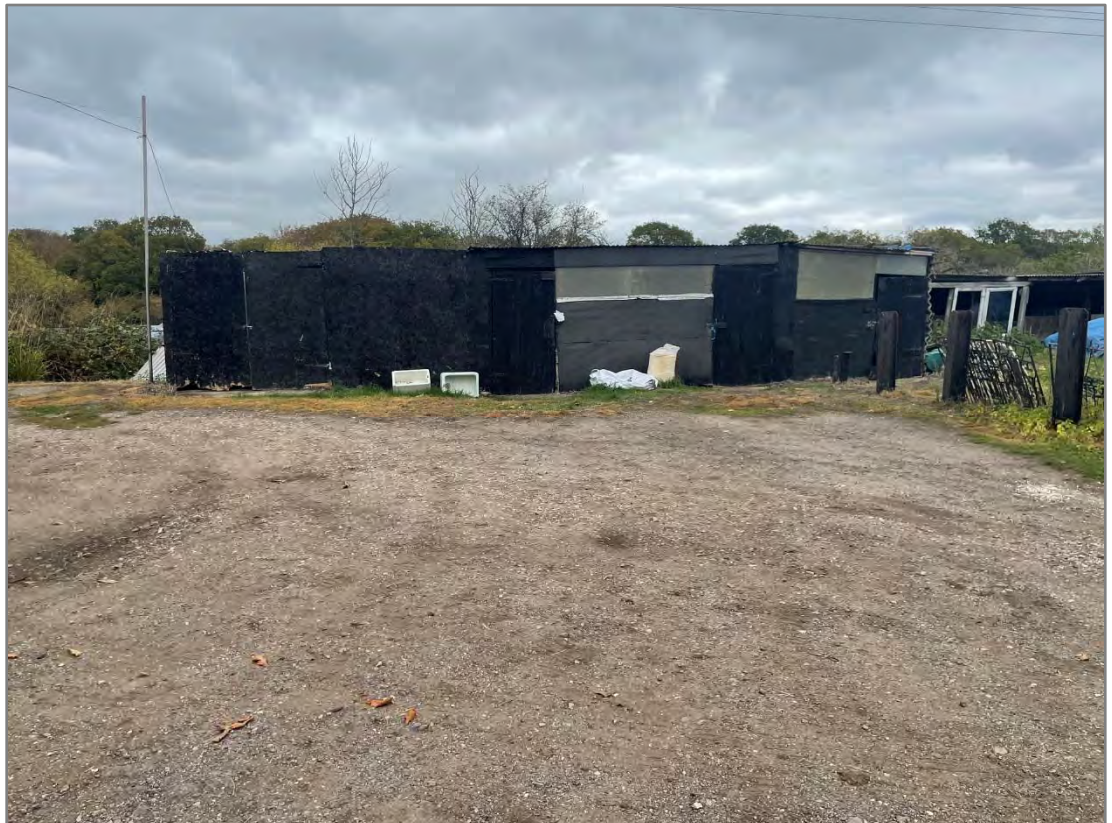
**Photo No 10**

**Description:**  
**Disused stables**

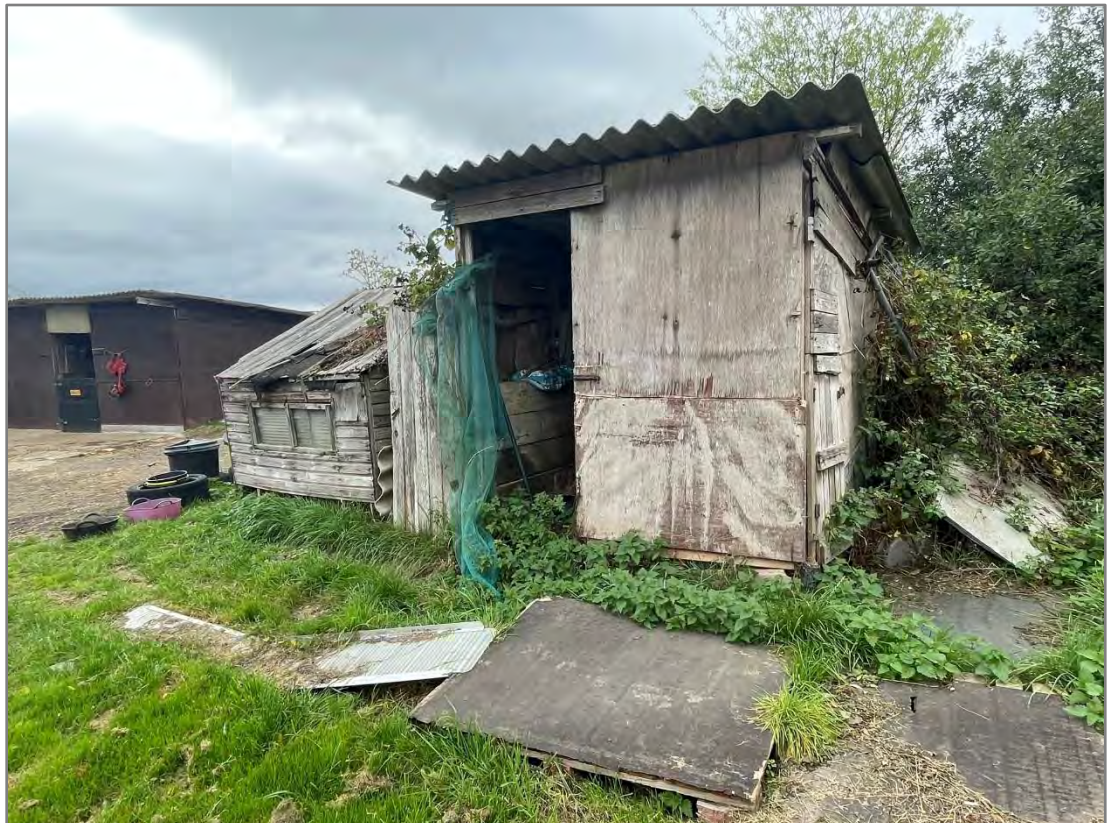
**Photo No 12**

**Description:**  
**Storage shed**

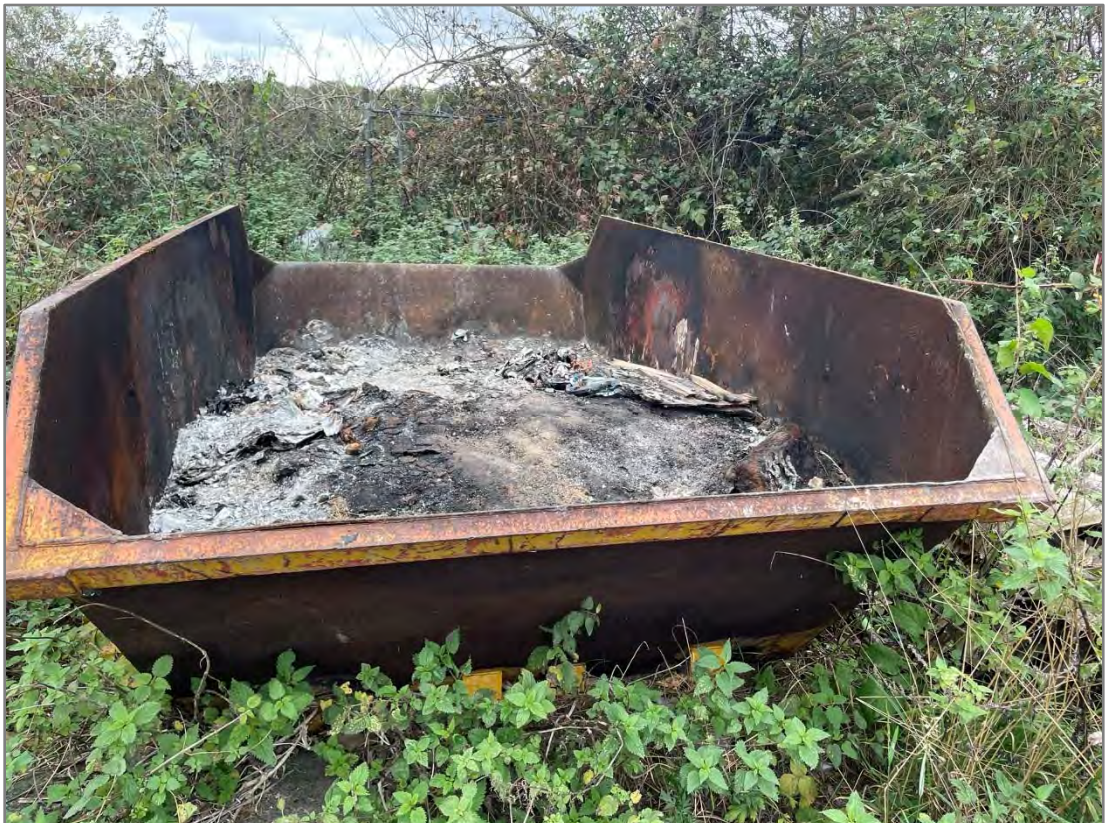
**Photo No 18**

**Description:**  
**Skip**  
**containing**  
**burnt waste**

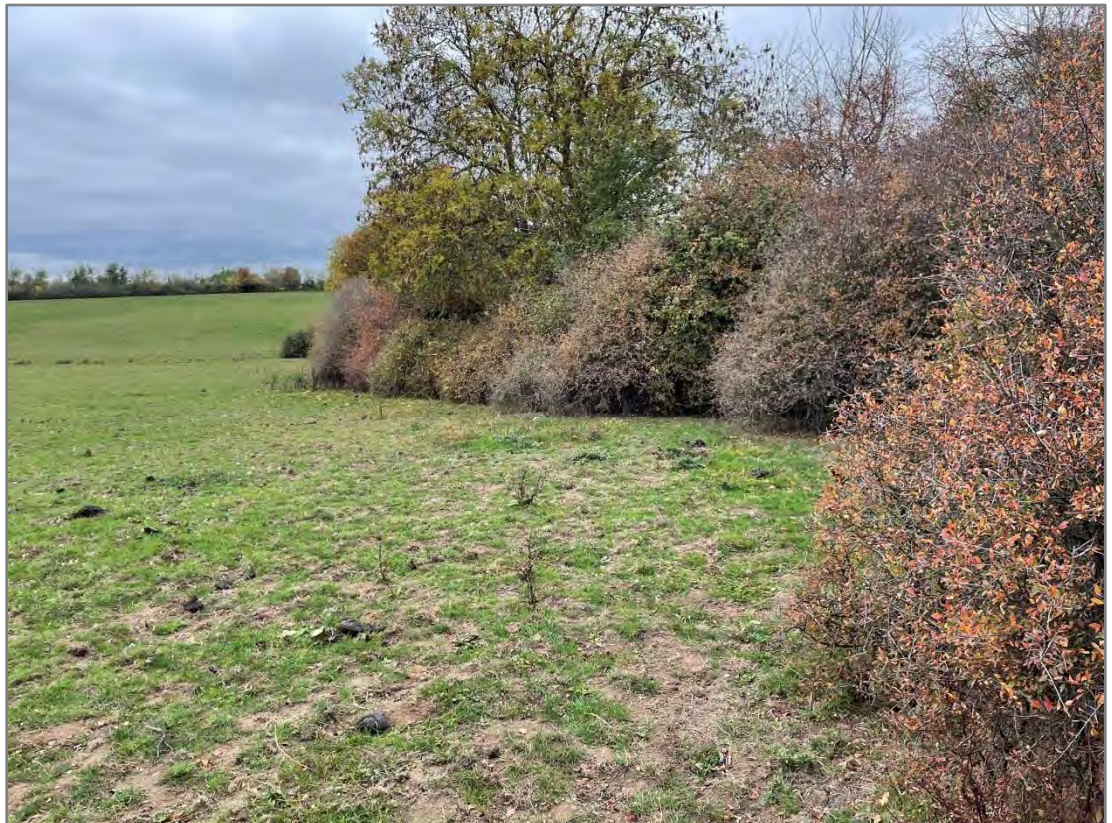
**Photo No 24**

**Description:**  
**Hedgerow**  
**forming the**  
**western 'arm'**  
**of the site**

Element	Description
Site location and setting	<ul style="list-style-type: none"> <li>✚ Located on the western side of Ducks Hill Road, within a rural area about 2km south-west of Northwood town centre.</li> <li>✚ NGR 507655E, 189995N at its centre.</li> </ul>
Site dimensions	<ul style="list-style-type: none"> <li>✚ The site is irregular in shape, measuring about 115m (E-W) x 45m (N-S) at its centre.</li> </ul>
Site boundaries	<ul style="list-style-type: none"> <li>✚ The majority of the site is bounded by a mixture of hedgerows and fences with fields and areas of dense brambles beyond (Photos 1 to 3).</li> <li>✚ The northern boundary falls within the northern part of the existing farm and comprises a mixture of fence lines, grassed areas and groups of trees/shrubs, with a dilapidated farmhouse and fields beyond (Photo 4).</li> </ul>
Site description	<ul style="list-style-type: none"> <li>✚ The site comprises an operational livery yard and adjacent field/paddock.</li> <li>✚ The main yard forms the eastern half of the site and comprises a timber framed barn at its centre (Photo 5) surrounded by a number of other barns, stable buildings, sheds and ancillary structures (Photos 6 to 12); a single-track concrete access road connects the site to the A4180 at its eastern extent (Photo 13). The existing surfacing generally comprises concrete hardstanding at its centre, with a mixture of unmade ground and soft-scaping around the periphery.</li> <li>✚ The majority of the buildings have suspected Asbestos Sheet (ACMs) roof construction with several of the smaller ancillary structures also utilising this material as external wall cladding. While the central barn structure and stables generally appear to be in satisfactory structural condition, some of the ancillary structures are disused and in a state of dilapidation/disrepair.</li> <li>✚ The southern periphery of the site contains a number of storage containers, horse boxes and vehicles (Photo 15 and 16).</li> <li>✚ A manure heap is present at its western end of the main yard (Photo 17) and an area of general waste storage at its south-western corner, containing a skip of burnt waste (Photo 18) and other disused/discarded items including timber, carpets and ACM panels (Photo 19).</li> <li>✚ General items/materials pertaining to the sites use as a livery yard are present throughout including bins/containers (generally containing feed), tools/machinery, tyres and waste wood/pallets. No obvious fuel/chemical storage or containers were observed within the accessible areas.</li> <li>✚ The western half of the site comprises a field/paddock (Photos 20 to 22), with a manège within its north-eastern corner (Photo 23). An elongated section of hedgerow extends from its north-western corner, which forms a western 'arm' to the wider site (Photo 24).</li> </ul>

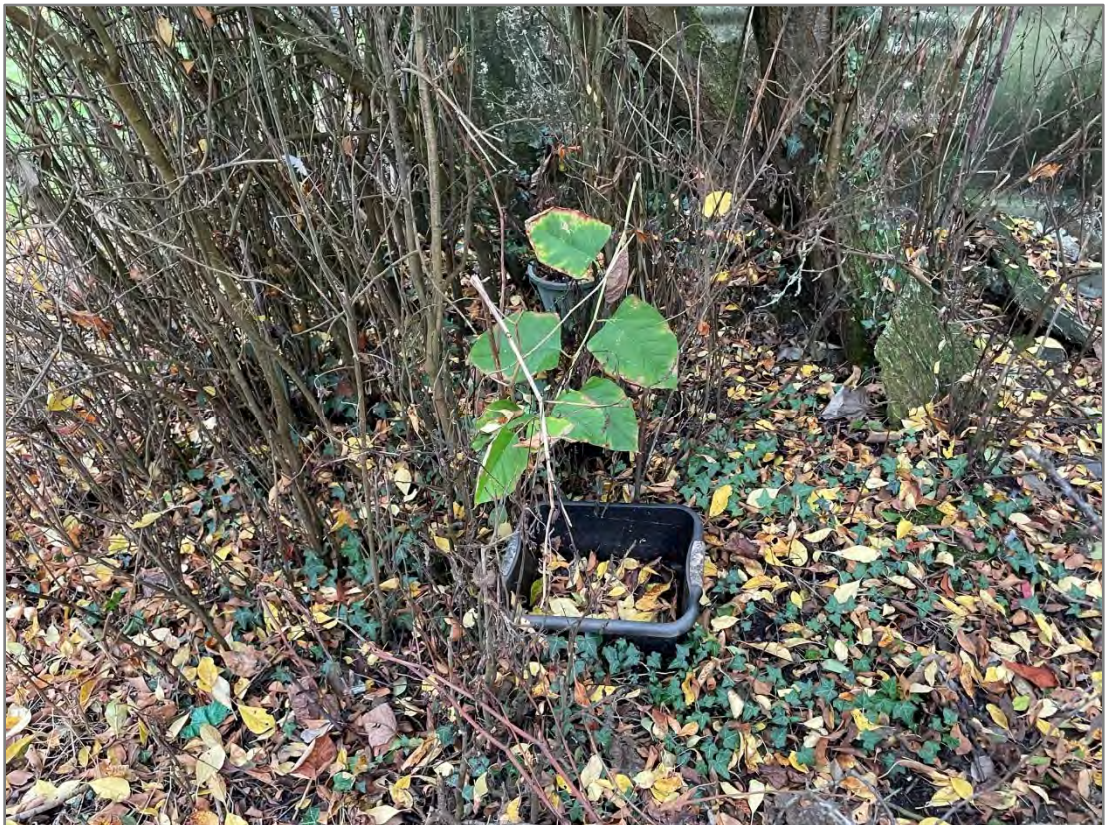
**Photo No 26**

**Description:**  
**Japanese**  
**Knotweed**

A Japanese Knotweed infestation has been noted immediately to the north of the site. While not currently identified within the site boundaries, this invasive species can quickly spread and can cause significant delays and cost to development as well as structural damage. Thus, we recommend that, where identified, full remediation should be undertaken by suitably qualified professional/specialists prior to construction. Any intrusive investigation works must be undertaken a suitable distance from any known Japanese Knotweed infestation; typically, 5m is considered acceptable.

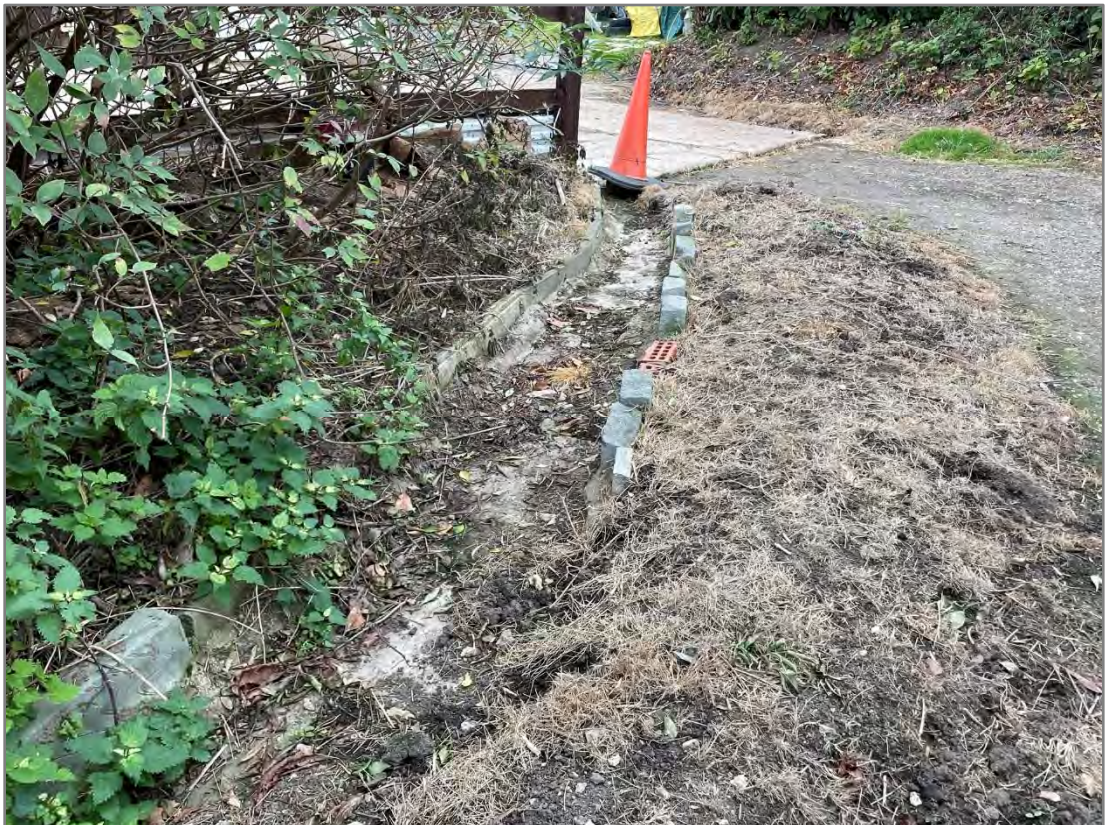
**Photo No 28**

**Description:**  
**Drainage**  
**channel**

Feature	Commentary
Electricity substations and transformers	<ul style="list-style-type: none"> <li>✚ None observed</li> <li>✚ Groundsure data indicates the nearest recorded energy feature to be &gt;500m from site.</li> </ul>
Fuel storage tanks	✚ None observed.
Fuel interceptors	✚ None observed.
General chemical storage/waste	✚ No readily identifiable chemical storage/waste.
Invasive species	✚ Infestation of Japanese Knotweed is recorded around the perimeter of the farmhouse immediately north of the site boundary (Photos 25 and 26). Another small infestation is recorded within a small area NE of the central barn; however, no obvious signs of Knotweed were observed.
Evidence of gas protection	✚ None observed.
Surface water contamination	<ul style="list-style-type: none"> <li>✚ No surface/pooled water were observed; however, drinking troughs were present</li> <li>✚ Concrete drainage channels and ditches were noted on site; however, these were observed to be either dry, blocked/infilled or densely overgrown (Photos 27 and 28).</li> </ul>
