## **Main Investigation Report**

**Haydon Drive, Pinner, London Borough of Hillingdon HA5 2PW**

**Philip Pank Partnership LLP**

**Reference: 21724/MIR Rev1.0**

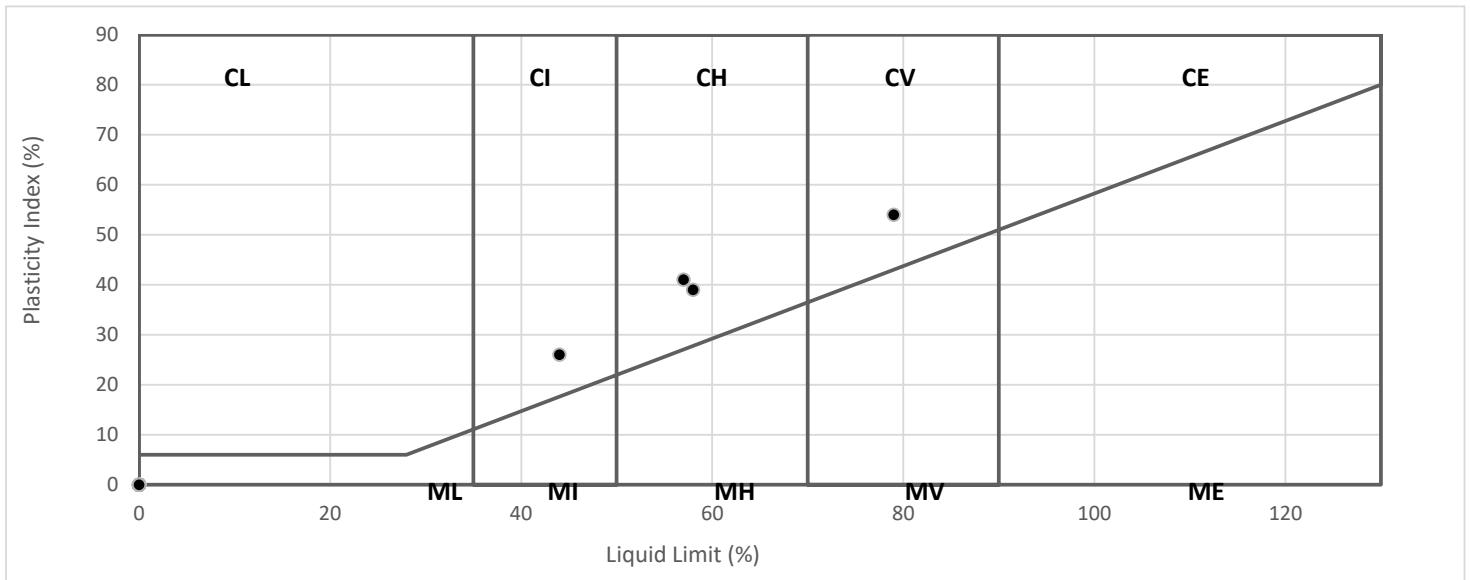
# PLASTICITY CHART FOR CASAGRANDE CLASSIFICATION

## BS 5930:2015+A1:2020

Cohesive soils of the Weathered Lambeth Group were noted to have plasticity index >20%, therefore and in accordance with Road Research Laboratory LR90, are expected to be **non-frost-susceptible**.

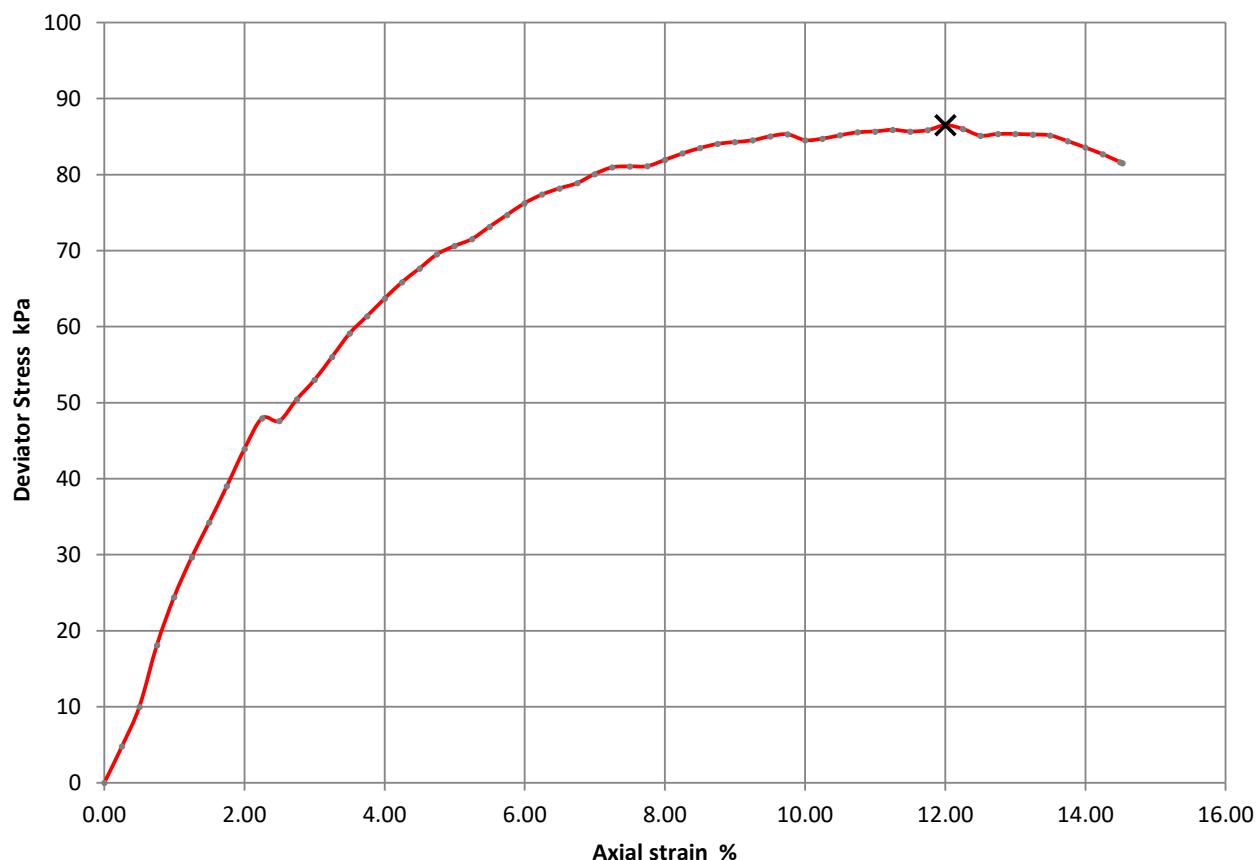
Moisture Content (%)	25
Bulk Density (Mg/m <sup>3</sup> )	1.88
Dry Density (Mg/m <sup>3</sup> )	1.50
Specimen Length (mm)	207.2
Specimen Diameter (mm)	104.2
Cell Pressure (kPa)	30
Deviator Stress (kPa)	87
Undrained Shear Strength (kPa)	43
Failure Strain (%)	12
Mode Of Failure	Compound
Membrane Used/Thickness	Rubber/0.4mm
Rate of Strain (%/min)	1.33

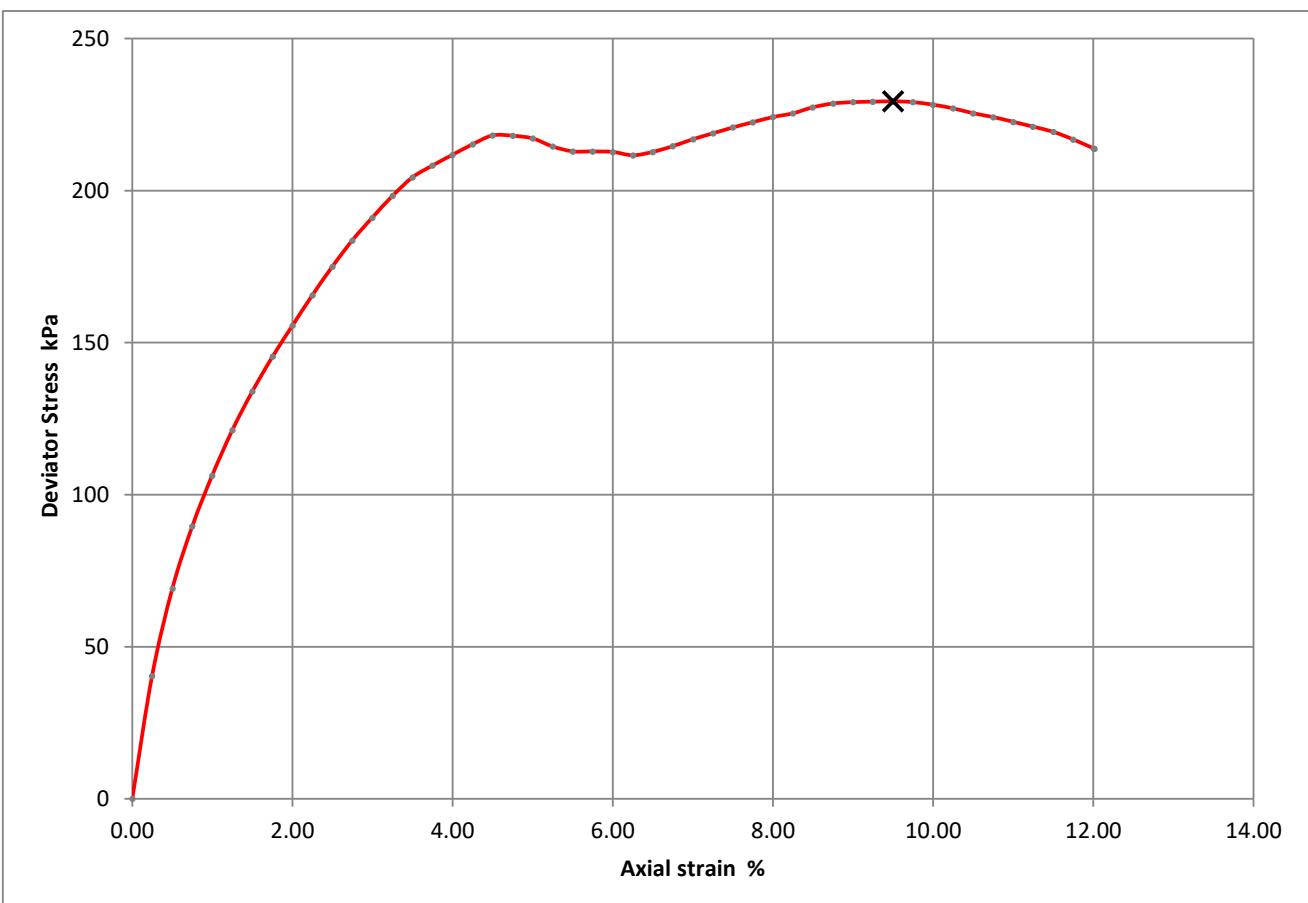
**Single Stage Unconsolidated-Undrained Triaxial Test  
BS 1377 : 1990 Part 7 : 8**

Project Name	Haydon Drive	Sample No.	
Soil Description	Grey/brown silty CLAY	Depth Top (m)	14.50
Date Tested	28/01/2025	Depth Base (m)	
		Sample Type	U
		Operator	David Edwards

Moisture Content (%)	19
Bulk Density (Mg/m <sup>3</sup> )	2.06
Dry Density (Mg/m <sup>3</sup> )	1.73
Specimen Length (mm)	209.3
Specimen Diameter (mm)	104.3
Cell Pressure (kPa)	290
Deviator Stress (kPa)	229
Undrained Shear Strength (kPa)	115
Failure Strain (%)	10
Mode Of Failure	Compound
Membrane Used/Thickness	Rubber/0.4mm
Rate of Strain (%/min)	1.31

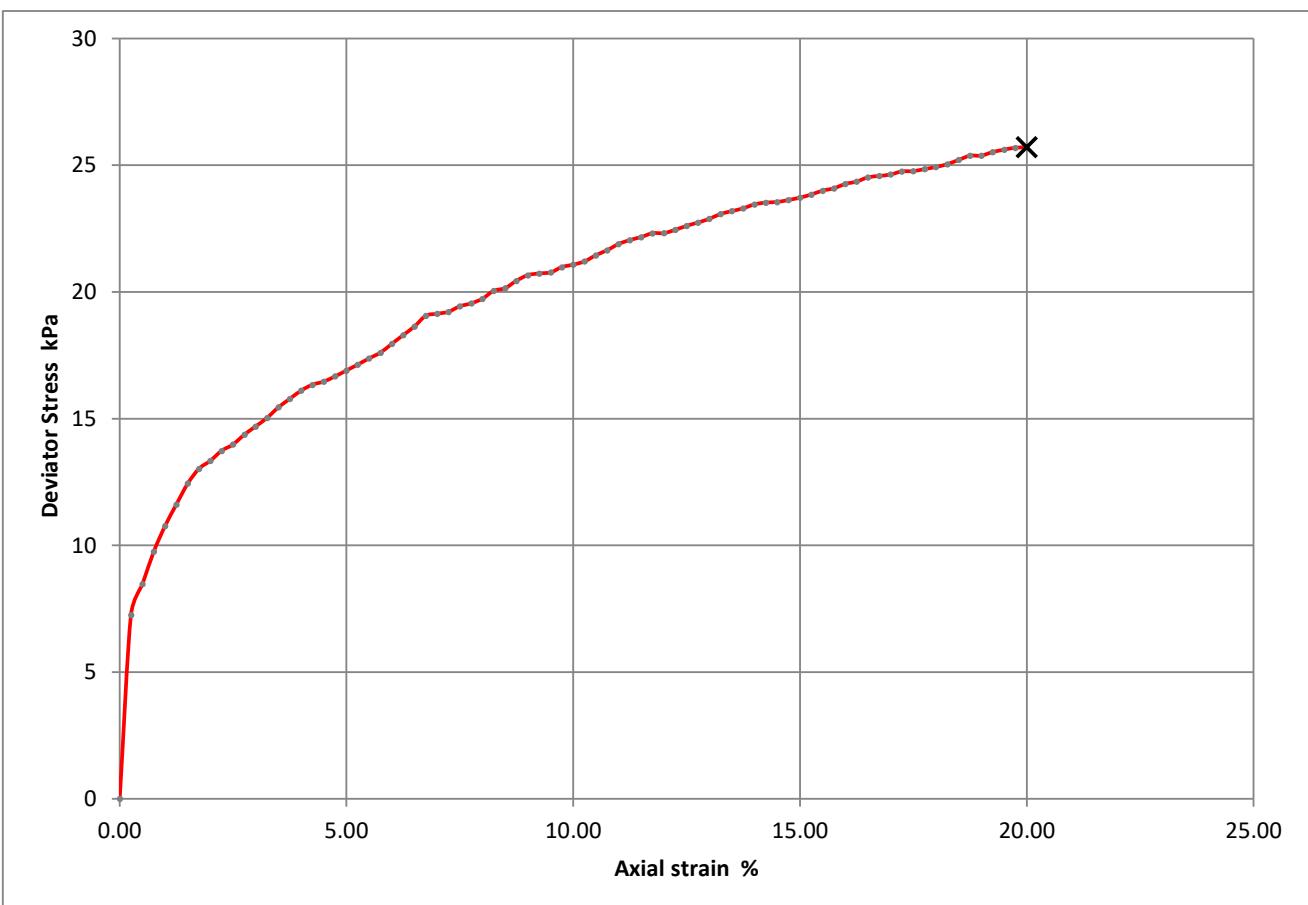
**Single Stage Unconsolidated-Undrained Triaxial Test  
BS 1377 : 1990 Part 7 : 8**

Project Name	Haydon Drive	Sample No.	
Soil Description	Brown silty sandy CLAY	Depth Top (m)	10.50
		Depth Base (m)	
Date Tested	28/01/2025	Sample Type	U
		Operator	David Edwards

Moisture Content (%)	27
Bulk Density (Mg/m <sup>3</sup> )	1.92
Dry Density (Mg/m <sup>3</sup> )	1.51
Specimen Length (mm)	204.3
Specimen Diameter (mm)	102.3
Cell Pressure (kPa)	210
Deviator Stress (kPa)	26
Undrained Shear Strength (kPa)	13
Failure Strain (%)	20
Mode Of Failure	Plastic
Membrane Used/Thickness	Rubber/0.4mm
Rate of Strain (%/min)	1.35

The strength interpretation was based on the classification outlined in Table C.2.2. An untypically low value of 13kPa was recorded at 10.5m bgl in BH2; based on the sample description it was the only sample submitted for QUU testing where sandy bands were noted within the clay structure, therefore it could be attributed clay softening due to water perched within the more permeable water-bearing sandy horizons. It must be mentioned that the above finding was in alignment with Section 2.3.3 based on which, a band of soft brown slightly mottled grey sandy CLAY was recorded at circa 10.5m-11.0m bgl in BH2.

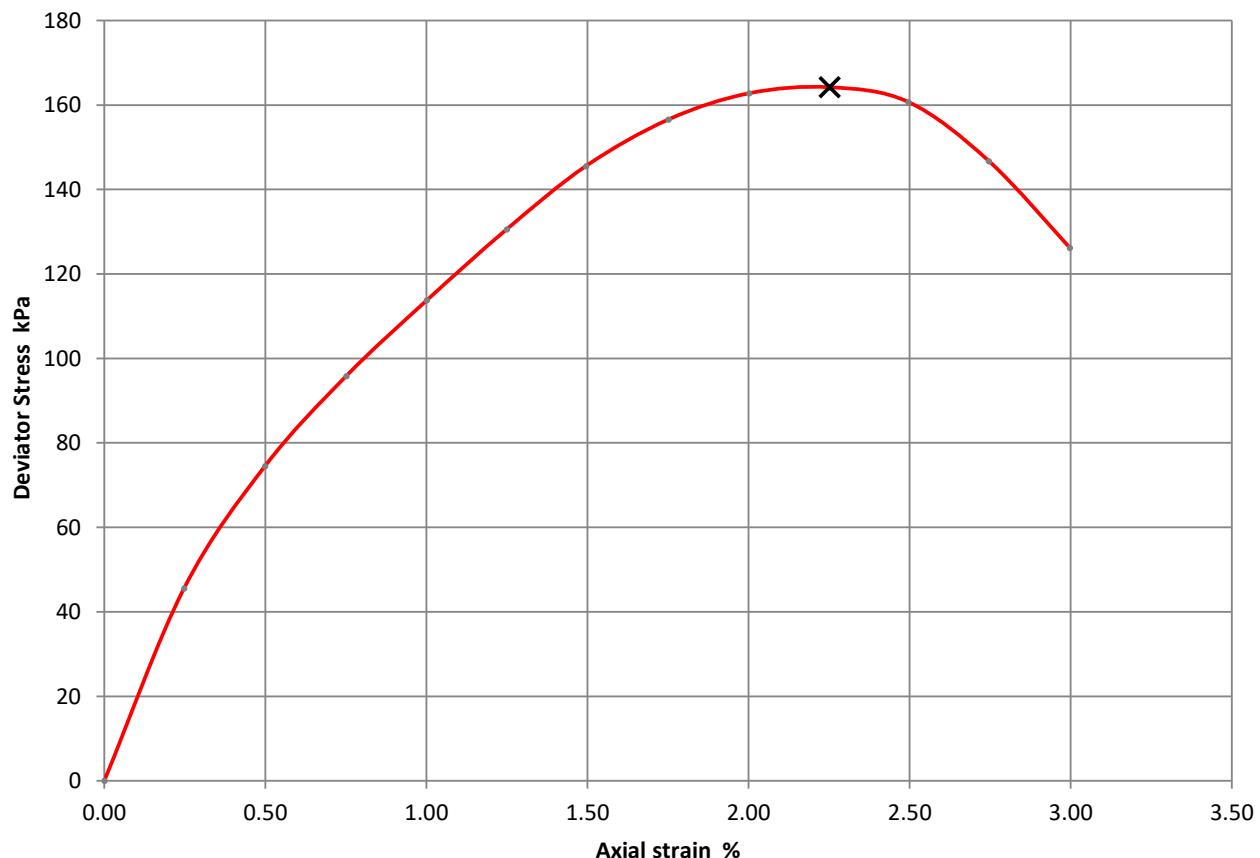
**Single Stage Unconsolidated-Undrained Triaxial  
Test  
BS 1377 : 1990 Part 7 : 8**

Contract Number	76728
Borehole/Pit No.	<u>BH2</u>
Project Name	Haydon Drive
Soil Description	Grey/brown silty CLAY
Date Tested	28/01/2025
Sample Type	U
Operator	David Edwards

Moisture Content (%)	25
Bulk Density (Mg/m <sup>3</sup> )	2.01
Dry Density (Mg/m <sup>3</sup> )	1.61
Specimen Length (mm)	208.3
Specimen Diameter (mm)	104.3
Cell Pressure (kPa)	100
Deviator Stress (kPa)	164
Undrained Shear Strength (kPa)	82
Failure Strain (%)	2
Mode Of Failure	Compound
Membrane Used/Thickness	Rubber/0.4mm
Rate of Strain (%/min)	1.32

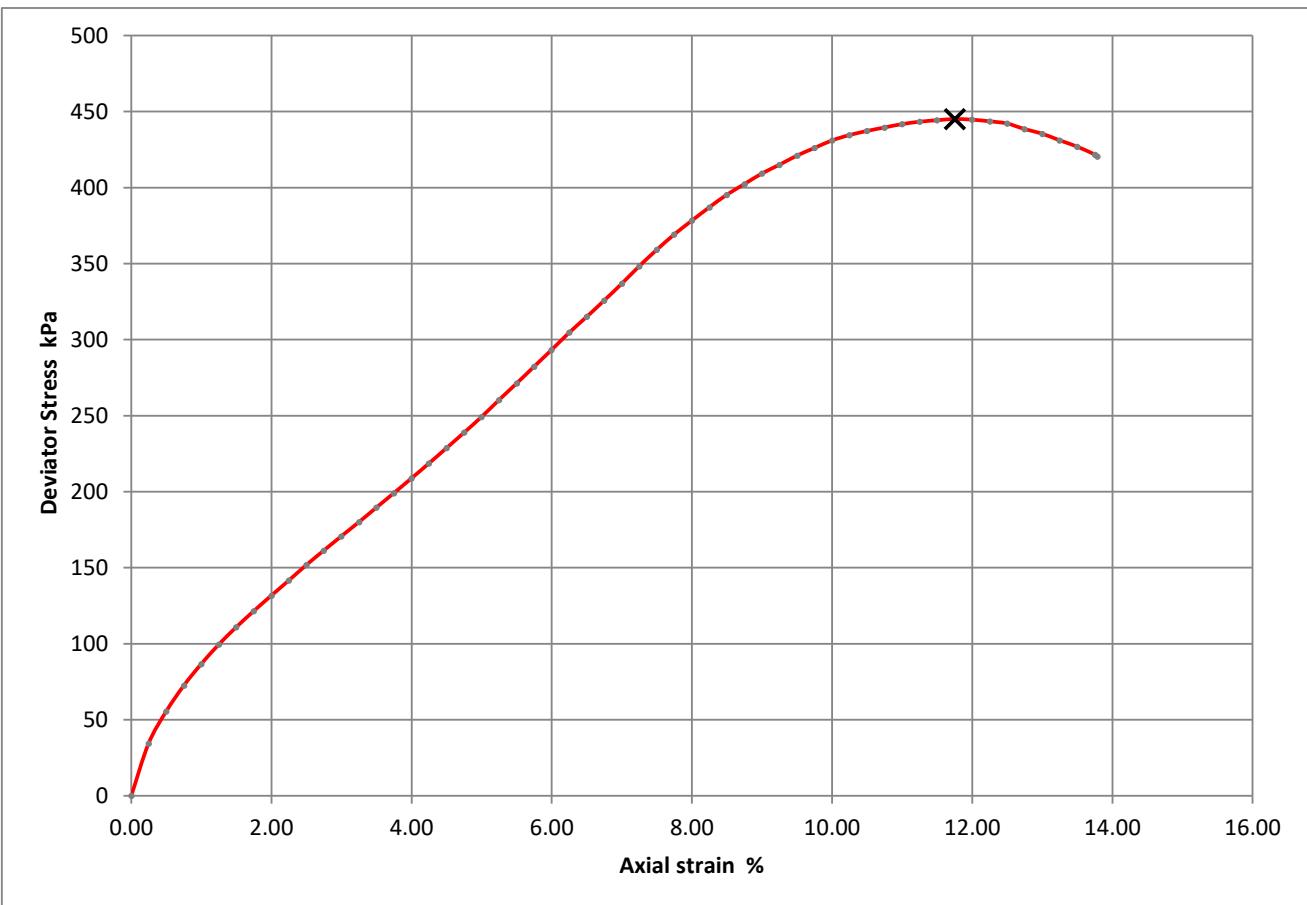
**Single Stage Unconsolidated-Undrained Triaxial  
Test  
BS 1377 : 1990 Part 7 : 8**

Project Name	Haydon Drive		Sample No.	
Soil Description	Grey/brown silty CLAY		Depth Top (m)	12.00
			Depth Base (m)	
Date Tested	28/01/2025		Sample Type	U
			Operator	David Edwards

Moisture Content (%)	15
Bulk Density (Mg/m <sup>3</sup> )	2.12
Dry Density (Mg/m <sup>3</sup> )	1.84
Specimen Length (mm)	204.5
Specimen Diameter (mm)	104.2
Cell Pressure (kPa)	240
Deviator Stress (kPa)	445
Undrained Shear Strength (kPa)	223
Failure Strain (%)	12
Mode Of Failure	Plastic
Membrane Used/Thickness	Rubber/0.4mm
Rate of Strain (%/min)	1.34

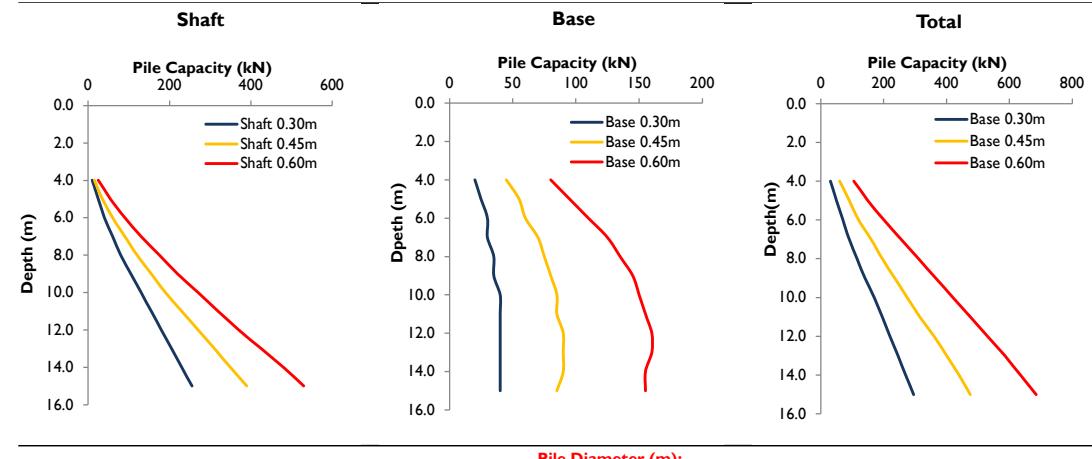
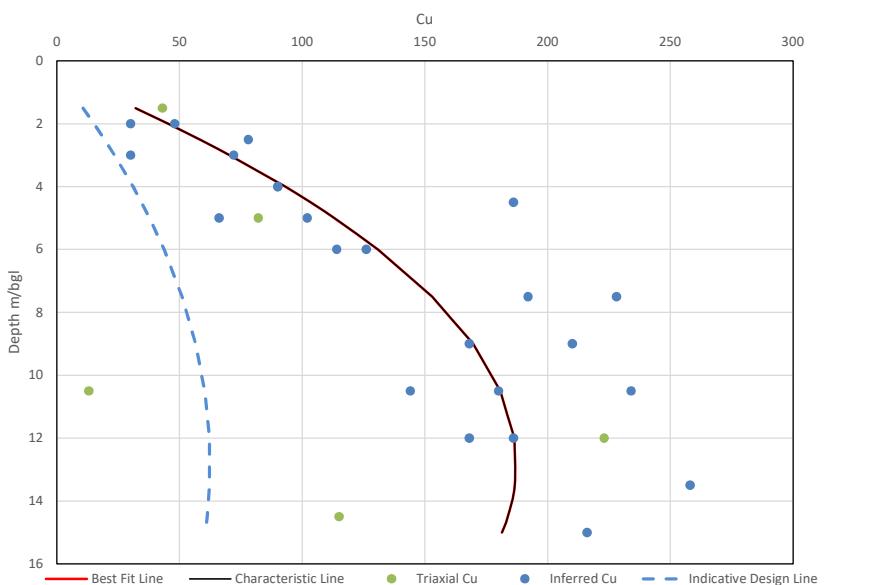
Preliminary Pile Working Loads  
Single Vertically Loaded Pile (kN)

Name:	<u>NS</u>	$N_c$ value	9	Pile Start Depth:	3	FOS
Job No:	21724	$\alpha$ value:	0.45	Pile Final Depth:	15	Shaft Base
Date:	10.2.25			Pile Increment:	1	3 3

The bearing values given in Appendix D.1. are applicable to single vertically loaded piles. Where piles are to be constructed in groups the bearing value of each individual pile should be reduced by a factor of about 0.8 and a calculation made to check the factor of safety against block failure.
