Arboricultural method statement to install a root barrier

POLICY HOLDER ADDRESS: 31 Copse Wood Way, Northwood, Harrow. HA6 2TZ
CLIENT REFERENCE: QG1S1210326
OUR REFERENCE: 7962
PROJECT MANAGER: Paul Milliam

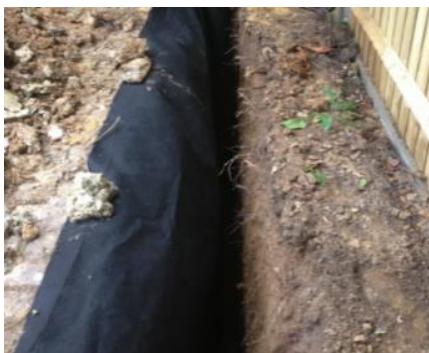
This solution is multipurpose and ideally suited to the current application. Traditional impervious barriers divert rather stop roots and may block moisture movement. Also, roots getting under such barriers can grow back to the surface. Therefore, the use of this permeable barrier stops roots either by engaging and constricting them or by chemically inhibiting them.

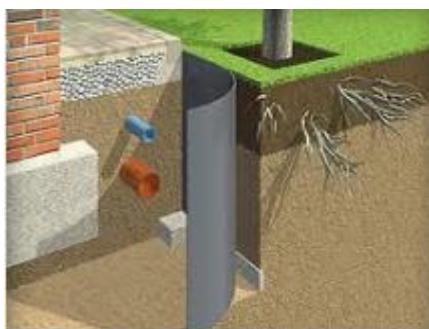
The benefits of such a shield are its dual protection both physical and biological. The multi layered sheets can be welded together whilst retaining its flexible qualities, i.e. can be cut and effectively resealed to fit round services and foundations, inert with a 60 year service life expectancy. Equally the solution inhibits root growth on the barrier face which is often problematic with conventional barriers where increased moisture levels can cause root growth to become more prolific on the face of a traditional barrier. Research has shown that the use of the recommended style of copper based screening has greatly reduced the effects of root growth when compared to other traditional physical barrier installations

Following the installation of the shield the trench will be backfilled and compacted mechanically with 20mm single sized stone. Alternatively, dependent upon site conditions backfill using lean mix concrete will be utilised on the structure side of the shield. On occasions some natural settlement is anticipated following completion. In all instances the project envisages a return visit to the property to affect any required maintenance of the surface of the reinstatement routinely programmed within 6 months following completion of the installation.
