## Site Investigation Report

**WHC reference: 8447**

Address: 31 Copse Wood Way, Northwood, HA6 2TZ

William Hunt Consulting were commissioned by Quest Gates to carry out a site investigation within the area of concern, located at the front elevation of the property. Site Investigation to consist of 1No. Trial Pit to record presence of roots alongside Root Identification.

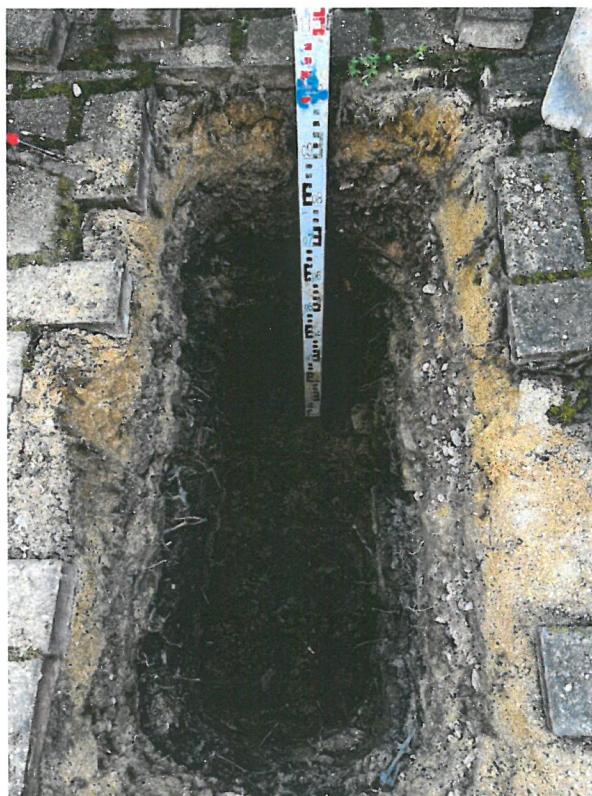
**Photo 3 – Trial Pit 1**

Trial Pit Details can be found in Appendix A, where in trial pit 1, roots were encountered at depths of 0.40m, 0.50m, 0.65m, 0.80m, 0.90m and 1.00m below ground level.

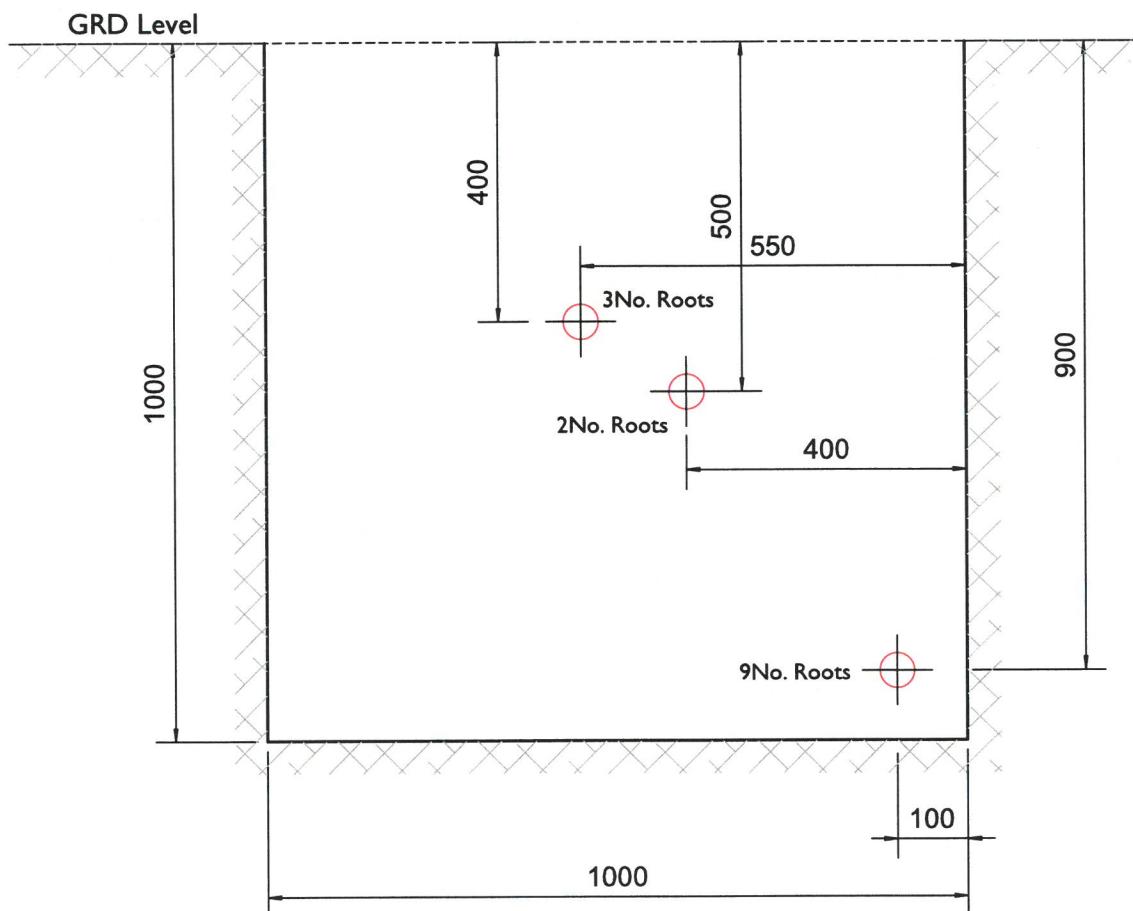
### Left Side Excavation

<b>WILLIAM HUNT</b> CONSULTING
Client Ref:	7962
WHC Ref:	8447
Address:	31 Copse Wood Way, Northwood, HA6 2TZ
Drawn By:	MS
Date:	08/05/2025
Dwg No:	WHC/8447/DC/002

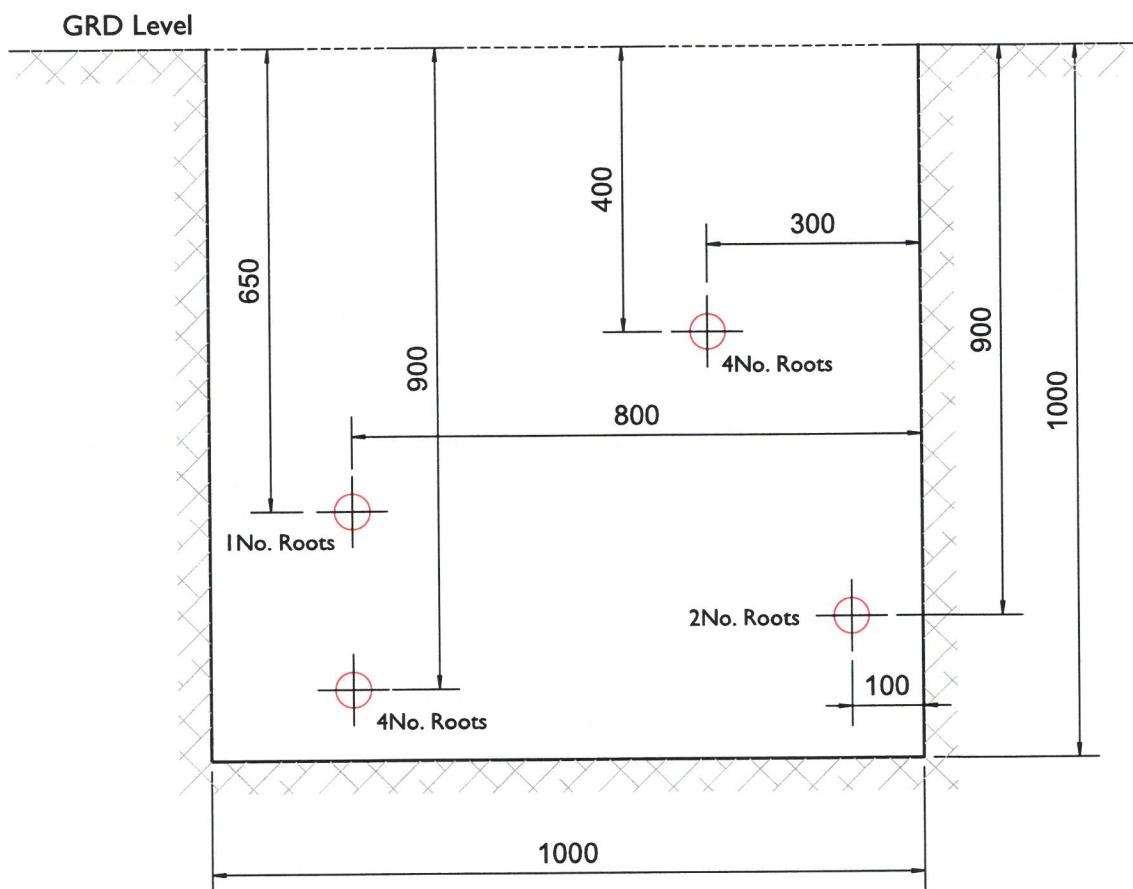
## Right Side Excavation

Client Ref:	7962
WHC Ref:	8447
Address:	31 Copse Wood Way, Northwood, HA6 2TZ
Drawn By:	MS
Dwg No:	WHC/8447/DC/003
