**3 Copse Wood Way  
Northwood  
HA6 2TP**

**Ecology Report focussing on Bats**

**Report Date: 13<sup>th</sup> July 2021**

**Jones & Sons Environmental Sciences Ltd,  
21-23 North Road, Hertford, Herts, SG14 1LN,  
Tel: 01992 552407, E-mail: [reception@jonesandsons.co.uk](mailto:reception@jonesandsons.co.uk)  
[www.jonesandsons.co.uk](http://www.jonesandsons.co.uk)**

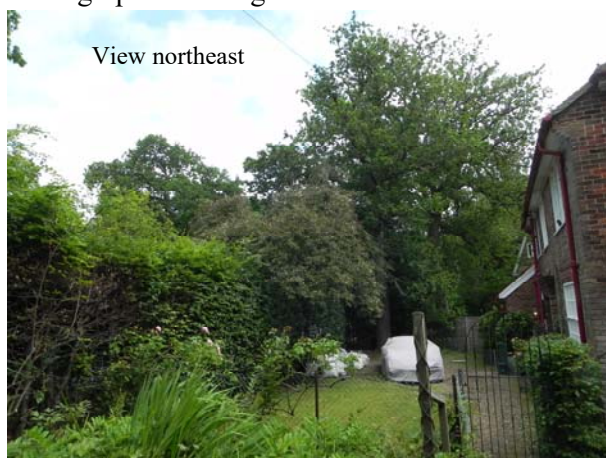
Photograph 1: front garden

The habitats within the garden immediately surrounding the house include: hardstanding (gravel driveway and paving), a conservatory and small shed, fences, lawns of amenity grassland, shrubs, scattered and bordering mature trees.

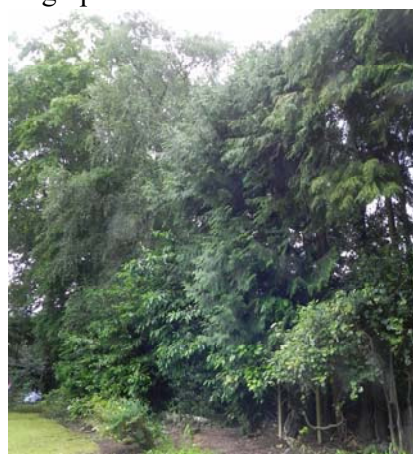
Photograph 2: trees southwest side

Trees along the front roadside include a tall beech hedge and an old oak. Other trees around the property include old oaks and hornbeam (former woodland habitat), an old mature beech, silver birch, cherry, cypress, laurel, yew, apple, elder, willow, holly, hazel and box. The mature trees around the boundary of the property are capable of supporting high concentrations of flying insects of benefit to a variety of bat species. They are regarded as ecological features of high site biodiversity value.

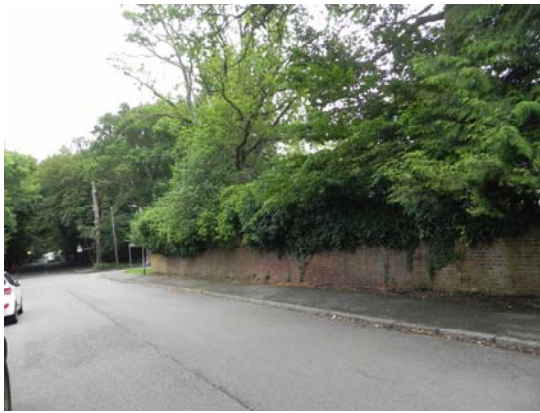
Photograph 5: road view northeast towards broadleaf woodland

The gardens of the residential area include patches of broadleaf woodland to the north and south of Copse Wood Way that provide connecting wildlife corridors (potential bat flight paths) through the area that connect to the Ruislip Woods complex to the south

Approximately 40 metres to the north of the property is an area of broadleaf woodland (known as The Gravel pits) and 140 metres to the northeast is Northwood Golf Club (also with patches of woodland) that provides connectivity to the Ruislip Woods complex.

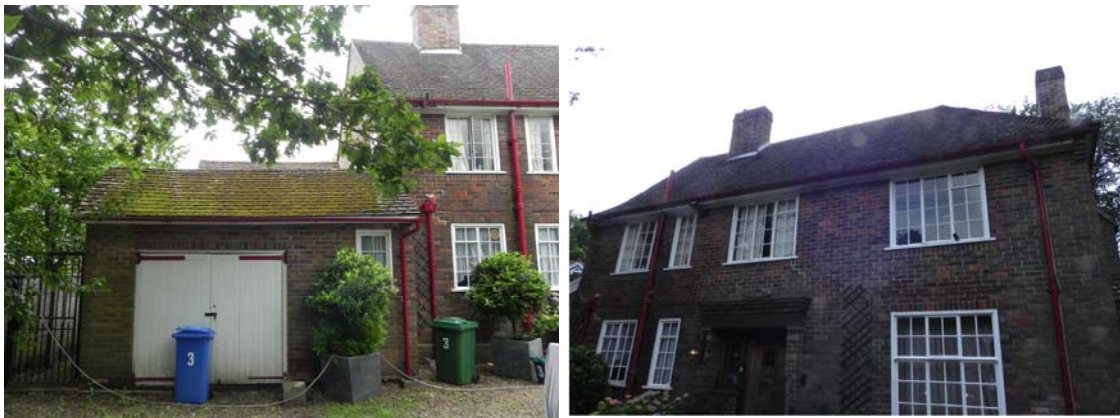
Photograph 6-7: front (northwest) elevation

The two-storey residential house built in the 1930s has red brick walls supporting a pitched tiled roof with a hipped roof to the southwest and gable roof to the northeast.

At the northeast end is a rear lower gabled extension and to the front is an attached single storey garage supporting a flat asphalt covered roof.

The garage has a tiled sloping section along the front and a small mock pitched tiled roof at the north end of the garage.

The house has two brick chimneys with lead flashing; one projecting from the front pitched roof and the other at the side southwest end.

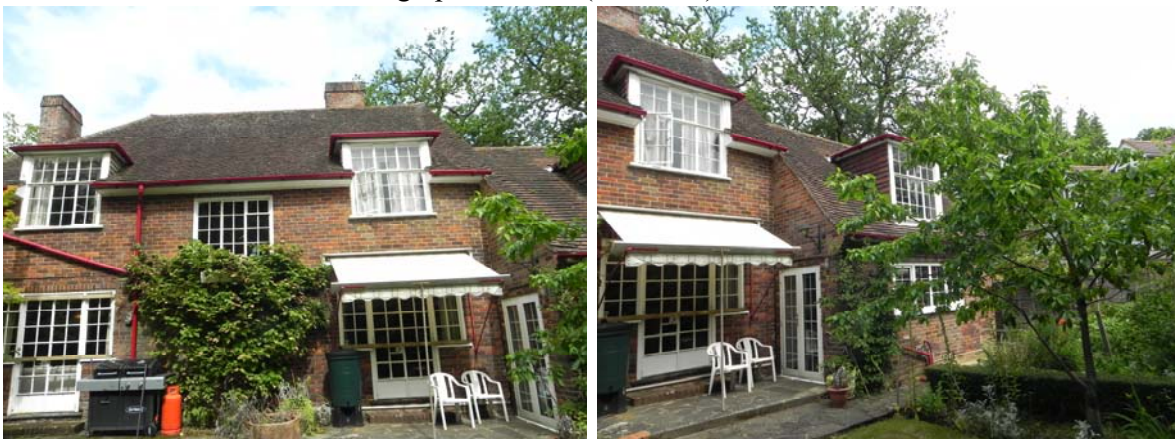
Photograph 8-9: rear (southeast) elevation

Dormer windows are present on the rear elevation of the house and also east extension. There are hanging tiles on the side of the dormer windows.

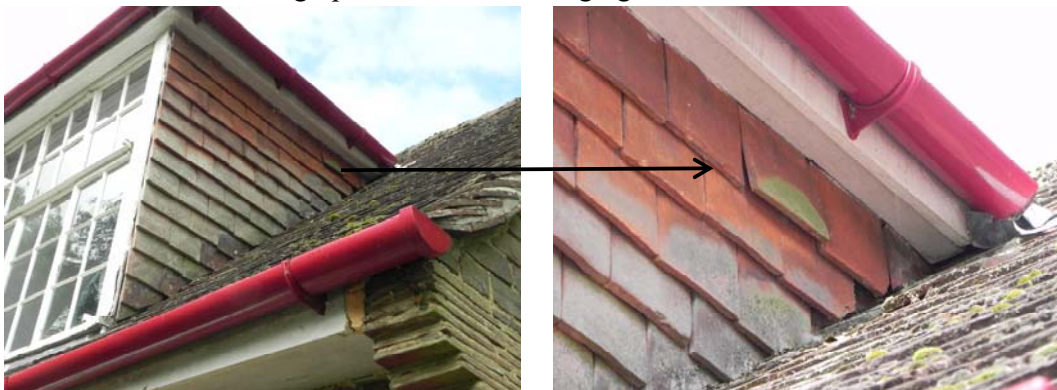
Photograph 12-13: raised hanging tile rear dormer

The exterior inspection of the house found the roof to be in good condition with the ridge and pitch tiles closely fitted together with no obvious openings enabling bat access. One slight gap suitable for bat access was however observed under a hanging tile around the extension dormer window. Using a zoomed in camera the area around the hanging tile was searched for any signs of bat use such as bat droppings but none were observed.

No bat roosting site was identified in the house at 3 Copse Wood Way and the house is assessed as supporting negligible suitability for roosting bats. However, although the house was generally considered unsuitable for roosting bats a raised hanging tile was identified at the side of the rear dormer that potentially could enable bat access at a future time. Since bat roosts can be of a transient nature a cautious approach to the development is recommended. Prior to complete demolition, it is recommended that the hanging tiles on the dormer windows are removed under the supervision of the bat ecologist.

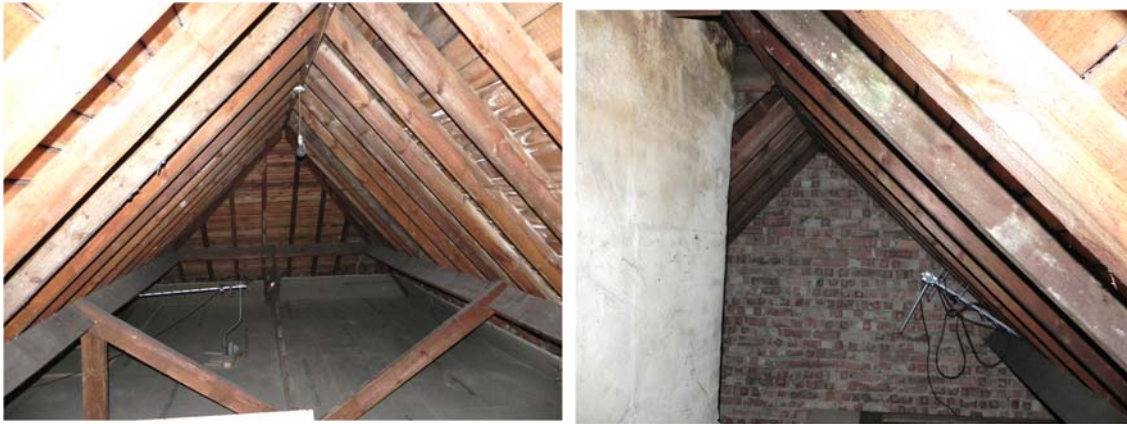
Photograph 14-15: loft view southwest and northeast

Inside the house there is a tall timber-framed loft along the full length of the house with a brick wall at the northeast end. The loft has an internal height of 2.3 metres and

provides warm dark conditions suitable for bats. The loft is however well sealed with no openings into the interior enabling potential bat access. The roof tiles are lined by sarking boards and the close inspection found the boards to be tight against the roof tiles with limited potential for bats to roost within the crevices between the tiles and felt boards.

No bats or any signs of bat use (such as droppings or bitten insect wings) were found during the search of the loft interior and taking account of the sealed nature, the loft is assessed as supporting negligible potential for roosting bats. The only feature of the house with potential for roosting bats is the raised hanging tile on the side of the dormer. It is however considered that while presence cannot be completely discounted, due to the limited number of features likely to be used by roosting bats, any bat presence of roosting bats in the house is considered unlikely.
