**62 BROADWOOD AVENUE, RUISLIP
MIDDLESEX**

PRELIMINARY ROOST ASSESSMENT

A Report to: The Drawing Room (London) Ltd

Date: May 2024

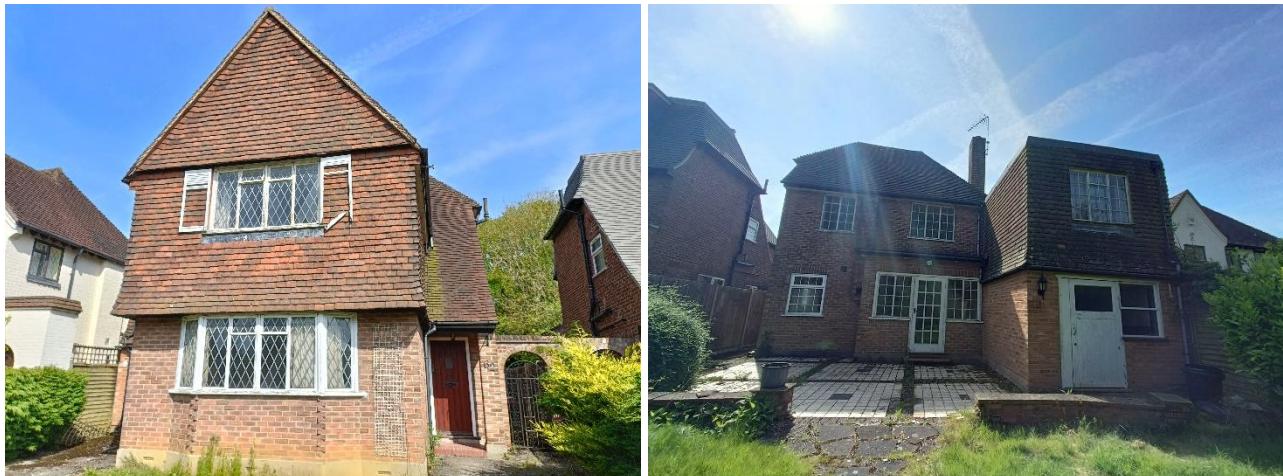
The vacant dwelling on site is a detached, two-storey, red brick building, with a part-pitched, part-hipped roof, covered by clay tiles. A two-storey extension with a flat roof is located to west. The upper storey of the dwelling is covered by clay hanging tiles. The brickwork is in good condition with no cracks, areas of missing mortar or holes present suitable for roosting bats.

Figure 2. View of the front and rear elevations of the dwelling

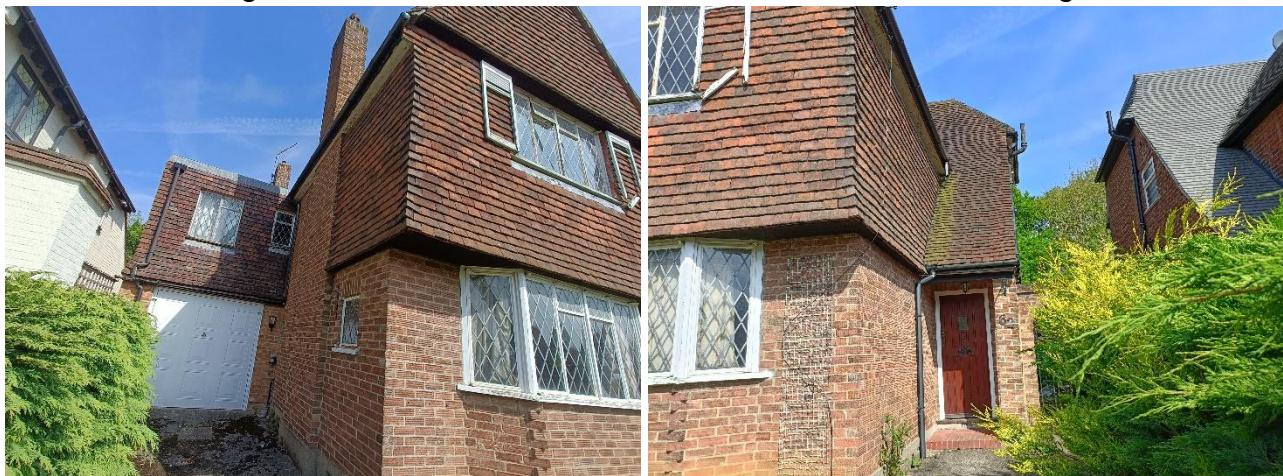
Figure 3. View of the side elevations

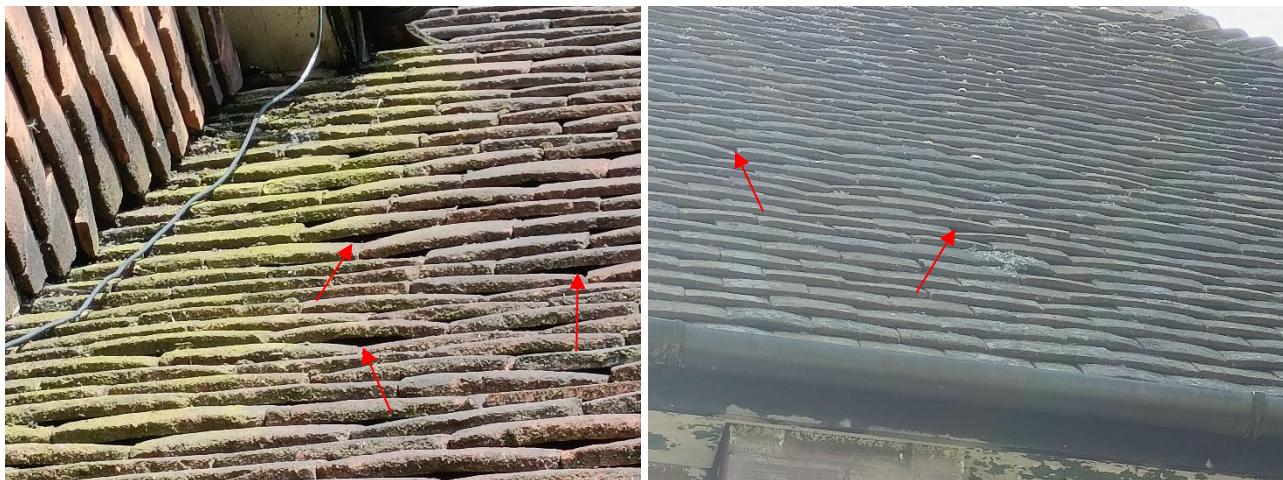
The roof tiles are generally in good condition; however, due to their hand-made nature, a number of small gaps were recorded below them. Similarly, a number of gaps were recorded behind the hanging tiles. Small gaps are also present along the flat roof capping. Gaps are also present between the soffit and the brickwork, particularly along the eastern elevation, where the chimney breast is located.

Figure 4. Example of gaps under roof tiles

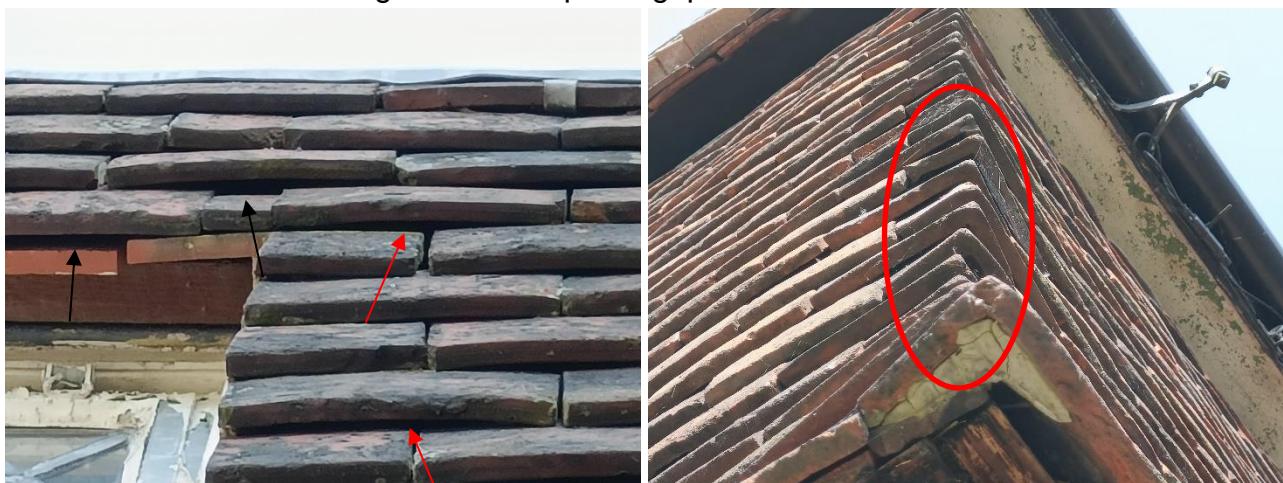
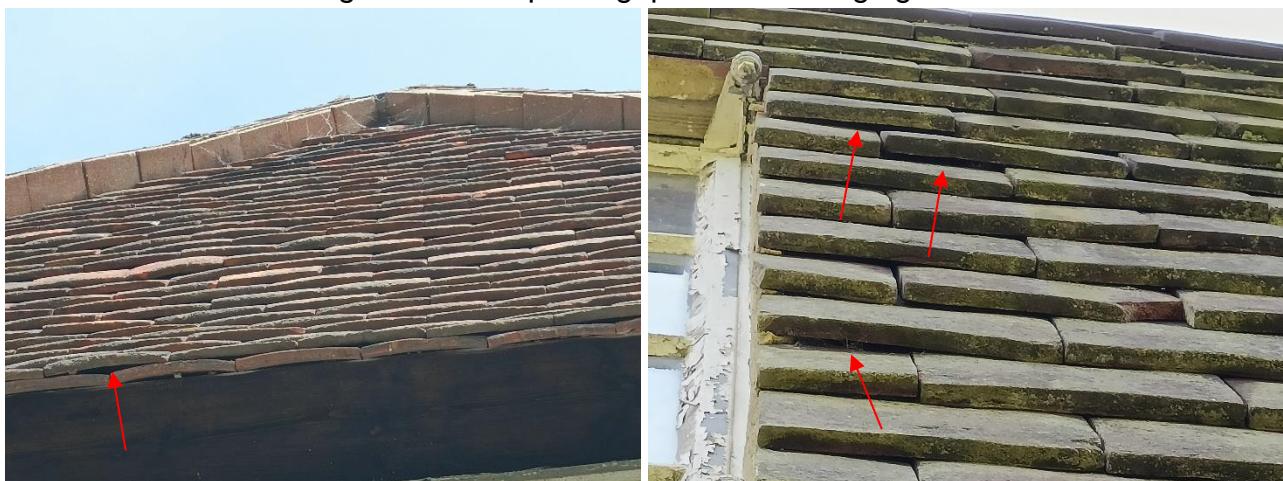
Figure 5. Example of gaps behind hanging tiles

Figure 6. Example of gaps behind hanging tiles

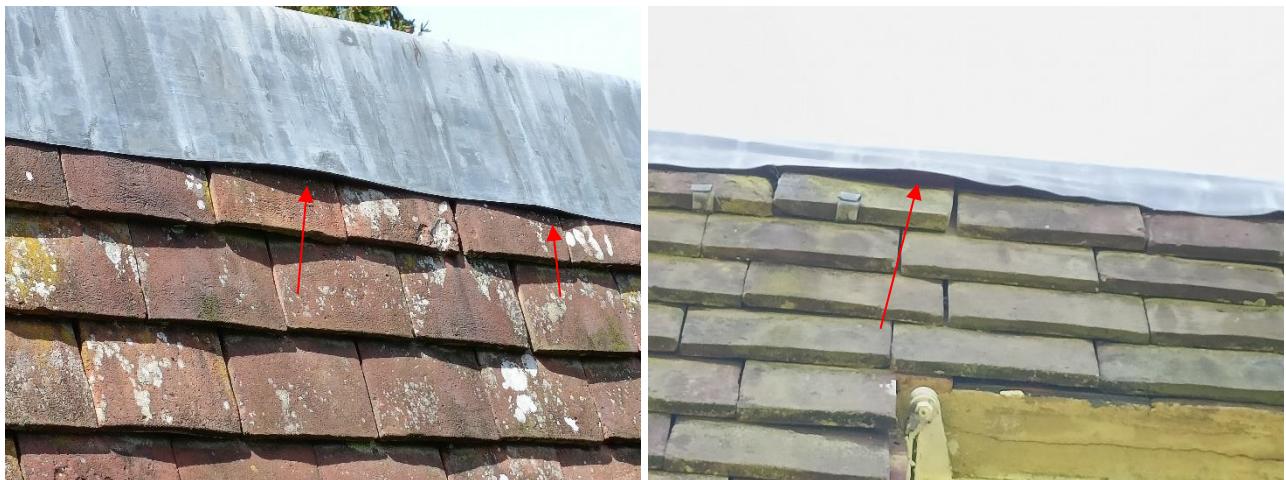
Figure 7. Example of lifted flat roof capping

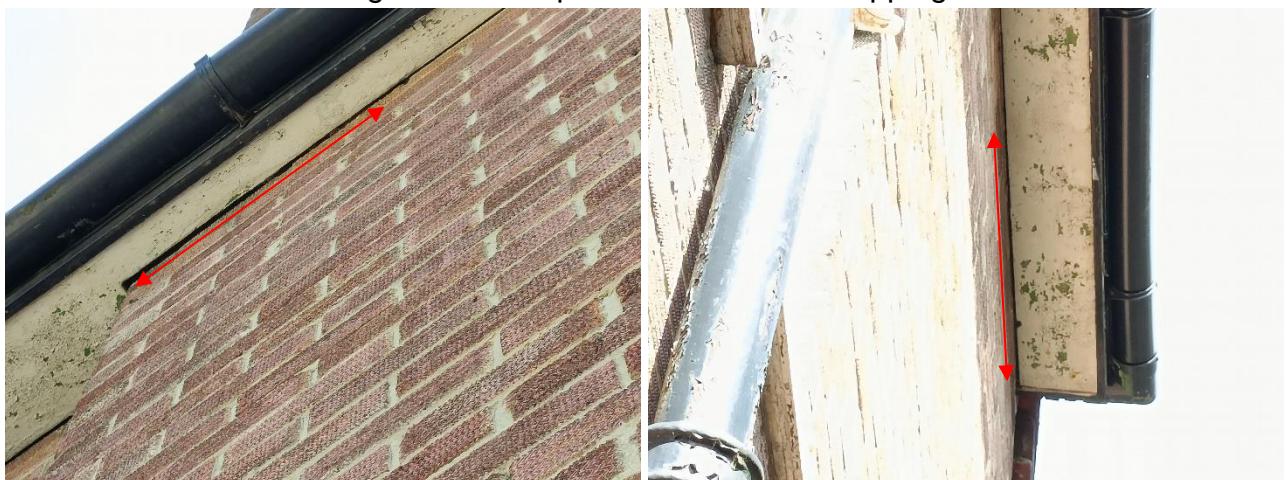
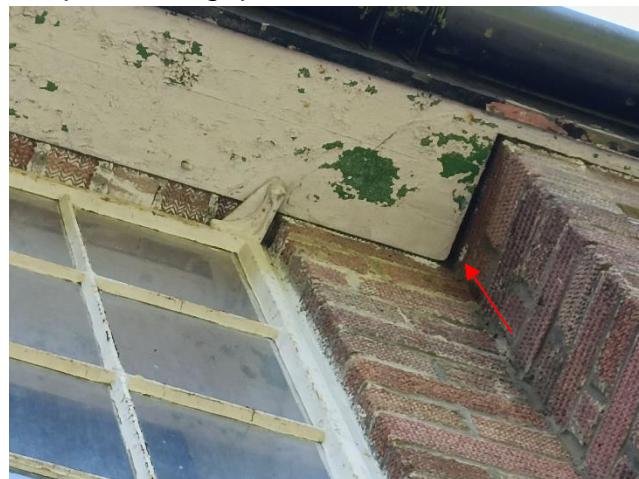
Figure 8. Example of the gaps between the soffits and the brickwork

Figure 9. Example of the gaps between the soffits and the brickwork

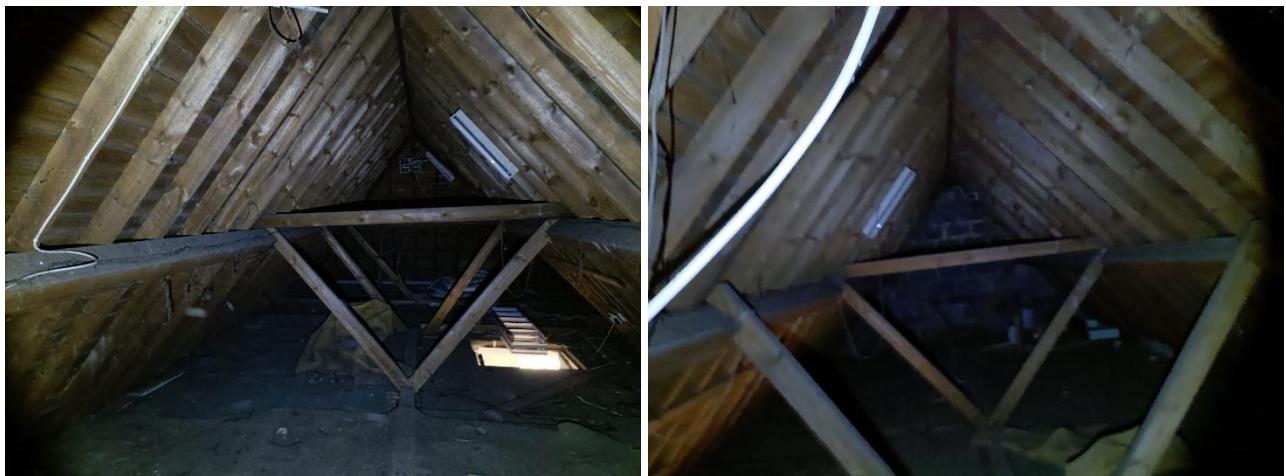
Internally, a single loft void is present. The floor to apex height is approximately 2m. The loft floor was insulated and not boarded. Weatherboarding was present between the roof tiles and the timber rafters, which was in a good condition and tightly fitted. The gable-ends were of breezeblock construction.

Figure 11. View of the loft void

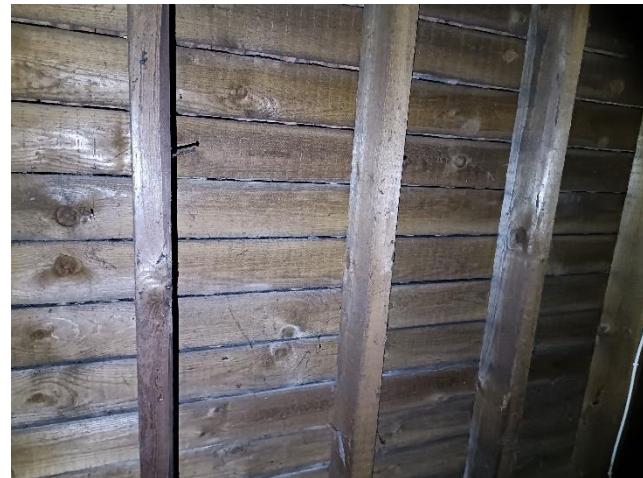
Figure 12. Example of tightly fitted weatherboarding in a good condition

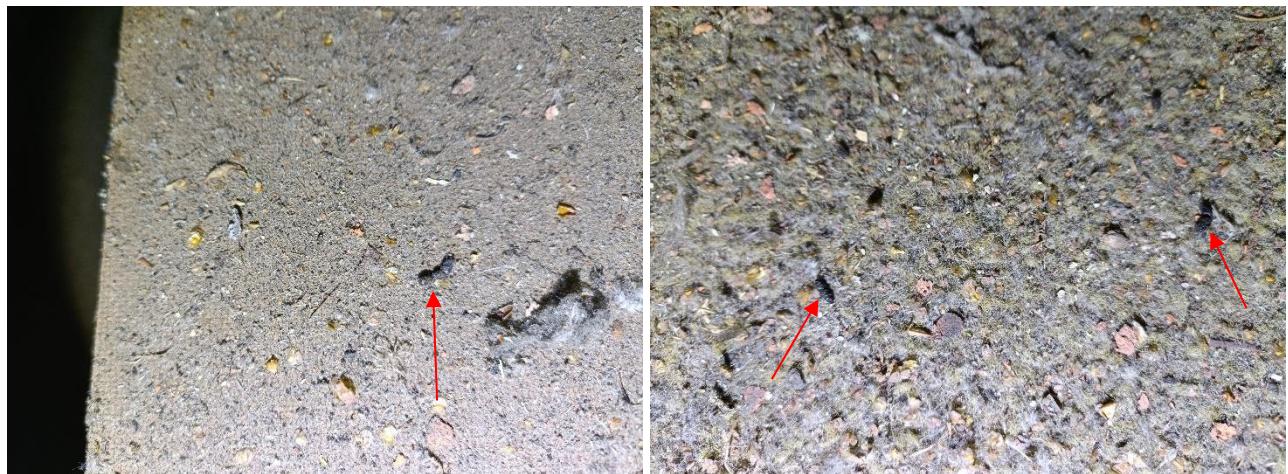
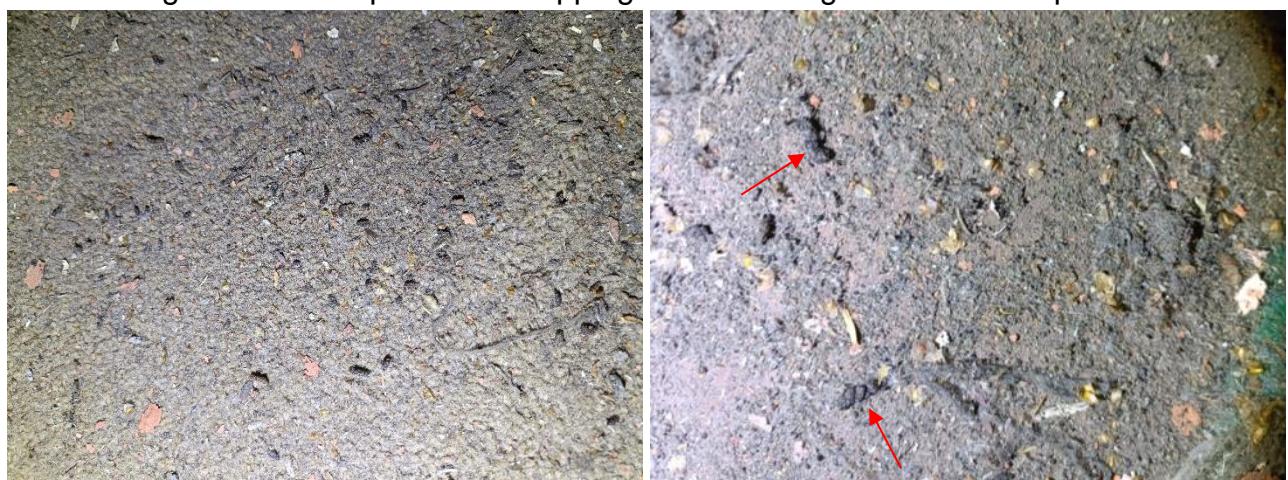
During the internal inspection, evidence of roosting bats in the form of a light scattering of old bat droppings on the loft floor was recorded, with a concentration below the southern gable-end. The dwelling is therefore a confirmed bat roost. To robustly identify the species of bat roosting in the building, a sample of the droppings should be sent for DNA analysis.

Figure 13. Example of bat droppings found during the internal inspection

Figure 14. Example of bat droppings found during the internal inspection

It will also be necessary to send a sample of the droppings found within the loft space for DNA analysis, to robustly identify the species of bat roosting on site. Available records of bats from the Local Environmental Records Centre will also be necessary to apply for a European Protected Species licence.

As presence of roosting bats has been confirmed, a Natural England European Protected Species licence or a Bat Mitigation Class Licence will be required to enable the proposals. Prior to a licence being issued, planning permission must be granted and relevant conditions relating to protected species must be discharged.
