Details of brickwork at Howcroft

Re 23213/APP/2022/1828

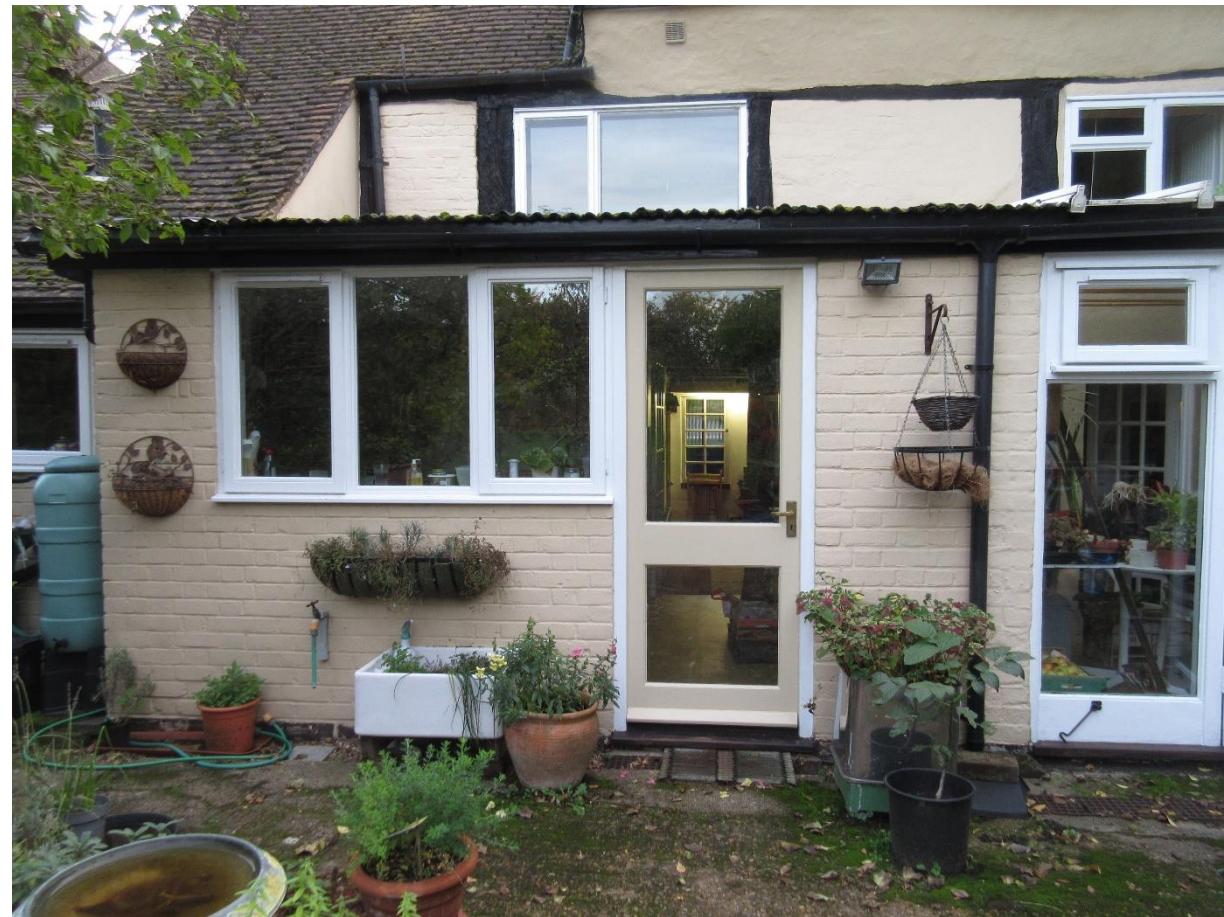
Outer wall of kitchen looking south with part of conservatory visible to right. This is all new brickwork constructed c.1995 with planning permission. The only old brickwork is the small strip to the right of the downpipe which effectively hides the join. The 1990s bricks are about 215 x 100 x 60mm while the old bricks are larger at 9 x 4½ x 2 5/8 inches.

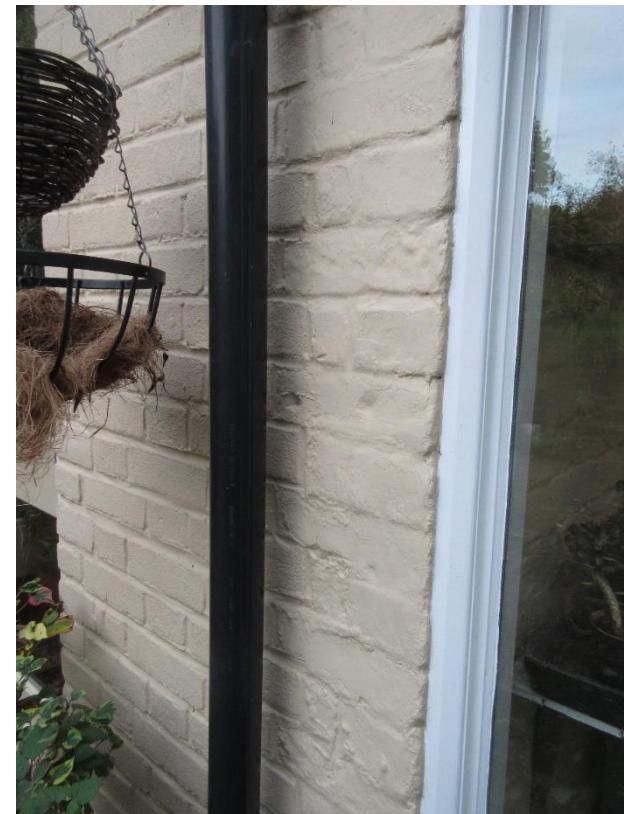
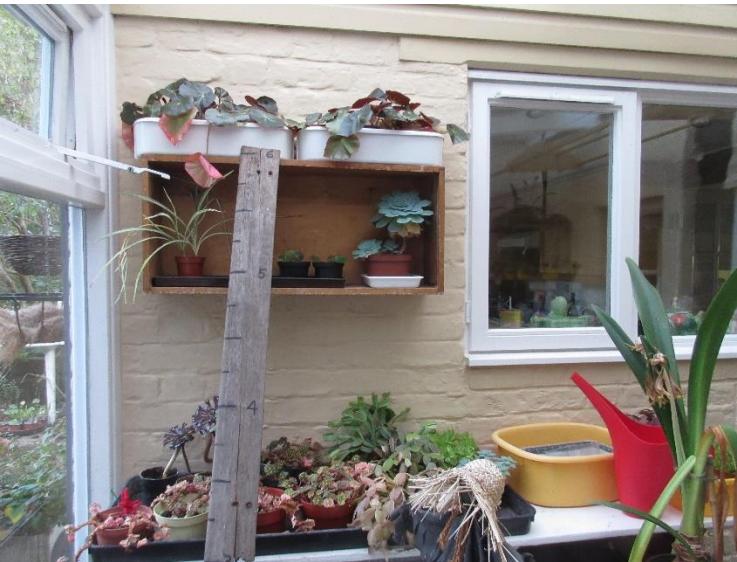
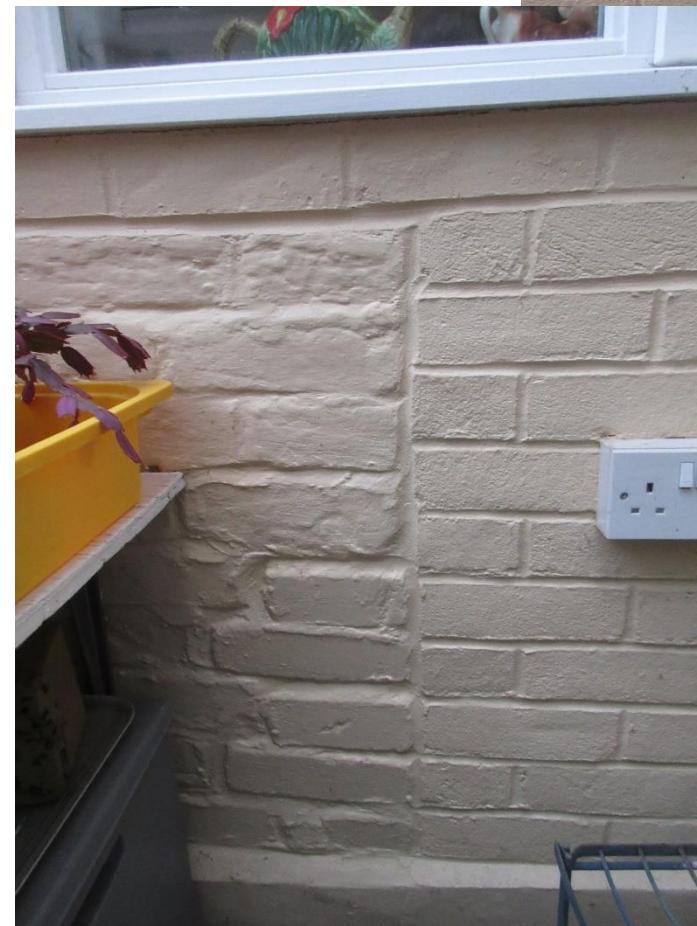
These three photos show the east wall inside the conservatory with the internal window to the kitchen. Note the section to the left of the internal window is all old bricks which continue half way under the window (central image). The new bricks are blocking a door removed in 1990s and a single course runs under the window. Note ten courses new bricks = nine courses of old ones. To the right of the window is a pillar of old brickwork, part rendered.

The 1990s external wall to the kitchen matches the bond pattern of the far older garden wall (Flemish bond). The bond pattern of the old brickwork inside the conservatory is far less regular and the doorway infilled in the 1990s uses a different bond pattern (running bond) – though much of this is due to be removed under the current application.

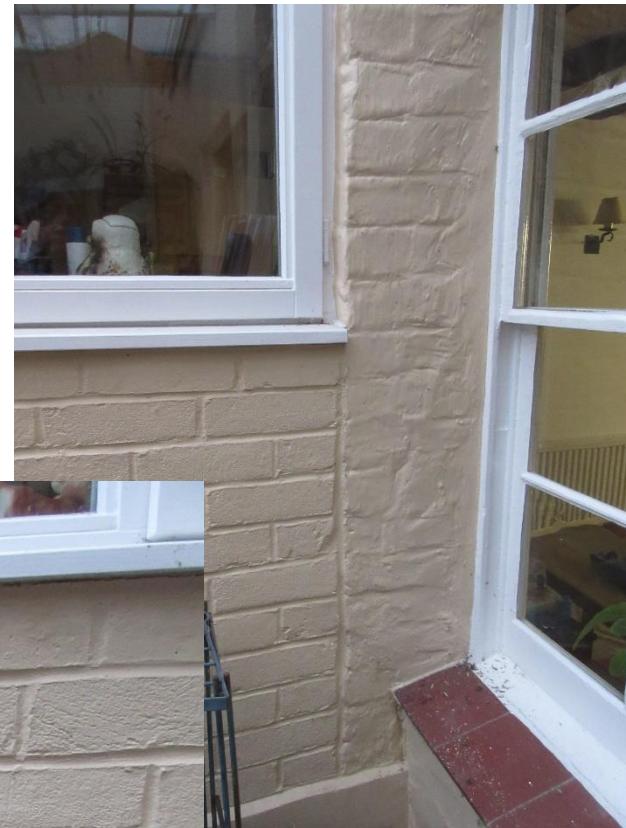
The garden wall ends inside the NW corner of the conservatory and the end surface (abutting the shelves in image to left) is rendered. The garden wall is all built of old bricks that are 9 x 4½ x 2 5/8 inches.
