**BS5837:2012 TREE SURVEY AND  
ARBORICULTURAL IMPACT ASSESSMENT:  
49 Nicholas Way, Northwood, HA6 2TR**

Dated: 16<sup>th</sup> June 2026

Our reference: GHA/DS/380160:26

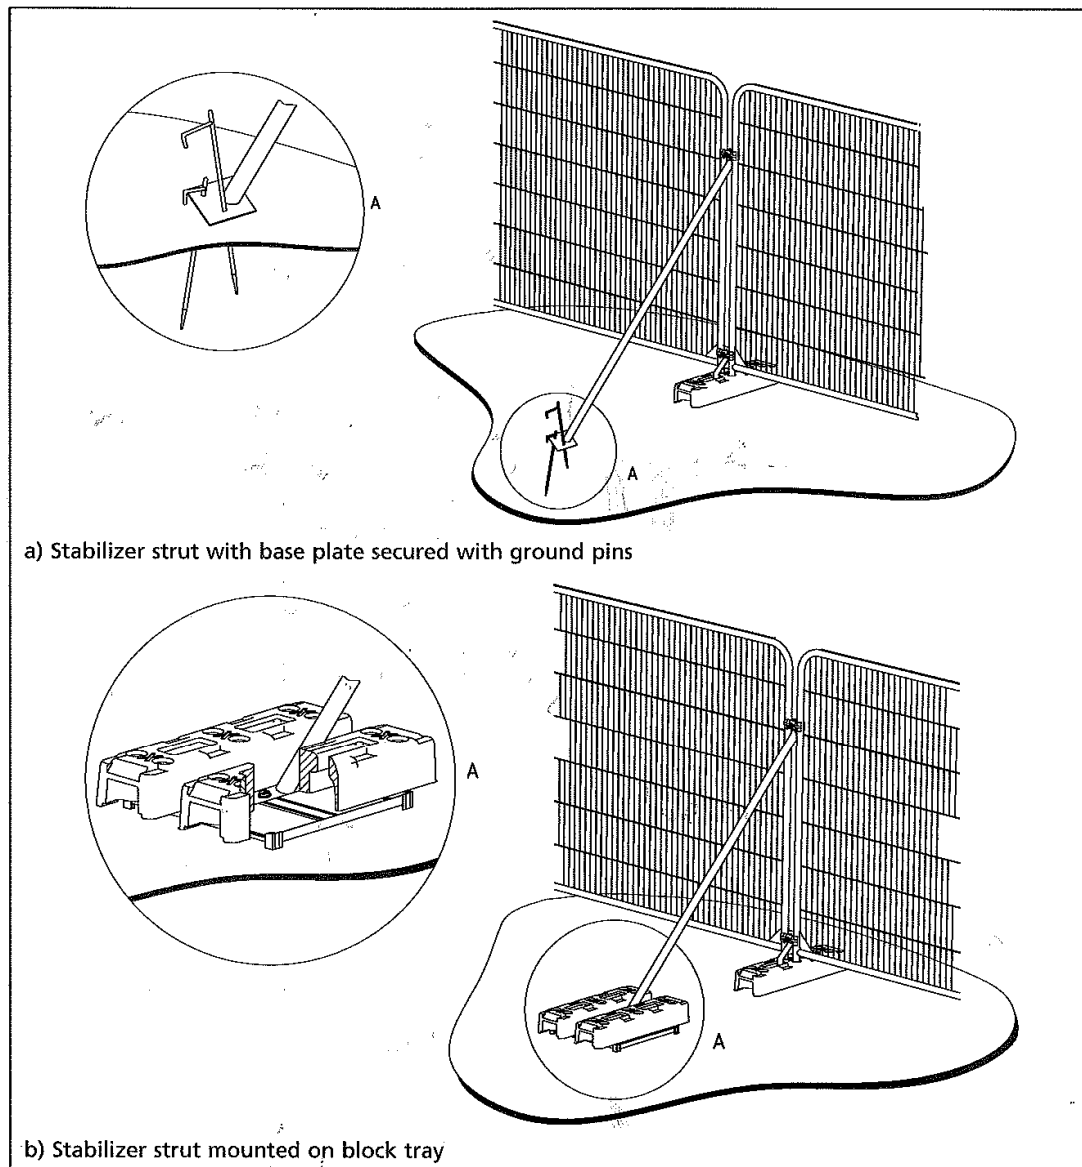
Figure 3 Examples of above-ground stabilizing systems

**Appendix C**  
**TREE FENCING DETAIL**

It is essential for the future health of the trees to be retained on site, that all development activity is undertaken outside the root protection zone of these trees. The position of the fence **MUST** be marked out with biodegradable marker paint on site and agreed with appropriate representatives from the contractor. The fencing **MUST** be erected **prior** to any works in the vicinity of the trees and removed only when all development activity is complete. The protective fencing **MUST** be as that shown in BS 5837 (see Appendix C). The herras panels **MUST** be joined together using a minimum of two anti-tamper couplers which **MUST** be installed so they can only be removed from the inside of the fence. The panels **MUST** supported by stabilizer struts, which **MUST** be installed on the inside and secured to the ground using pins or appropriate weights.
