NHS Property Services

Northwood and Pinner Cottage Hospital, Pinner Road, HA6 1DE

Phase 2 Geo-environmental and Geotechnical Site
Investigation

MARCH 2021

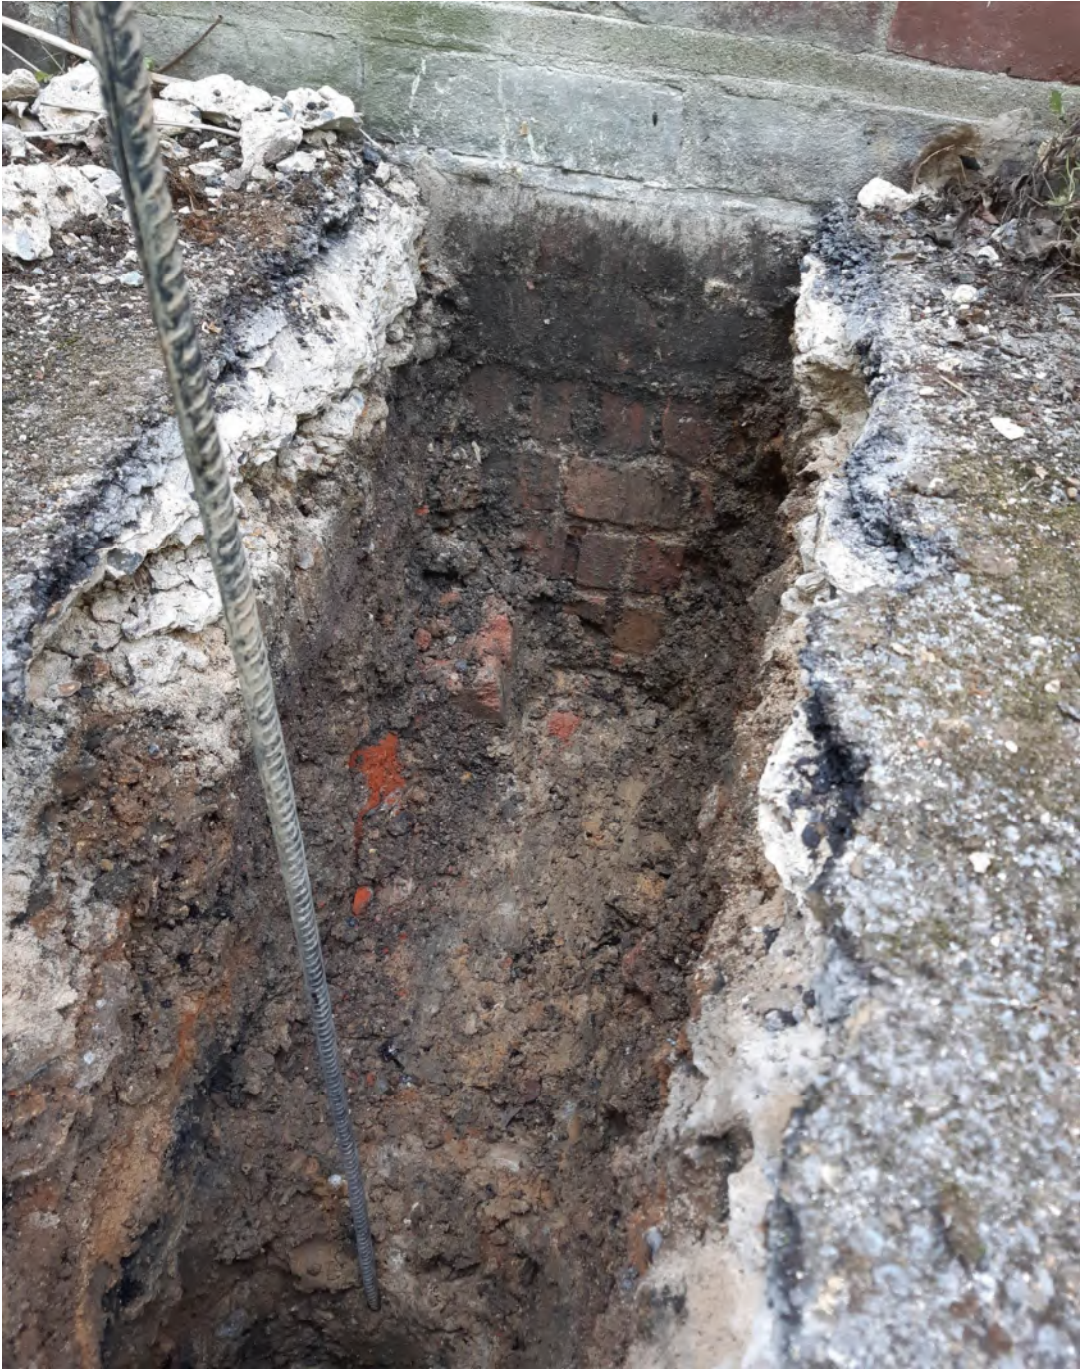
- 0.00m - Asphalt
- 0.05m - Concrete
- 0.15m - MADE GROUND: Dark brown slightly silty sandy subangular to subrounded fine to coarse GRAVEL of flint, brick and concrete. Medium cobble content of brick and concrete. Sand is fine to coarse.
- 0.45m - MADE GROUND: Orangish brown mottled grey slightly gravelly CLAY with occasional fragments of brick and concrete. Gravel is subangular to subrounded fine to medium flint.

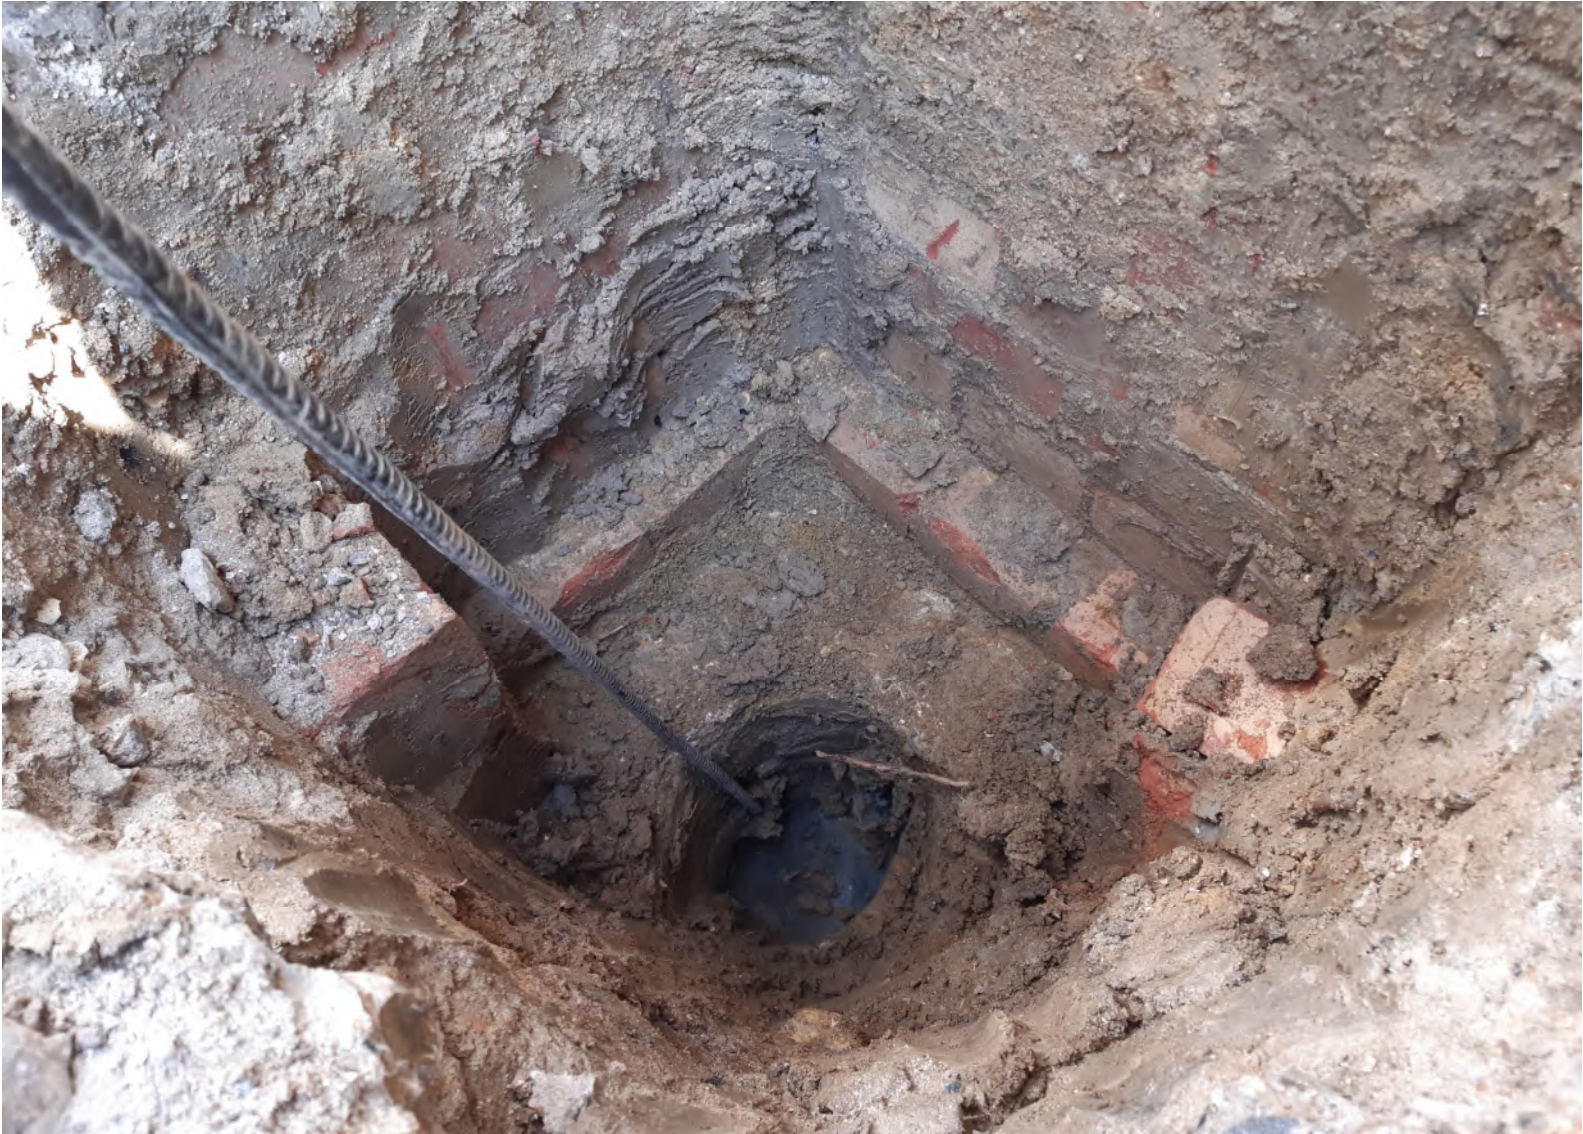
0.00m - Tile
0.05m - Concrete
0.20m - MADE GROUND: Brown slightly slightly gravelly sandy CLAY with high cobble content of brick and concrete. Gravel is subangular to subrounded fine to coarse flint, brick and concrete. Sand is fine to coarse.

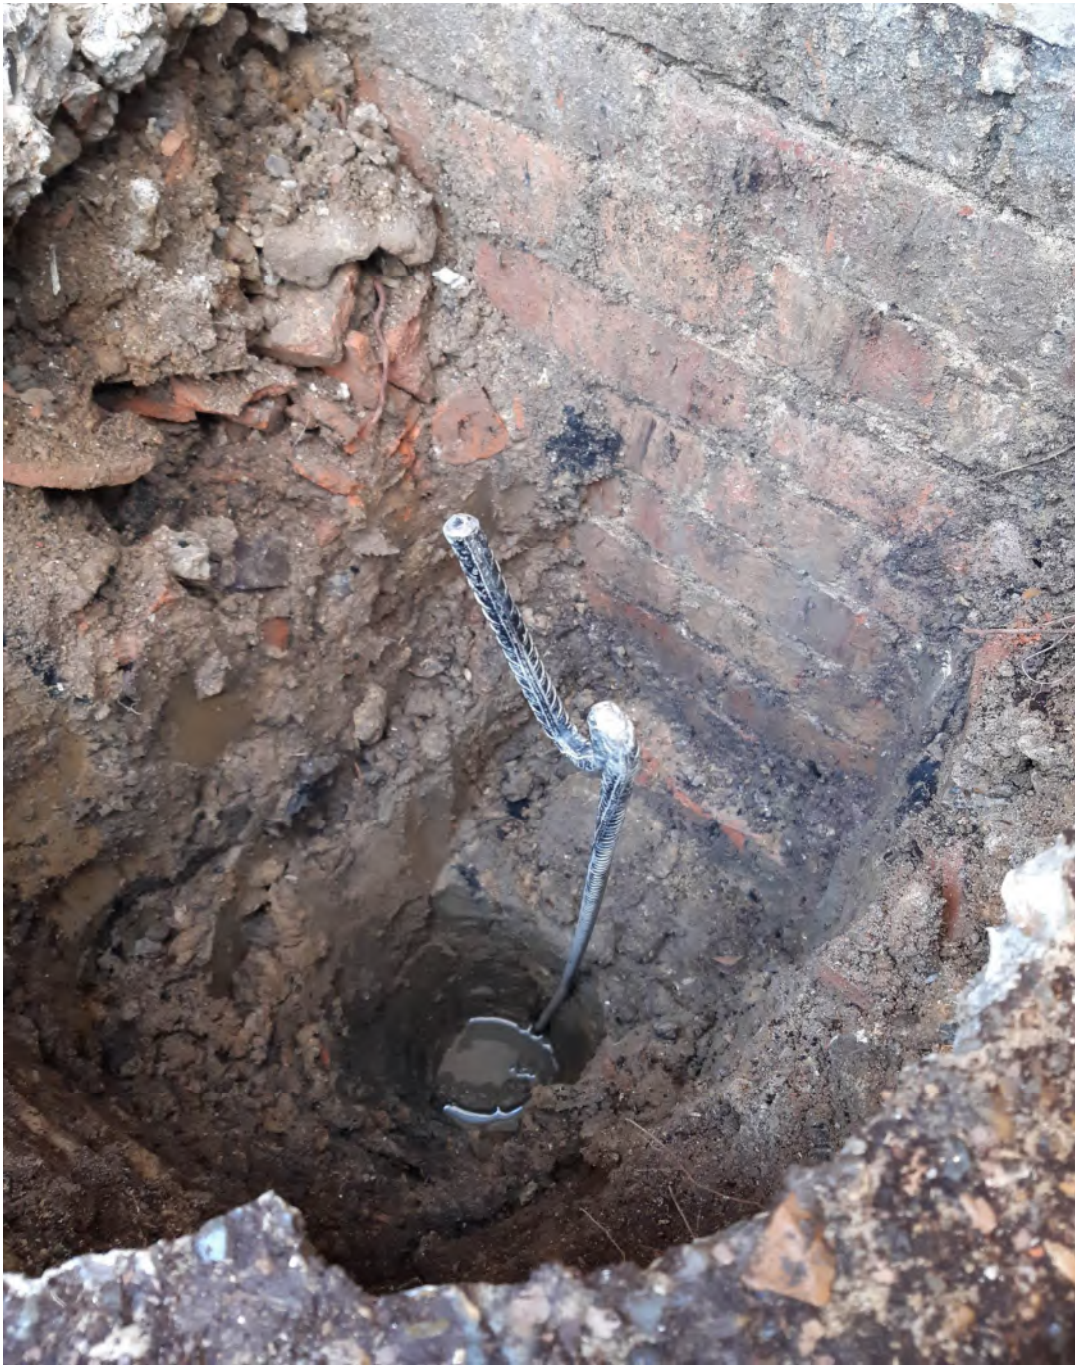
0.05m - MADE GROUND: Brown slightly sandy subangular to subrounded fine to coarse GRAVEL of flint, brick and concrete. High cobble content of flint, brick and concrete. Sand is fine to coarse.

0.45m - MADE GROUND: Brown mottled grey slightly gravelly sandy CLAY with low cobble content of brick. Gravel is subangular to subrounded fine to medium flint, brick and concrete. Sand is fine to medium.

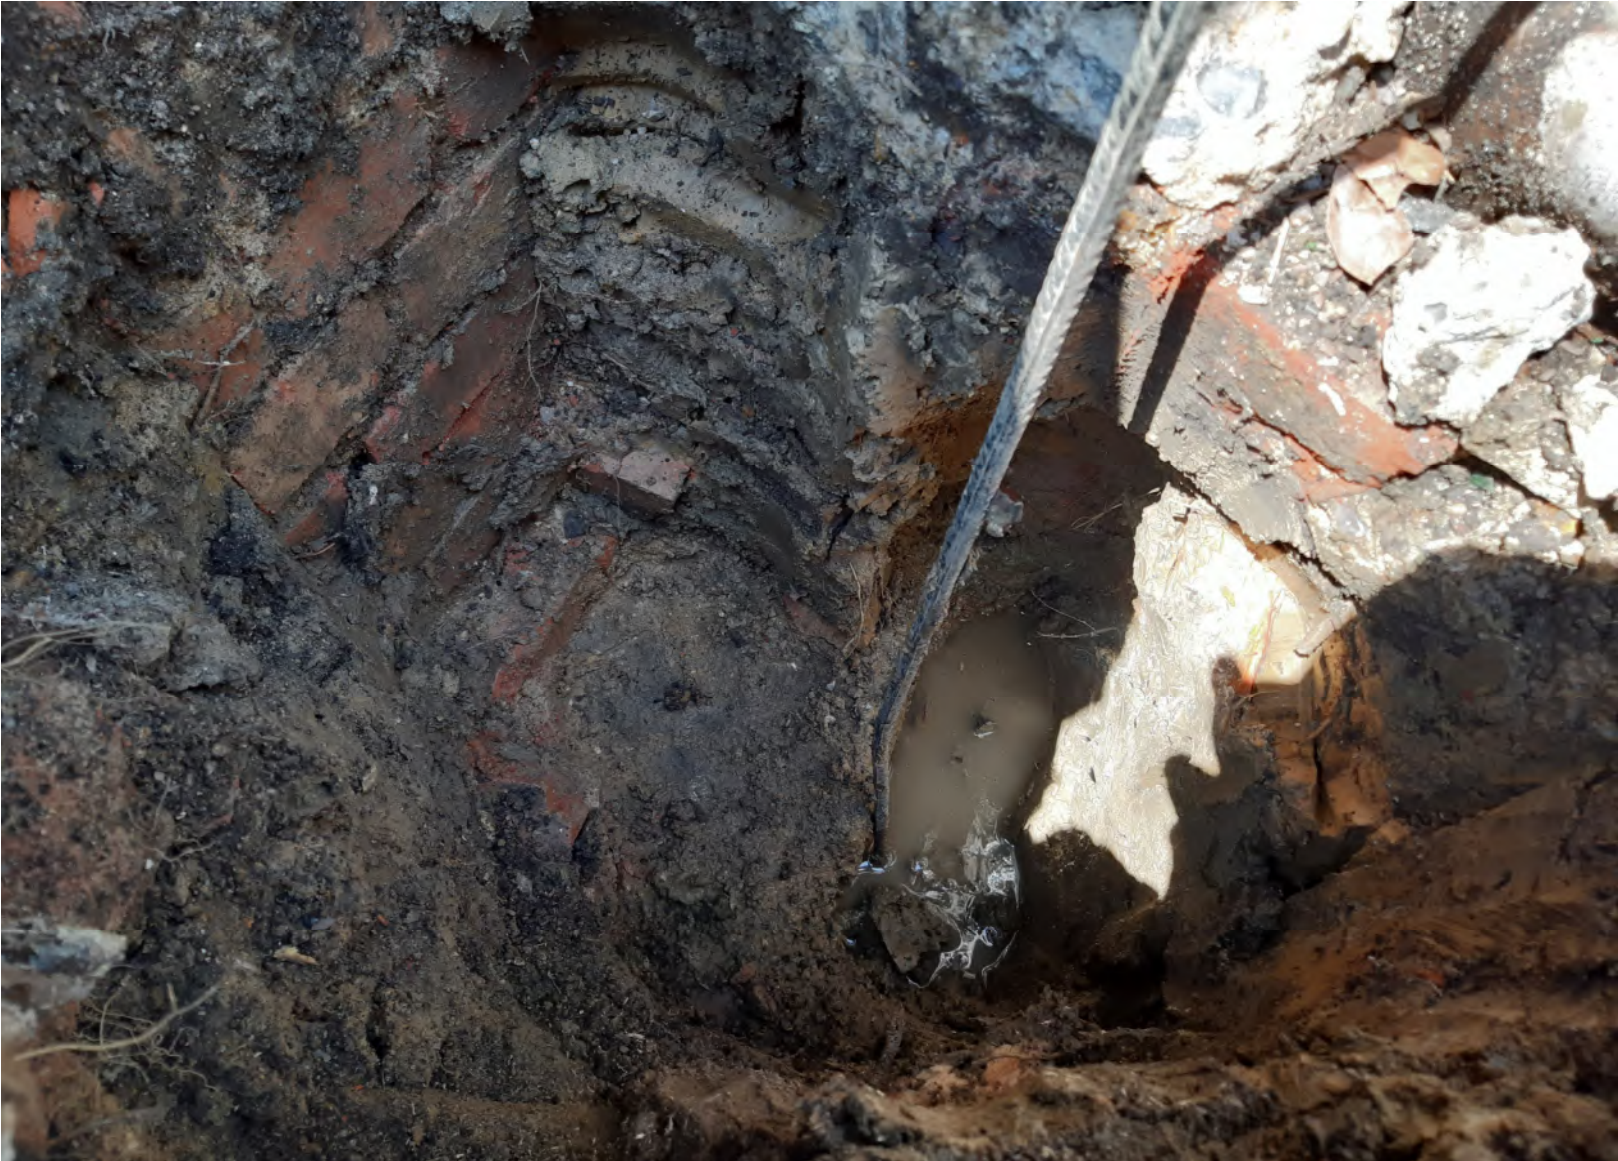
0.05m - MADE GROUND: Brown slightly sandy subangular to subrounded fine to coarse GRAVEL of flint, brick and concrete. High cobble content of flint, brick and concrete. Sand is fine to coarse.

0.40m - MADE GROUND: Brown mottled grey slightly gravelly sandy CLAY with low cobble content of brick. Gravel is subangular to subrounded fine to medium flint, brick and concrete. Sand is fine to medium.

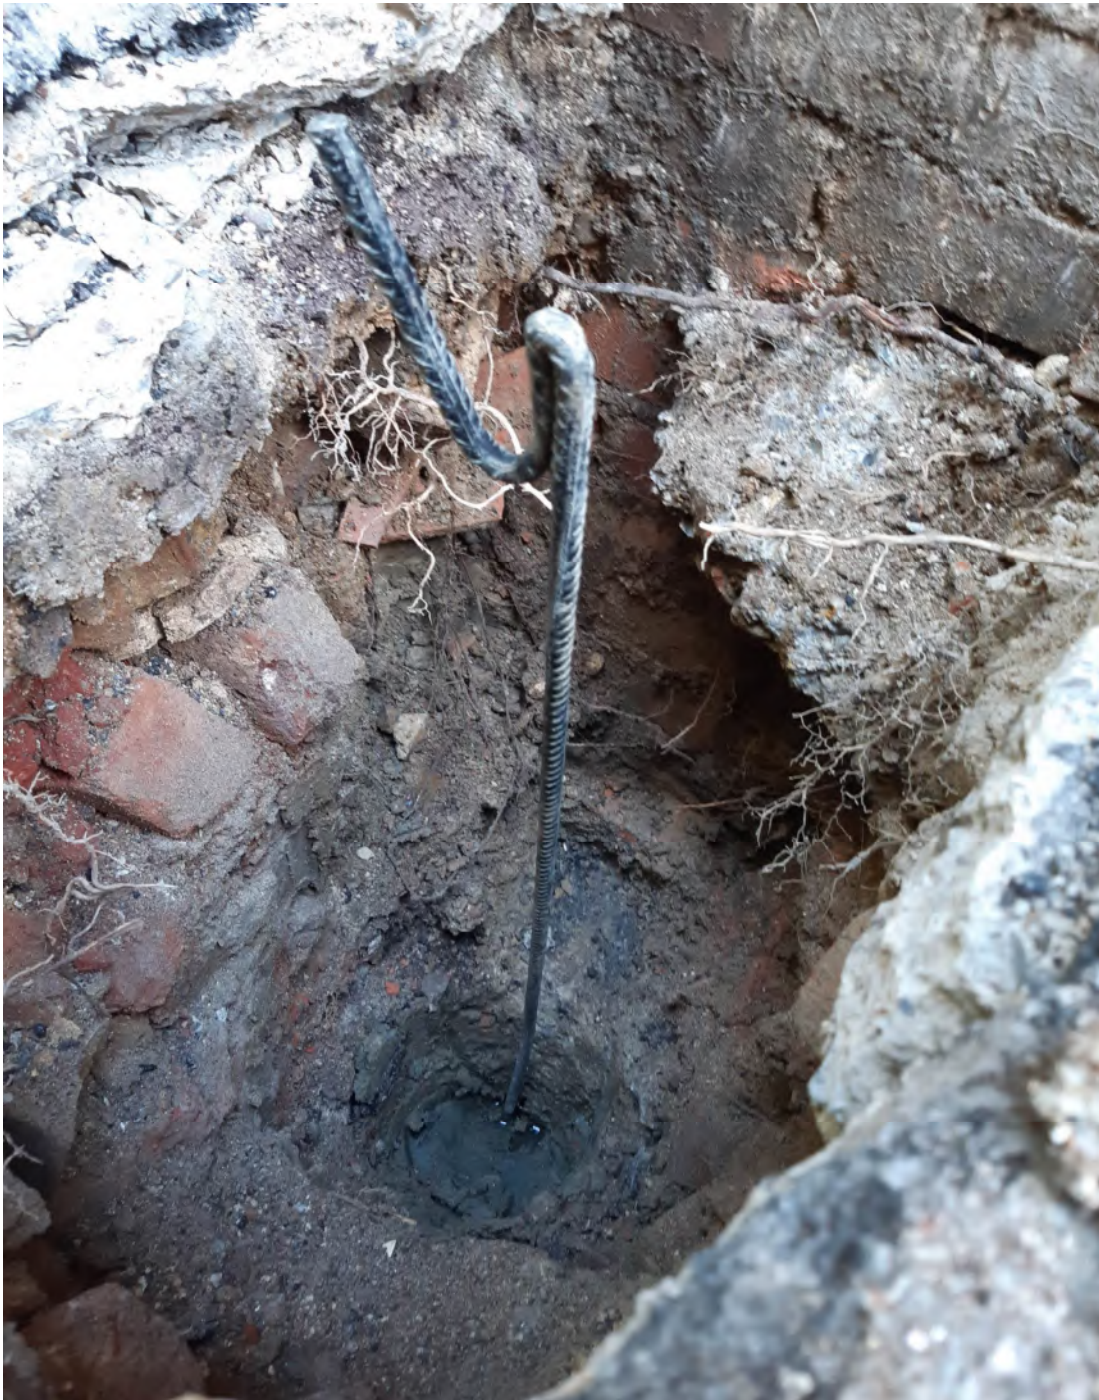
- 0.00m - Asphalt
- 0.05m - Concrete
- 0.15m - MADE GROUND: Brown slightly silty sandy subangular to subrounded fine to coarse GRAVEL of flint, brick and concrete. High cobble content of brick. Sand is fine to coarse.
- 0.75m - MADE GROUND: Brown sandy gravelly CLAY with high cobble content of brick. Gravel is subangular to subrounded fine to coarse flint, brick and concrete.
