ARCHAEOLOGICAL DESK BASED ASSESSMENT

Hillingdon Water Sports Facility and Activity Centre (HWSFAC),
Broadwater Lake, Moorhall Road, Harefield, UB9 6PE

JAC 28557
Hillingdon WSFAC,
UB9 6BB
September 2023

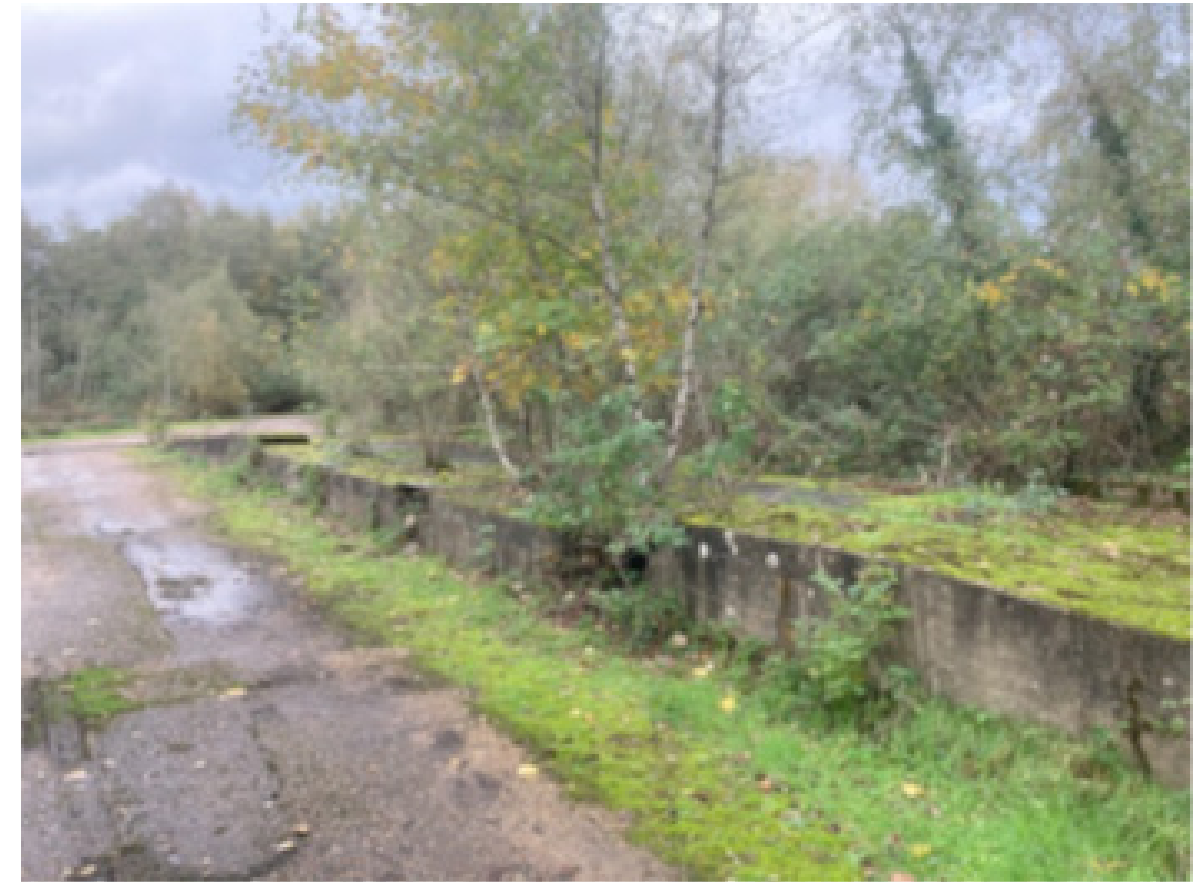
Plate 3: Weighbridge at site entrance

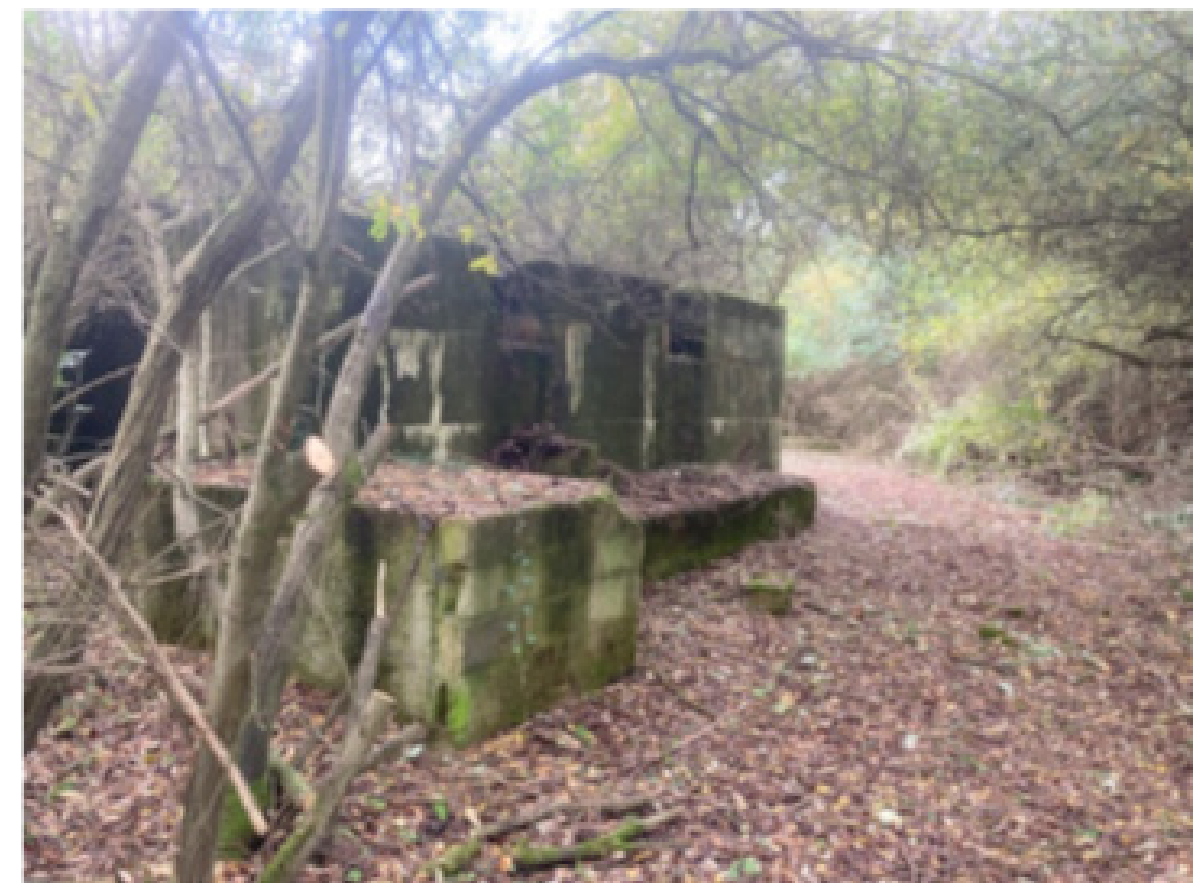
Plate 4: Remnants of conveyor structure on main site

The results of that industrial activity are visible on the Site with Site walk-over showing massive truncation from sand and gravel extraction and heavy industrial impact and re-working of the ground. The remnants of Sand & Gravel works infrastructure are also visible.

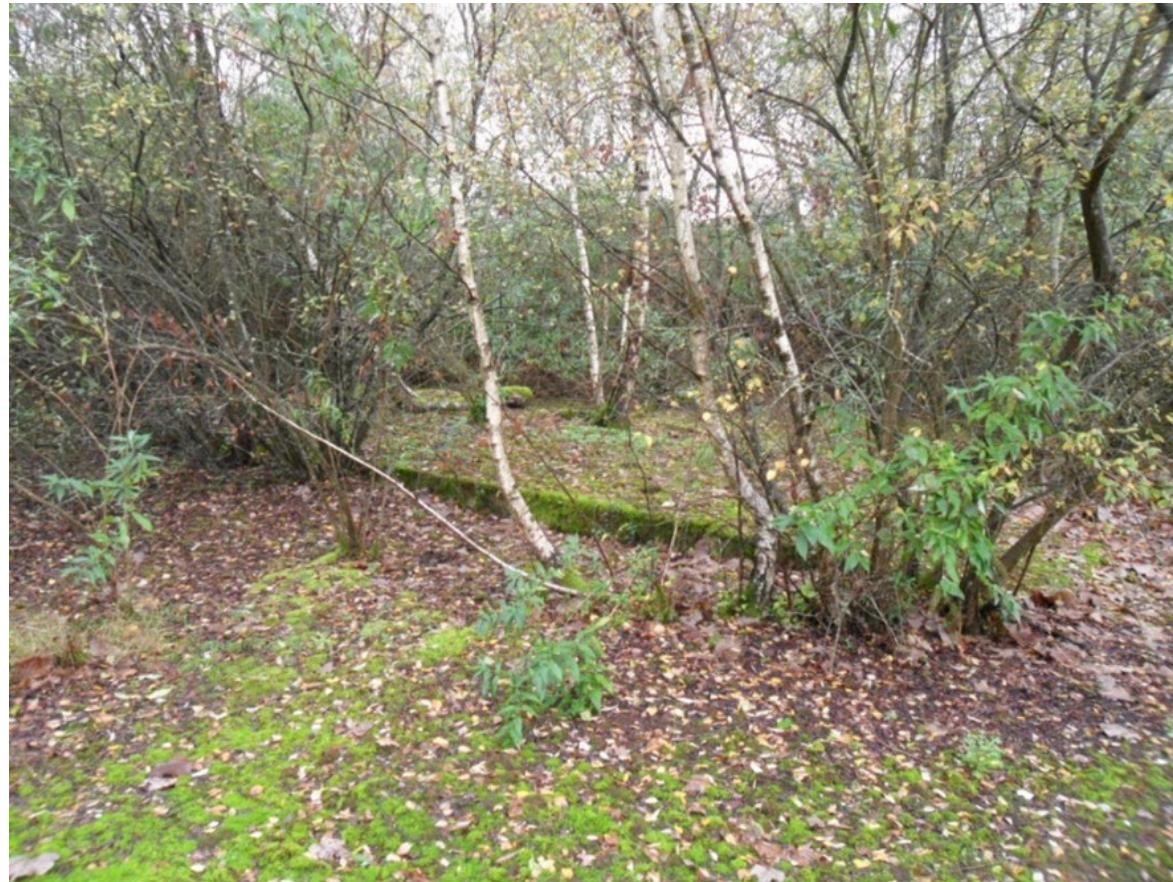
Plate 5: Remnants of industrial remains on main site

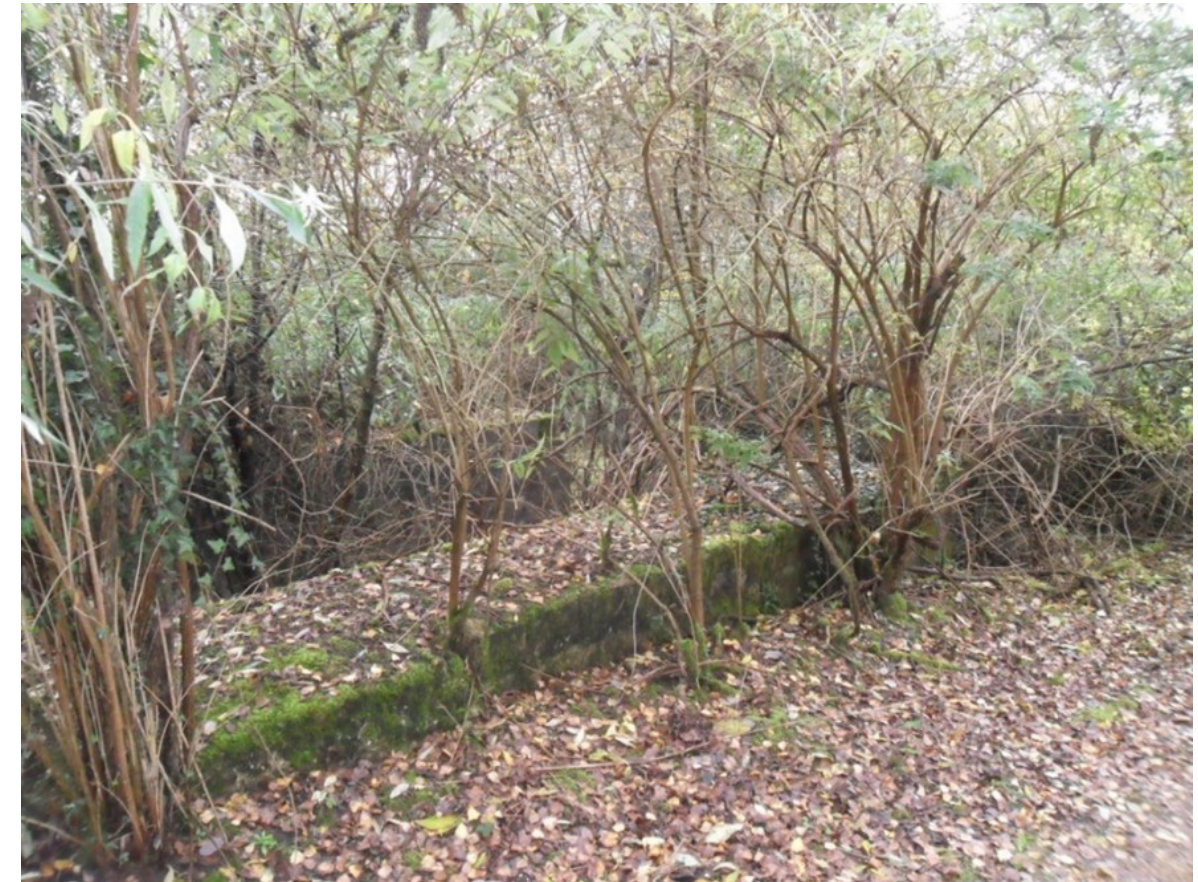
Plate 7: Remnants of industrial remains on main site

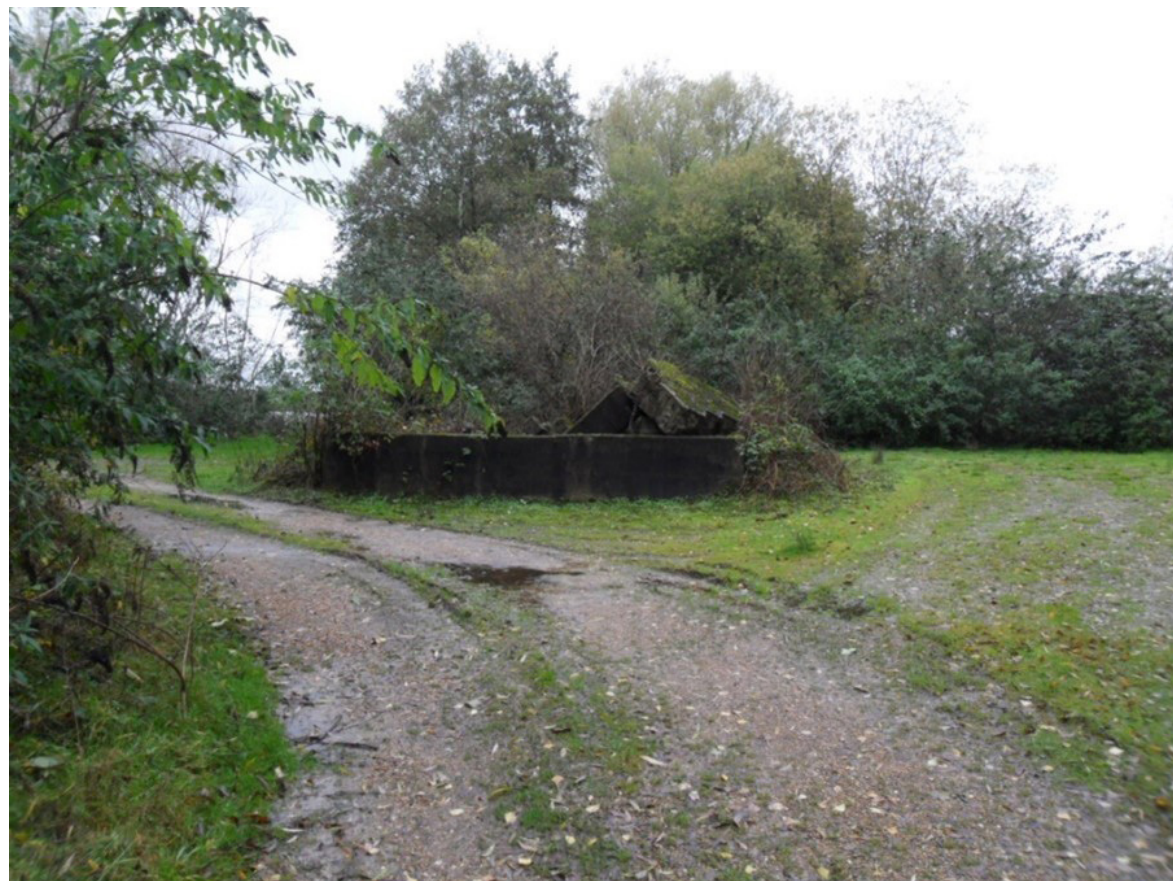
Plate 6: Remnants of industrial remains on main site

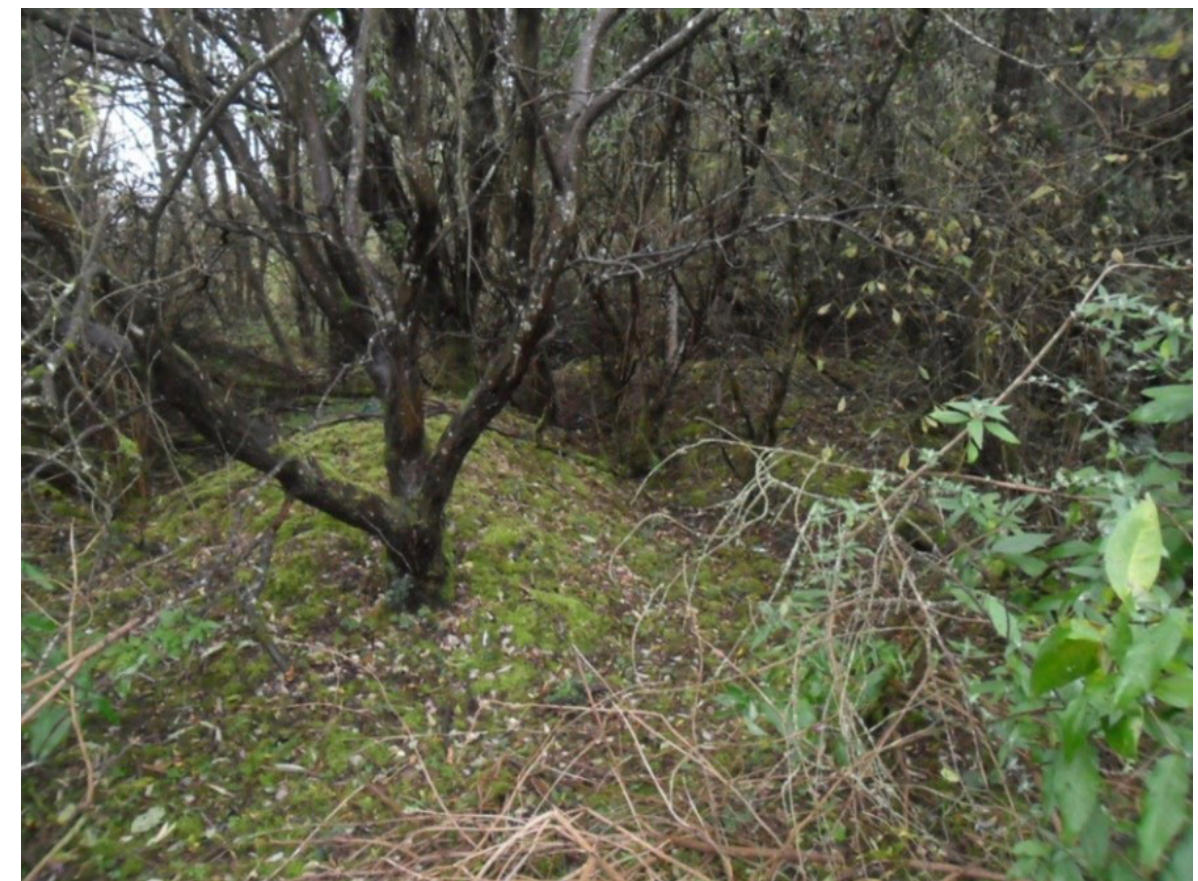
Plate 8: Evidence of industrial re-working of the Site

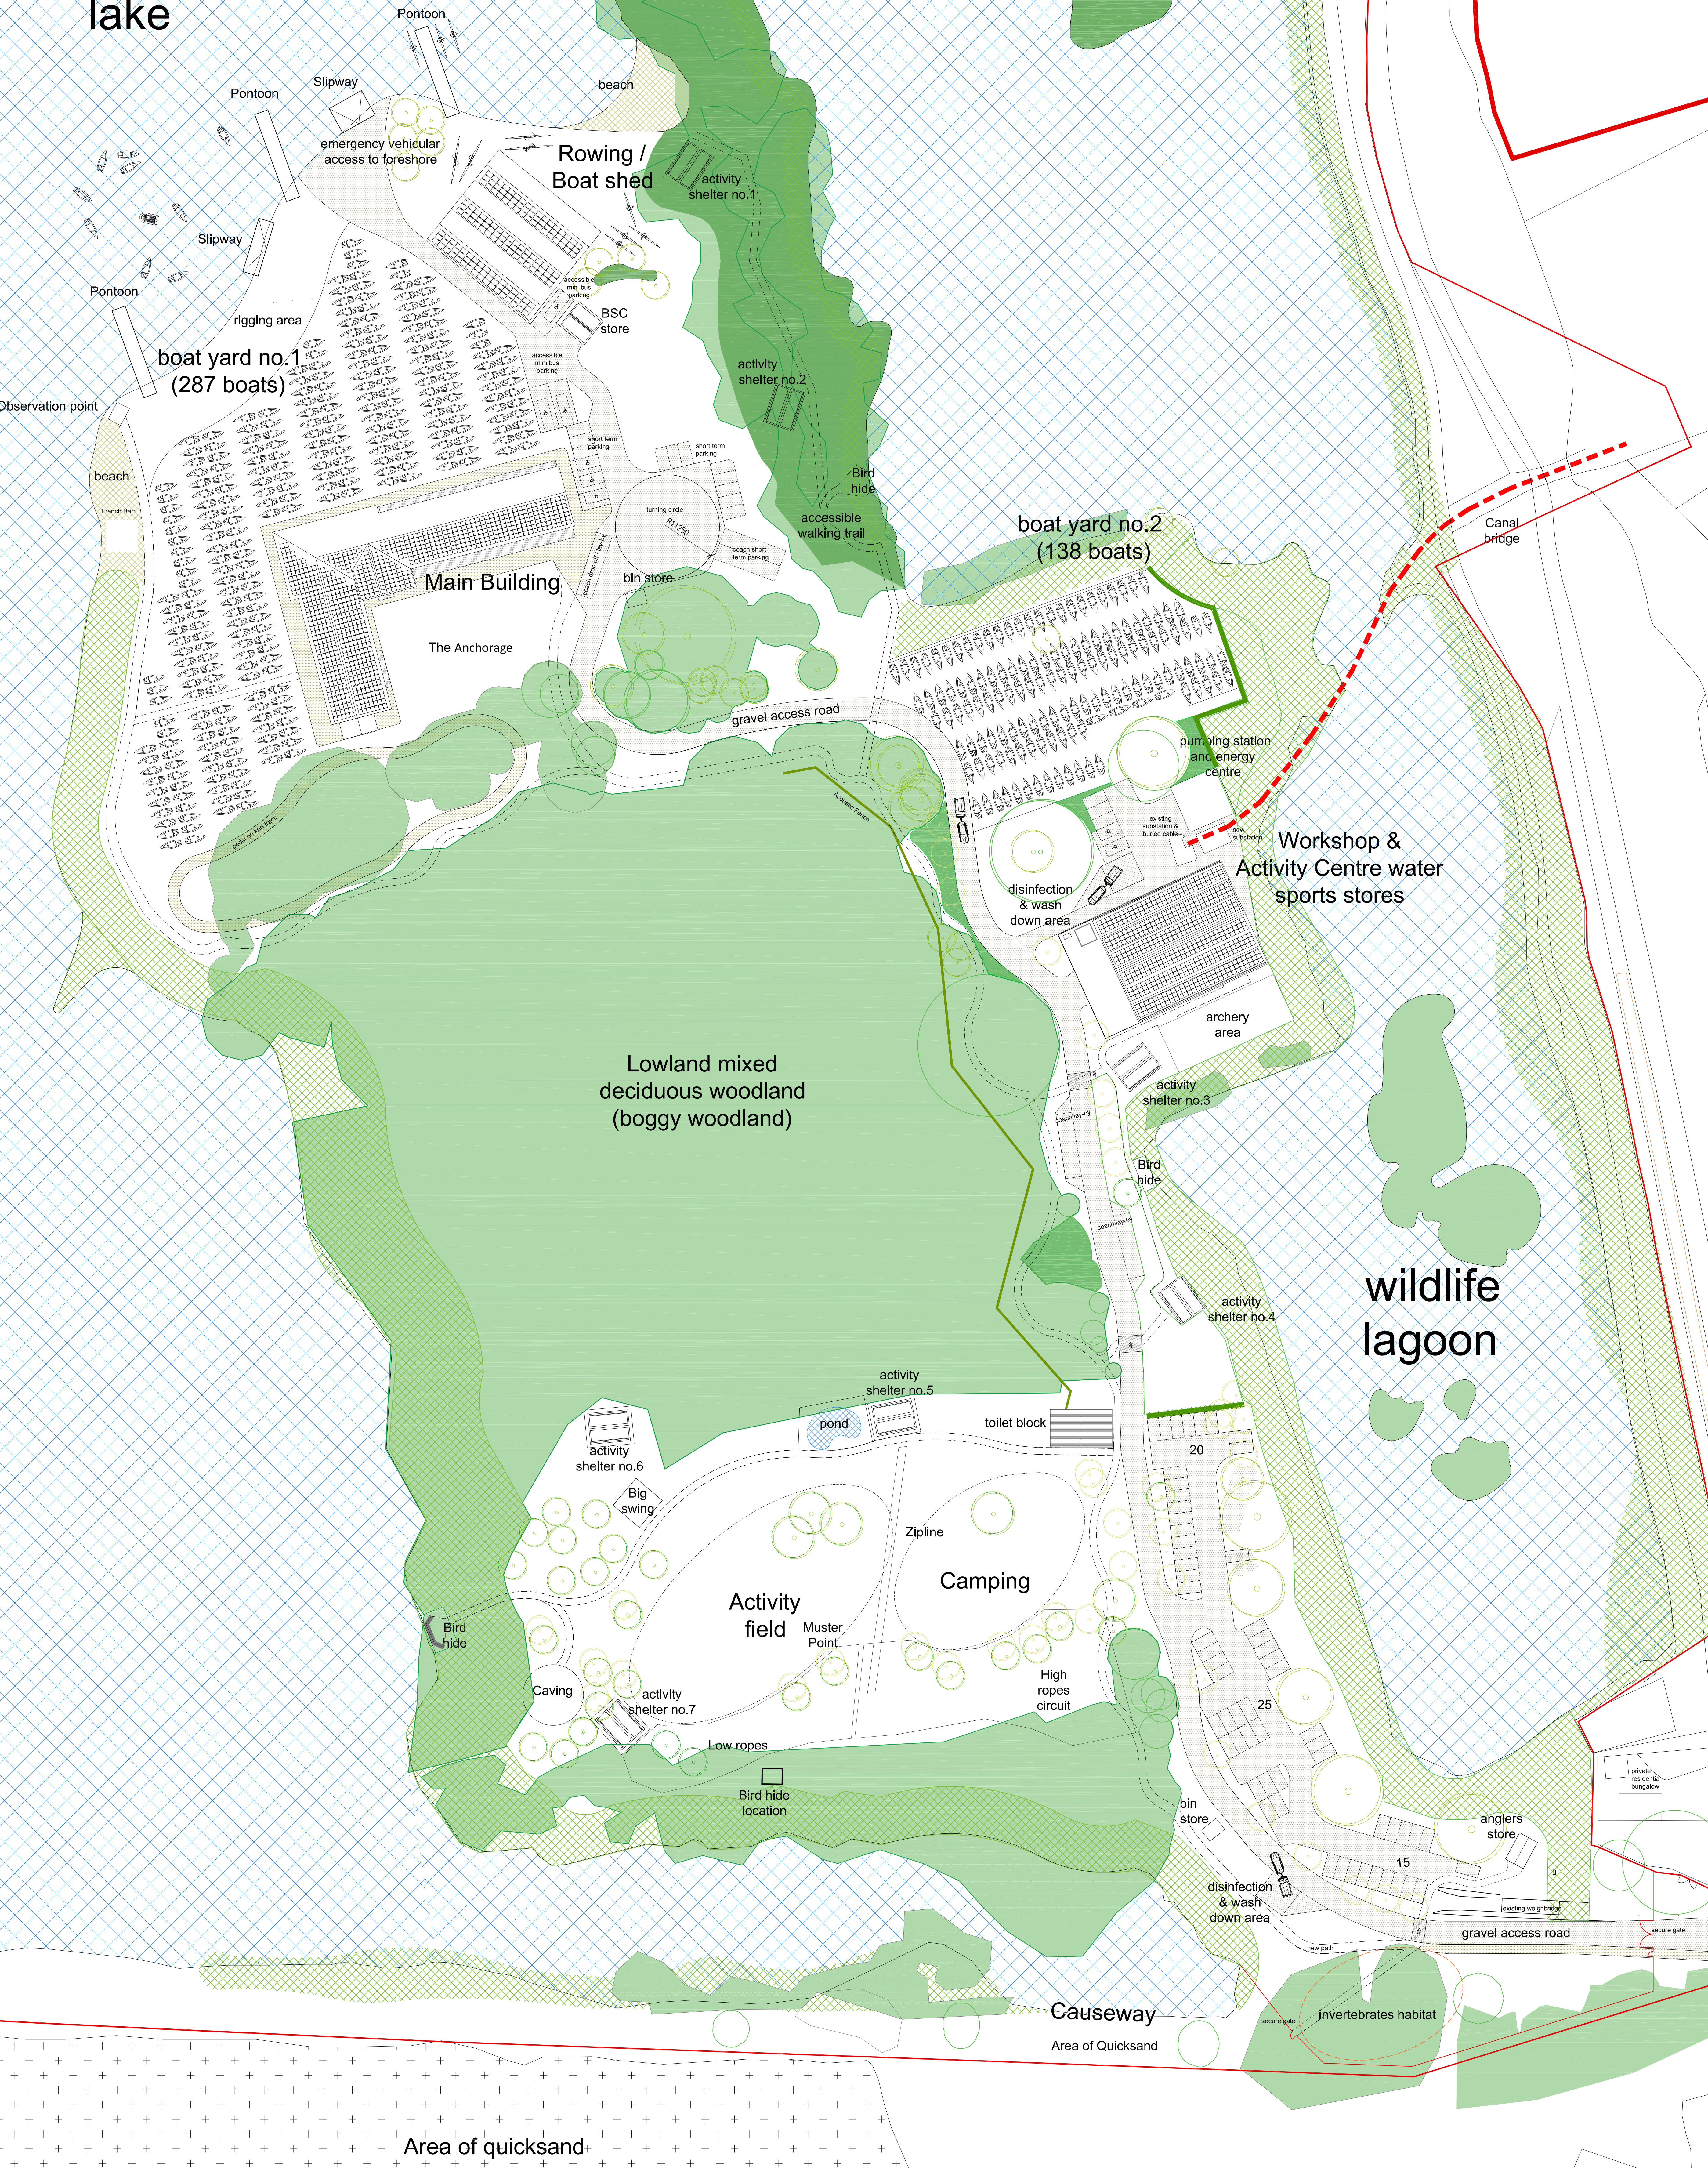
Area of quicksand

Quick-sand deposits are recorded on part of the Site.
