## **EXISTING TREE QUALITY**

Hillingdon Watersports & **Activity Centre Broadwater Lakes** Addendum Landscape Strategy Colo

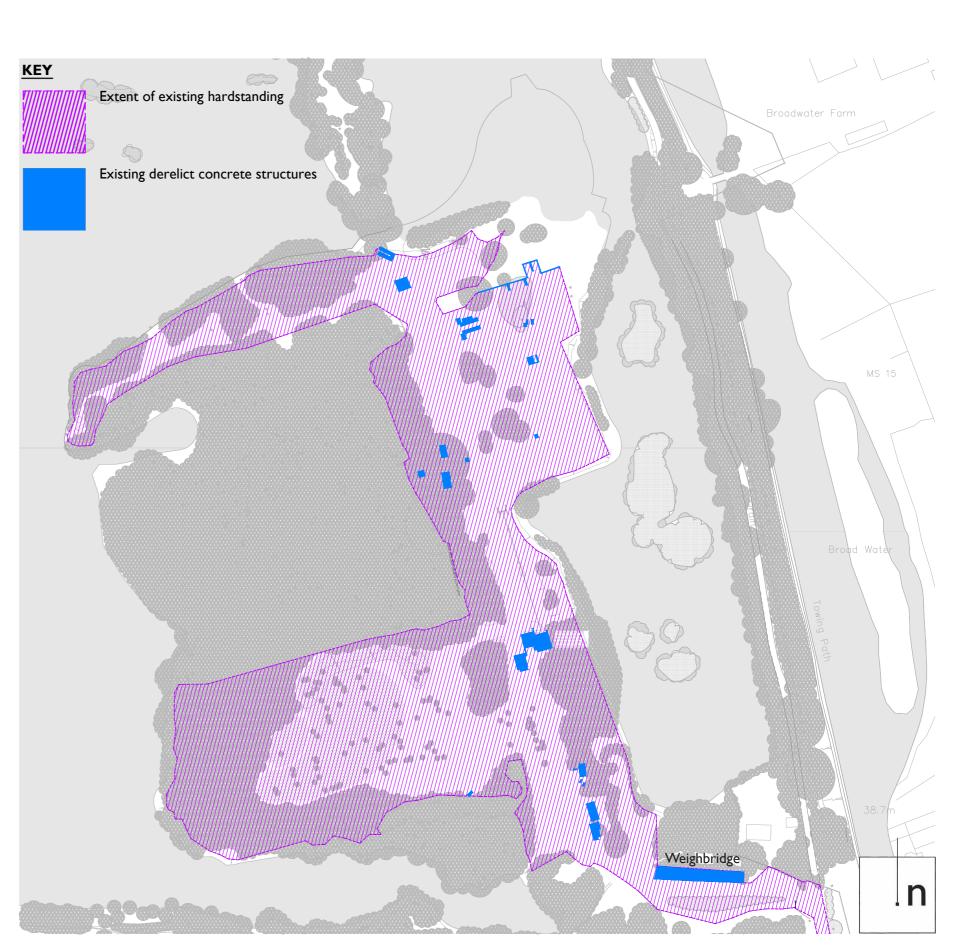
As can be seen, extensive areas of concrete hard surface cover the peninsular, remnants of gravel extraction and processing and most likely of a depth to withstand laden trucks, therefore in the order of 500m thick.

The concrete, is of variable condition, degree of colonised vegetation and depth of naturally formed soil, accumulated humic material and leaf litter.

In addition, remnant structures are present on site such as the weighbridge. Wherever possible these are to be retained or repurposed (see material strategy).

Weighbridge

Existing concrete feature

Existing concrete surface

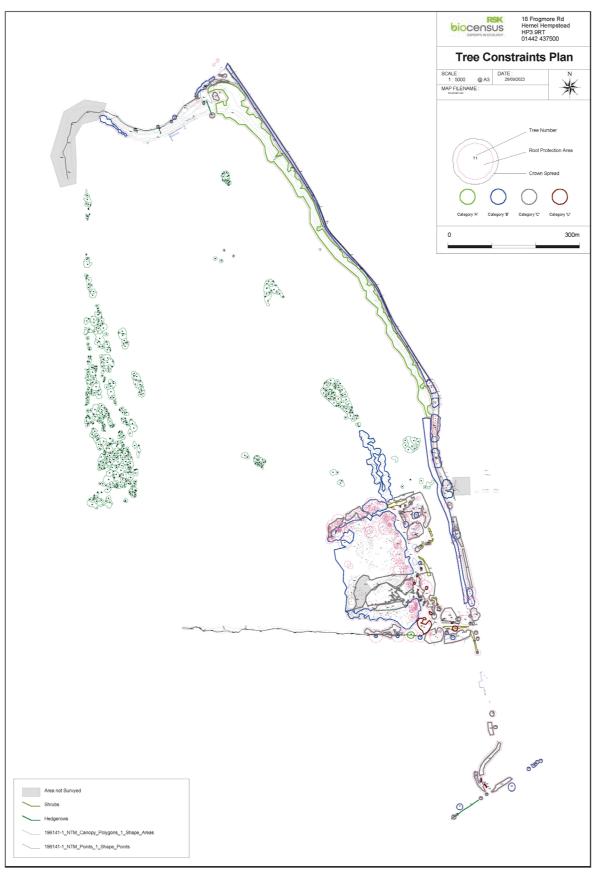
A wider survey of tree groups across the full site was undertaken by RSK Bioncensus in April 2023.

Other than the tree group on island 07 within the eastern channel which is to be removed so as to enable the increase in area of the southwestern refuge, no existing trees with the wider site are proposed to be removed.
