**London Borough of Hillingdon**

**Geotechnical and Geo-Environmental Report**

**Hillingdon Water Sports Facility and Activity Centre (HWSFAC)**

**Report No: 23-09-03B**

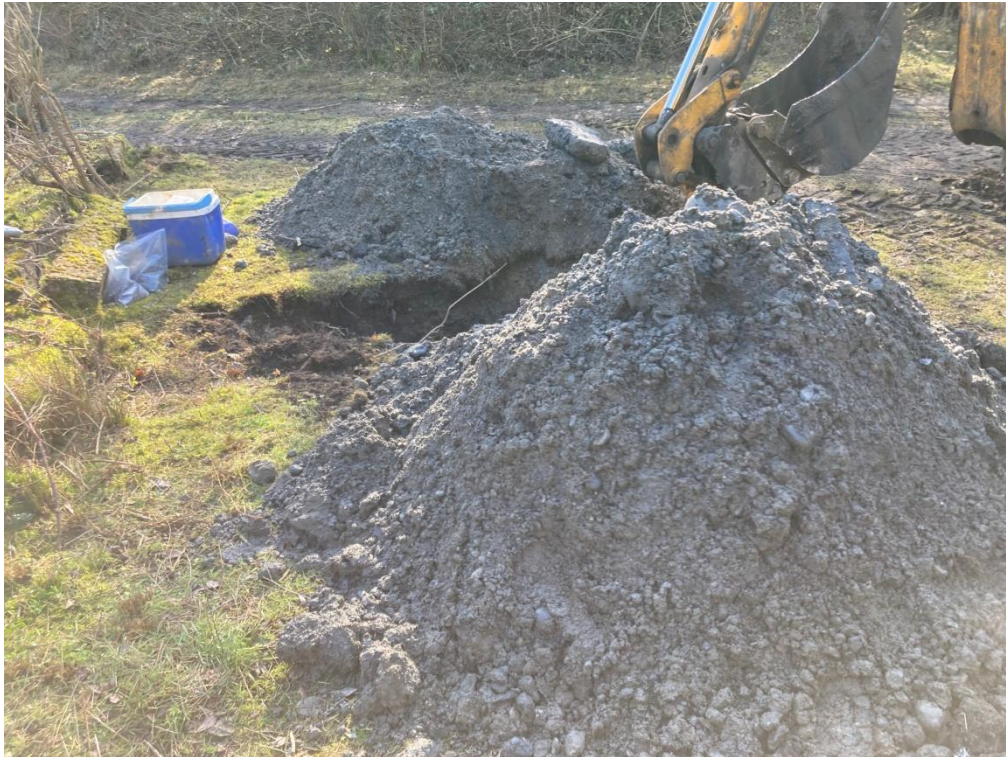
Distinct hydrocarbon staining and odour was encountered within the Made Ground soils surrounding the historic concrete bund located at the north of the site covered by TP4 and CBR5. Additional trial pits were undertaken around the historic concrete bund which did not encounter hydrocarbon staining and odour these include TP3, TP5, BH7. As such, it is considered the main impact from hydrocarbons is localised to the immediate west side of the historic bund.

Some obvious signs of contamination were identified locally within the Made Ground soils encountered during the field work. This relates to significant hydrocarbon staining and odour within two trial pits (TP4 and CBR5) positioned next to a historic concrete bund situated at the north of the site. In addition, some man-made materials were encountered within the Made Ground such as brick, concrete, ash, slag and slate with occasional cobbles and boulder size fragments of concrete.
