# **Preliminary Risk Assessment and Geo- Environmental Assessment**

Bradfield Road, South Ruislip  
HA4 0NU

**For Safestore**

21 February 2025  
Report ref. 25/4383.A

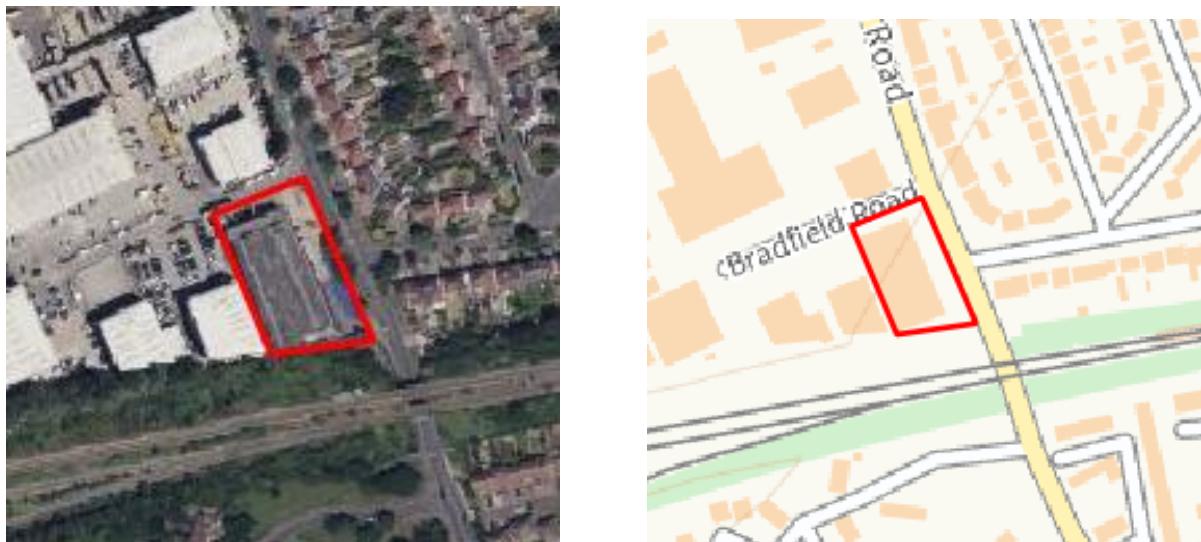
**Figure A:** Site Location Plan. Red is the site boundary. © Crown Copyright and Database Right 2024

The site is located at 1 Bradfield Road, Ruislip HA4 0NU, approximately 1.35 km east of South Ruislip train station and approximately 1.3 km north of A40 road. Figure 1 in Appendix A shows the location of the site. The area shown within the red site boundary on Plate A below, will be referred to throughout this document as 'the site'.

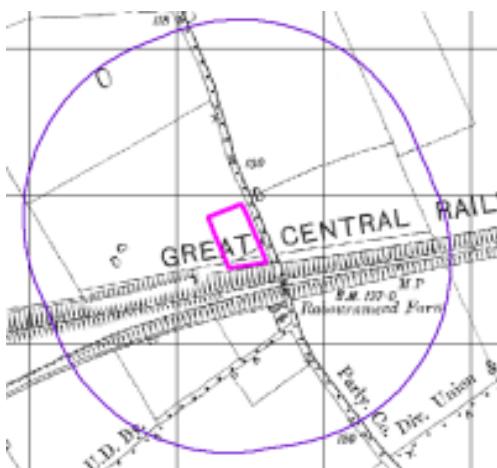
**Plate D:** Envirocheck Historical Map Extract dated 1916. Full plan provided in Appendix C. ©Crown copyright and database rights 2024

From the earliest map edition dated 1868 the site comprised agricultural land with drainage in the southern area of the site. By 1916 the site has been subject to the development of a railway line along the southern boundary of the site.
