Project: Safestore, South Ruislip

Appendix E – Borehole Logs and SPT Certificate

Hole Type DS	Easting 512463.28	Northing 185373.10	Ground Level (m) 39.19	Scale 1:25
Project Name Safestore, Ruislip	Project No. 4383	Start Date 2025-01-08	End Date 2025-01-08

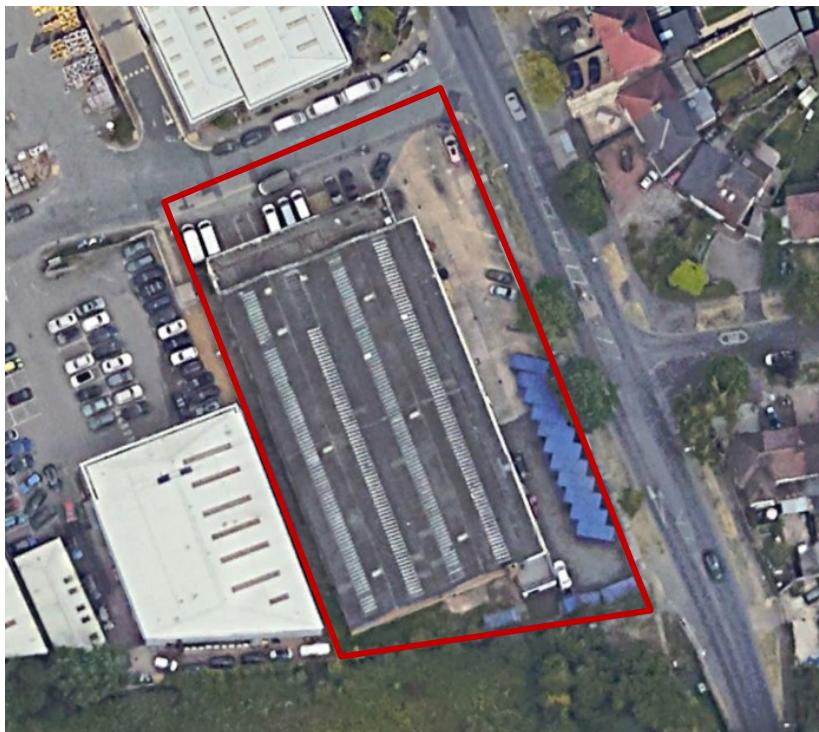
The Site

British National Grid Ref:

TQ 12483 85349

Current Site Occupancy		A post-WW2 constructed warehouse type building and associated hardstanding.
Historic Site occupancy (OS maps review)	Pre-WW1	Farmland.
	Interwar / Pre-WW2	Unchanged.
	Post-WW2 (circa 1950s)	Unchanged.
Proposed Works		<p>Two extensions to the existing building are planned, in the north and southeast. Various shallow mechanical excavations are assumed and the possible requirement for piled foundations cannot be discounted at this stage.</p> <p>Prior to development a GI will be undertaken, comprising four window sampler boreholes to 5.0m bgl.</p>

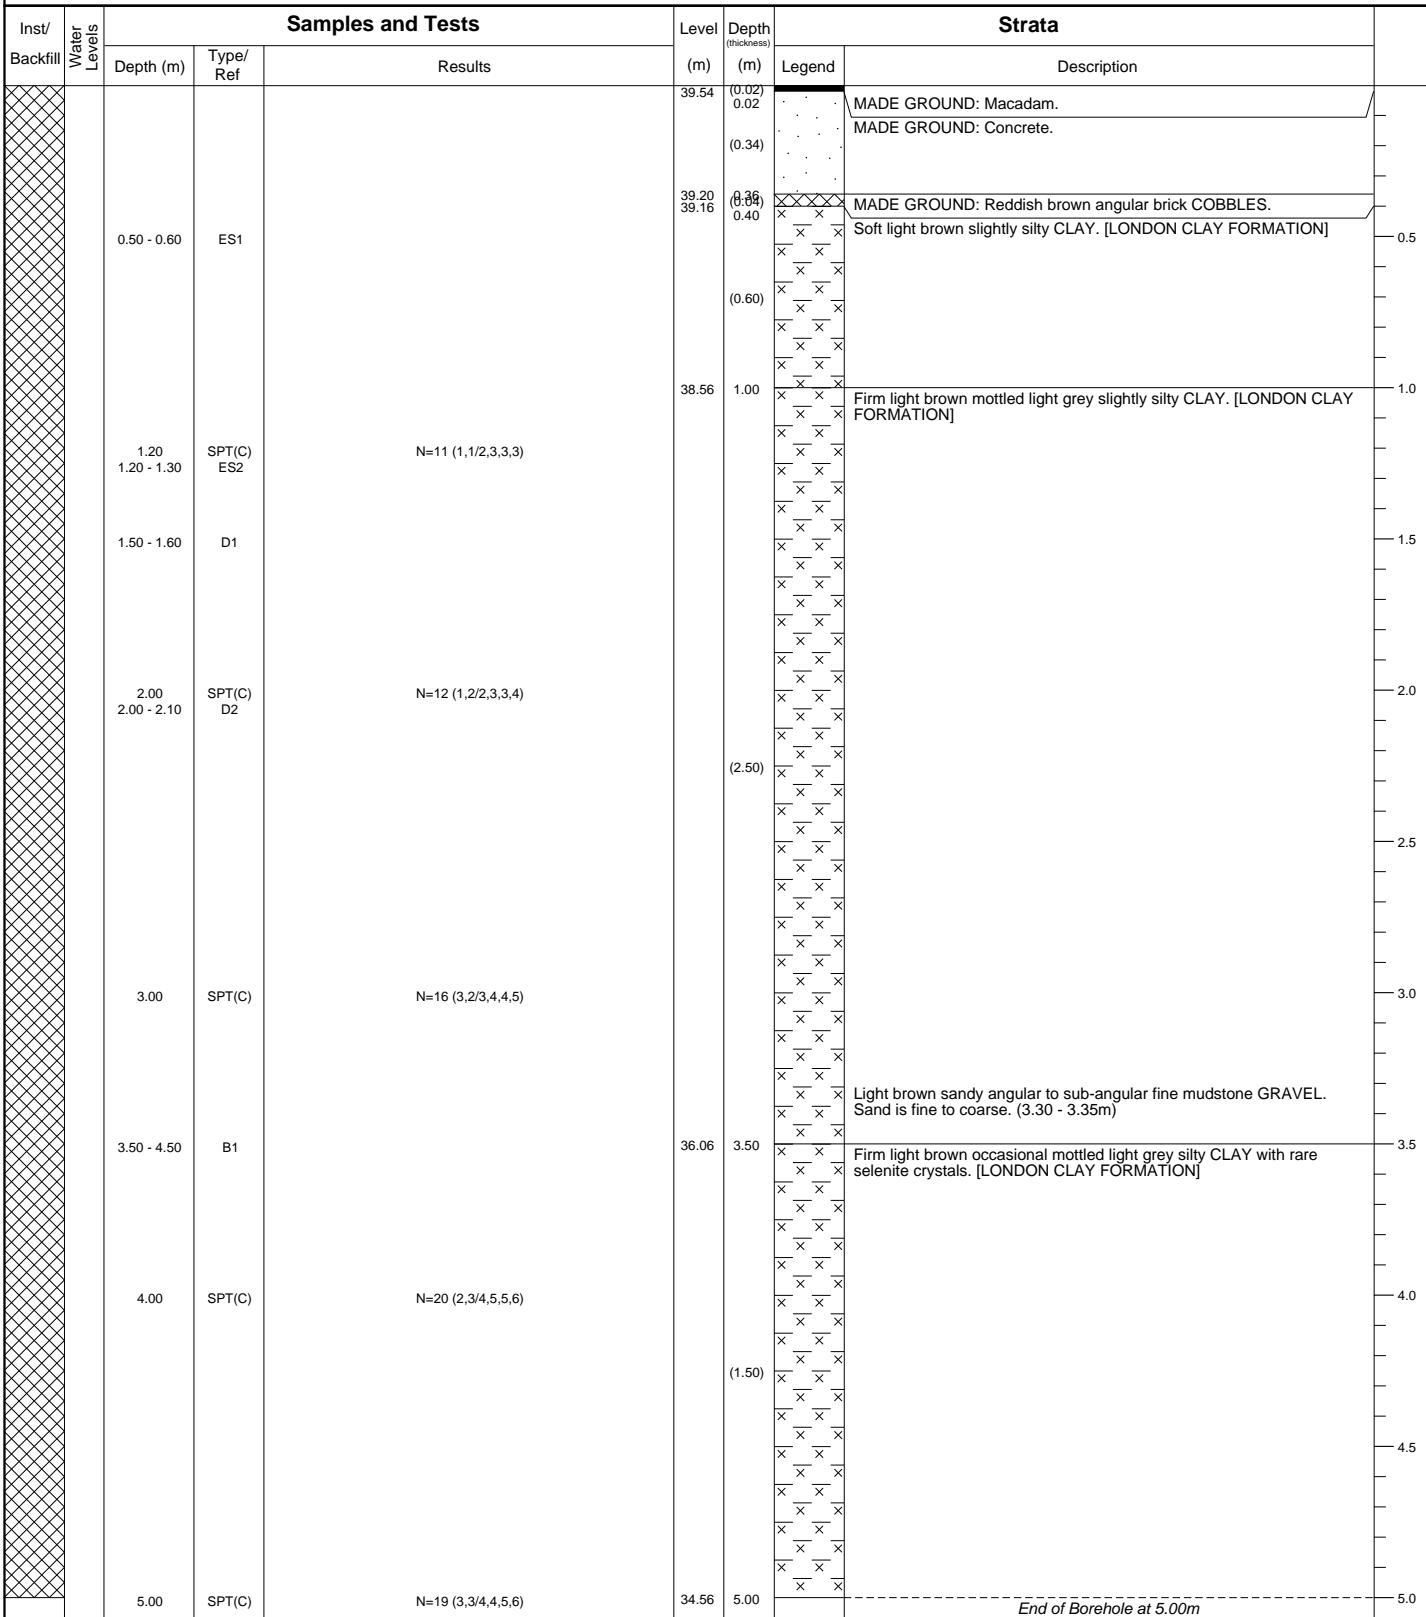
DS102

Hole Type	Easting	Northing	Ground Level (m)	Scale
DS	512475.60	185379.10	39.56	1:25
Project Name		Project No.	Start Date	End Date
Safestore, Ruislip		4383	2025-01-08	2025-01-08

1. Logged in general accordance with BS 5930:2015+A1:2020. 2. Area spot cleared for services prior to excavation by a specialist third-party contractor. 3. Hand dug pit advanced to 1.20 m bgl. 4. Not olfactory or visual evidence of contamination was noted. 5. SPT Hammer Test 10.71, Energy Ratio 76 %. 6. Borehole terminated at 5.00 m bgl due to target depth reached. 7. Borehole backfilled with arisings. 8. Borehole remained dry upon completion.

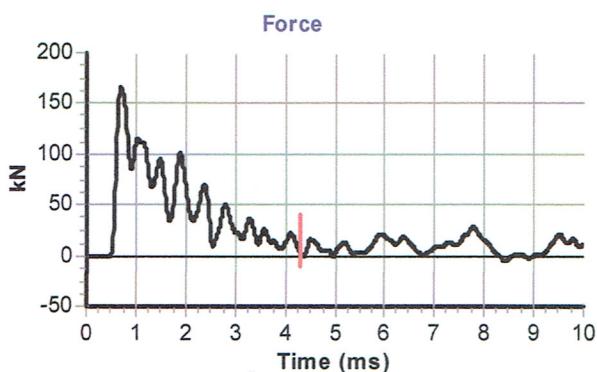
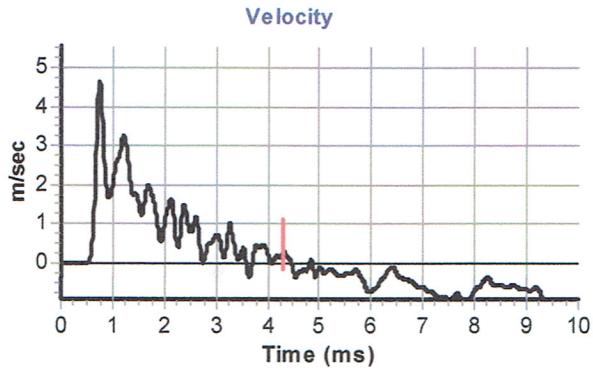
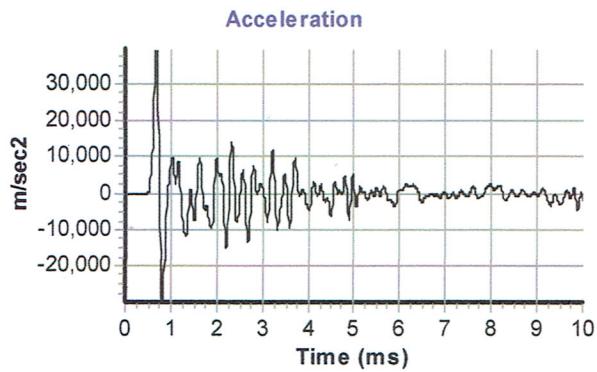
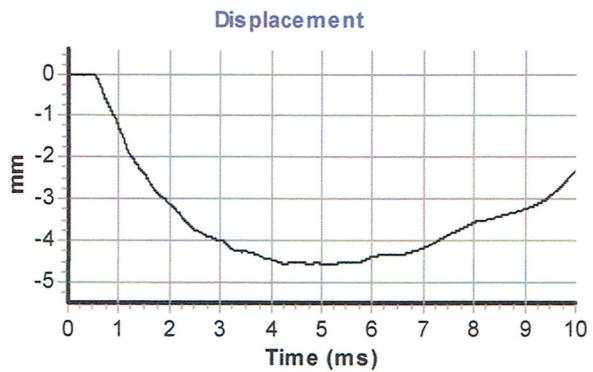
Comments / Location

Hammer Mass m (kg): 63.5
 Falling Height h (mm): 760
 SPT String Length L (m): 10.0

Area of Rod A (mm²): 983
 Theoretical Energy E_{theor} (J): 473
 Measured Energy E_{meas} (J): 359

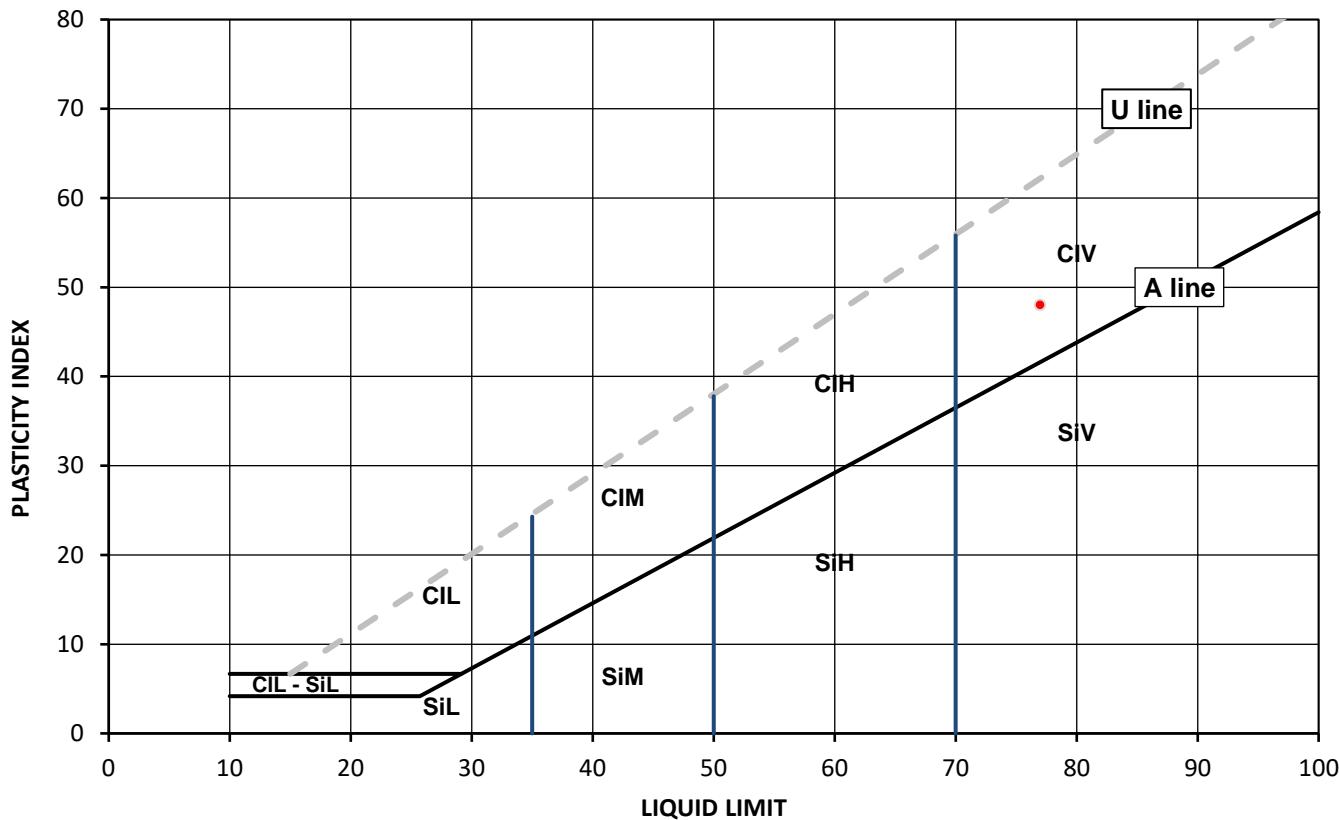
As Received Water Content [W] %	Liquid Limit [WL] %	Plastic Limit [Wp] %	Plasticity Index [Ip] %	Liquidity Index [IL] % #	Consistency Index [IC] % #	% Passing 425µm BS Test Sieve
34.2	77	29	48	0.10	0.90	94

Plasticity	Liquid Limit
Cl	Clay	L Low	below 35
Si	Silt	M Medium	35 to 50
		H High	50 to 70
		V Very high	exceeding 70
		O Organic	append to classification for organic material (eg CIHO)

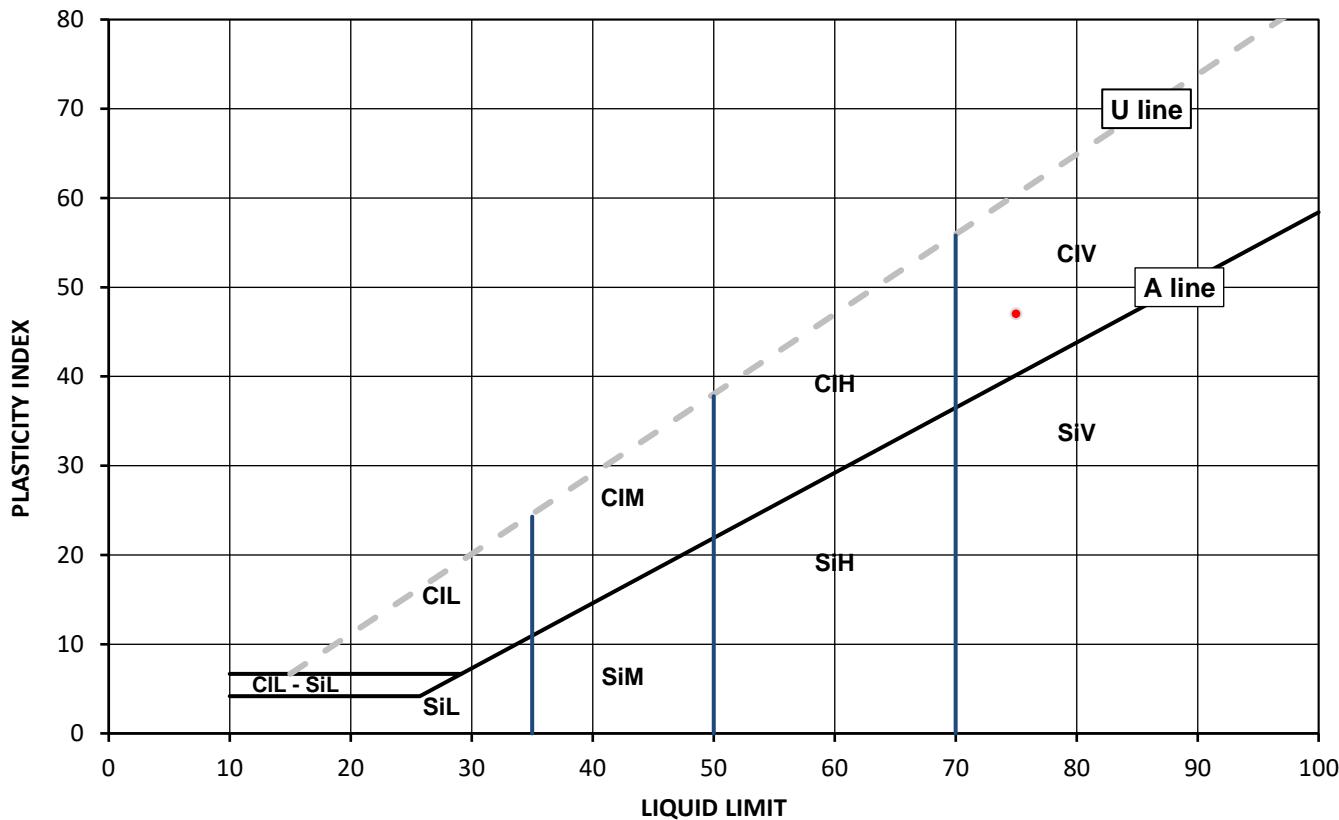
As Received Water Content [W] %	Liquid Limit [WL] %	Plastic Limit [Wp] %	Plasticity Index [Ip] %	Liquidity Index [IL] % #	Consistency Index [IC] % #	% Passing 425µm BS Test Sieve
31.1	75	28	47	0.06	0.94	95

Plasticity	Liquid Limit
Cl	Clay	L Low	below 35
Si	Silt	M Medium	35 to 50
		H High	50 to 70
		V Very high	exceeding 70
		O Organic	append to classification for organic material (eg CIHO)

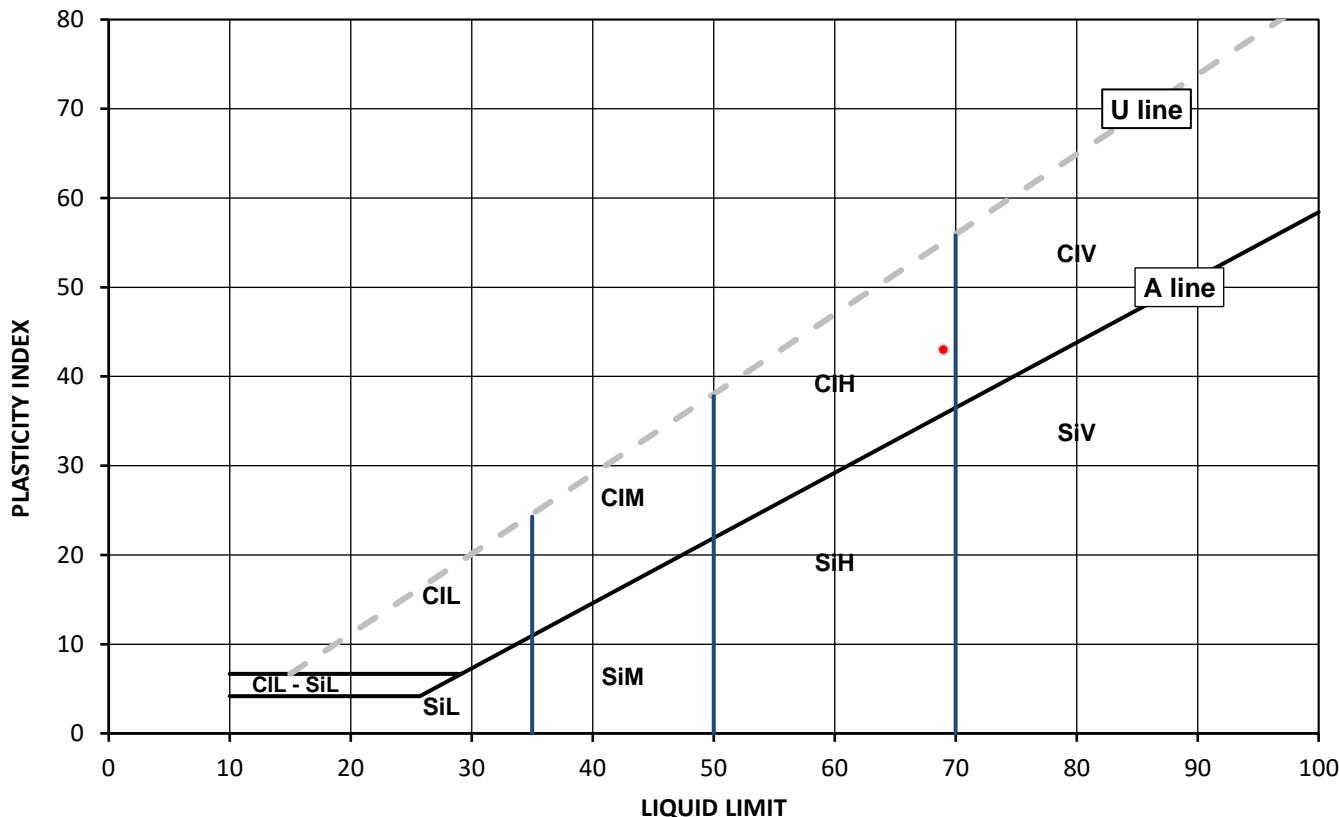
As Received Water Content [W] %	Liquid Limit [WL] %	Plastic Limit [Wp] %	Plasticity Index [Ip] %	Liquidity Index [IL] % #	Consistency Index [IC] % #	% Passing 425µm BS Test Sieve
28.7	69	26	43	0.07	0.93	100

Plasticity	Liquid Limit
Cl	Clay	L Low	below 35
Si	Silt	M Medium	35 to 50
		H High	50 to 70
		V Very high	exceeding 70
		O Organic	append to classification for organic material (eg CIHO)
