## **Bat Survey Report**

**61 Long Lane**

**Ickenham  
Uxbridge  
Middlesex  
UB10 8QU**

**19-019-BS  
September 2020**

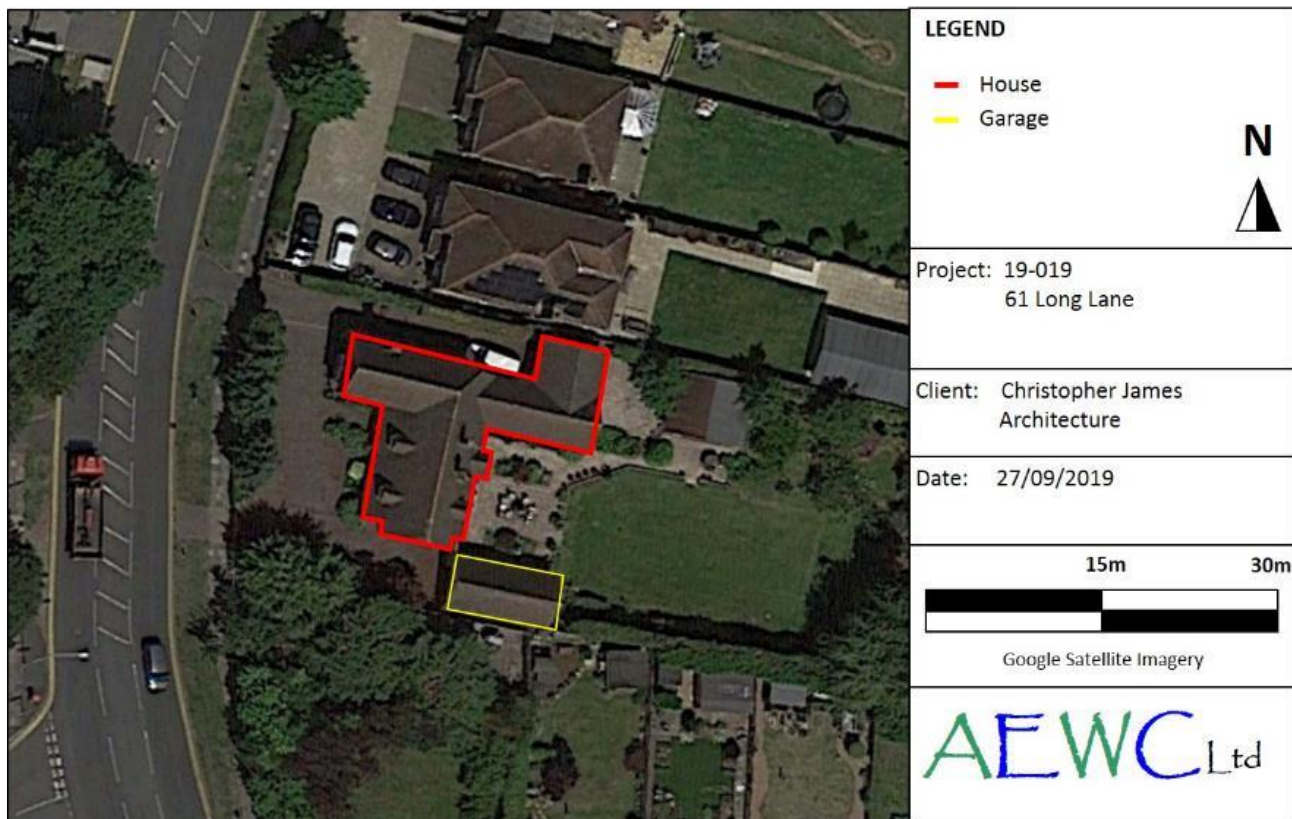
**FIGURE 2: SHOWING THE BUILDINGS SUBJECT TO SURVEY.**

- 1.6 The site comprises a detached, two-storey house and separate large garage set within a large, mature garden. The house is of brick construction with a complex pitched roof clad in clay tile. The main roof is L-shaped with a catslide and two dormers to both the western and eastern pitches. The single-storey extension to the north-eastern corner is also L-shaped. The garage is single-storey and of brick construction with a pitched, clay tile roof.

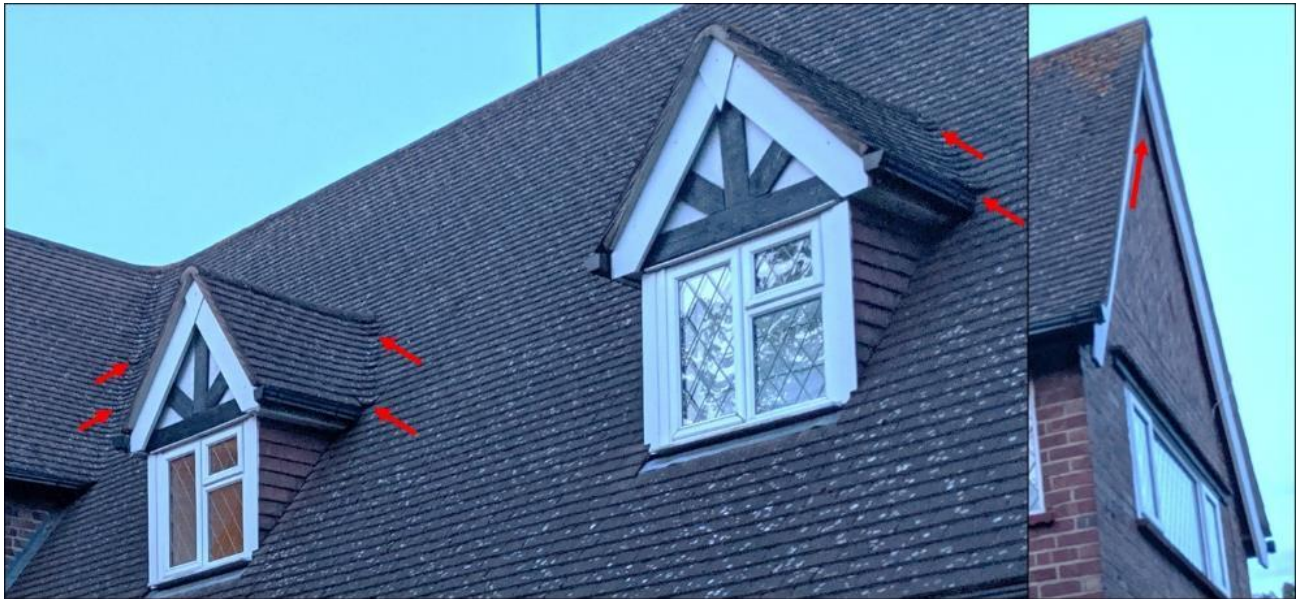
- 4.1 The house and garage were found to be in overall good condition, with even and tight-fitting roof tiles and well-sealed lead flashing. Some gaps were noted beneath individual roof tiles on the house, predominantly in the valleys and dormer valleys (Photograph 1). There was also a gap beneath the barge boards on the various gable ends, with potential for gaps at the wall top (Photograph 1). No evidence of bats was identified at any location externally around the house or garage on any of the survey visits.

**Photograph 1:** *Showing gaps beneath valley tiles and barge board on the house.*

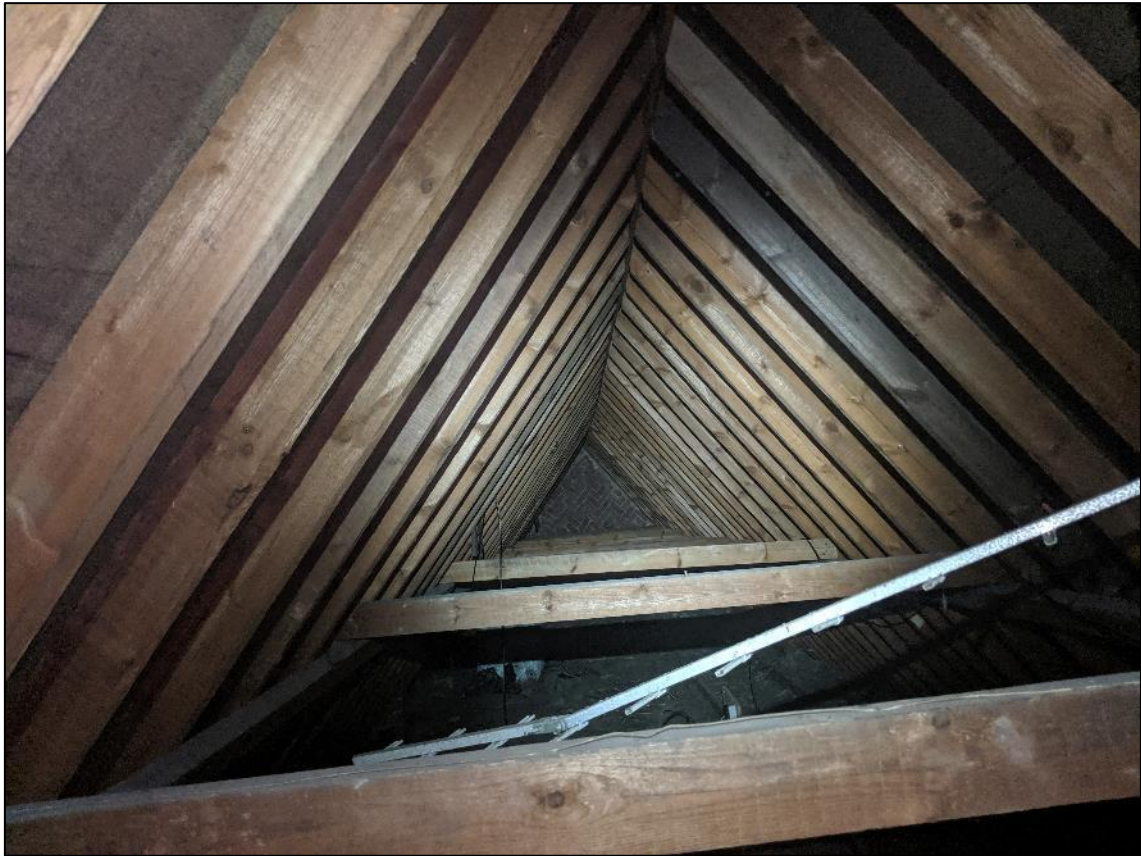
- 4.2 The house has two separate roof voids, one L-shaped void above the double-storey portion of the house and an additional loft void in the single-storey extension. Both voids have a timber construction and are lined internally with bitumen felt, with fibreglass insulation above the ceiling. Bat droppings were identified throughout the main void, of a size and shape typical of long-eared bats. Droppings were scattered along the full length of the void, predominantly below the ridge, with higher concentrations below the intersection of the two ridges and at the southern and western gable ends, where droppings were also found stuck to the gable end walls.

**Photograph 2:** Showing interior of the main void.

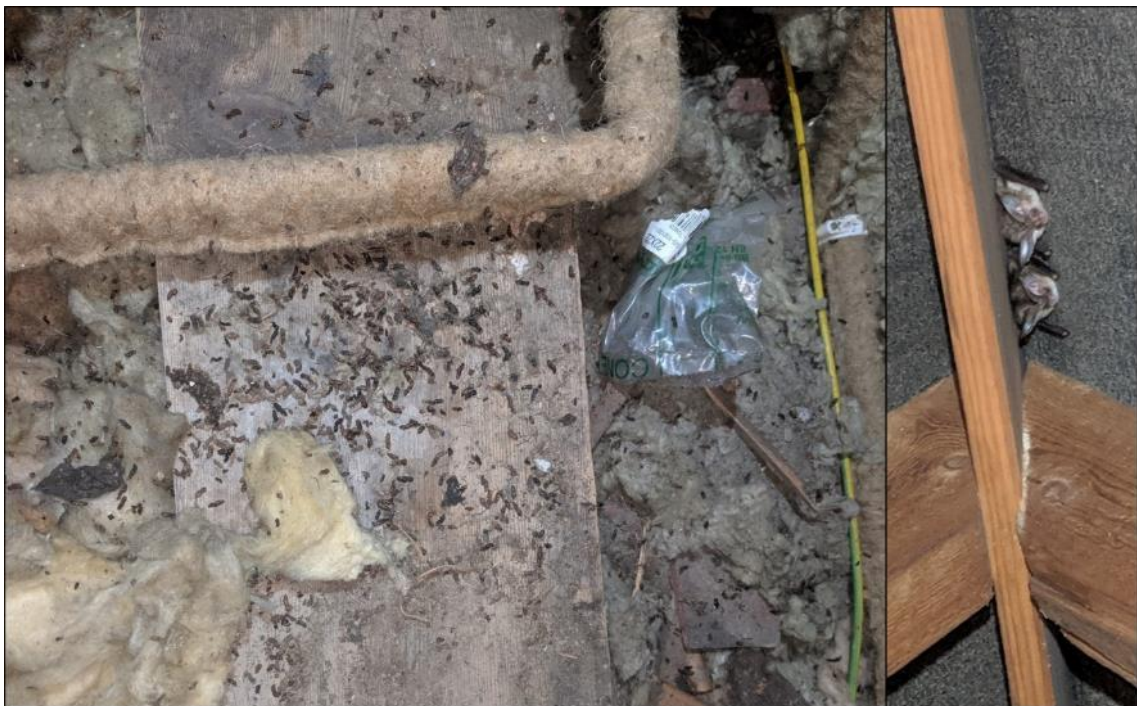
- 4.3 During the internal assessment on 21<sup>st</sup> June 2019 five brown long-eared bats were identified roosting at individual locations along the ridge of the main void, one of these was handled and confirmed to be a pregnant female. The additional inspection on 12<sup>th</sup> August 2019 identified two brown long-eared bats roosting together at the ridge of the main void (Photograph 3), one of which had colouration more typical of a juvenile bat. No bats were present during the inspection on 30<sup>th</sup> August 2019.

**Photograph 3:** Showing bat droppings within the main void of the house, and two brown long-eared bats present in the main void on 12<sup>th</sup> August 2019.

- 5.1 The house is a confirmed bat roost; several thousand droppings were identified within the main loft void and brown long-eared bats have been confirmed present in the void on two occasions: 21<sup>st</sup> June (five bats) and 12<sup>th</sup> August 2019 (two bats). From the numbers present, level of droppings, and the presence of a pregnant female on 21<sup>st</sup> June and a likely juvenile bat on 12<sup>th</sup> August, the house most likely supports a small maternity or satellite roost for brown long-eared bats.

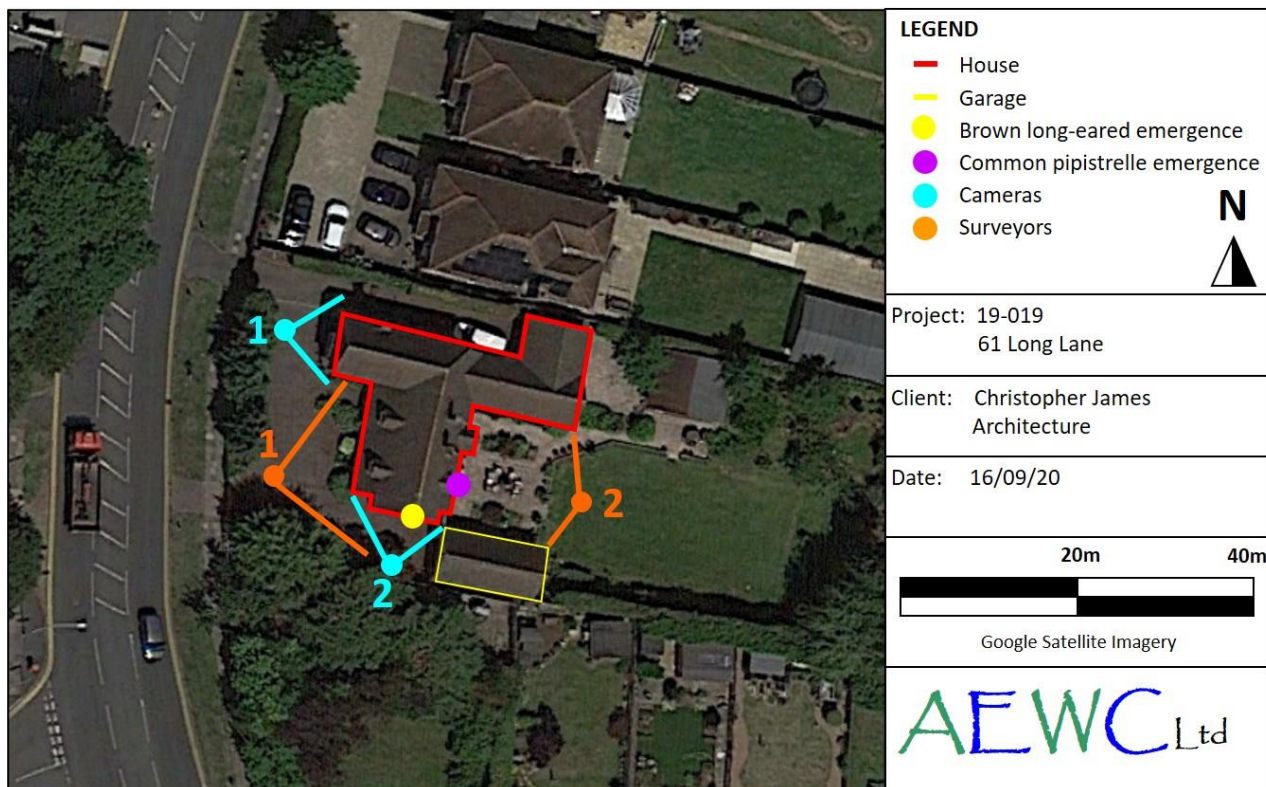
**FIGURE 3: SHOWING POSITIONS OF SURVEYORS AND CAMERAS, AND EMERGENCE POINT OF LONG-EARED BATS DURING THE SURVEYS.**

- 2.11 Two surveyors and two professional night vision cameras were used for the emergence surveys (Figure 3). The surveyors and cameras were positioned to get a good all-round view of the buildings, focusing on features with potential as access points for bats, to record any bats that may emerge.

- 4.7 **12<sup>th</sup> August 2019** – Weather conditions were good for the survey (17°C and clear with a slight breeze at 20:31) and any bats present were likely to be active. Two brown long-eared bats were recorded emerging from the southern gable end of the house, from below the barge board at the apex, and are likely the two seen during the internal inspection prior to the emergence survey starting. Bat activity was slightly higher than the first survey, with regular common and soprano pipistrelle foraging activity to the east of the house in the garden, a couple of long-eared bat passes and a single commuting noctule partway through the survey. Foraging bats approached from the south-east and west. No bats emerged from the garage during the survey.

- 4.9 **23<sup>rd</sup> July 2020** – Weather conditions were good for the survey (21°C and overcast with a light to moderate breeze at 21:03) and any bats present were likely to be active. Five common pipistrelle bats were recorded emerging from the apex of the southernmost dormer on the eastern roof pitch. The survey recorded low levels of bat activity with occasional common or soprano pipistrelle passes. No bats emerged from the garage during the survey.

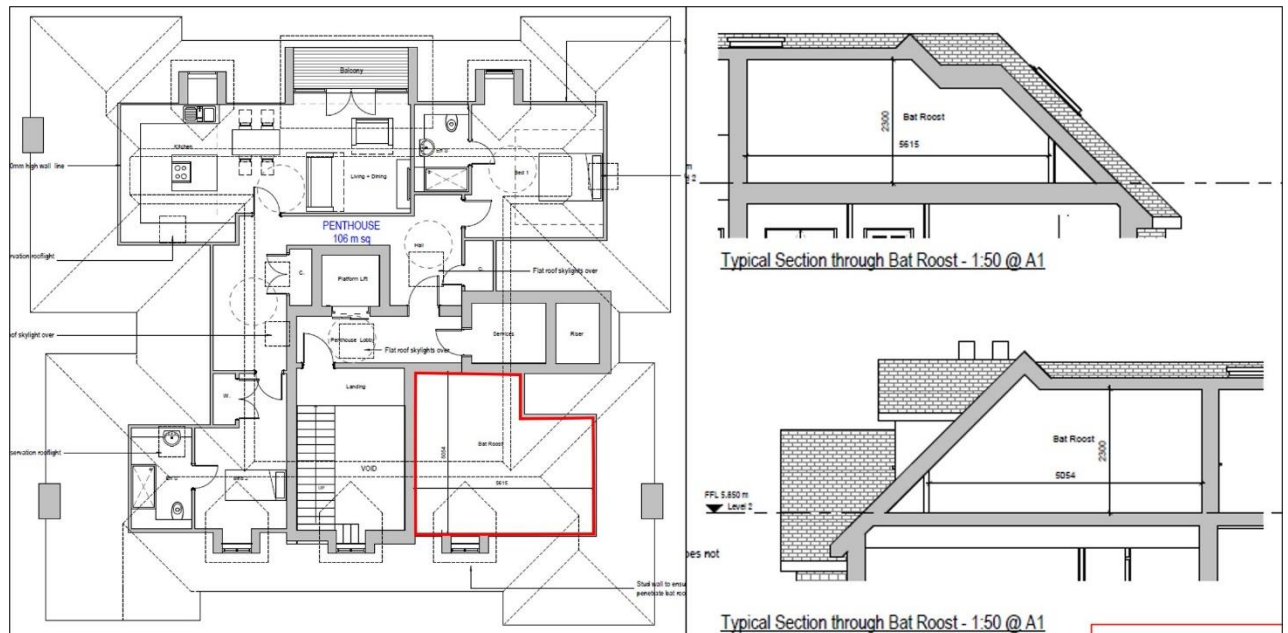
**FIGURE 4: SHOWING PROPOSED DEDICATED REPLACEMENT BAT LOFT.**

- 6.13 A dedicated bat loft must be created as mitigation for the loss of the existing void, and this is proposed to be created in the void over Apartment 8. A replacement bat loft has been agreed with the client of minimum dimensions 5.6 x 5 x 2.3 (L x W x internal height) and must be uncluttered (not trussed) – see Figure 4. The loft must have a timber ridge, this can be enhanced for long-eared bats by incorporating parallel timbers in between sections of rafters to provide a double ridge cavity, and triangular wedges to provide additional roosting crevices.
