# Preliminary Bat Roost Assessment

Charville Lane Children's Home, 113 Charville Lane, Hayes, London Borough of Hillingdon

A Report to: Hunters Architects  
Report Number: RT-MME-161166-02  
Date: August 2023

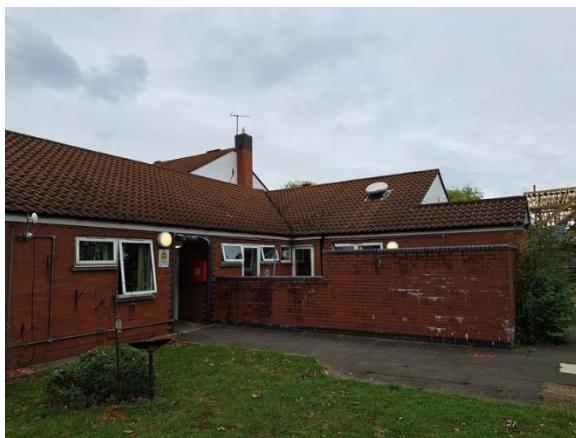
Plate 4.1: Building 1 (southern and western elevations)

A single brick building was present on site with a pitched, clay-tiled roof. The building consisted of an irregular shape and included single-storey and two-storey sections (Plates 4.1 and 4.2). The eaves consisted of plastic barge boards, while cladding was present high up at gable ends. The building also included a small conservatory on the southern elevation formed of bricks and glass and including a pitched grass roof. In addition, canopies and small porch areas, with single pitched, clay-tiled roofs were present at a number of the entrances.

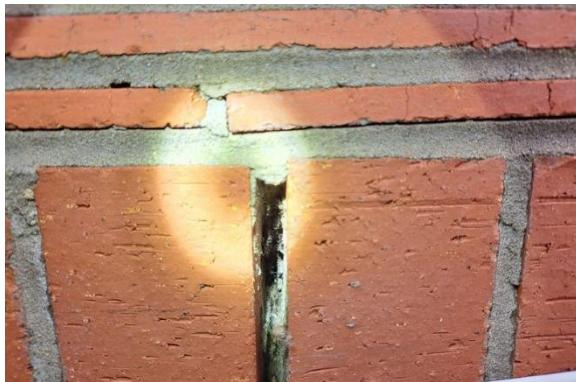
The building was in generally good repair, albeit a number of PRFs were present. The brickwork, although in good condition, contained a number of weepholes throughout, which could potentially offer small crevices suitable for roosting bats (Plate 4.3). Nonetheless, closer inspection of a number of these weepholes confirmed these crevices not to provide access into a cavity wall and these features are therefore only of limited suitability for roosting bats. Single gaps/vents were present in the cladding at the gable ends of Roof Voids RV1, RV3 and RV4 (see Drawing C161166-02-01), albeit these gaps were meshed and therefore did not provide access for roosting bats (Plate 4.4). Single, small gaps were also present in the barge boards on the southern elevation of roof void RV1 (Plate 4.5), and on the eastern elevation of roof void RV3. Although small, these gaps provided potential access points into the associated loft voids. While the tiles were generally closely fitted, gaps were sometimes present beneath the lower tiles across the building, above the guttering. Where present, these gaps comprised a relatively large space underneath the tile (Plate 4.6), albeit the location of guttering in front of and below these tiles would likely prevent/restrict bats from accessing these features (Plate 4.7). Finally, a number of vents were present on top of the roof ridge tiles (Plate 4.8). These vents likely provided limited access for bats given their structure, albeit the potential for bats to fit enter the vents, particularly where slightly warped, cannot be ruled out. Please see Drawing C161166-02-1 for the location of specific PRFs, albeit this plan does not include the weepholes or gaps beneath lower tiles given their location across the building.

**Plate 4.3: Example of weep hole**

**R1** **Building 1** has been identified as having moderate potential to support roosting bats. Bat Surveys: Good Practice Guidelines published by the Bat Conservation Trust (Collins, 2016)<sup>2</sup> recommends that for structures with moderate bat roosting potential two separate survey visits (consisting of one dusk emergence and a separate dawn re-entry survey) be undertaken during the bat emergence/re-entry survey season to determine the presence/absence of roosting bats within the structure. The bat emergence/re-entry survey season extends from May to September. At least one of the surveys should be undertaken during the peak season for emergence/re-entry surveys between May and August. Should this survey confirm the presence of roosting bats, it will be necessary to undertake additional surveys in order to inform a Natural England licence application. In addition, should the survey identify the presence of significant levels of bat activity at the site, it may be necessary to undertake further survey visits to comprehensively assess the value of the site to bats.

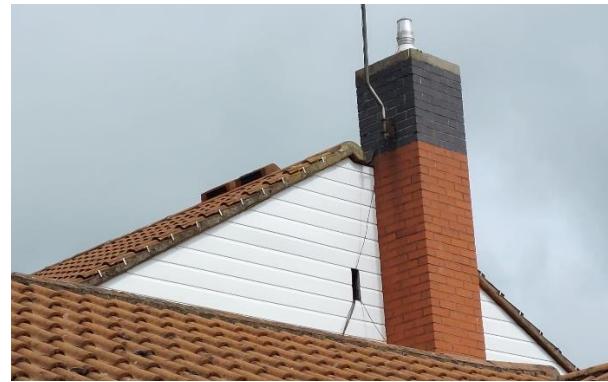
**Plate 4.4: Meshed gap in cladding on southern elevation**

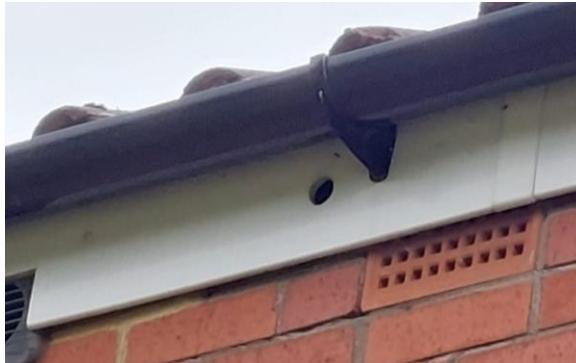
**Plate 4.5: Gap in barge board on southern elevation**

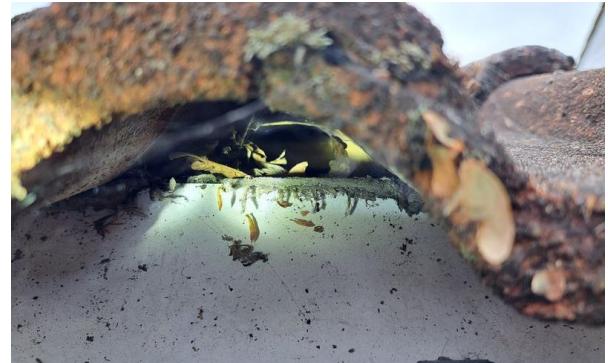
**Plate 4.6: Gap underneath lower tile**

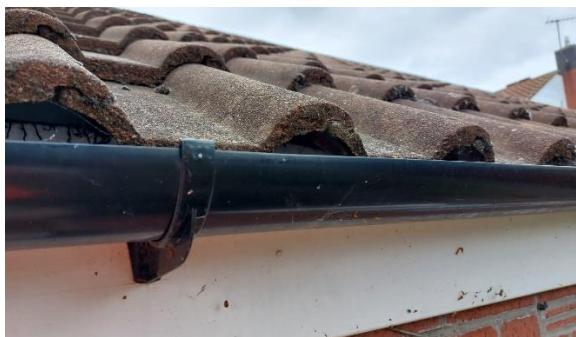
**Plate 4.7: Gaps beneath lower tiles partially blocked by guttering**

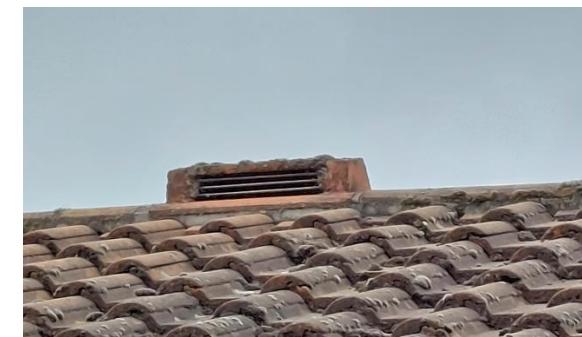
**Plate 4.8: Example of vent on ridge tile**

In summary, potential roosting features/access points for bats included weepholes, occasional gaps in the barge boards, gaps underneath tiles at the eaves (which appeared to provide access into roof void RV2a) and vents on the ridge tiles. However, in general, access to favourable roosting spaces was limited, with only occasional access points into the loft voids, while the voids themselves were in good condition with no evidence of roosting bats recorded. Other PRFs had restricted value or limited access and overall, based on the nature of the features present, the building is considered to support moderate bat roosting potential.

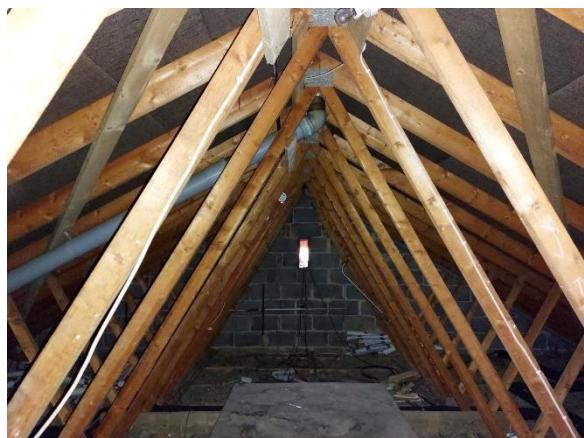
**Plate 4.9: Roof void RV1**

The building internals comprised four loft voids as mapped on Drawing C161166-02-01. Roof void RV1 (Plate 4.9), located over the far western section of the building, comprised a large open void approximately 2m tall, 10m long and 10m wide. The void included a number of beams and rafters, but with no ridge beam present, while the vents present on the ridge tiles (viewed externally), were not visible above the felt sarking. The felt sarking was untorn and in good condition with no associated gaps present (Plate 4.10), while the remainder of the void also appeared to be in good condition with strong insulation and no storage or clutter, with the void likely having been recently refurbished. The void contained minimal light, including from the eaves, suggesting an absence of access points. Nonetheless, a small pocket of light entered from the south-facing aspect due to a hole in the fascia (see Plate 4.5 above). Rectangular gaps/vents were present at the gable ends, albeit these were meshed (Plate 4.11) and as such did not provide access for bats.

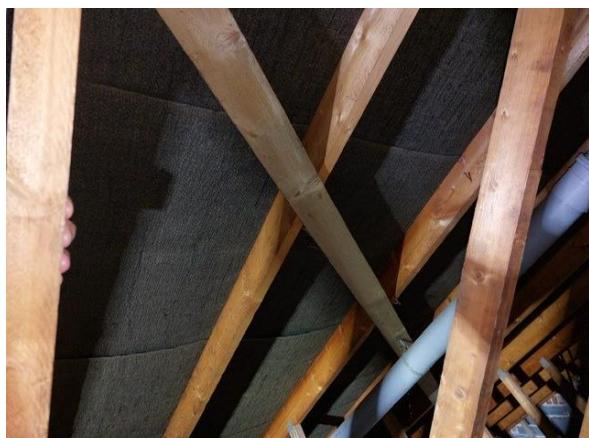
**Plate 4.10: Example of felt sarking in good condition**

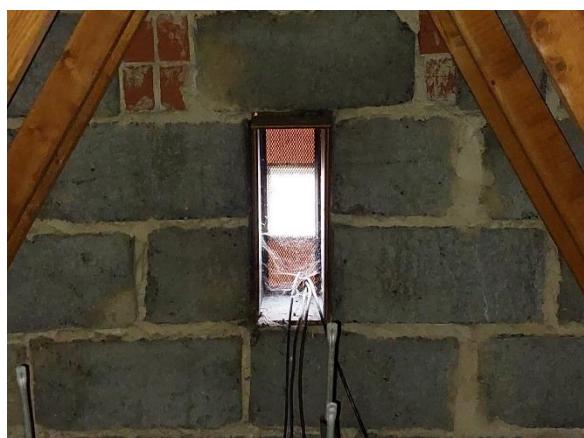
**Plate 4.11: Example of meshed gap/vent**

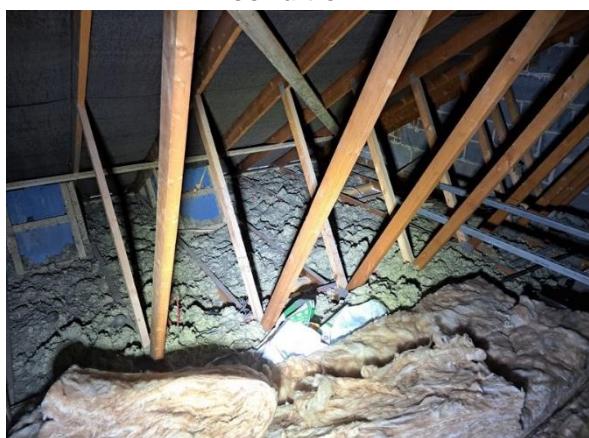
**Plate 4.12: Roof void RV4**

Roof void RV4 (Plate 4.12), again, was similar in structure and size to void RV1, but with no evidence of entry points for roosting bats. A rectangular gap was present in the southern gable but was meshed off.

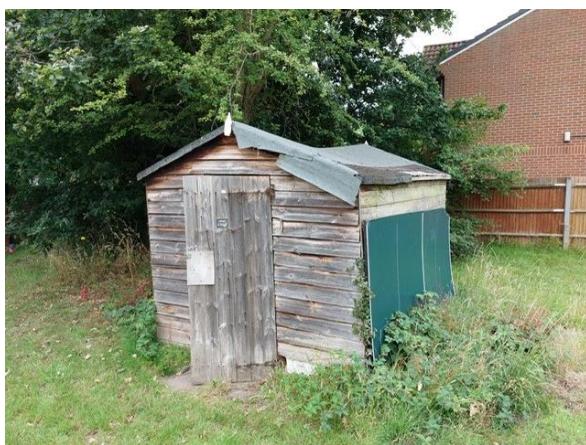
**Plate 4.13: Shed**

A single wooden shed, with a pitched felt roof, was present on site (Plate 4.13). The shed was fully inspected and despite being in relatively poor repair, presented no suitable access points or roosting opportunities for bats.

**R2** **Shed:** The wooden shed was fully surveyed and no bat roosts were found, while the structure was identified to have negligible potential to support roosting bats. The survey data obtained for the site is valid for 12 months from the survey date. If proposed site works have not commenced within this timeframe it will be essential to update the survey effort to establish if features have formed which could be used by roosting bats in the interim. In the unlikely event that a bat is found during works, all works must immediately cease and a suitably qualified ecologist should be contacted.
