## **APPENDIX C**

*Site Photographs*

Hillingdon Borough Council

Charville Lane

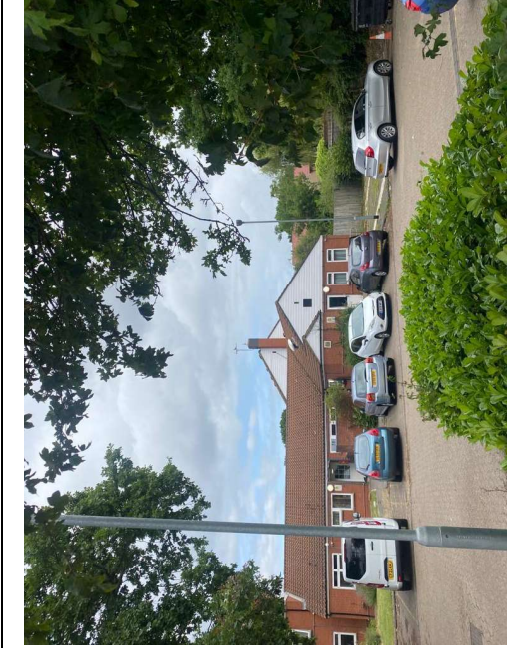
**Photographic plate 1** – View of the existing property

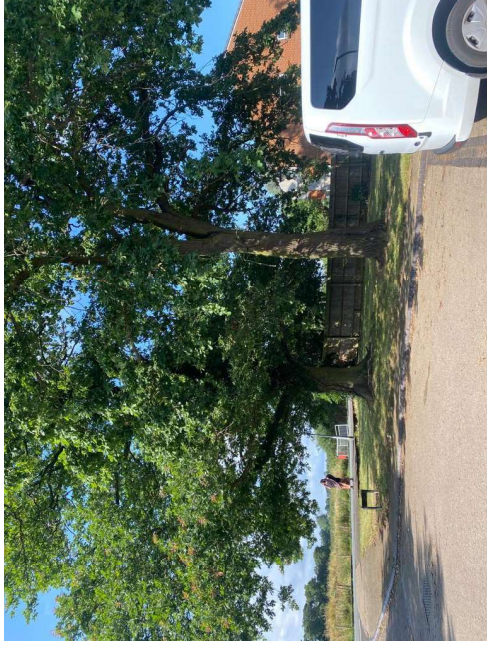
**Photographic plate 2** – Existing mature oak trees in the southwestern corner where WS07 was conducted

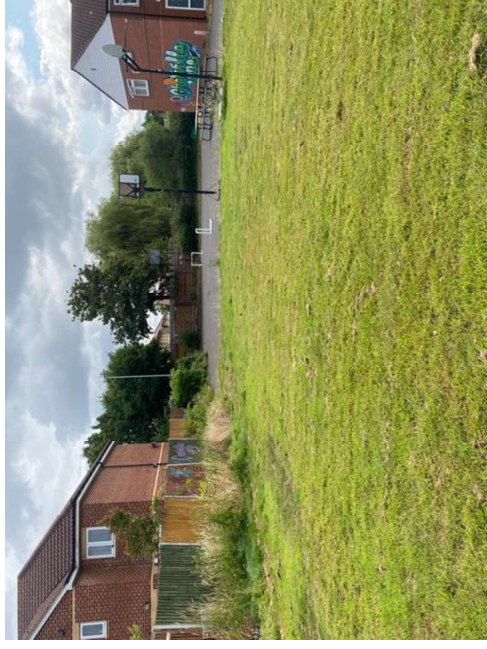
**Photographic plate 3** – Soft landscaping along the northern boundary where WS01, WS02 and WS03 were conducted

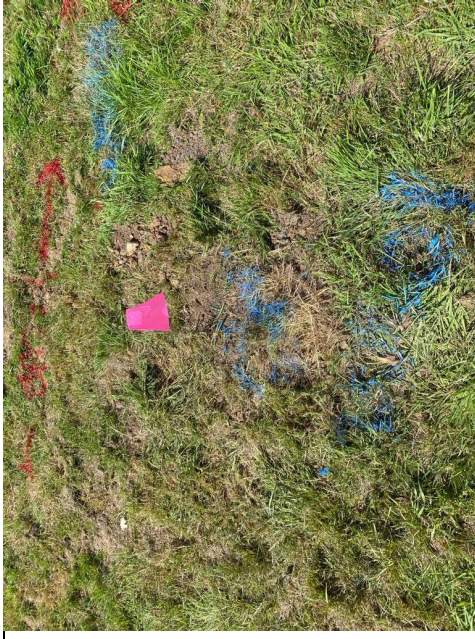
**Photographic plate 4** – WS01 backfilled after excavation

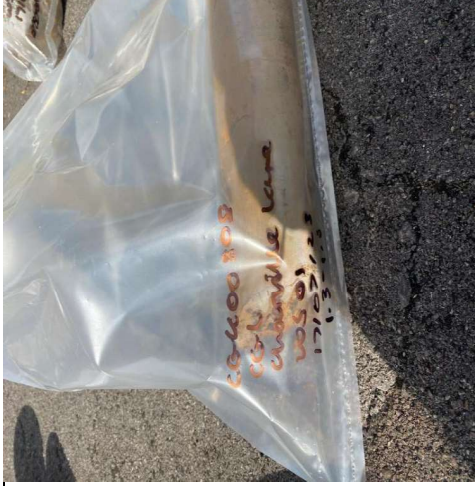
**Photographic plate 5** – Samples collected between 1.3 to 1.6m bgl from WS01

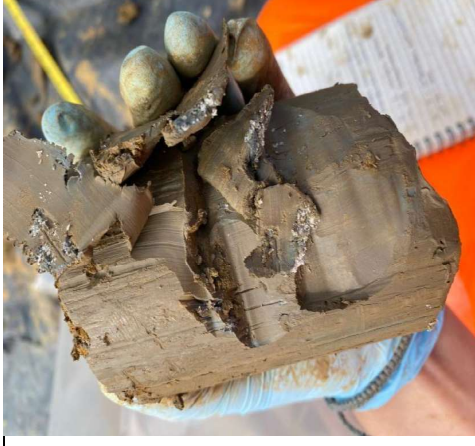
**Photographic plate 6** – Selenite crystals encountered from 2.5m bgl in WS01

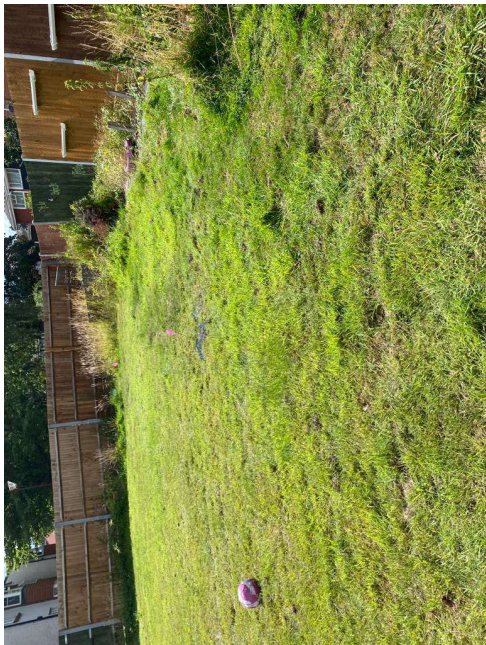
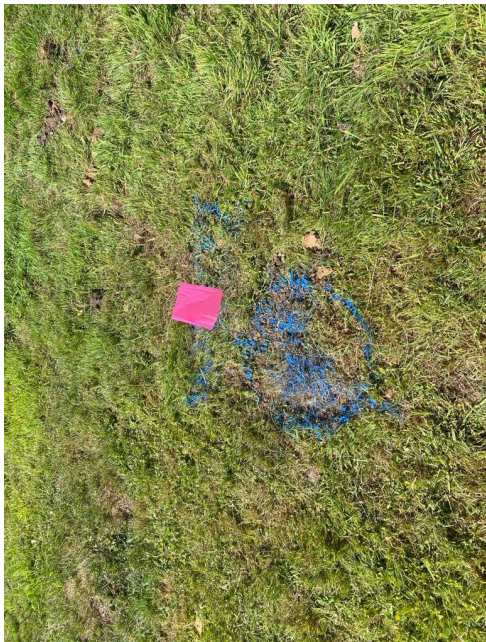
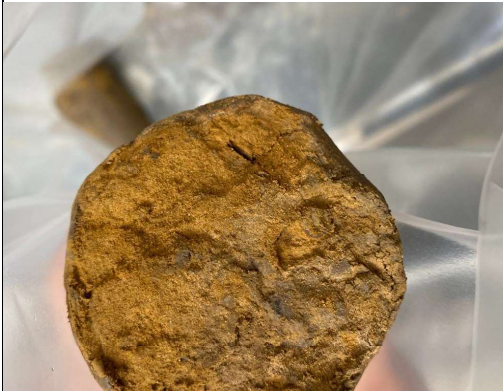
| <b>Photographic plate 7</b> – Location of WS02 | <b>Photographic plate 8</b> – WS02 backfilled after excavation | <b>Photographic plate 9</b> – material excavated from WS02 between 2 to 2.45m<br>bgl |

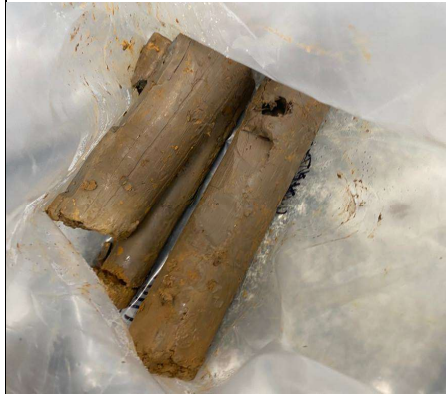
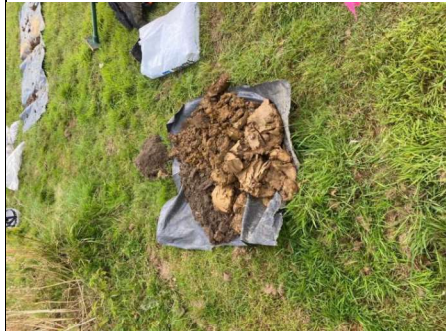
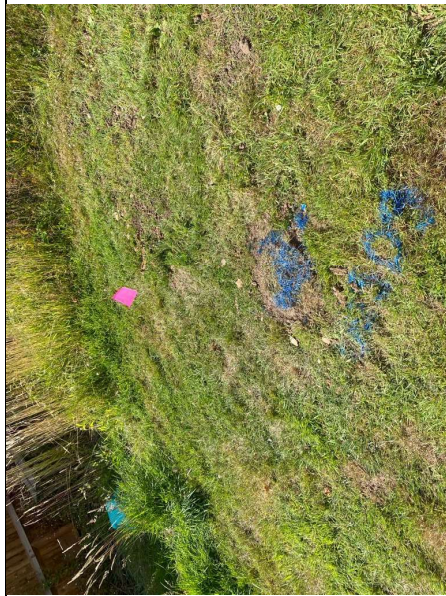
| <b>Photographic plate 10</b> – material excavated from WS02 between 3.5 to 4m<br>bgl | <b>Photographic plate 11</b> – Spoil from WS02 | <b>Photographic plate 12</b> – WS03 backfilled after excavation |

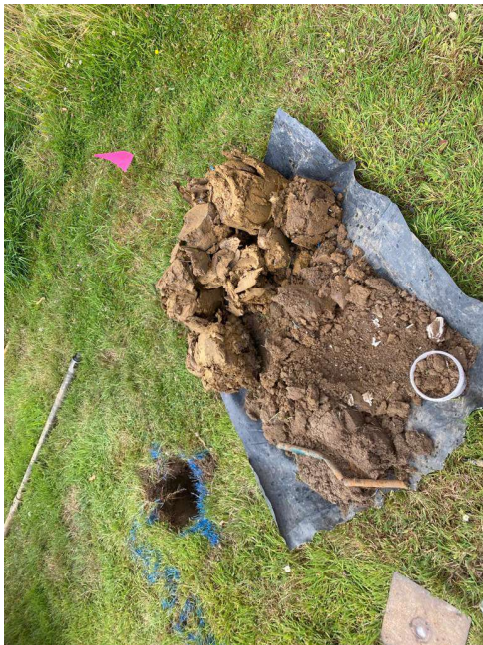
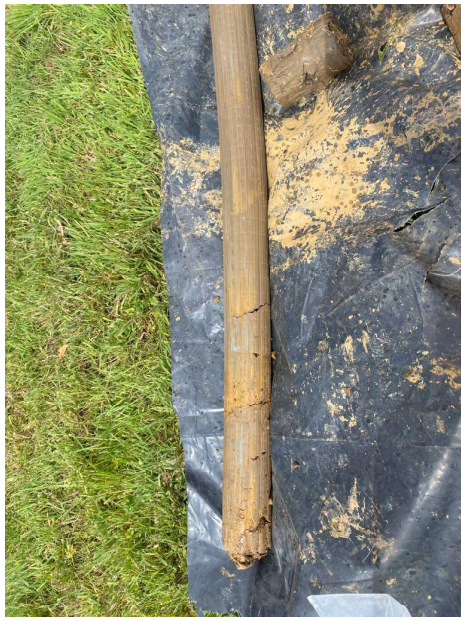
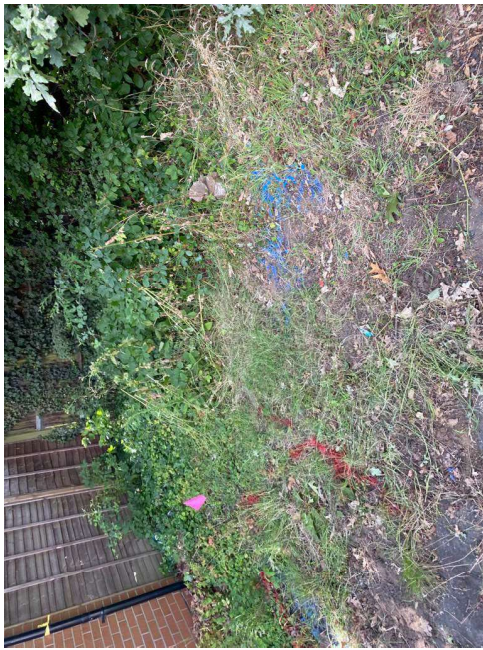
| <b>Photographic plate 13</b> – Spoil from WS03 and view of the open exploratory hole | <b>Photographic plate 14</b> – Core from 2.0 to 3.0m bgl from WS03 | <b>Photographic plate 15</b> – WS04 backfilled after excavation |

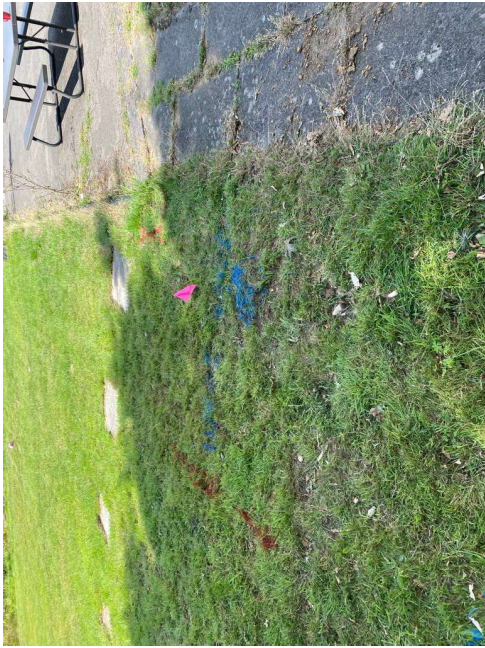
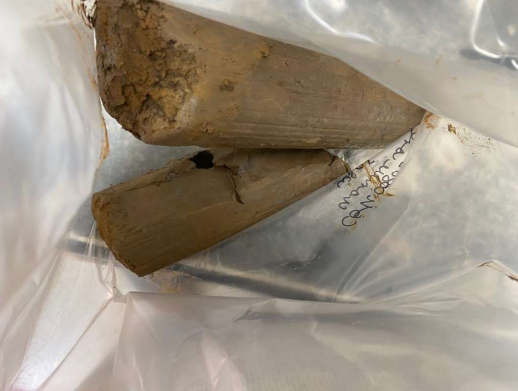
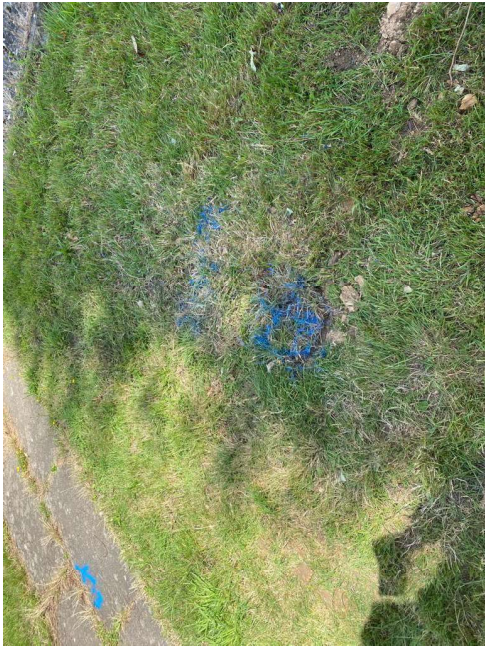
| <b>Photographic plate 19</b> – WS05 backfilled after excavation | <b>Photographic plate 20</b> – material excavated from WS05 between 2.5 to 3m bgl | <b>Photographic plate 21</b> – WS06 backfilled after excavation |

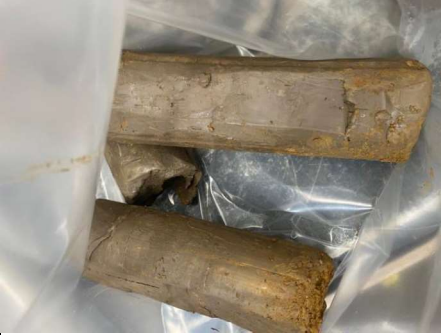
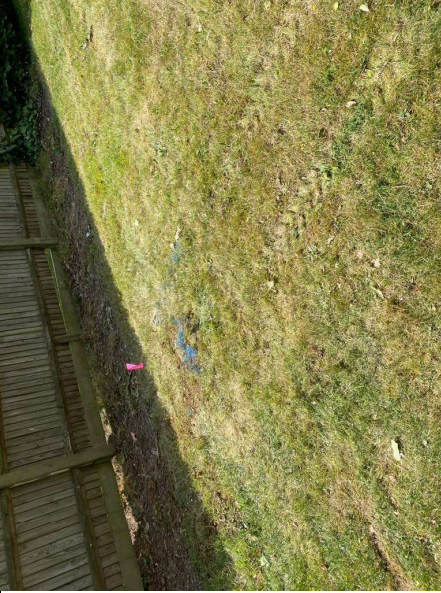
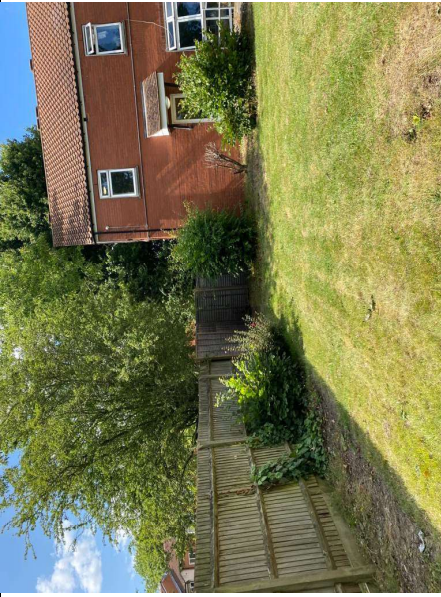
| <b>Photographic plate 22</b> – material excavated from WS06 between 3.5 to 4m bgl | <b>Photographic plate 23</b> – WS07 backfilled after excavation | <b>Photographic plate 24</b> – View to the north of WS07 |

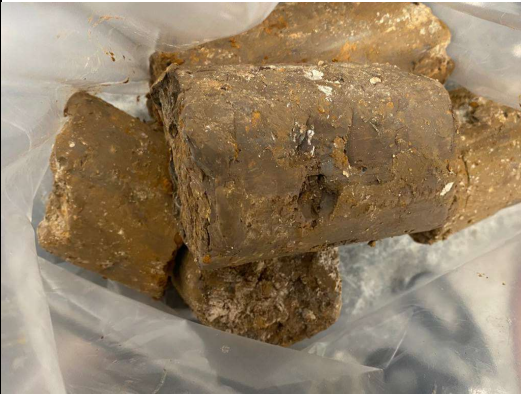
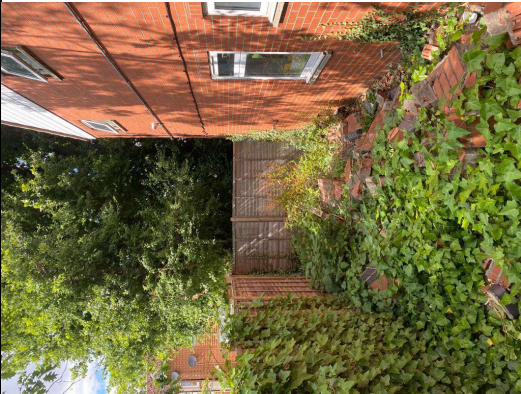
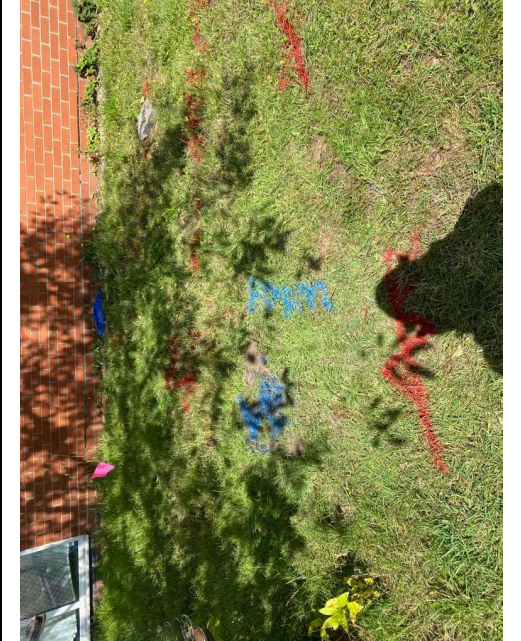
| <b>Photographic plate 25</b> – Material excavated from WS07 between 1.8 to 2m<br>bgl | <b>Photographic plate 26</b> – Area to the west of the property which was inaccessible to the drilling rig. Approximate location of proposed garden of House C | <b>Photographic plate 27</b> – Areas marked out for the GPR survey |
