## PART 2

### SUPPLEMENTARY SOIL CONTAMINATION ASSESSMENT

<b>Client</b>	Bugler Developments Limited
<b>Works</b>	Hand Excavated Trial Pitting and Soil Contamination Testing
<b>Site</b>	Former Childrens Centre, 113 Charville Lane, Hayes, UB4 8PD

<b>Project</b>	<b>Version</b>	<b>Date</b>
23-267.03	1	23 March 2024

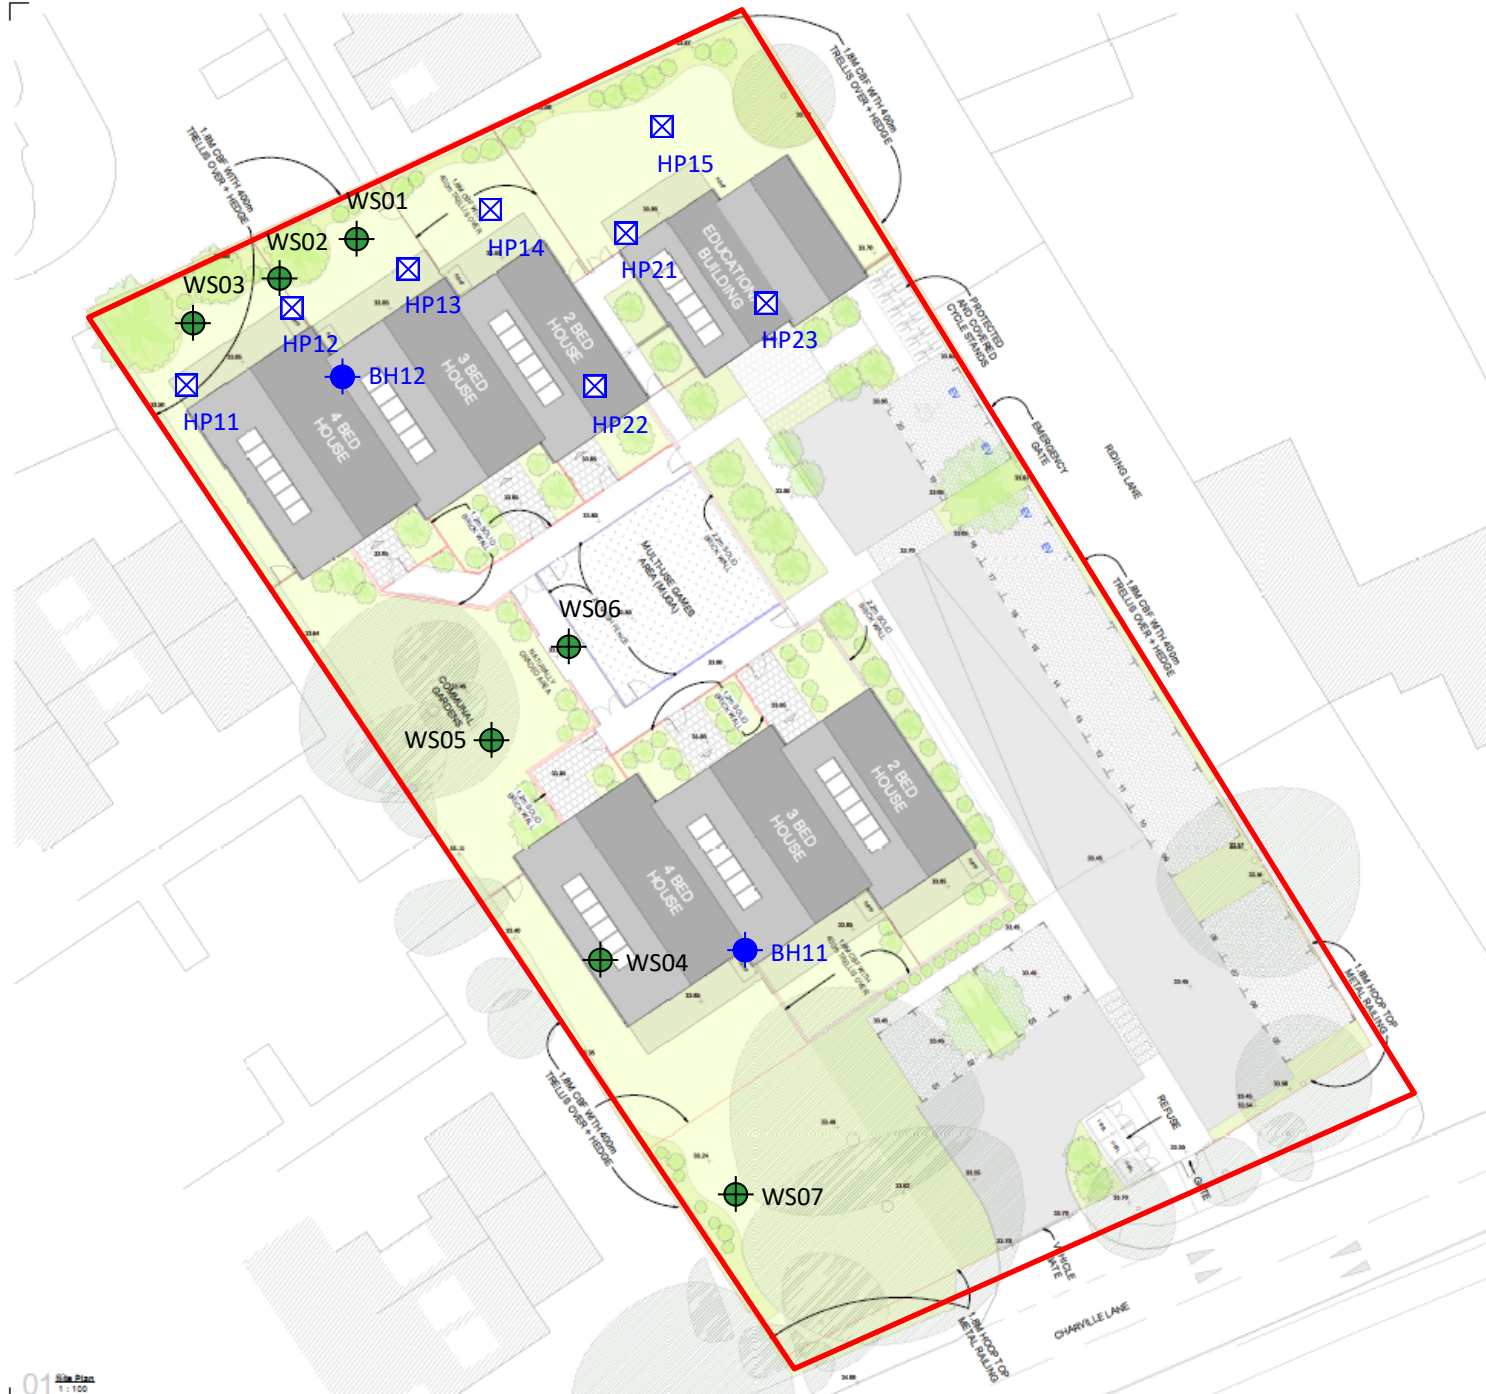
#### Figure 2

**Figures 1 and 2** presents Exploratory Hole Location Plans and Table 1 provides a rationale of trial hole locations.

Exploratory Hole and Proposed Site Layout Plan

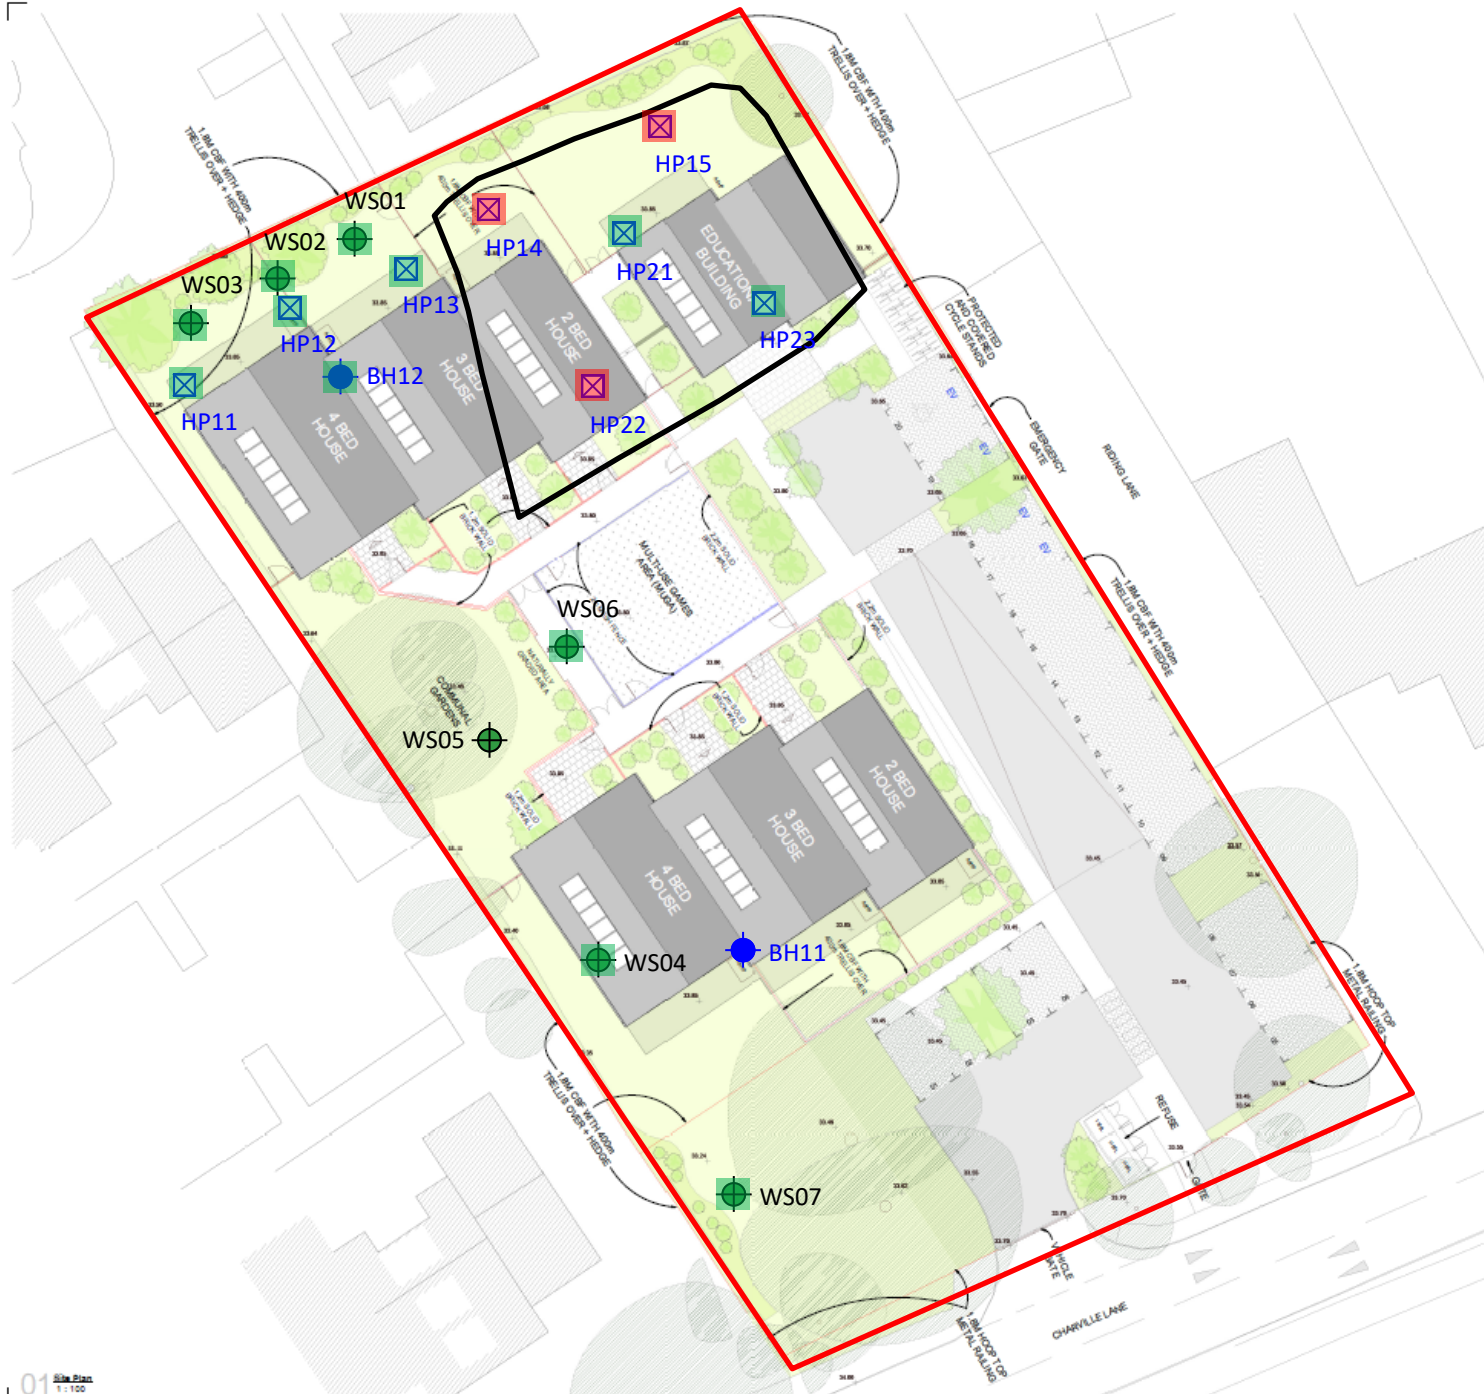
#### Figure 5

Detections of amosite, chrysotile and crocidolite asbestos have been recorded within HP14, HP15 and HP22 within the Made Ground sub-base beneath the tarmac Play-Area, which shall form new private and communal gardens.

Enclosed within **Appendix I** is **Figure 5** which provide a Human Health Soil Contamination Location Plan. Although asbestos was not encountered within the samples obtained from HP21 and HP23 the entire sub-base should be treated as potentially asbestos contaminated given the presence of asbestos within the Made Ground of HP14, HP15 and HP22.

Human Health Soil Contamination Location Plan

The presence of asbestos fibre is likely a result of asbestos contamination within re-purposed fill material/agreement which was used to form the sub-base to the Play-Area. Accordingly remedial shall be required which will involve:

**Private Graden (HP14).** Removal of the Made Ground sub-base to a depth of 0.6m below final levels. At 0.6m the formation should be covered with a high-viz geotextile membrane prior to laying with 0.6m (600mm) of 'clean cover' of sub-soils and topsoil.
-

**Communal Graden (HP15).** Removal of the Made Ground sub-base to a depth of 0.3m below final levels. At 0.6m the formation should be covered with a high-viz geotextile membrane prior to laying with 0.6m (600mm) of 'clean cover' of sub-soils and topsoil. Should vegetable/produce planting be proposed in parts of this communal/education garden the removal/cover thickness/depth should be increased to 600mm.

1. Cover the area in permanent hardstand (pavers/tarmac) to create a hard-landscaped encapsulated surfacing.
2. Construct a 600mm/300mm thick cover system to soft landscaped/gardens areas with at least 600mm/300mm of 'clean Topsoil' (and sub-soil) placed upon a geotextile membrane. The 600mm thickness applied to private gardens or area of vegetable/produce planting and the lesser 300mm thickness to communal gardens where produce shall not be grown.

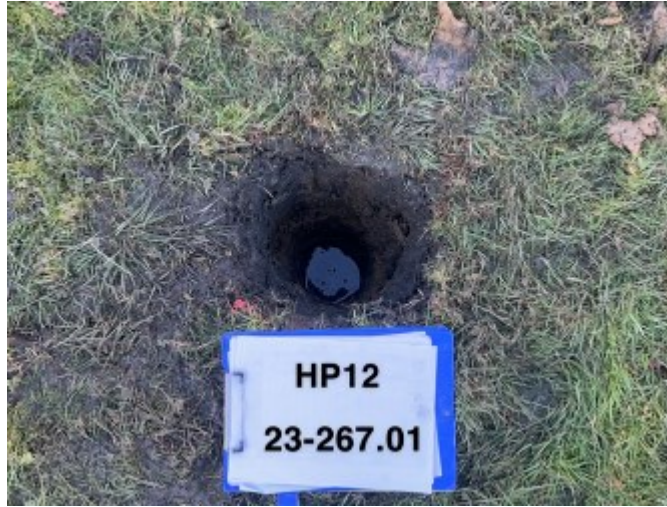
- 🌱 HP11 at 0.4m to west of WS02 of 110mg/kg
- 🌱 HP12 at 0.2m upon WS02 of 290mg/kg
- 🌱 HP13 at 0.3m to east of WS02 of 120mg/kg
- 🌱 BH12 at 0.3m to south of WS02 of 140mg/kg

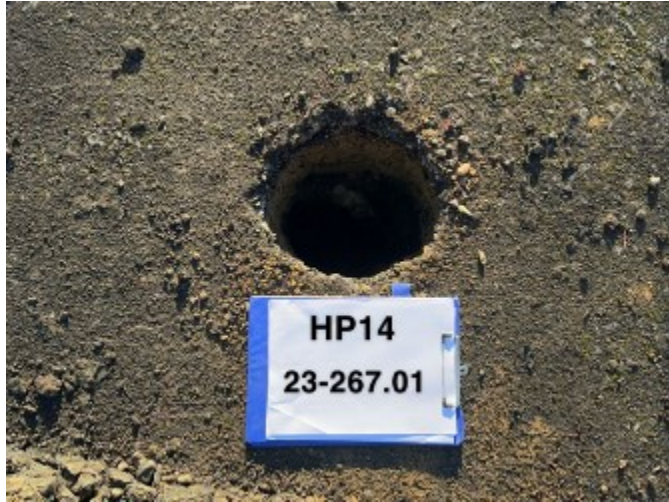
HP14

Observations	An oily/hydrocarbon odour was encountered within the MG of HP14, HP15 and HP23 at 0.3-0.7m bgl, 0.4-0.9m bgl and 0.5-0.7m bgl respectively.		
GL = Ground Level

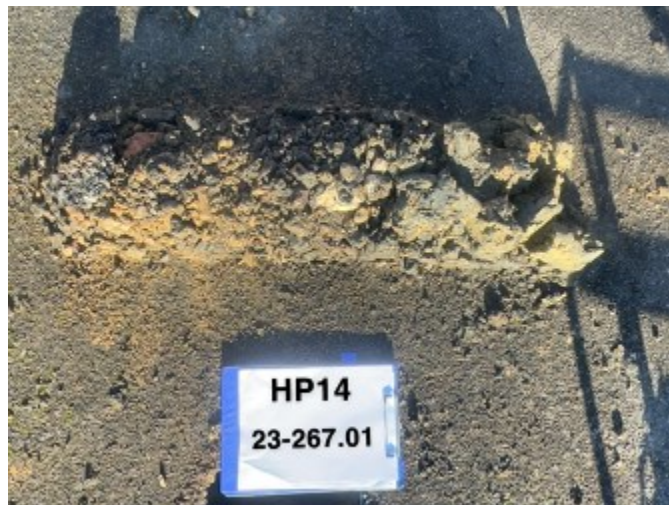
HP14 arisings

Sample Number	Sample ID	Sample Depth (m)	Sample Weight (g)	Asbestos Containing Material Types Detected (ACM)	PLM Results	Asbestos by hand picking/weighing (%)	Total % Asbestos in Sample
102843	HP14	0.50	168	Loose Fibrous Debris	Chrysotile	0.005	0.005
102845	HP15	0.80	169	Loose Fibres	Amosite & Chrysotile	< 0.001	< 0.001

***Given the presence of asbestos within the sub-base base beneath the tarmac playground construction workers should ensure suitable Personal Protective Equipment (PPE) is worn and working practices are adopted to prevent fibre release. The presence of amosite and crocidolite may also be notifiable to the Health and Safety Executive (HSE) as a hazardous material and suitable advice in this regard should be sought from an asbestos specialist.***
