KDK ARCHAEOLOGY LTD

## Historic Building Recording

Harefield Grove  
Rickmansworth Road  
Harefield  
London

October 2018

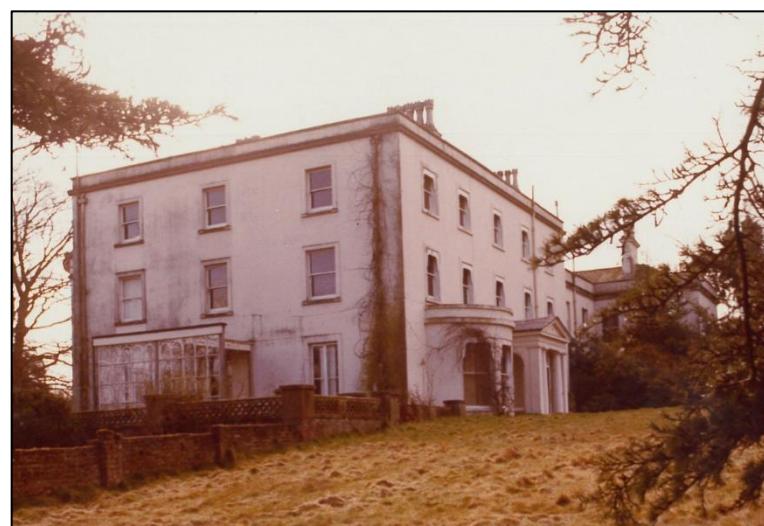
**Figure 14:** The north and west elevations in 1983

The main elevation is double fronted with a centrally located porch with Tuscan capitals supporting the pediment. An extension to the south is similar in style and fenestration and is similarly stuccoed. Photographs dating from 1983 show a bay window at the northern end of the elevation, and 19<sup>th</sup> century timber blind cases to the windows in the west elevation (Fig. 29).

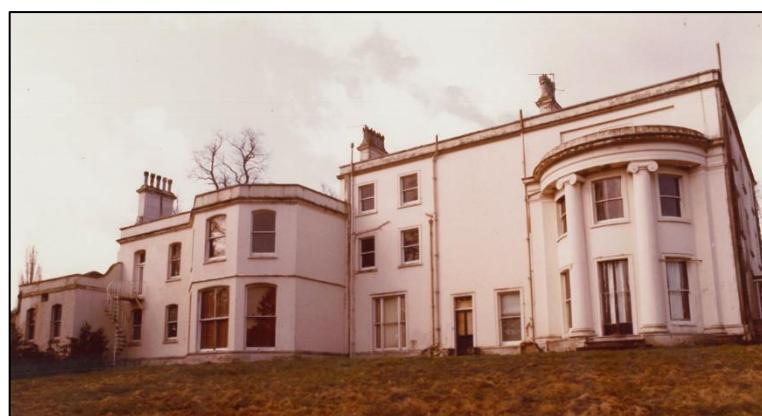
**Figure 17:** The east elevation in 1983

The east elevation has two bay windows; that to the south, in the later extension, is a 2-storey canted bay and that to the west a rounded 2-storey structure with Ionic capitals between the windows. The original back door and a window to the north of it were removed in the early 1980s leaving a large area of blank walling that is now covered in vegetation (Fig. 30).

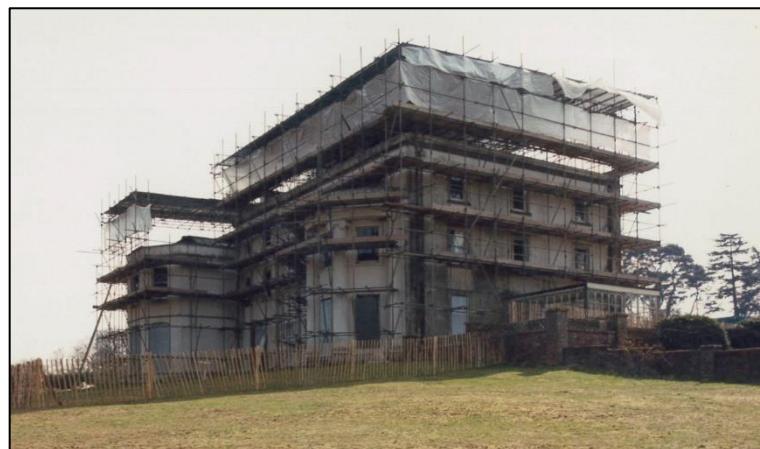
**Figure 19:** The north elevation showing the Orangery

There is a 2-storey rounded turret in the north elevation with a door at ground floor level giving access to the terrace. This was added c. 1985 and partially replaces an Orangery that stood on the north elevation (Fig 31).

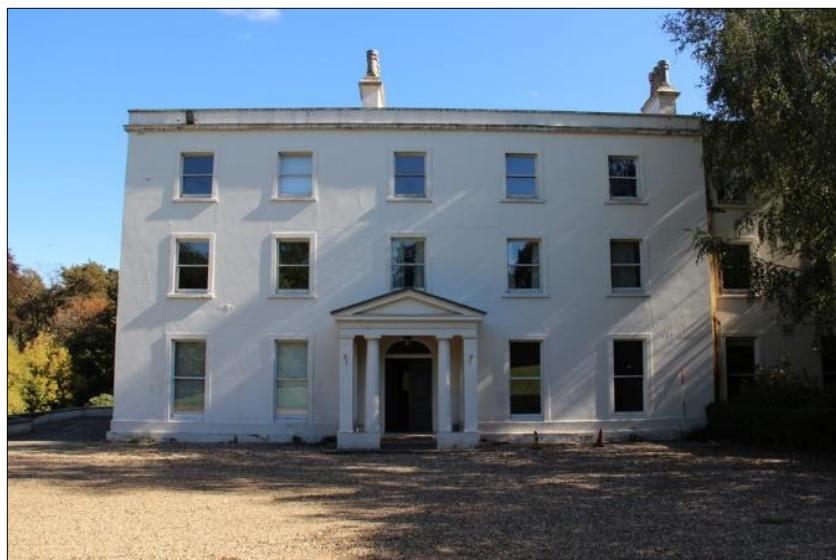
Plate 1: West elevation (1)

Project No: 384/HHG	Project: Harefield House	Building no: 1	Elevation: West
<p>Timber 6 panelled door within porch supported by Doric columns. All the windows are 1/1 timber sash. Walling is ashlar stucco, some 10mm thick. Slate tiled roofs.</p>			
Recorder: KK	Survey Date: 29 <sup>th</sup> September 2018

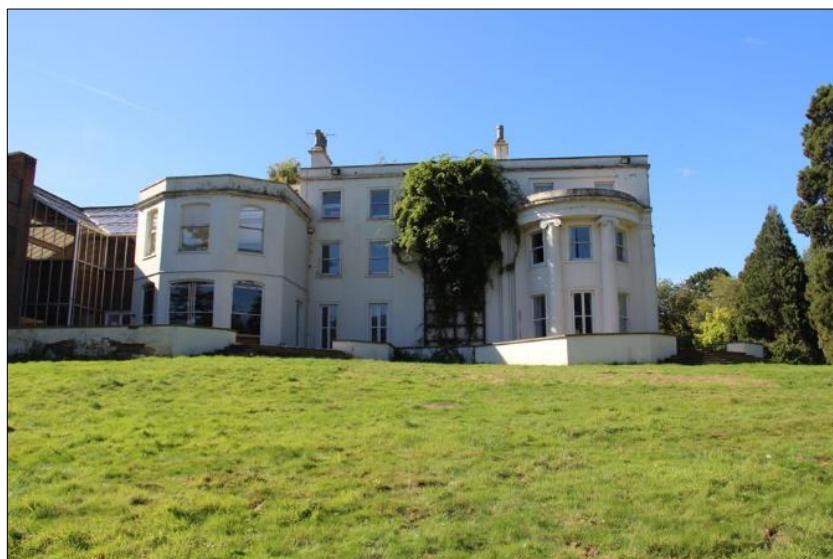
Plate 2: East elevation (3)

Project No: 384/HHG	Project: Harefield House	Building no: 1	Elevation: East
<p>Bricks exposed on the wall in front of the elevation are the same as on the north elevation. They measure 21 x 10 x 6cm and set in English bond using lime mortar. The render here is 30mm thick. Ionic capitals on the columns to the north.</p>			
Recorder: KK	Survey Date: 29 <sup>th</sup> September 2018

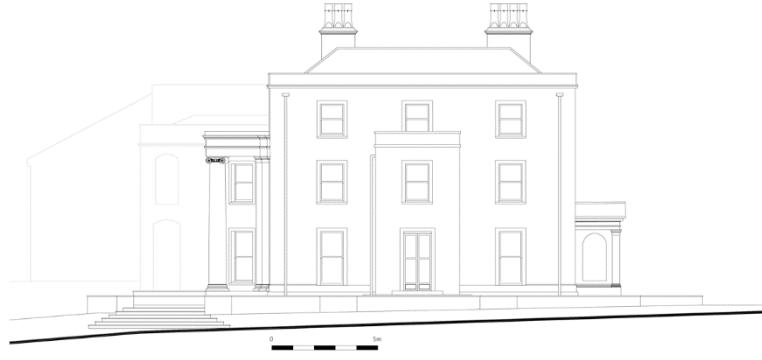
<p>Exposed brickwork in the northwest corner reveals poorly puddled bricks with small stone inclusions. The render on the wall is ashlar and c.10cm thick. The turret in the centre is 1980s</p>			
Recorder: KK	Survey Date: 29 <sup>th</sup> September 2018

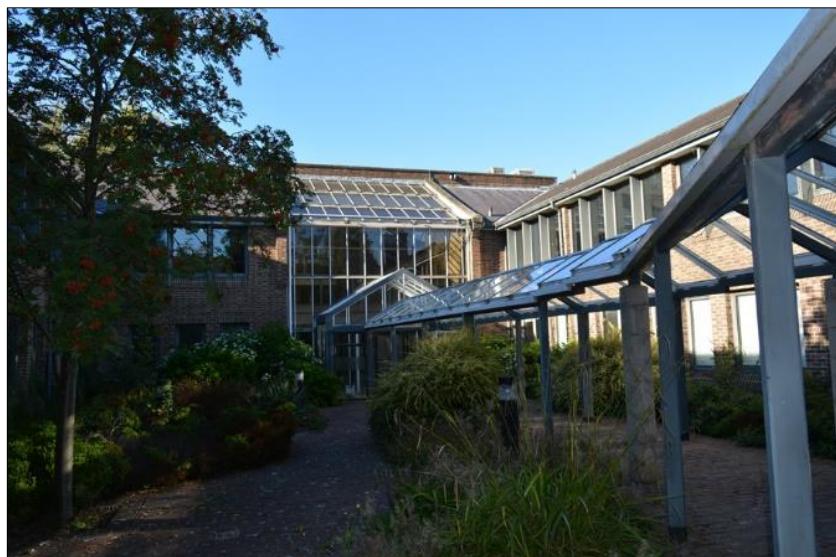
Plate 7: South elevation (7)

Project No: 384/HHG	Project: Harefield House	Building no: 1	Elevation: South
<p>House itself is largely obscured by the glass walkway and the 1980s rear wings</p>			
Recorder: KK	Survey Date: 29 <sup>th</sup> September 2018

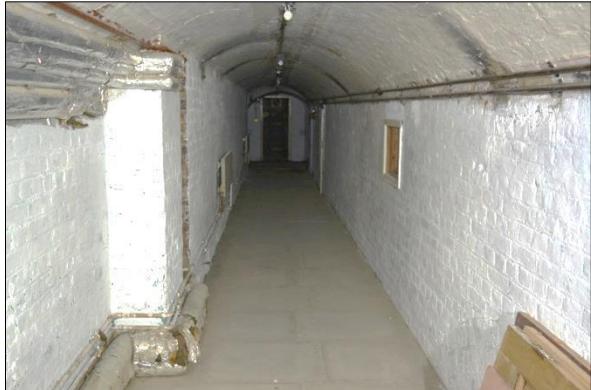
Plate 8: B1, facing northwest (133)

Project code: 384/HHG	Project: Harefield Grove: Main House	Room no: B1
<b>Location:</b> Basement		<b>Function:</b> Basement passage
<b>Wall form &amp; decor:</b> Brick built, painted white.		
<b>Ceiling / roof structure:</b> Vaulted brick ceiling.		
<b>Windows:</b>		
<b>Doors:</b>		
<b>Floor:</b> Stone at Northern end with asbestos further south.		
<b>Fireplace:</b>		
<b>Staircase:</b> Step at southern end.		
<b>Other architectural details:</b> Blocked fire at Northern end to set		
Recorder: KK	<b>Survey Date:</b> 09.10.2018

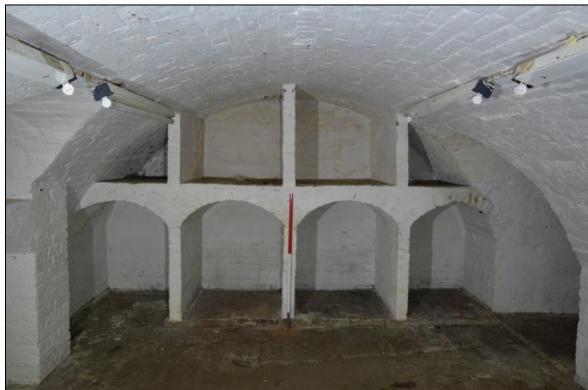
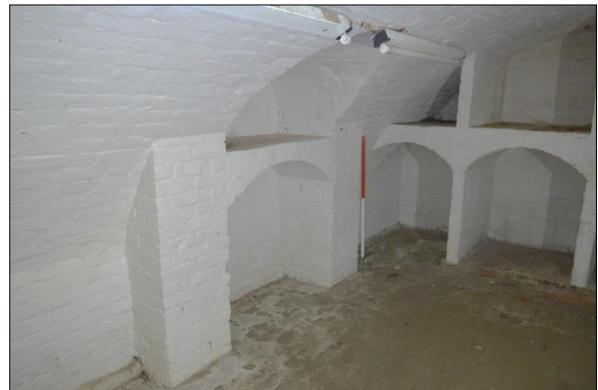
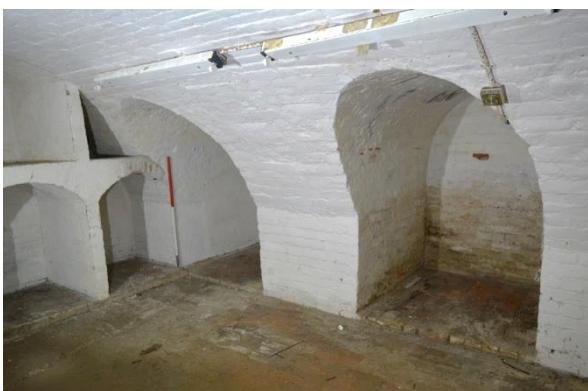
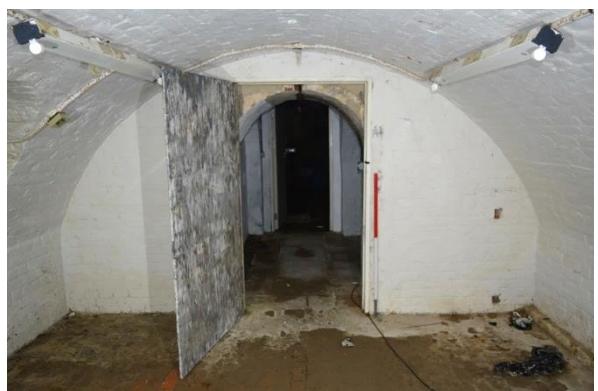
Project code: 384/HHG	Project: Harefield House: Main House	Room no: B2
Location: NW corner	Function: Wine store	
<b>Wall form &amp; decor:</b> Painted brick		
<b>Ceiling / roof structure:</b> Vaulted brick ceiling.		
<b>Windows:</b>		
<b>Doors:</b> Plywood door insert in vaulted opening to east.		
<b>Floor:</b> Brick aligned east to West.		
<b>Fireplace:</b>		
<b>Staircase:</b>		
<b>Other architectural details:</b> Two recesses to North, single one to south beneath fireplace and barrel/bottle shelves to West.		
<b>Recorder:</b> KK	<b>Survey Date:</b> 09.10.2018

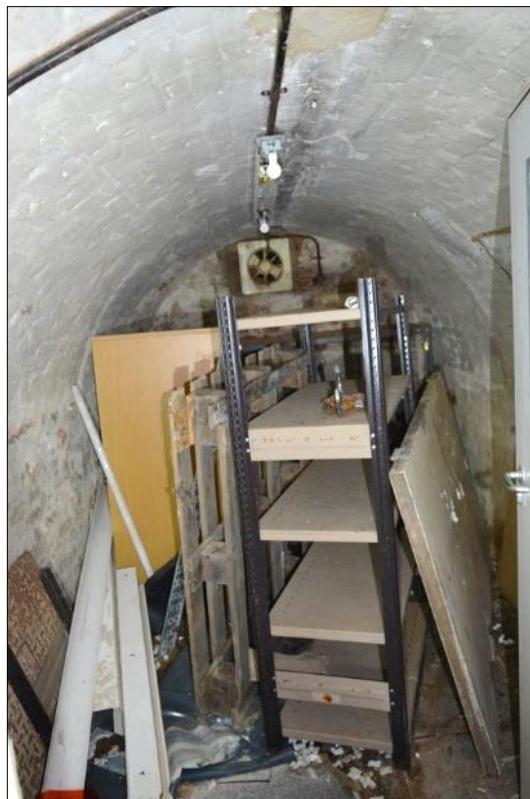
Plate 14: B3, facing northwest (138)

Project code: 384/HHG	Project: Harefield Grove: Main House	Room no: B3
Location: NW corner of basement	Function: Store	
<b>Wall form &amp; decor:</b> Painted brick		
<b>Ceiling / roof structure:</b> Vaulted brick ceiling.		
<b>Windows:</b>		
<b>Doors:</b> For inserted into opening of Fletton brickwork		
<b>Floor:</b> Brick		
<b>Fireplace:</b>		
<b>Staircase:</b>		
<b>Other architectural details:</b>		
Recorder: KK	Survey Date: 09.10.2018

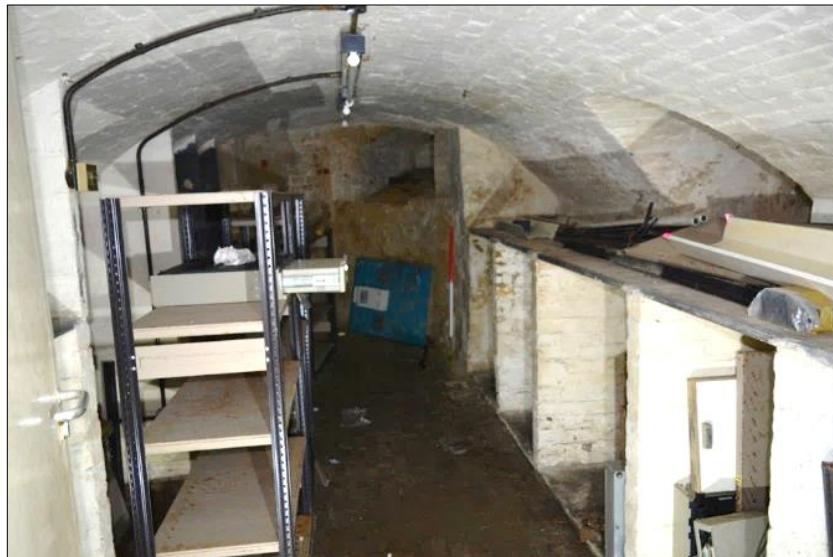
Plate 15: B4, facing northeast (139)

Project code: 384/HHG	Project: Harefield Grove: Main House	Room no: B4
Location: North corner of basement	Function: Store	
<b>Wall form &amp; decor:</b> Red brick with skintling		
<b>Ceiling / roof structure:</b> Vaulted brick ceiling.		
<b>Windows:</b> possible blocked off ventilation hatch at East end, or former coal shoot		
<b>Doors:</b> Modern flush door		
<b>Floor:</b> Bricks running east to west		
<b>Fireplace:</b>		
<b>Staircase:</b>		
<b>Other architectural details:</b> South wall has 5 openings with slate topper central one possible blocked doorway. North series of 3/2 then 1 large then 3/2 openings with slate will and divides for tops		
Recorder: KK	<b>Survey Date:</b> 09.10.2018

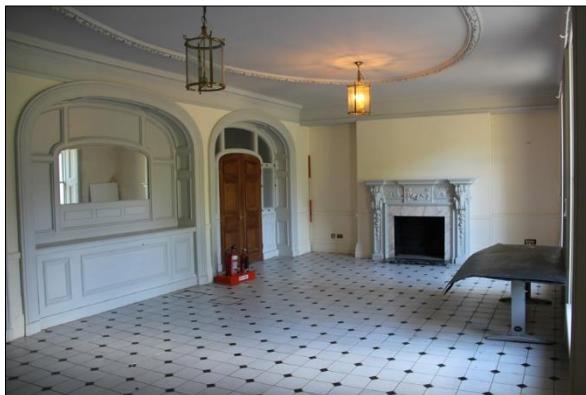
Plate 16: G1; facing southeast (8)

Project code: 384/HHG	Project: Harefield Grove: Main House	Room no: G1
<b>Location:</b> Front of house	<b>Function:</b> Entrance hall	
<b>Wall form &amp; decor:</b> Walls painted with tall moulded skirting, dado rail and deep coving incorporating a picture rail. The protruding section in the north wall and the fireplace wall has roll moulding on either side.		
<b>Ceiling / roof structure:</b> This appears to have been reconstructed in the 1980s as it is painted plasterboard with an oval moulded centre piece, which could have replaced or replicated an earlier feature.		
<b>Windows:</b> Two full height 1/1 timber sash in shuttered recesses to west. Low window seats with a vent to the front. The shutters are painted closed and have modern brass handles.		
<b>Doors:</b> The double front door in the west wall has a simple glazed fan light. The two double doors to the east are set within an arched recess with windows all around the upper half of the door. The lower half is panelled below mid height moulded rail. The recess are also panelled.

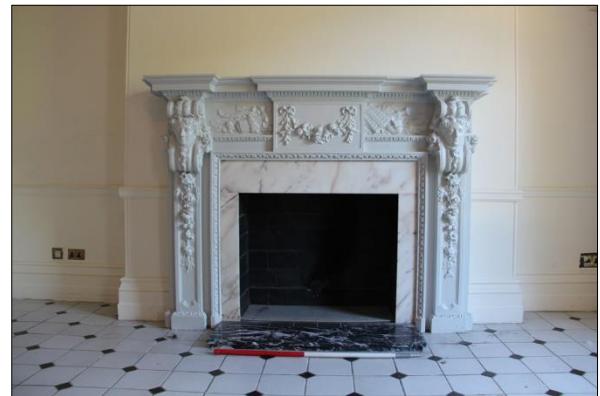
Plate 19: G1; fireplace (11)

<b>Floor:</b> Ceramic tiles (modern)		
<b>Fireplace:</b> Ornate fireplace with classical ornamentation in the upper panels either side of a central panel housing a Regency garland. The brackets are classical heads above Regency garlands. The chimney piece is a light modern material. The inset is of marble as is the hearth. The fireback is modern brickwork (bricks 23 X 11x13cm), painted black and not used.		
<b>Staircase:</b>		
<b>Other architectural details:</b> Between the two doors is a panelled recess to match the adjacent doors. It has a mirror within a recess in the upper section.		
<b>Recorder:</b> KK	<b>Survey Date:</b> 24.09.2018

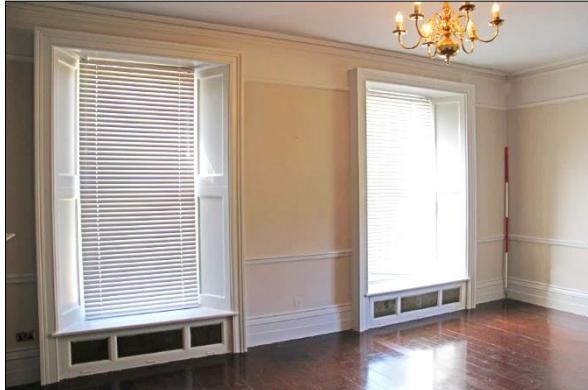
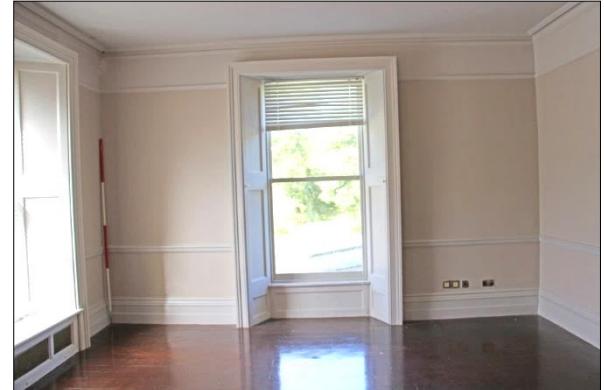
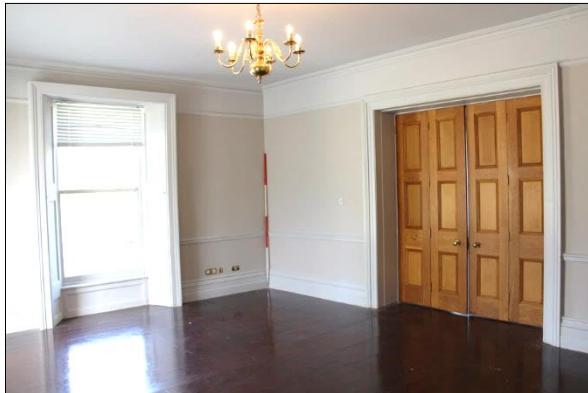
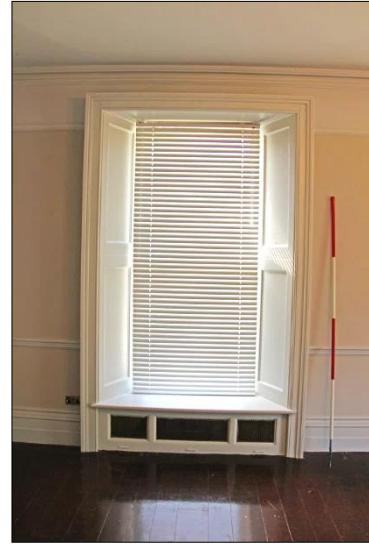
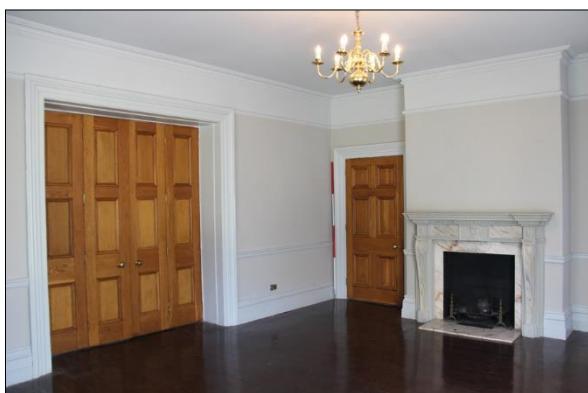
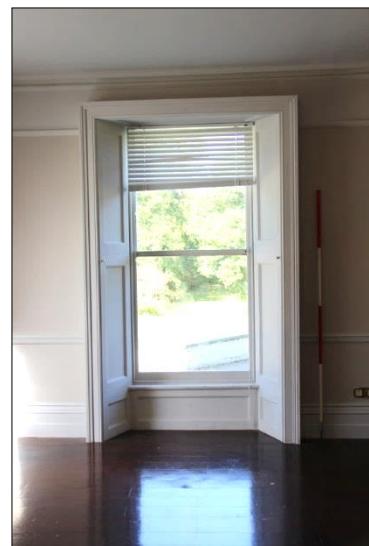
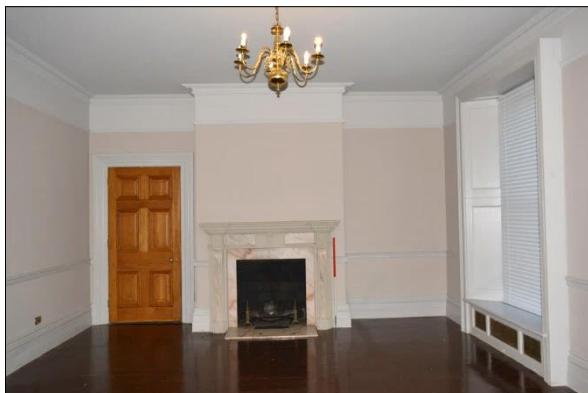
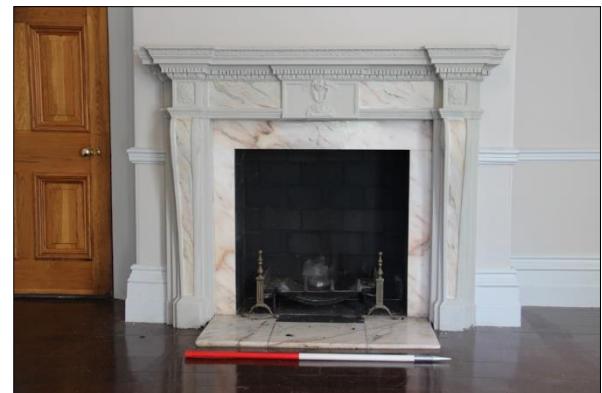
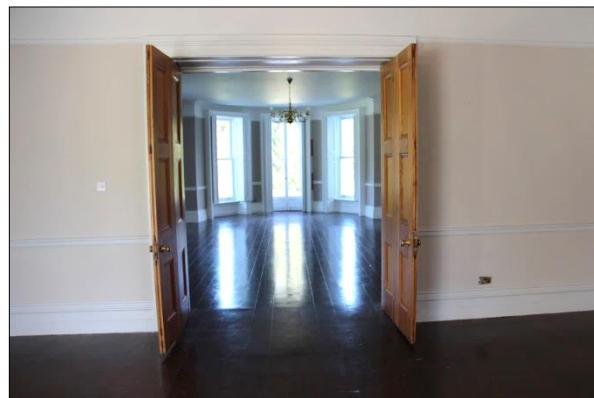
Room G2, immediately to the north of G1, originally had a bay window in the west wall and French doors to the north. These have now been replaced by full height sash windows with imitation shutters and window seats beneath the western windows. The fireplace appears to be made of a timber based material and the marble brackets and panels are simply painted. The inset and hearth, however, are of marble and the fireback is painted brick as in the hall. The floor was at that time parquet, but now has highly polished boards aligned east-west. Another alteration in this room is the removal of a floral decorative band running along the edge of the ceiling. The remaining cornice appears little changed, although the use of plasterboard for the ceiling would suggest that this too has been replaced. The Regency style double door between this room and G3 to the east has been installed since 1983.

Project code: 384/HHG	Project: Harefield Grove: Main House		Room no: G2
Location: North of G1		Function: Reception	
Dimensions (m):	Length:	Width:	Height:
<b>Wall form &amp; decor:</b> Painted plaster over brick. Moulded dado rail and tall moulded skirting. The picture rail is separate from the cornice and is also moulded.			
<b>Ceiling / roof structure:</b> Painted plasterboard. Moulded coving with large hollow chamfer between the upper/ceiling and lower/wall series of moulding.			
<b>Windows:</b> 1/1 timber sash in full height recess to north. Two similar windows to the west have similar vented window seats to G1. The northern window appears to have shutters but they are modern imitations that do not open. They too have modern brass knobs. The shutters in the north window in the west wall are likely to be original but are painted shut. Those in the southern window appear to be replicas.			
<b>Doors:</b> Stripped 6- panelled oak door to the south with modern knob and lock. Double oak door to east

<b>Floor:</b> Heavily varnished timber boards, 15-20cm wide, aligned east- west.			
<b>Fireplace:</b> Replica timber or timber based material chimney piece. The shelf has both dentilation and egg and dart above a central panel with urn and flowers, either side of which the fields have been painted to look like marble. Similarly, the Regency style brackets are painted to look like marble. The insert is of marble as is the hearth. The fire back is painted brick as in G1.			
<b>Staircase:</b>			
<b>Other architectural details:</b> The architraves appear to be modern. The grain is still very evident beneath the paint.			
Recorder: KK	Survey Date: 24.09.2018

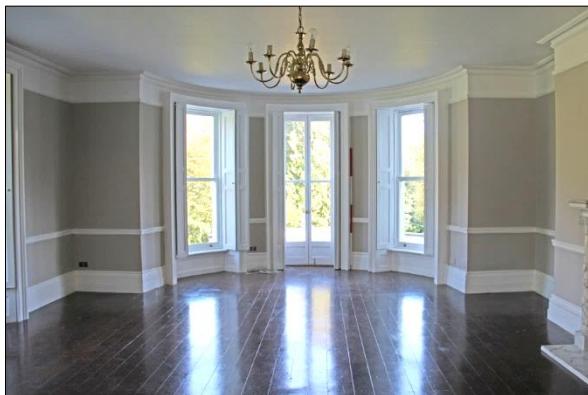
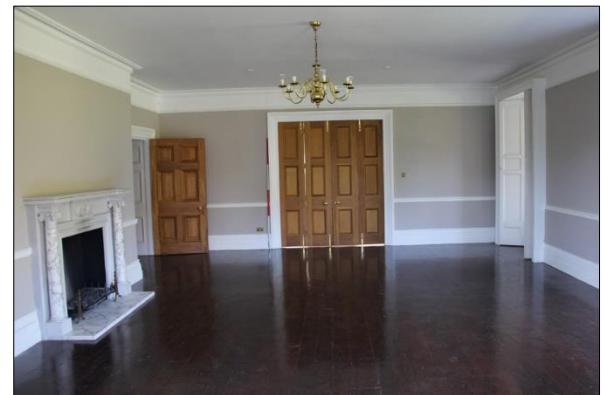
Plate 32: G3; facing east (24)

Project code:384/HHG	Project: Harefield Grove: Main House		Room no: G3
Location: East of G2		Function: Reception	
Dimensions (m):	Length:	Width:	Height:
<b>Wall form &amp; decor:</b> Painted with moulded dado rail, tall moulded skirting and moulded picture rail.			
<b>Ceiling / roof structure:</b> Possibly lath and plaster with some later repairs.			
<b>Windows:</b> Oriel arrangement to the east with a 1/1 timber sash to either side of a French door. The window sills are c.40cm above the floor and have timber shutters of 1½ leaves apiece. They are unlikely to be original as the hinges are modern, there is too little paintwork covering the grain of the timber and the style (two long panels between a short one) are unconvincing. There is a similar window in the north wall where the left side is 1½ and the right one is a single leaf.			
<b>Doors:</b> French door with shutters to the north and east. Double oak door to the west and a 6- panelled stripped oak door to the south.

<b>Floor:</b> As G2			
<b>Fireplace:</b> Painted timber chimney piece with egg and dart moulding over fields with wheat and flowers in individual cells to either side of a central panel decorated with an urn with grasses or reeds below. The classical pillars with Corinthian columns are painted to look like marble. The hearth is timber painted to look like marble. Flush timber fire back.			
<b>Staircase:</b>			
<b>Other architectural details:</b>			
Recorder: KK	Survey Date: 24.09.2018

Room G3, in the northeast corner of the ground floor has similarly been updated. The former French doors in the north wall have been replaced by door and a window. The windows in the east wall also appears to have been rebuilt. The fireplace has been stripped of its earlier paint, the columns and hearth painted to look like marble and the fireback has been replaced.

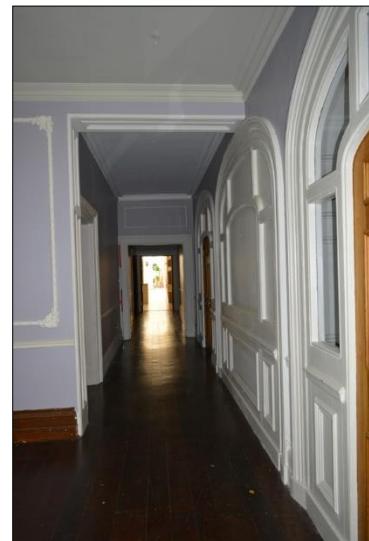
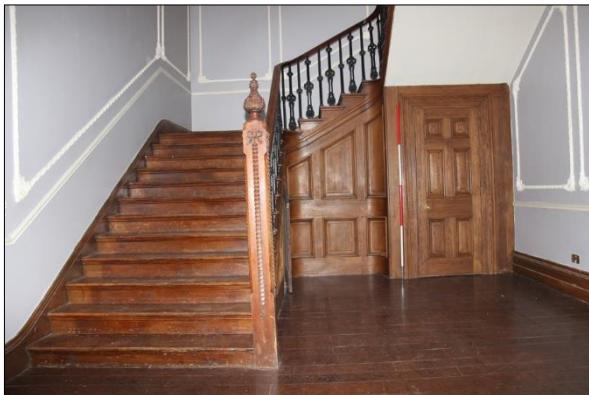
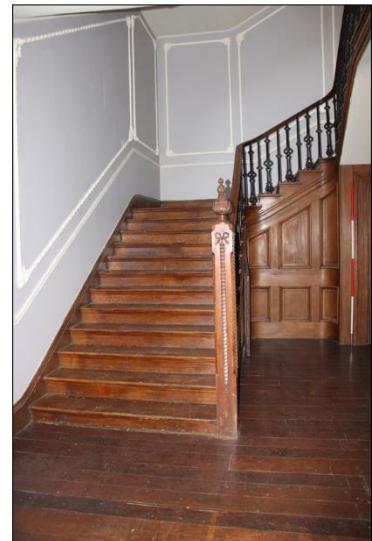
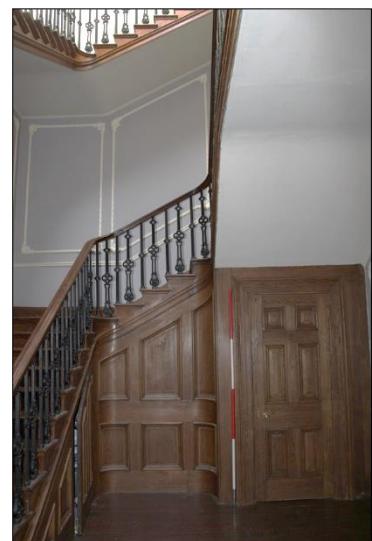
The staircase in Room G4 is an open string, open well staircase with flat metal balusters, a toad backed handrails and Jacobean style newel post that is decorated with Regency motifs. The simple decorative plasterwork on the stair wails is shown on the 1983 photographs and may date from the 19<sup>th</sup> century. The original floorboards have survived on the staircase, although elsewhere, including the entrance hall, the flooring has been replaced. A floor plan of 1983 as well as photographs of the same date show a rear lobby to the right of the staircase serving a back door. This door and the window formerly to the north of it have been removed and a large built in cupboard has replaced the lobby. A lift shaft that stood to the right of the staircase has also been removed and a new lift installed at the southern end of the house. The parquet floor that was present here in 1983 has been replaced with timber boards.

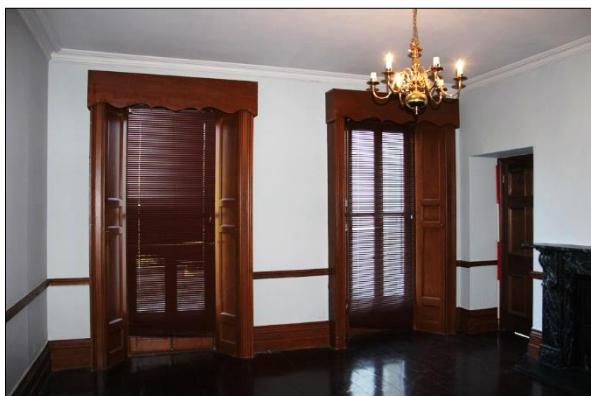
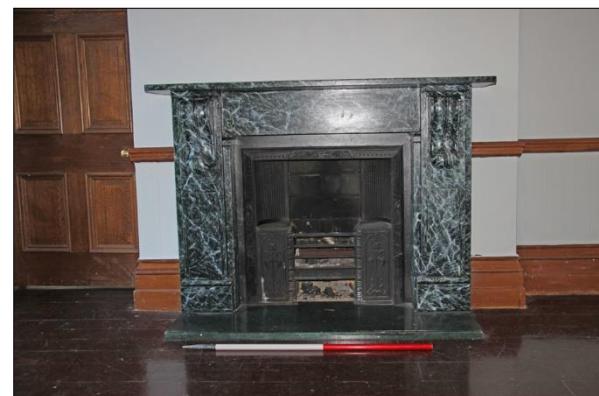
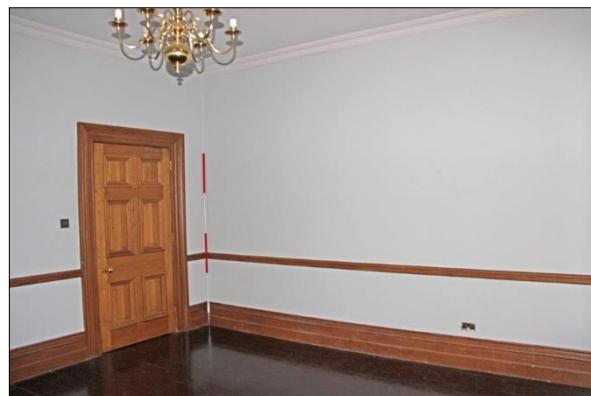
Room G5 to the south of the stair has seen considerable alterations since it was first built. It is likely to have been foreshortened to accommodate a passage to the late 19<sup>th</sup> century extension to the house. The two French doors in the east wall have been installed since 1983 and replace a single large full height window. The fireplace has been given a timber hearth and painted to look like marble. The door to the east of the fireplace is also a late 20<sup>th</sup> century installation, as are the dado rail and cornices. It is uncertain whether the skirting boards have been replaced, but the picture rail that is shown in a photograph of 1983 has been removed.

Project code:384/HHG	Project: Harefield Grove: Main House	Room no: G5
<b>Location:</b> South of G3		<b>Function:</b> Reception
<b>Wall form &amp; decor:</b> Solid plastered and painted walls with unpainted moulded dado and tall skirting. Both are oak. No picture rail but there is a moulded cornice.		
<b>Ceiling / roof structure:</b> Painted plasterboard		
<b>Windows:</b> Two French doors to the east in modern oak shuttered recesses.		
<b>Doors:</b> 6- panelled stripped oak for to west and south.		
<b>Floor:</b> East-west aligned boards, 14-20cm wide. Heavily varnished so grain obscured.		
<b>Fireplace:</b> Green marble effect chimney piece to south. Large acanthus leaf brackets provide the only ornamentation. The insert is art Deco and the hearth painted timber		
<b>Staircase:</b>		
<b>Other architectural details:</b>		
Recorder: KK	<b>Survey Date:</b> 24.09.2018

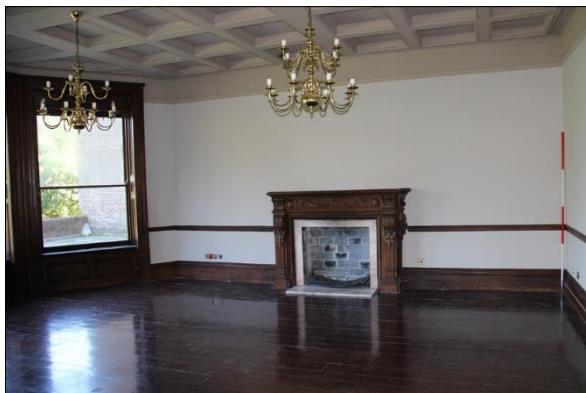
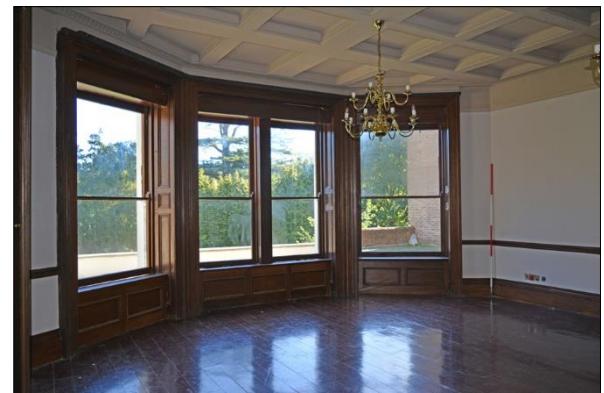
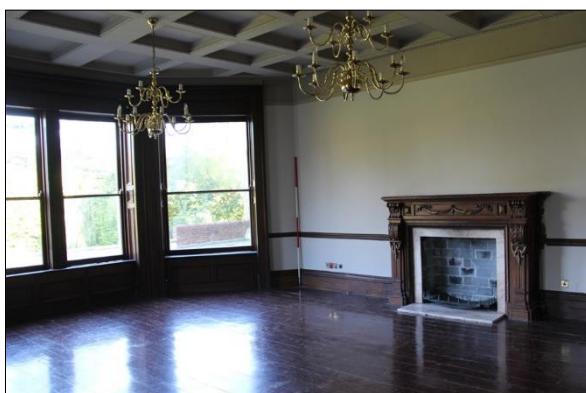
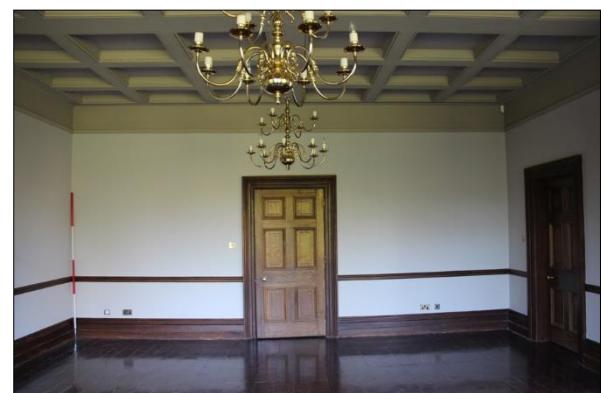
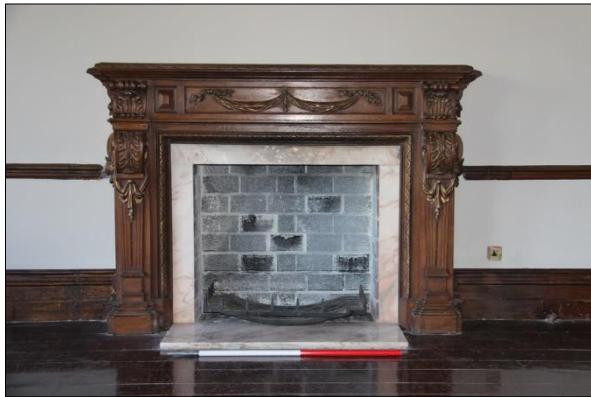
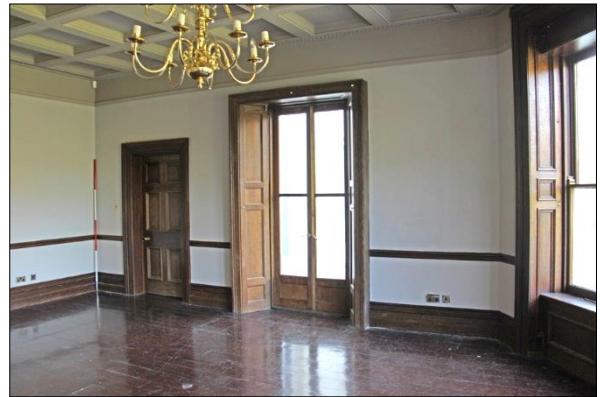
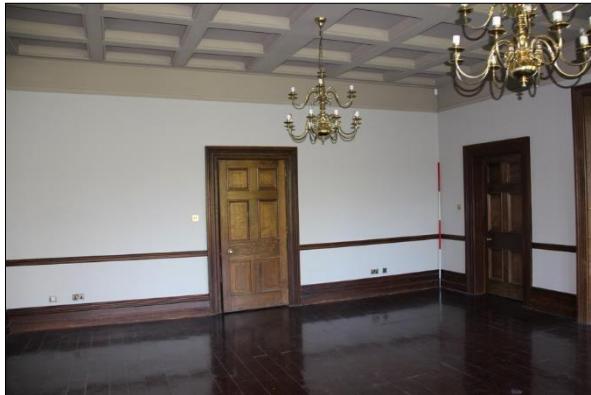
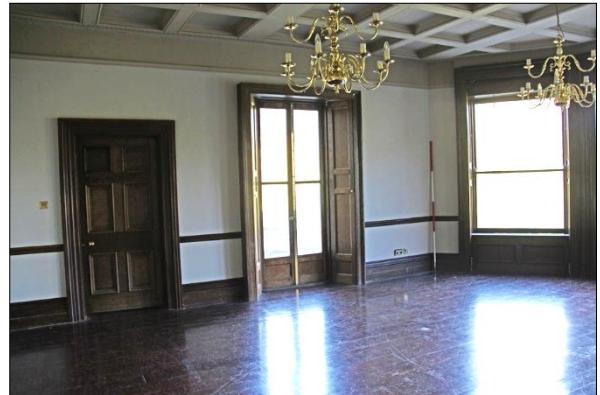
Room G6 lies in the later addition to the house and has an imposing coffered ceiling with a border of flowers within intertwined cells. The canted bay window in the east wall replace earlier windows as is evident from earlier photographs and the quality of the build. The fireplace is timber built with a swag in the central panel and heavy ornamented brackets. The insert and hearth are of marble and the timber fire back of modern material to look like painted brick. This was moved to the south wall some time after 1983 when a door was created in the north wall where the fireplace had originally been located. The room has also been subdivided to form a small antechamber (G6) and allow for a lift shaft. An unusual feature in this room is that the dado rail and skirting boards are of moulded plastic, painted to look like hardwood.

Project code: 384/HHG	Project: Harefield Grove: Main House	Room no: G6
Location: South of G5	Function: Reception	
<b>Wall form &amp; decor:</b> Painted with moulded plastic dado rail and tall skirting also moulded plastic.		
<b>Ceiling / roof structure:</b> Coffered timber ceiling with a border of flowers within intertwined cells		
<b>Windows:</b> Four 1/1 timber sash windows to the east in panelled recesses. The cill is c.60cm high. 1980s creation and possibly also using moulded plastic in for example, the window seat.		
<b>Doors:</b> French doors to north in panelled recess with faux shutters. 6- panelled door to north and west.		
<b>Floor:</b> East-west aligned timbers as G5.		
<b>Fireplace:</b> Timber chimney piece with swag in central panel, heavy ornamented brackets. Marble insert and hearth. Timber fire back of modern material to look like painted brick.		
<b>Staircase:</b>		
<b>Other architectural details:</b>

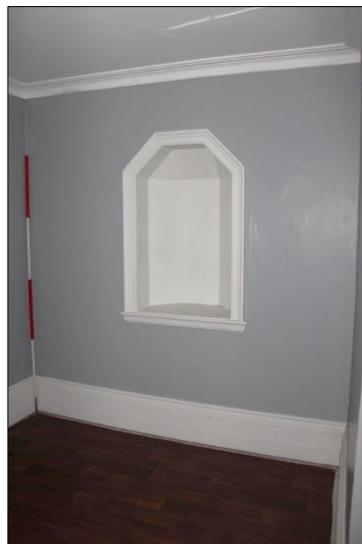
Plate 54: G7; facing south (46)

Project code:384/HHG	Project: Harefield Grove: Main House	Room no: G7
Location: West of G6		Function: Ante-room
<b>Wall form &amp; decor:</b> Painted wood walls to south and west. Stud to north and east. Recess in north wall and blocked door to south. Tall moulded skirting. Moulded cornice.		
<b>Ceiling / roof structure:</b> Painted plasterboard with hatch in south east corner.		
<b>Windows:</b>		
<b>Doors:</b> 6- panelled door to east and west.		
<b>Floor:</b> Vinyl		
<b>Fireplace:</b>		
<b>Staircase:</b>		
<b>Other architectural details:</b>		
Recorder: KK	Survey Date: 24.09.2018

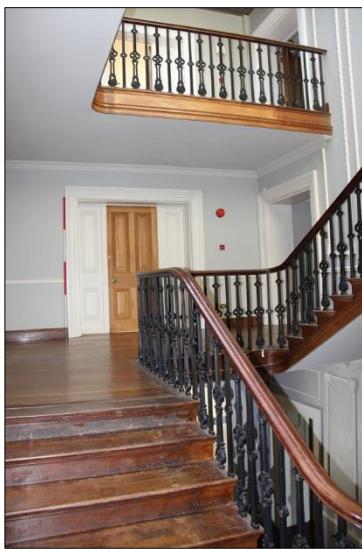
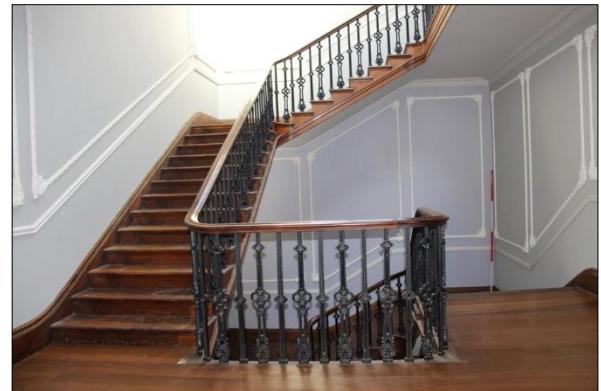
Project code: 384/HHG	Project: Harefield Grove: Main House	Room no: F1
Location: First floor	Function: Landing	
<b>Wall form &amp; decor:</b> Painted with applied plaster moulding. Dado rail, unpainted oak skirting.		
<b>Ceiling / roof structure:</b> Painted plasterboard. Moulded cornice with hollow chamfer between ceiling and wall moulding. Coffered ceiling over stair with rooflight in the centre.		
<b>Windows:</b>		
<b>Doors:</b> Modern door to east with painted panels on either side. Set within an unpanelled recess. Openings to north and south		
<b>Floor:</b> Modern timber probably overlying original timber floor.		
<b>Fireplace:</b>		
<b>Staircase:</b> As G4		
<b>Other architectural details:</b>		
Recorder: KK	Survey Date: 24.09.2018

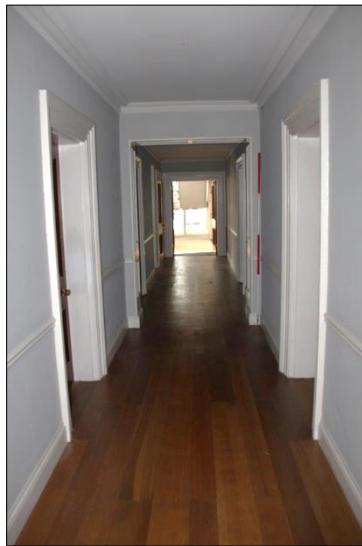
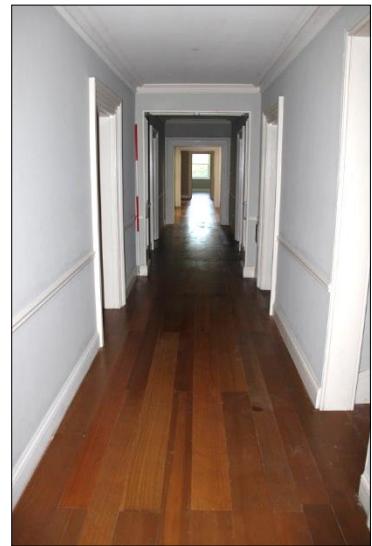
Project code: 384/HHG	Project: Harefield Grove: Main House	Room no: F2
Location: South of F1	Function: Passage	
<b>Wall form &amp; decor:</b> Painted with same skirting boards, cornice and dado as in F1		
<b>Ceiling / roof structure:</b> Painted plasterboard		
<b>Windows:</b>		
<b>Doors:</b> 4- panelled doors to east and west		
<b>Floor:</b> Modern laminated timber boards 15-20cm wide		
<b>Fireplace:</b>		
<b>Staircase:</b> Stairs up to G3		
<b>Other architectural details:</b> Panelled opening between Rooms F4 and F11		
Recorder: KK	<b>Survey Date:</b> 24.09.2018

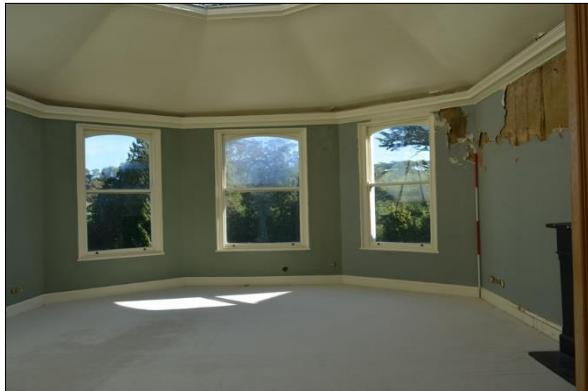
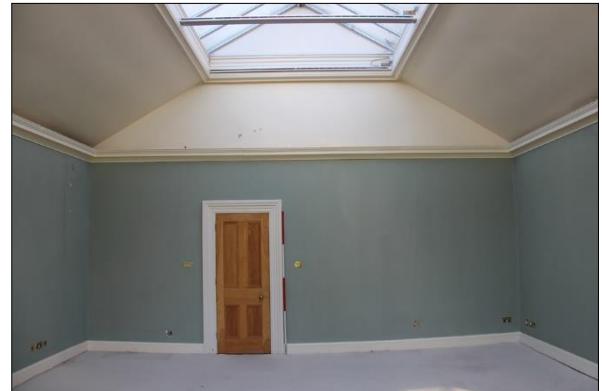
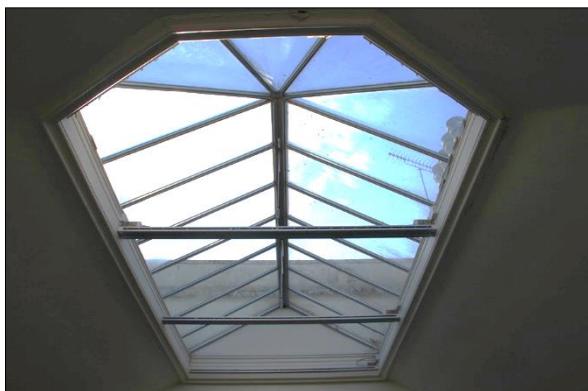
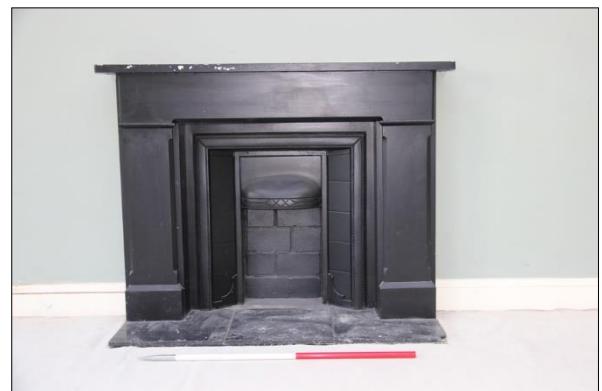
A rooflight has also been installed in the former Billiards Room in the southern extension (F3), which is also lit by three large windows in the canted bay to the east. The fireplace in this room is a modern composite piece with a marble hearth that was never intended for use and replaces an earlier fireplace on the north wall, as is the case in the room below (G6). Like G6,

Project code: 384/HHG	Project: Harefield Grove: Main House	Room no: F3
Location: Eastern end	Function: Office	
<b>Wall form &amp; decor:</b> Solid painted walls. Cyma moulded skirting.		
<b>Ceiling / roof structure:</b> Cornice stands proud of the ceiling which is modern with a large roof light		
<b>Windows:</b> Three large 1/1 lightly arched timber sash windows in east wall		
<b>Doors:</b> 4-panelled door to west		
<b>Floor:</b> Carpet over timber		
<b>Fireplace:</b> Modern composite chimney piece with marble hearth		
<b>Staircase:</b>		
<b>Other architectural details:</b>		
Recorder: KK	Survey Date: 24.09.2018

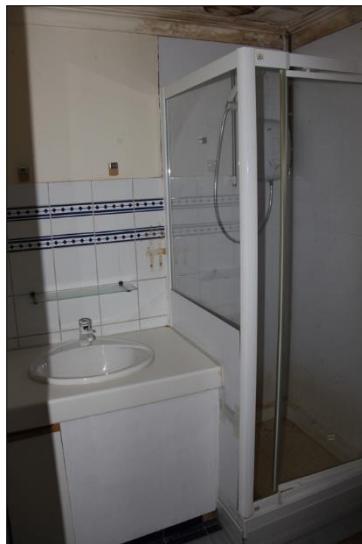
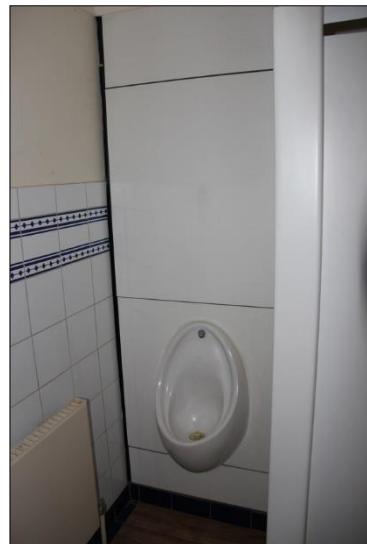
Project code: 384/HHG	Project: Harefield Grove: Main House	Room no: F4
Location: North of F3	Function: WC	
<b>Wall form &amp; decor:</b> Largely tiled but with complete cornice on all four walls		
<b>Ceiling / roof structure:</b> Painted plasterboard with hatch to roof space		
<b>Windows:</b>		
<b>Doors:</b> 4-panelled		
<b>Floor:</b> Vinyl		
<b>Fireplace:</b>		
<b>Staircase:</b>		
<b>Other architectural details:</b>		
Recorder: KK	Survey Date: 24.09.2018

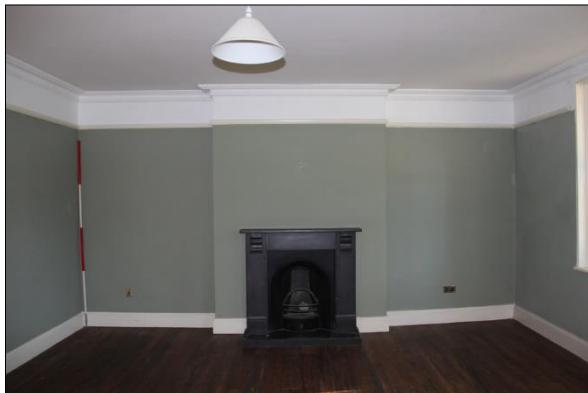
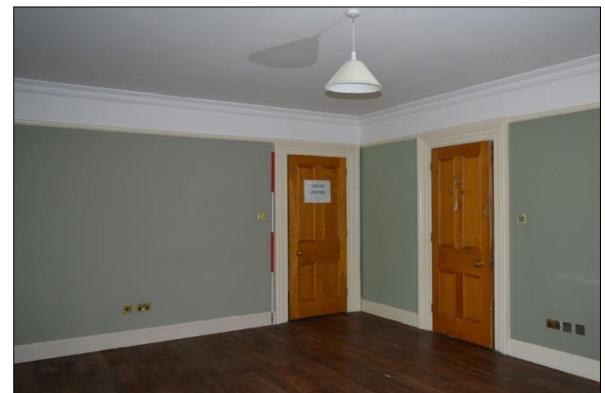
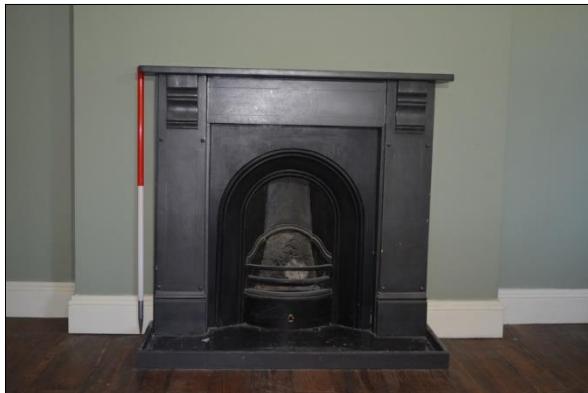
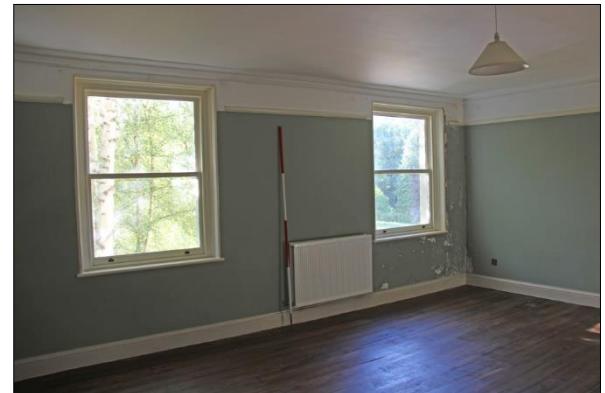
Project code: 384/HHG	Project: Harefield Grove: Main House	Room no: F5
Location: Southwest corner	Function:	
<b>Wall form &amp; decor:</b> Plastered and painted brick. Ogee skirting, picture rail and cornice with a hollow chamfer.		
<b>Ceiling / roof structure:</b> Painted plasterboard		
<b>Windows:</b> Two 1/1 timber sash in the west wall		
<b>Doors:</b> 4 panelled doors to the north and east		
<b>Floor:</b> Laminate board aligned north-south		
<b>Fireplace:</b> Black timber fire surround with arched grate and marble hearth with timber border. Modern.		
<b>Staircase:</b>		
<b>Other architectural details:</b>		
Recorder: KK	Survey Date: 24.09.2018

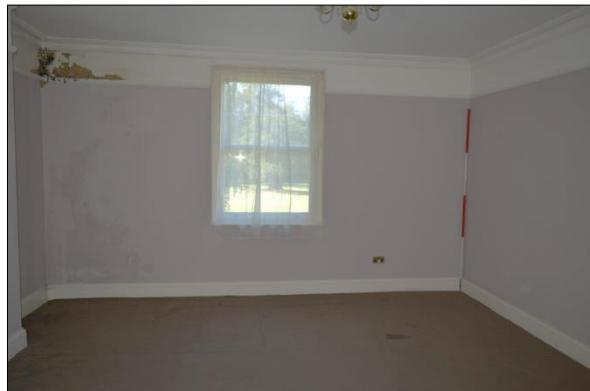
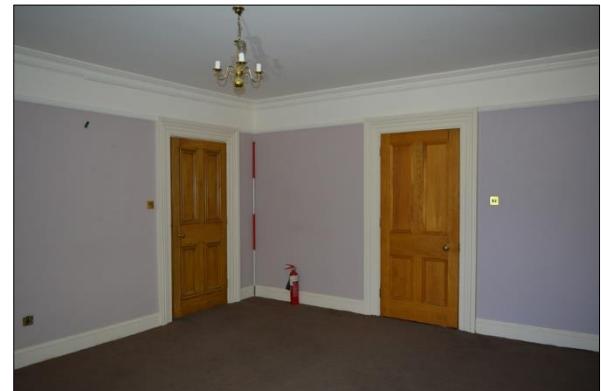
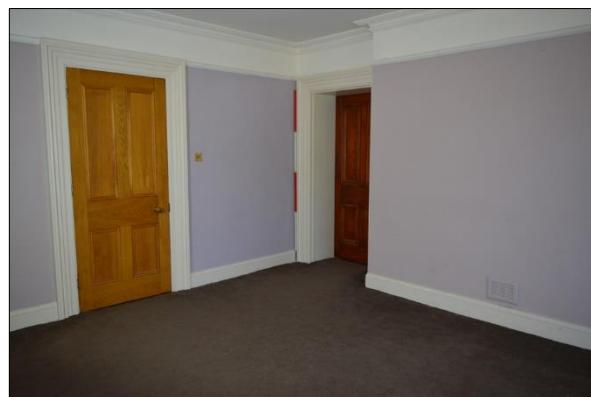
Project code: 384/HHG	Project: Harefield Grove: Main House	Room no: F6
Location: North of F5	Function: Office	
<b>Wall form &amp; decor:</b> Solid painted walls to east, west and south. Painted stud to north. Ogee skirting. Moulded cornice with hollow chamfer between ceiling and wall mouldings.		
<b>Ceiling / roof structure:</b> Painted plasterboard		
<b>Windows:</b> 1/ timber sash to west.		
<b>Doors:</b> 4- panelled doors to north, south and east. Southern door set in a deep recess.		
<b>Floor:</b> Carpet over ?ply. No feel or sound of timber		
<b>Fireplace:</b> Formerly in south wall. Only a vent remains		
<b>Staircase:</b>		
<b>Other architectural details:</b>		
Recorder: KK	Survey Date: 24.09.2018

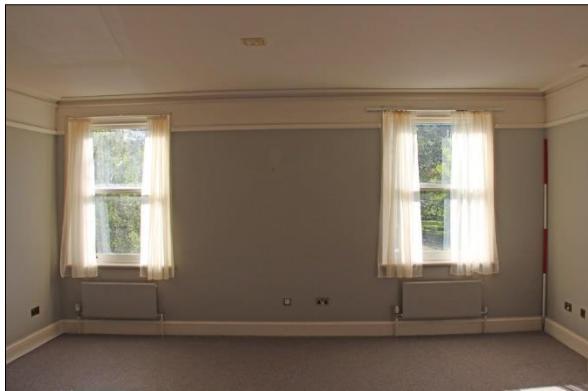
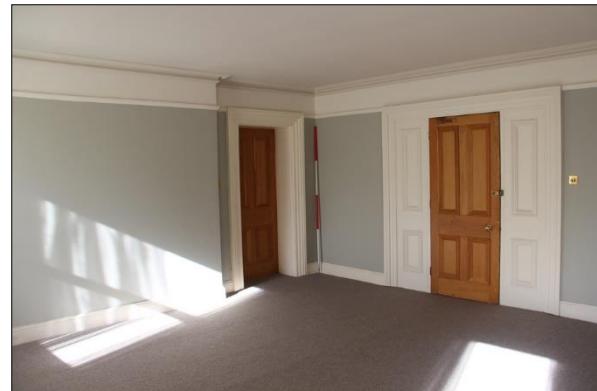
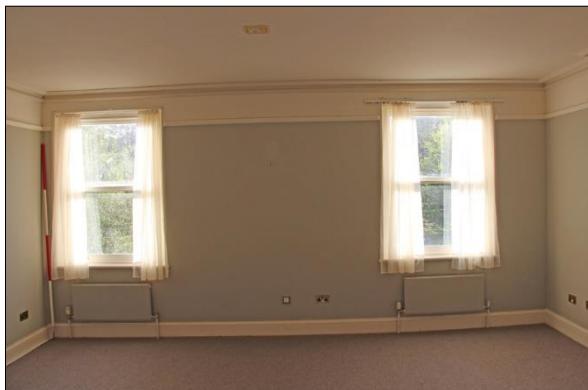
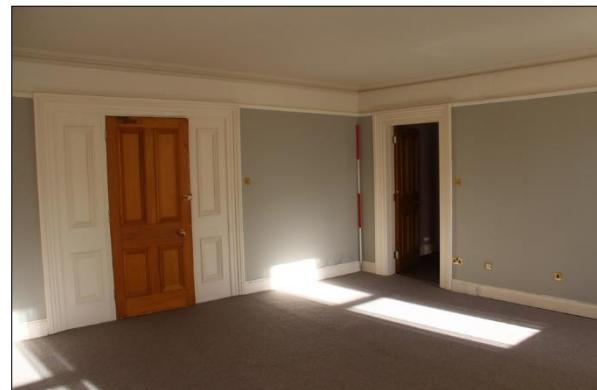
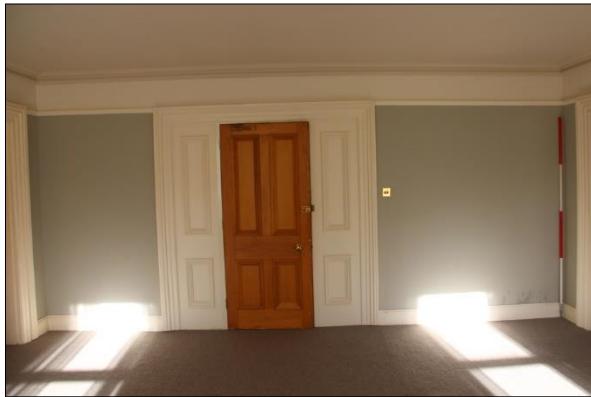
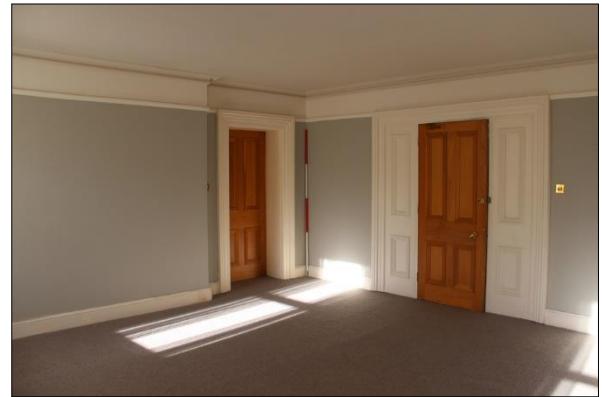
Project code: 384/HHG	Project: Harefield Grove: Main House	Room no: F7
Location: West of F1	Function: Office	
<b>Wall form &amp; decor:</b> Plastered and painted. Ogee skirting, picture rail and hollow chamfered cornice as in F5 & F6		
<b>Ceiling / roof structure:</b> Painted plasterboard		
<b>Windows:</b> Two sash windows to the west		
<b>Doors:</b> 4 panelled doors to north, south and east. That to the east is set within a deep recess and has panels on either side. The north door is also with a plain recess.		
<b>Floor:</b> Carpet over boards		
<b>Fireplace:</b>		
<b>Staircase:</b>		
<b>Other architectural details:</b>		
Recorder: KK	Survey Date: 24.09.2018
