KDK ARCHAEOLOGY LTD

## Historic Building Recording

Harefield Grove  
Rickmansworth Road  
Harefield  
London

October 2018

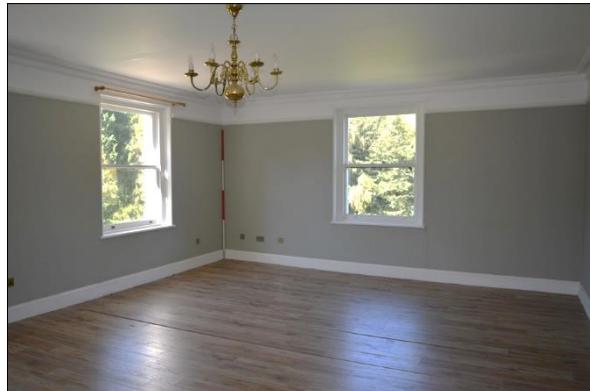
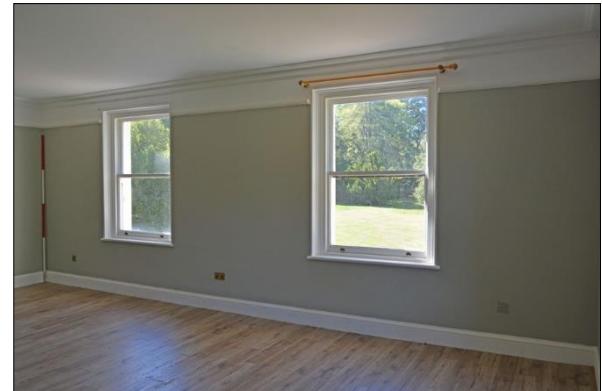
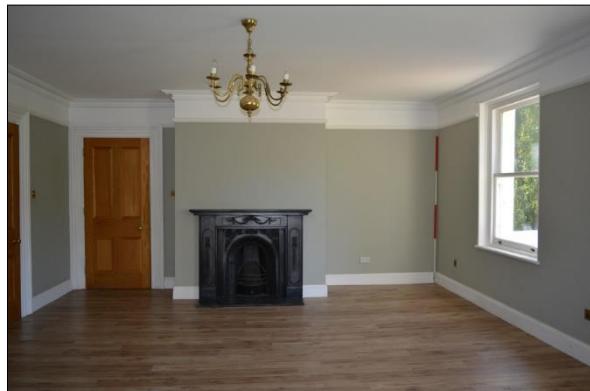
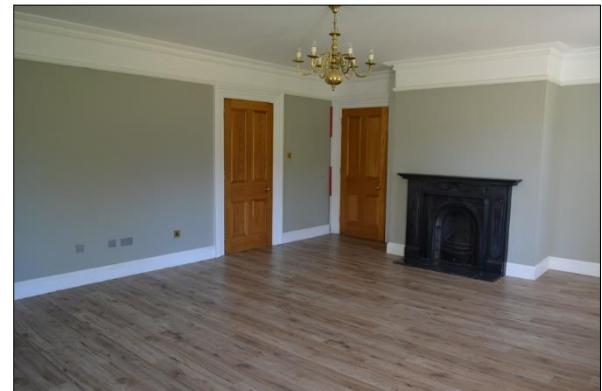
Project code: 384/HHG	Project: Harefield Grove: Main House	Room no: F8
Location: Northwest corner	Function: Office	
<b>Wall form &amp; decor:</b> Solid plastered and painted. Same skirting, picture rail and cornice as F5-F7		
<b>Ceiling / roof structure:</b> Painted plasterboard		
<b>Windows:</b> Two sash windows to the west, single one to the north.		
<b>Doors:</b> 4 panelled doors in the east and south walls.		
<b>Floor:</b> Laminate		
<b>Fireplace:</b> Regency style chimney piece to the south with arched grate and marble hearth. Modern.		
<b>Staircase:</b>		
<b>Other architectural details:</b>		
Recorder: KK	Survey Date: 24.09.2018

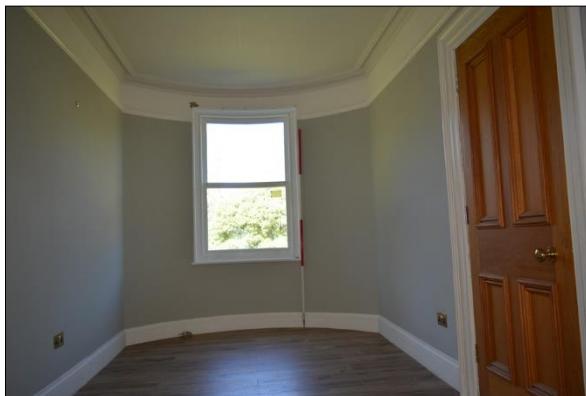
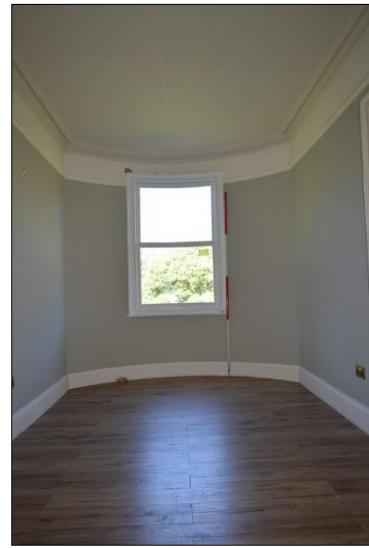
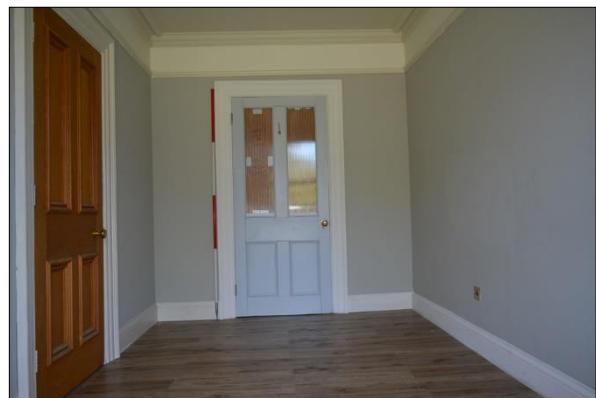
Project code: 384/HHG	Project: Harefield Grove: Main House	Room no: F9
<b>Location:</b> In the apsidal turret	<b>Function:</b> Office	
<b>Wall form &amp; decor:</b> Painted and plastered stud wall to the east. Solid walls elsewhere. Ogee moulded cornice to the north but hollow moulded cornice elsewhere. The skirting in the north wall appears to be older and very slightly different to that in the east and west walls. The same applies to the picture rail.		
<b>Ceiling / roof structure:</b> Painted plasterboard		
<b>Windows:</b> Single timber sash to the north, curved to match the curve in the wall.		
<b>Doors:</b> 4 panelled doors to east and south. Southern door is original and half glazed although the glazing is new.		
<b>Floor:</b> Laminate		
<b>Fireplace:</b>		
<b>Staircase:</b>		
<b>Other architectural details:</b> The north wall is curved.		
<b>Recorder:</b> KK	<b>Survey Date:</b> 24.09.2018

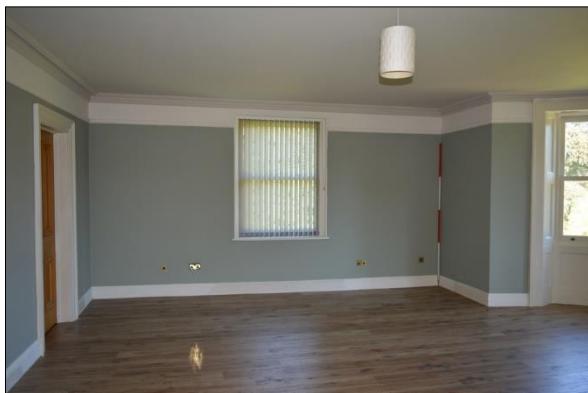
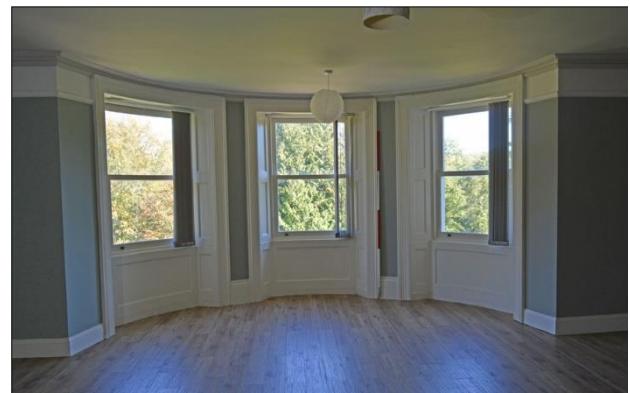
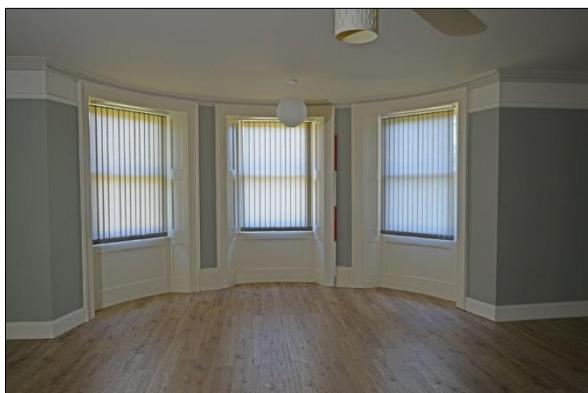
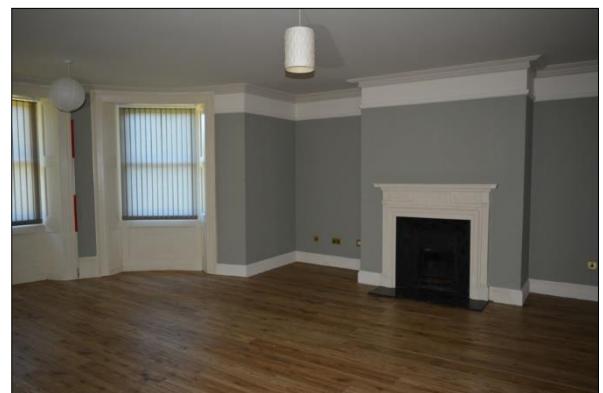
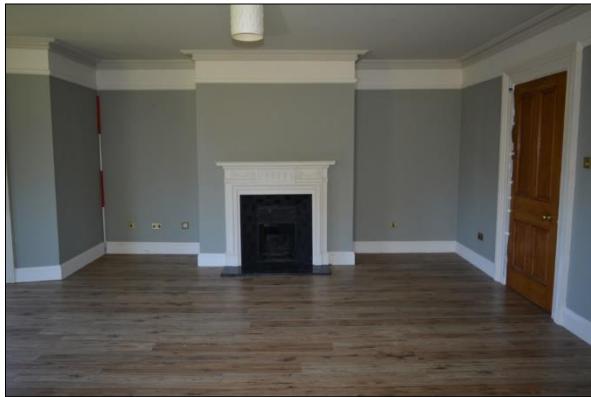
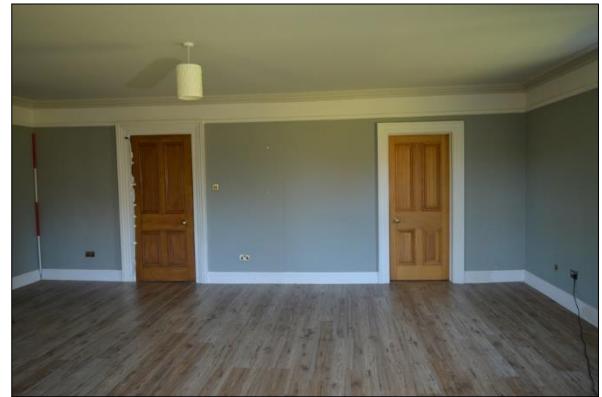
Project code: 384/HHG	Project: Harefield Grove: Main House	Room no: F10
Location: Northeast corner	Function: Office	
<b>Wall form &amp; decor:</b> Solid plastered and painted. Same skirting, picture rail and cornice as F5-F9		
<b>Ceiling / roof structure:</b> Painted plasterboard		
<b>Windows:</b> Single sash to the north, three sash windows in the bay to the east. The eastern windows have paneling to either side and below the window.		
<b>Doors:</b> Two 4 panelled doors in the west wall.		
<b>Floor:</b> Laminate		
<b>Fireplace:</b> Regency style/ Regency chimney piece to the south with dancing figure in the central panel flanked by shield and swag on either side. New iron insert but original fire back. Black marble hearth.		
<b>Staircase:</b>		
<b>Other architectural details:</b>		
Recorder: KK	Survey Date: 24.09.2018

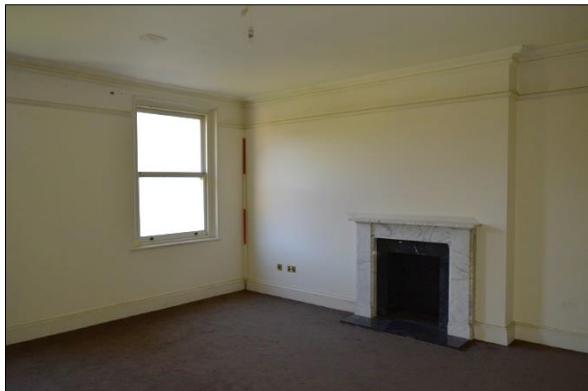
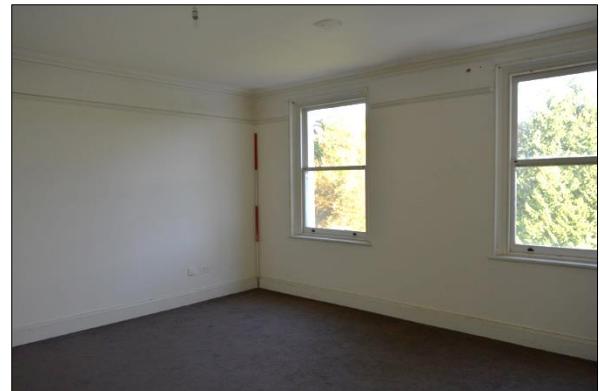
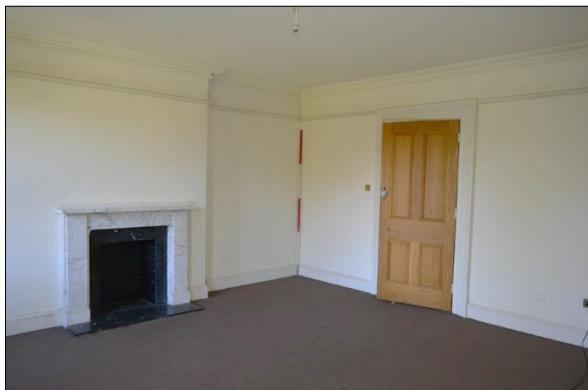
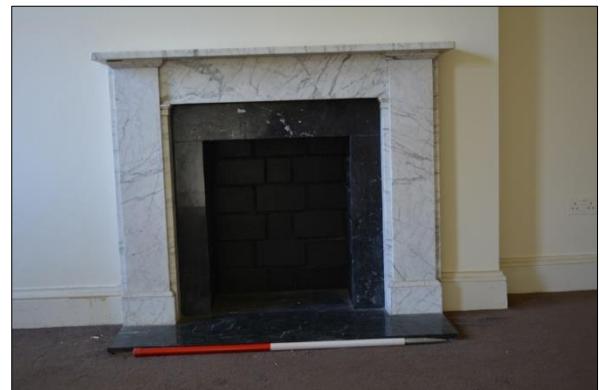
Project code: 384/HHG	Project: Harefield Grove: Main House	Room no: F11
Location: South of F1	Function: Office	
<b>Wall form &amp; decor:</b> Stud partition to west, brick elsewhere. Painted plaster with same cornice skirting and dado as elsewhere.		
<b>Ceiling / roof structure:</b> Painted plasterboard.		
<b>Windows:</b> Two 1/1 timber sash to east.		
<b>Doors:</b> 4 panelled timber door to west.		
<b>Floor:</b> Carpet over boards.		
<b>Fireplace:</b> Marble with brick fireback and marble hearth.		
<b>Staircase:</b>		
<b>Other architectural details:</b>		
Recorder: KK	Survey Date: 09.10.2018

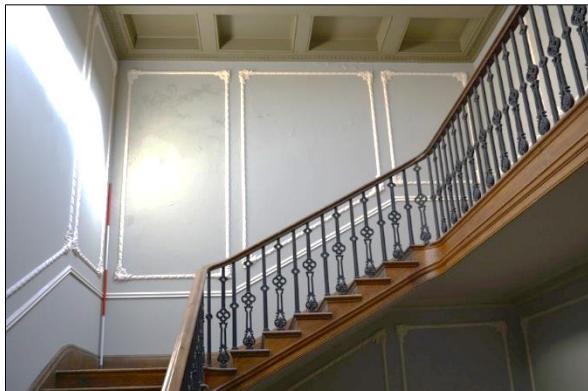
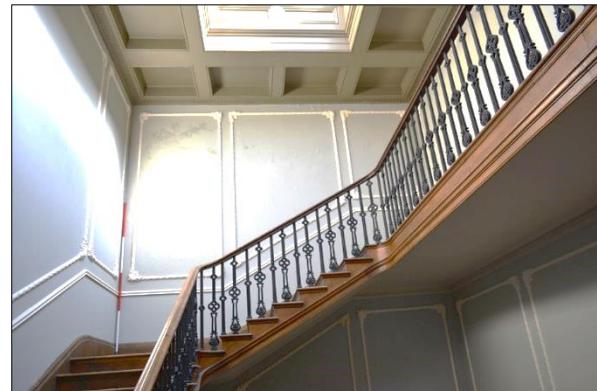
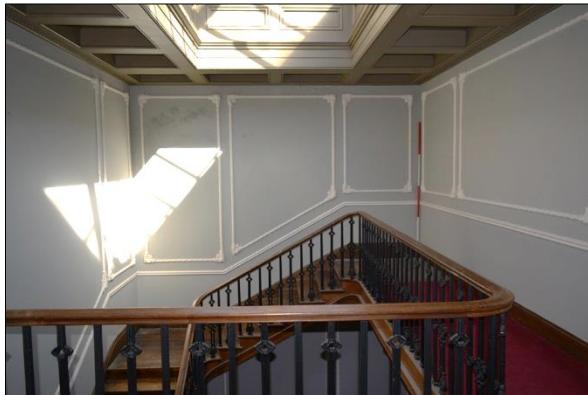
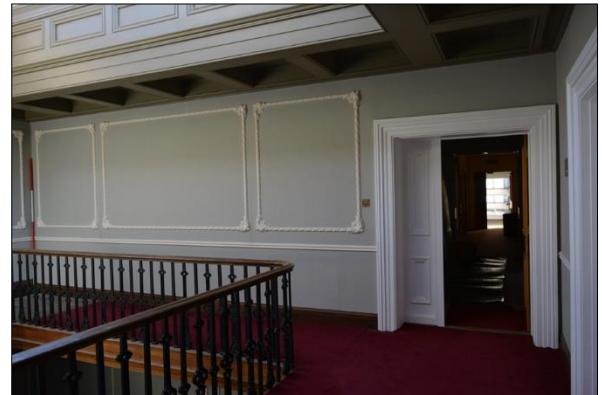
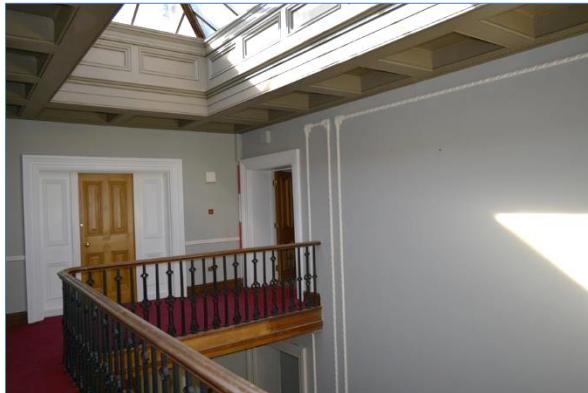
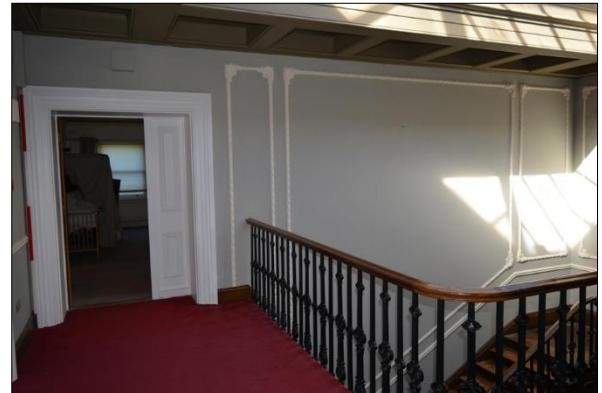
Project code: 384/HHG	Project: Harefield Grove: Main House	Room no: S1
Location: Central second floor	Function: Landing	
<b>Wall form &amp; decor:</b> As F1. Skirting boards are ogee moulded and become shorter in the we corner.		
<b>Ceiling / roof structure:</b> Coffered ceiling with flowers in intertwined cells as in G6. Central rooflight supported by panelled walling		
<b>Windows:</b> Rooflight		
<b>Doors:</b> 4 panelled door to west in deep recess with panelled wings to either side, as on first floor. 4 panelled doors to north and south also in deep recesses, but only the eastern side has a panelled section.		
<b>Floor:</b> Carpet over timber boards aligned east-west, c.14.5 to 17cm wide. Original where visible		
<b>Fireplace:</b>		
<b>Staircase:</b> As G4		
<b>Other architectural details:</b>		
Recorder: KK	Survey Date: 24.09.2018

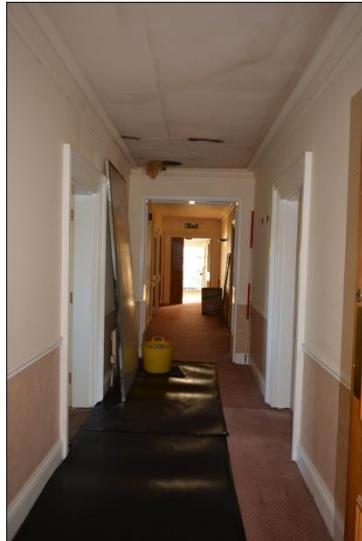
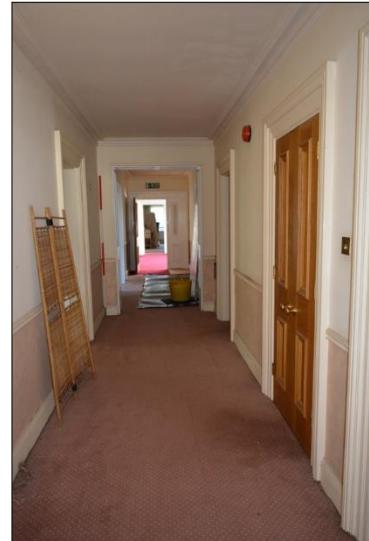
Project code: 384/HHG	Project: Project: Harefield Grove: Main House	Room no: S2
Location: South of S1	Function: Passage to sourh	
<b>Wall form &amp; decor:</b> Solid walls, papered below the dado and painted above. Skirting board and cornice as on first floor.		
<b>Ceiling / roof structure:</b> Painted plasterboard		
<b>Windows:</b>		
<b>Doors:</b> 4 panelled doors to east and west. Those to rooms are set within a deep plain recess. The two southernmost open into a kitchenette and a cupboard. They have the same architrave and doors but are not recessed.		
<b>Floor:</b> Carpet over mixed flooring		
<b>Fireplace:</b>		
<b>Staircase:</b>		
<b>Other architectural details:</b>		
Recorder: KK	Survey Date: 24.09.2018

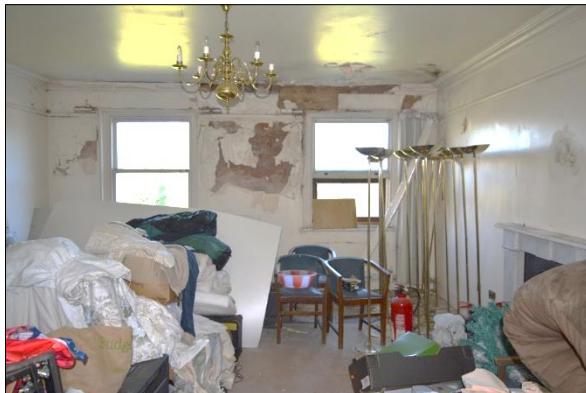
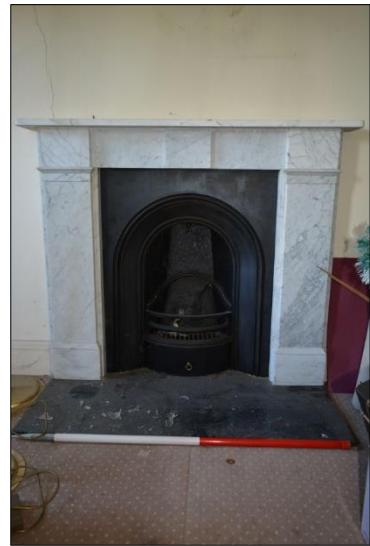
Project code: 384/HHG	Project: Harefield Grove: Main House	Room no: S3
Location: South of S1	Function: Store	
<b>Wall form &amp; decor:</b> Plastered and painted. Skirting, picture rail and cornice as on first floor.		
<b>Ceiling / roof structure:</b> Painted plasterboard		
<b>Windows:</b> Two sash windows to the east		
<b>Doors:</b> Door opening to the west		
<b>Floor:</b> Carpet		
<b>Fireplace:</b> Regency style marble chimney piece with arched timber insert, iron grate and marble hearth.		
<b>Staircase:</b>		
<b>Other architectural details:</b>		
Recorder: KK	<b>Survey Date:</b> 24.09.2018

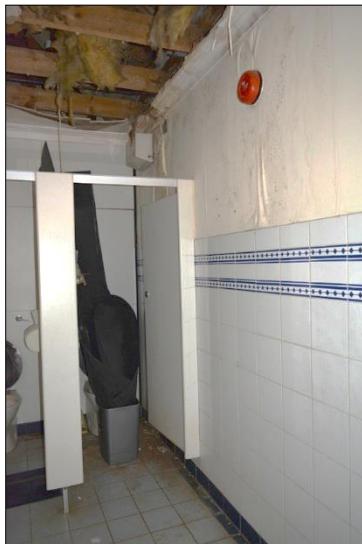
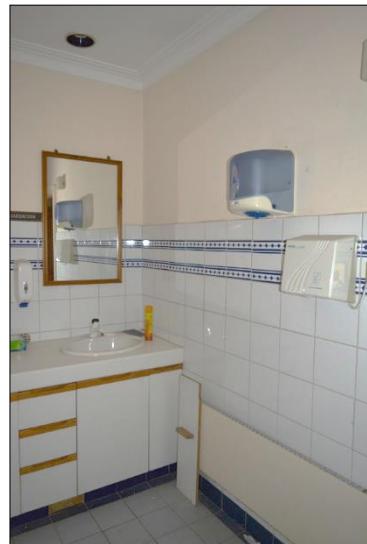
Project code: 384/HHG	Project: Harefield Grove: Main House	Room no: S4
Location: South of S3	Function: WC	
<b>Wall form &amp; decor:</b> Ante room painted with similar skirting but simple cornice. WC tiled to three quarter height then painted. Same cornice as in ante room		
<b>Ceiling / roof structure:</b> Painted plasterboard		
<b>Windows:</b>		
<b>Doors:</b> 4 panelled to S2 and between ante room and WC.		
<b>Floor:</b> Ceramic tiles		
<b>Fireplace:</b>		
<b>Staircase:</b>		
<b>Other architectural details:</b> Basins to south and cubicles to north		
Recorder: KK	<b>Survey Date:</b> 24.09.2018

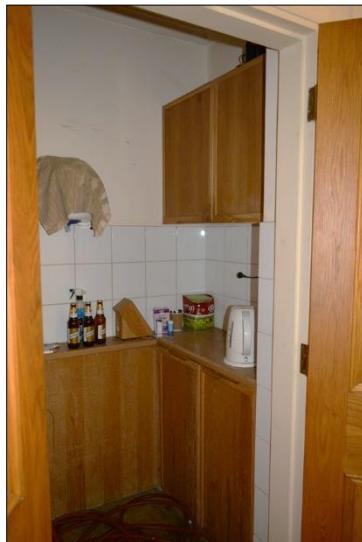
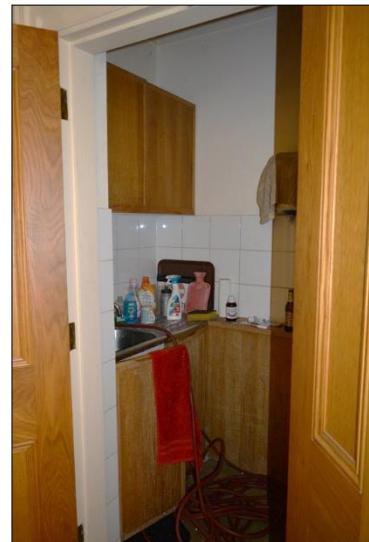
Project code: 384/HHG	Project: Harefield Grove: Main House	Room no: S5
Location: South of S4	Function: Kitchenette	
<b>Wall form &amp; decor:</b> Half tiled and painted above. Simple cornice.		
<b>Ceiling / roof structure:</b> Painted plasterboard		
<b>Windows:</b>		
<b>Doors:</b>		
<b>Floor:</b> Carpet		
<b>Fireplace:</b>		
<b>Staircase:</b>		
<b>Other architectural details:</b> Sink to north, wall and base units to north and south		
Recorder: KK	<b>Survey Date:</b> 24.09.2018

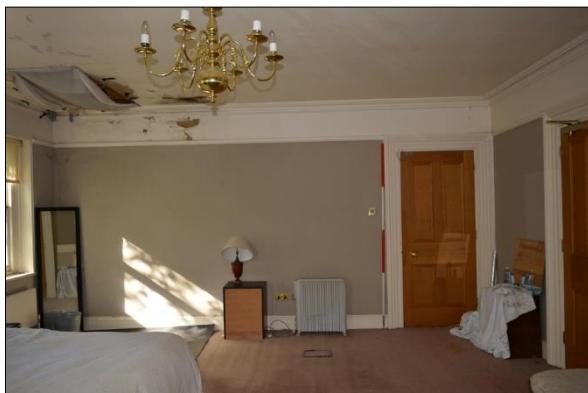
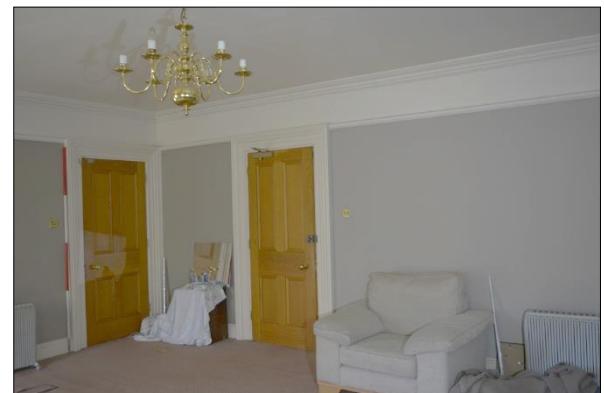
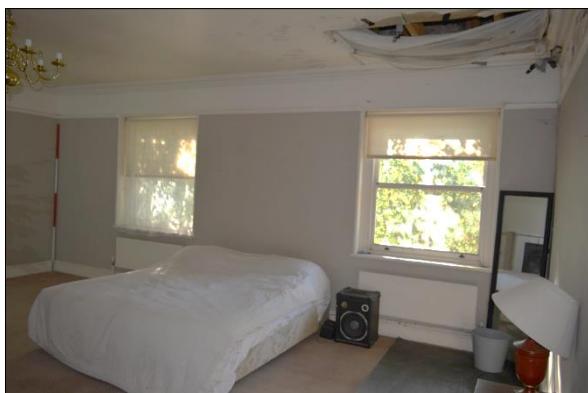
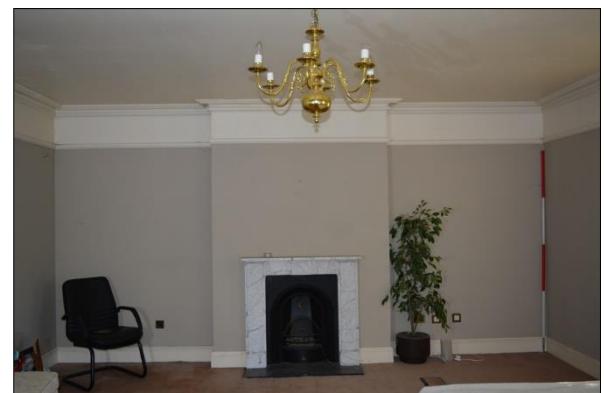
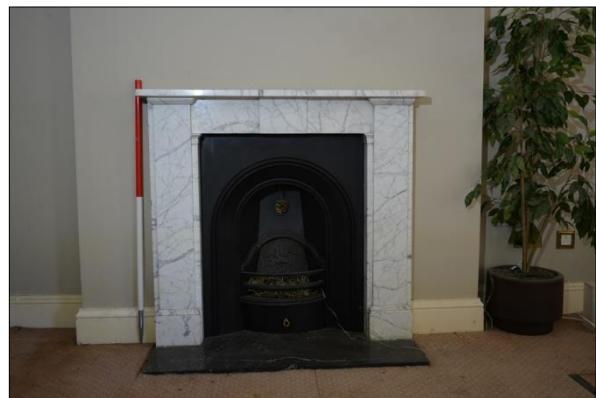
Project code: 384/HHG	Project: Harefield Grove: Main House	Room no: S6
Location: Southwest corner	Function: Bedroom	
<b>Wall form &amp; decor:</b> Solid plastered and painted to all sides. Same detailing as first floor.		
<b>Ceiling / roof structure:</b> Painted plasterboard		
<b>Windows:</b> Two timber sash to west		
<b>Doors:</b> 4 panelled doors to east and north		
<b>Floor:</b> Carpet over timber		
<b>Fireplace:</b> Regency style as S3		
<b>Staircase:</b>		
<b>Other architectural details:</b>		
Recorder: KK	<b>Survey Date:</b> 24.09.2018

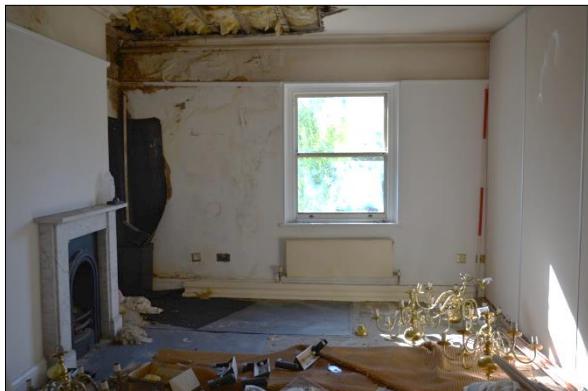
Plate 120: S7, facing west (110)

The second floor may well have been modernised in the early 1980s, but is now suffering from disrepair. The ceiling has partially collapsed in Room S7, revealing the plasterboard that has replaced the lath and plaster ceiling with the scars of the laths still evident on the joists. Part of the cornice has also come away in Room S11 at the northern end of the house, and here too it is clear that the walls have been completely re-plastered and that the cornice is modern. Given that the same style of cornice and skirting is present in nearly all of the two upper floor rooms, it would not be unreasonable to assume that they are all late 20<sup>th</sup> century replacements.

Project code: 384/HHG	Project: Harefield Grove: Main House	Room no: S7
Location: North of S6	Function: Store	
<b>Wall form &amp; decor:</b> North wall is modern partition. All others are solid, late and painted with the same detailing as FF.		
<b>Ceiling / roof structure:</b> Painted plasterboard		
<b>Windows:</b> Single timber sash to west		
<b>Doors:</b> 4 panelled to east and south. Flush door with narrow light to north.		
<b>Floor:</b> Carpet over timber sheets		
<b>Fireplace:</b> Regency style as in S3 to south		
<b>Staircase:</b>		
<b>Other architectural details:</b> Joists exposed where the ceiling has collapsed have scars from the laths. Roof timbers that can be seen above the joists are new.		
Recorder: KK	Survey Date: 24.09.2018

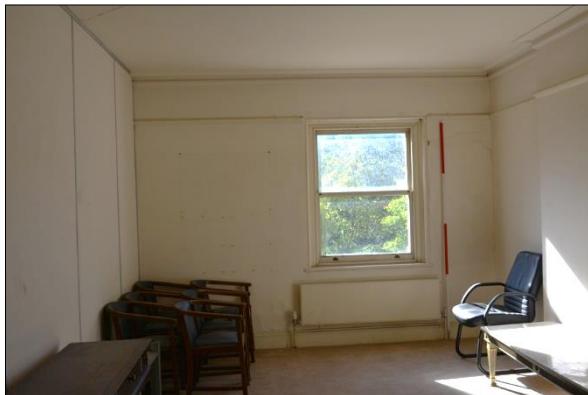
Plate 124: S9, facing west (114)

Project code: 384/HHG	Project: Harefield Grove: Main House	Room no: S9
Location: West of S1	Function: Store	
<b>Wall form &amp; decor:</b> Modern partition to south. All others are solid painted walls with the same skirting etc		
<b>Ceiling / roof structure:</b> PP		
<b>Windows:</b> Single sash to west		
<b>Doors:</b> Blocked door to North. Modern flush to south . 4panelled recessed door as F2 to east		
<b>Floor:</b> Carpet		
<b>Fireplace:</b>		
<b>Staircase:</b>		
<b>Other architectural details:</b>		
Recorder: KK	Survey Date: 24.09.2018

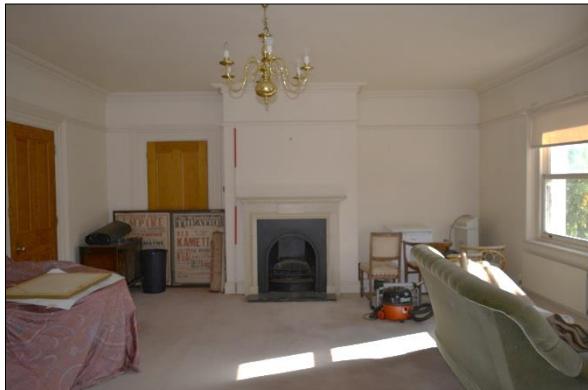
Plate 126: S10, facing south (116)

Project code: 384/HHG	Project: Harefield Grove: Main House	Room no: S10
Location: Northwest corner	Function: Store	
<b>Wall form &amp; decor:</b> Solid plastered and painted with the same detailing as she where		
<b>Ceiling / roof structure:</b> Painter plasterboard		
<b>Windows:</b> Two timber sash to west and one to north		
<b>Doors:</b> 4 panelled to north and south		
<b>Floor:</b> Carpet		
<b>Fireplace:</b> Timber chimney piece painted to look like marble. Arched inset and black hearth. Appears the same as elsewhere on the second floor but is wider		
<b>Staircase:</b>		
<b>Other architectural details:</b>		
Recorder: KK	Survey Date: 24.09.2018

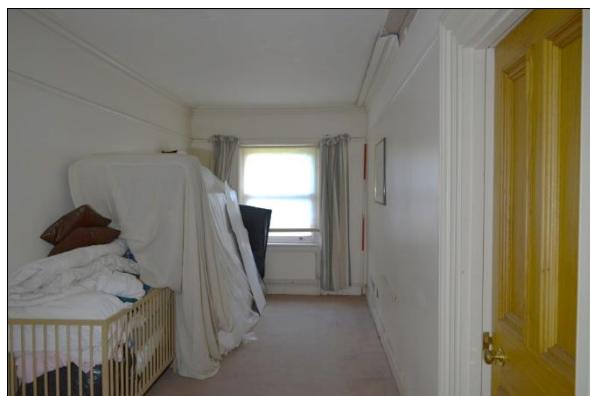
Plate 131: S11, facing north (121)

Project code: 384/HHG	Project: Harefield Grove: Main House	Room no: S11
Location: West of S1	Function: Store	
<b>Wall form &amp; decor:</b> Stud wall to east but solid elsewhere. Painted and has same detailing as elsewhere. Part of the cornice has fallen off the stud wall showing the modern plasterwork beneath.		
<b>Ceiling / roof structure:</b> Painted plasterboard		
<b>Windows:</b> Single sash to north		
<b>Doors:</b> 4 panelled doors to east, west and south. The southern door is within a deep recess with panelled side to the east. The western door is also recessed.		
<b>Floor:</b> Carpet possibly over boards		
<b>Fireplace:</b>		
<b>Staircase:</b>		
<b>Other architectural details:</b>		
Recorder: KK	Survey Date: 24.09.2018

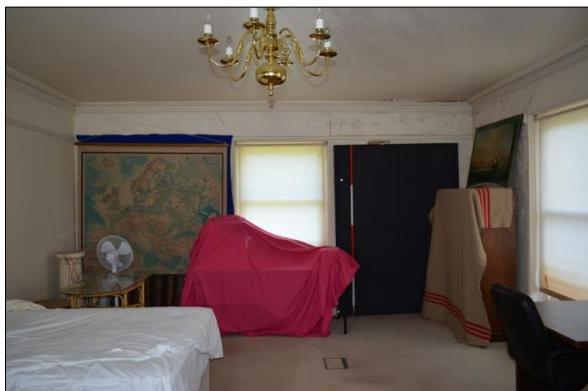
Plate 134: S12, facing north (124)

Project code: 384/HHG	Project: Harefield Grove: Main House	Room no: S12
Location: Northeast corner	Function: Store	
<b>Wall form &amp; decor:</b> West wall is a stud partition, the others are solid with the same detailing as elsewhere		
<b>Ceiling / roof structure:</b> Painted plasterboard		
<b>Windows:</b> Two sash windows to the east, one to the north		
<b>Doors:</b> 4 panelled door to the west		
<b>Floor:</b> Carpet possibly over boards		
<b>Fireplace:</b> Regency style fireplace as in S3		
<b>Staircase:</b>		
<b>Other architectural details:</b>		
Recorder: KK	Survey Date: 24.09.2018
