# Bat Survey Report

## **Harefield Grove**

On behalf of Comer Homes Group

Issue date: 06 August 2026

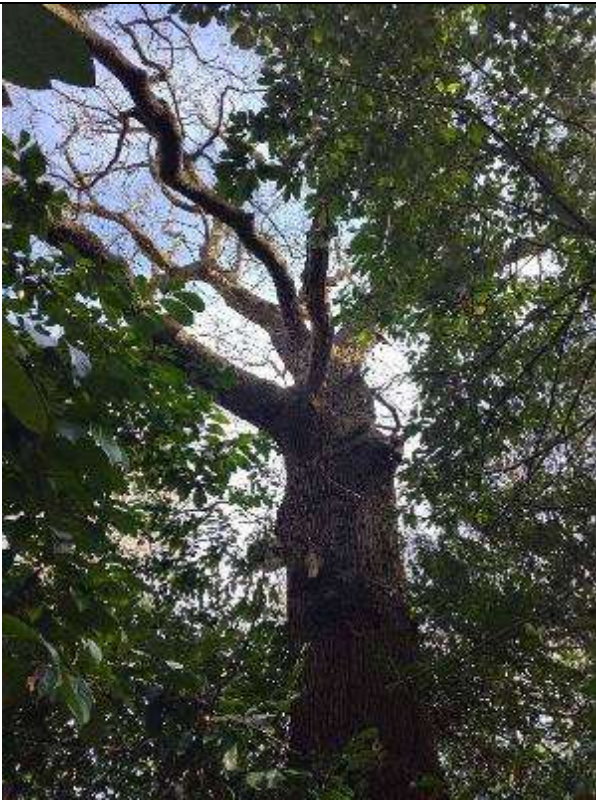
| Summary of PRFs | Veteran oak with significant amount of deadwood. View of crown obscured by understory. |
| <i>Photo from ground</i> | <i>Aerial photo from drone survey</i> |

| Further survey recommendations | Summer aerial inspections |

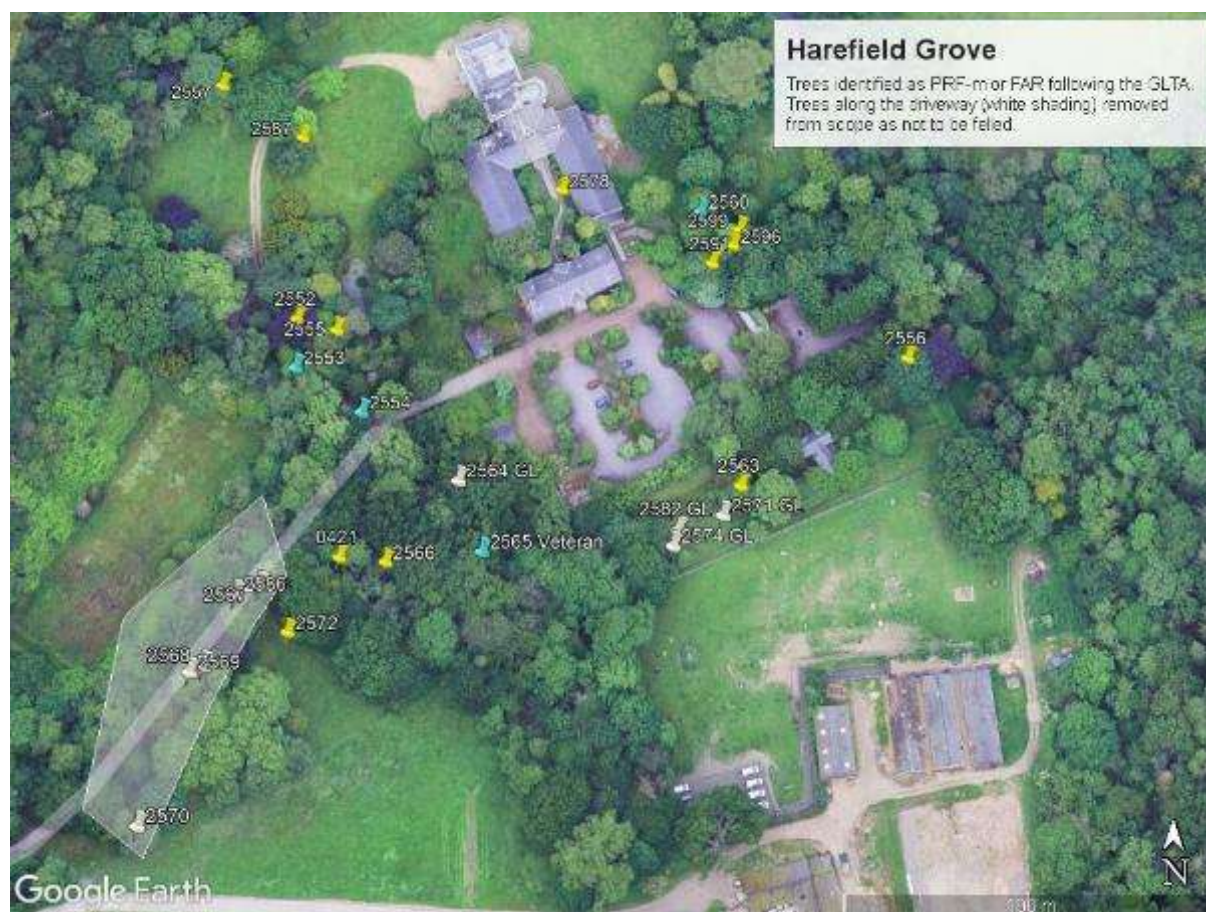
- This review removed 6 trees from scope, leaving 21 trees requiring further survey. These trees are shown in Figure 3.4 below. Four trees within the white shaded area along the driveway were removed from scope as no tree works are expected in this area.

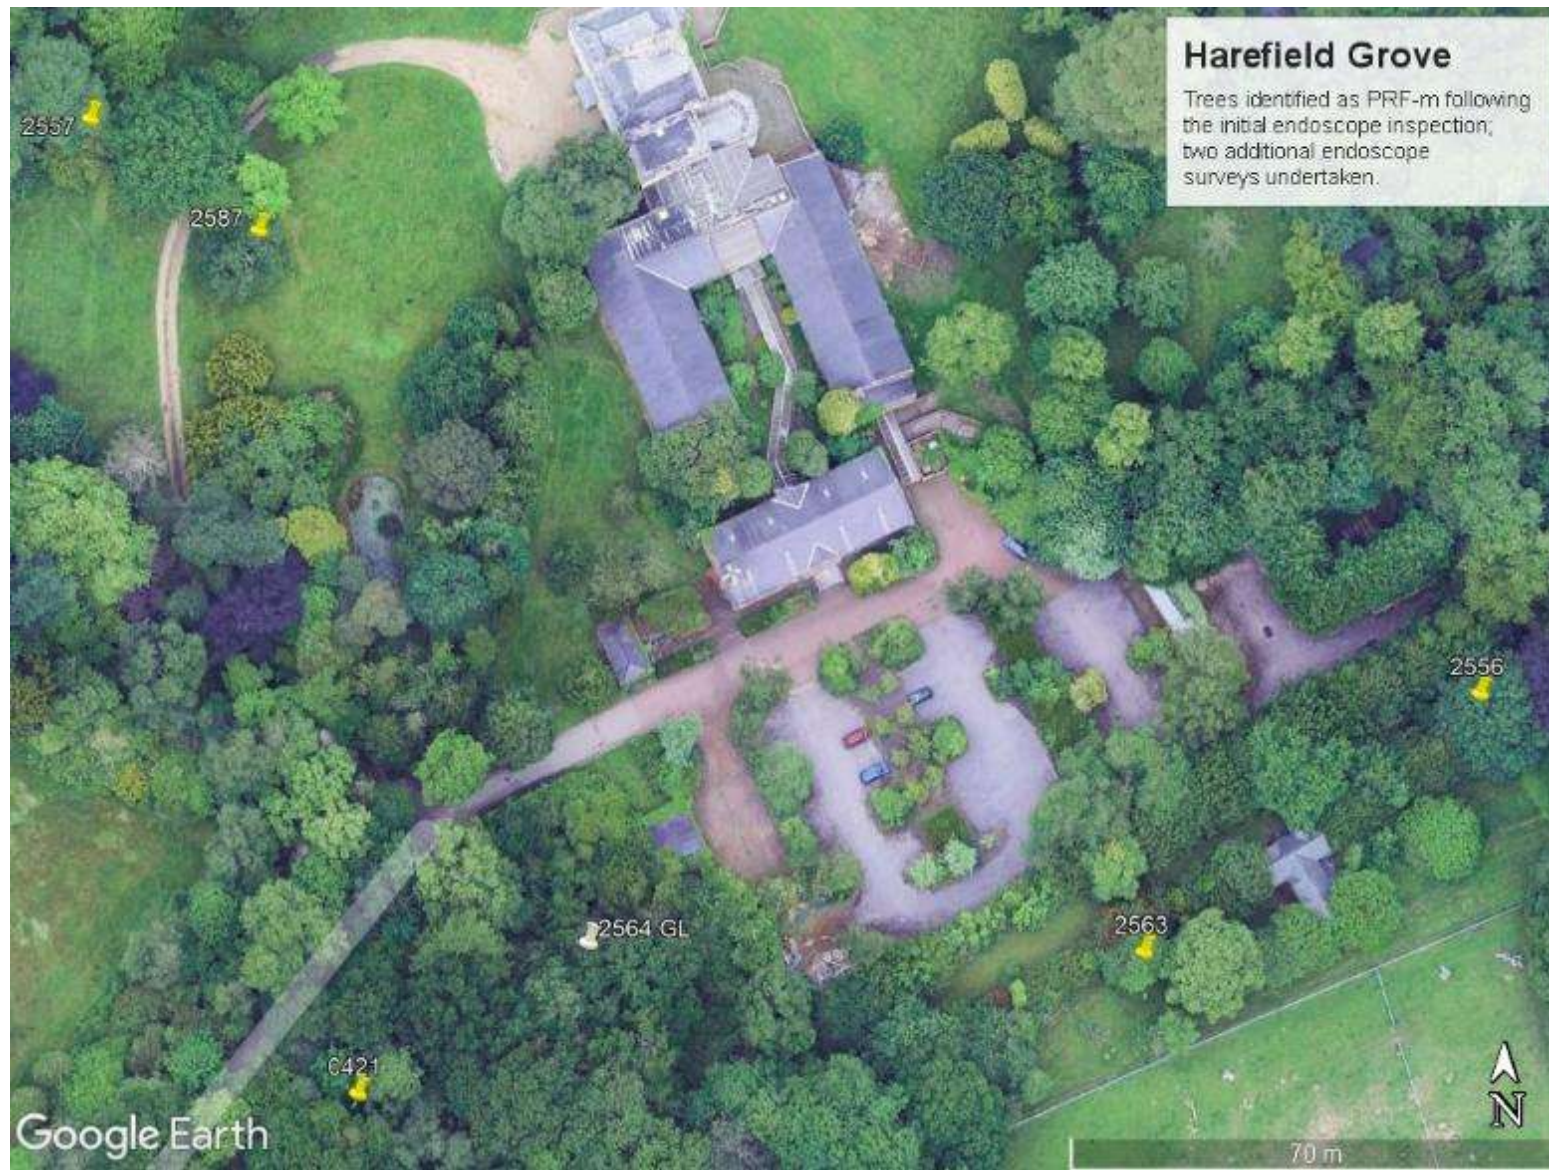
Figure 3.5: PRF-m trees given two additional endoscope surveys

Second and third endoscope surveys were carried out for 6 trees confirmed as PRF-m following the initial endoscope inspection. This is because these trees have a high potential to support bat roosts. Figure 3.5 shows the trees assessed. Table 3.3 provides the results.

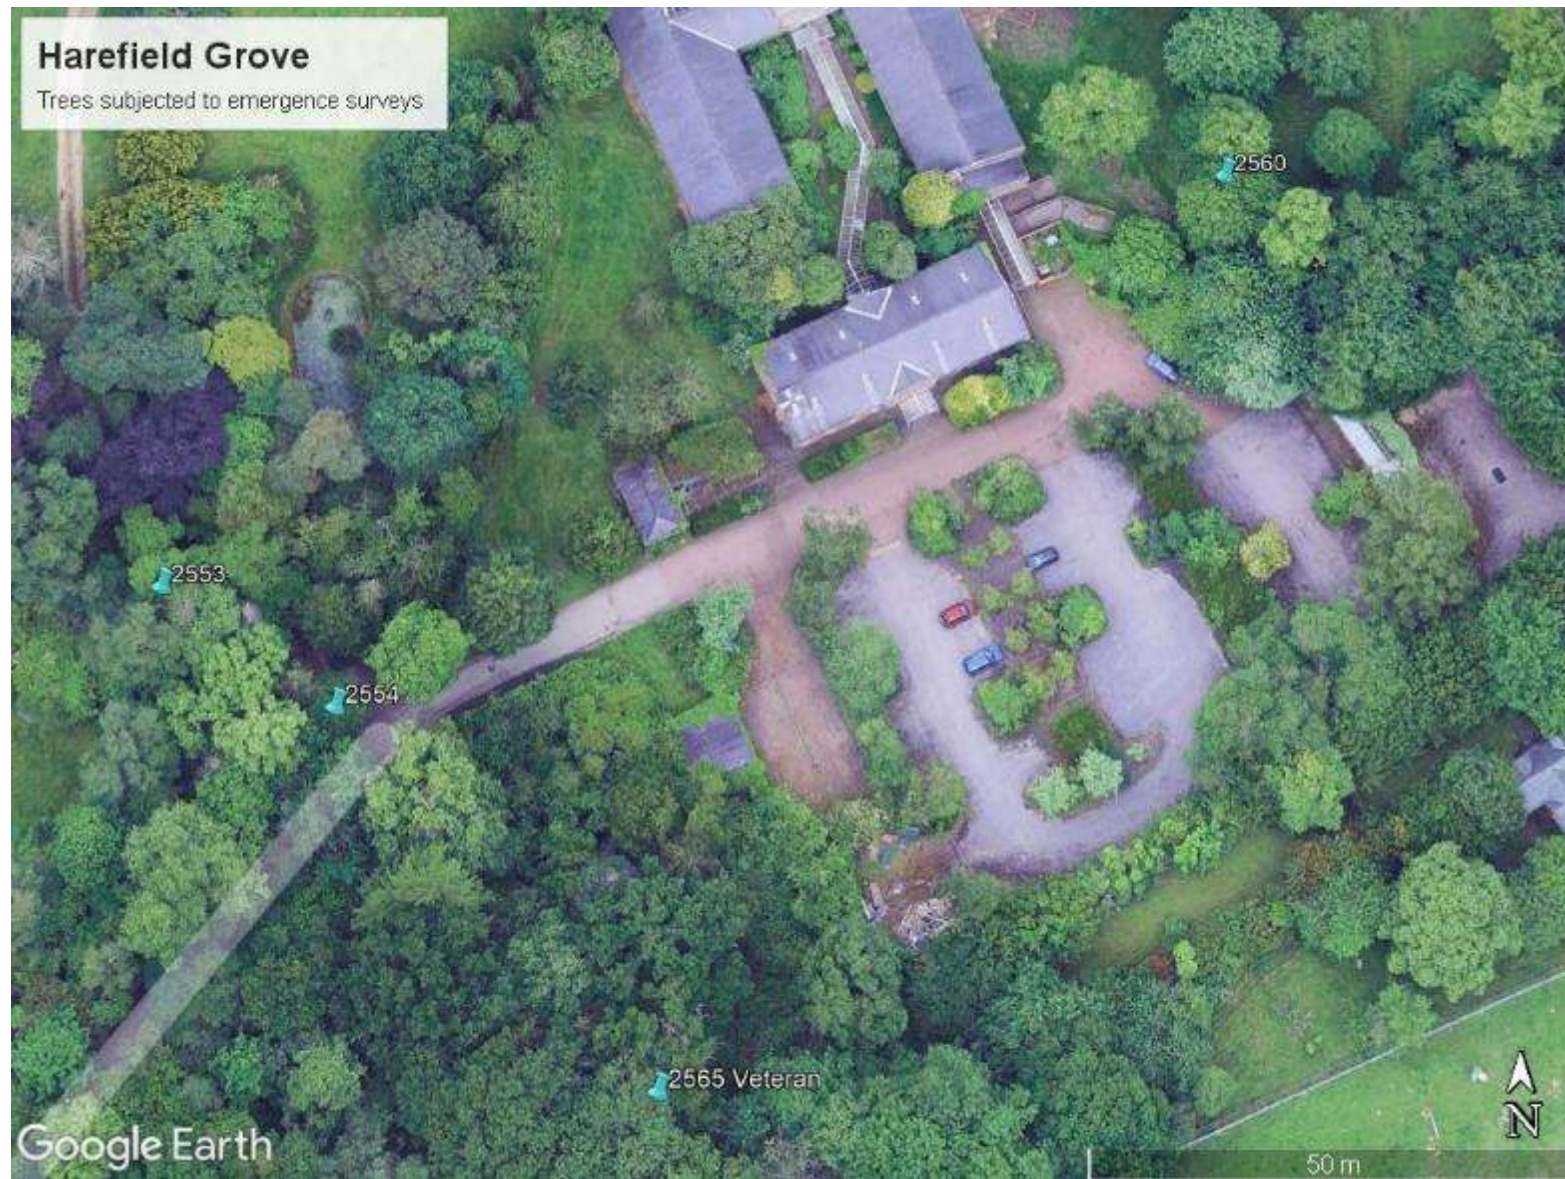
Figure 3.6: Trees with PRF-m or FAR classification which were subject to emergence surveys.

PRF-m trees that could not be surveyed via endoscope were: 2553, 2554, 2560 and 2565. These trees were taken forward for survey using the bat emergence survey technique. See Figure 3.6 below. Photos of these trees, taken during the GLTA, are provided in Appendix B. The end of survey vantage points are provided in Appendix C.

No bat roosts were positively identified.

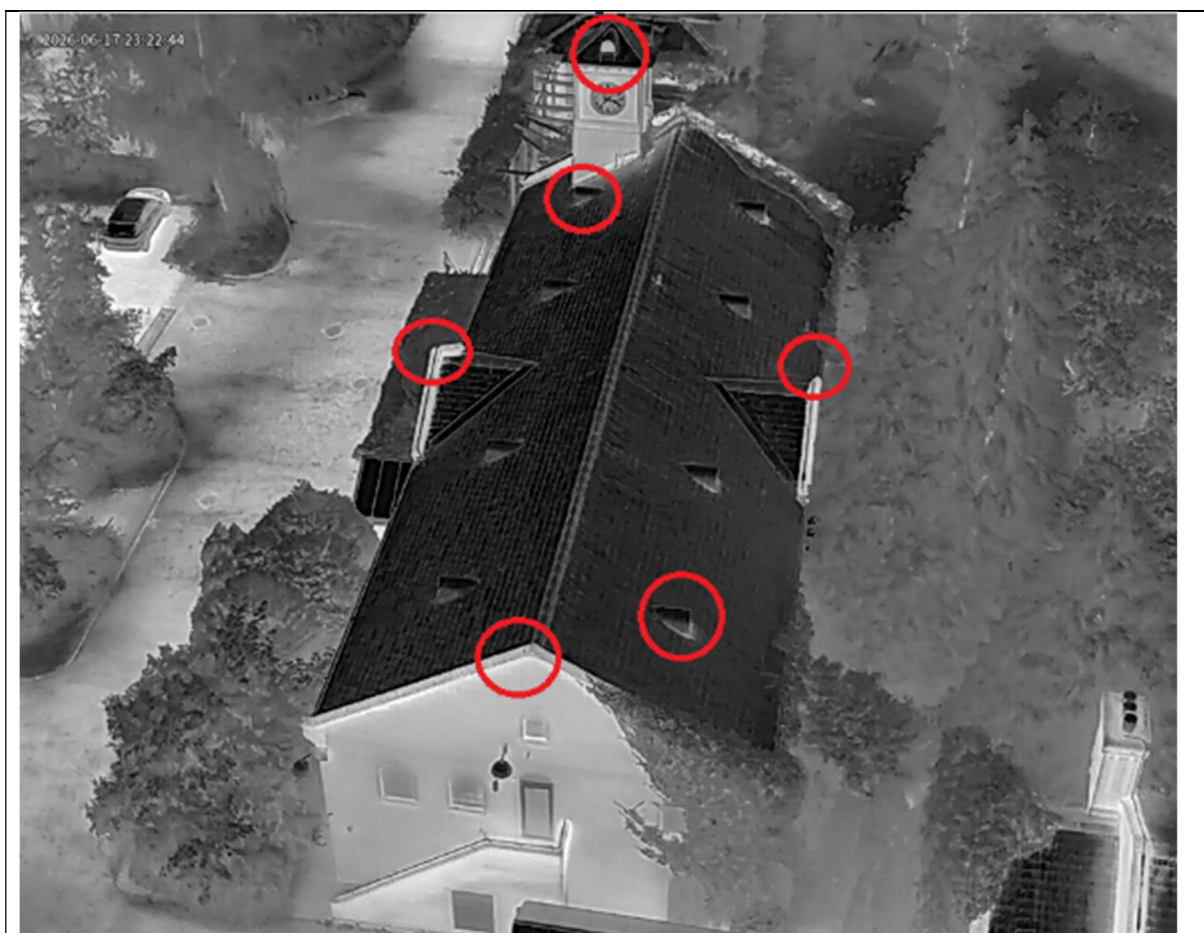
26/05/2026 - Common and soprano pipistrelles were recorded commuting and foraging throughout the survey. Occasional noctule and myotis sp. activity was also recorded. Eight bats were observed emerging from the building. Sound analysis confirms that both common and soprano pipistrelle echolocated at the times of the emergences. **8 emergences (soprano and common pipistrelle)**

17/06/2026 - There were 2 emergences from a small dormer vent beside the clock tower at 21:56 and 22:03. Sound analysis has identified these emergences as soprano pipistrelle. In the opposite corner of B1, 1 bat emerged at 22:19 from a small dormer vent at the back of the building. A *Myotis* sp. was recorded echolocating at 22:19 and no other species were recorded for the next 6 minutes. **3 emergences (2 soprano pipistrelle and a single *Myotis* sp. bat)**

06/07/2026 - There were 3 emergences from a small dormer vent beside the clock tower and the clocktower itself at 21:16, 21:38 and 21:55. The first 2 bats did not echolocate as they emerged. Common pipistrelle were recorded echolocating during the time of the final emergence, although a single brown long-eared bat was also recorded at the exact emergence time too. **3 emergences (common pipistrelle/ brown long-eared)**

Above: Sites of emergences on B1 on 26/05/2026, 17/06/2026 and 06/07/2026

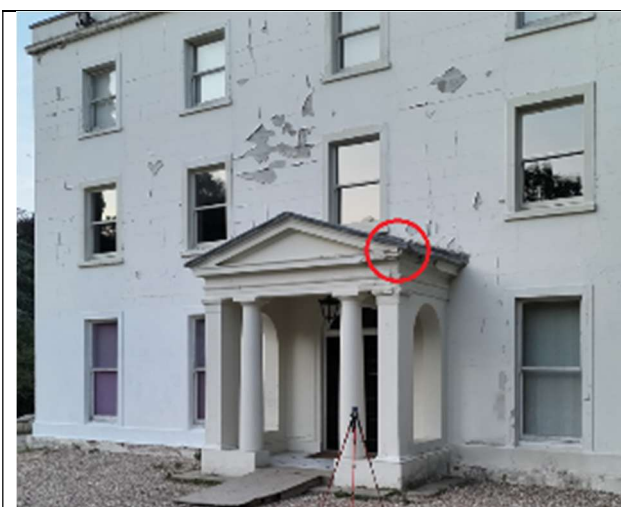
23/06/2026 – 2 bats emerged from under the corner of the porch on the side of B3 at 21:55 and 22:36. The first bat was not recorded echolocating. Both soprano and common pipistrelle were recorded during the time of the second emergence. **2 soprano/common pipistrelle emergences.**

21/07/2026 – 2 soprano pipistrelle bats chased each other around the west side of B3 and into the junction area between B2 and B3 for 45 minutes shortly after sunset. 1 bat emerged from under the corner of the porch on the side of B3 at 21:35. This is confirmed as soprano pipistrelle. **One soprano pipistrelle emergence.**

Above: sites of emergences on B3

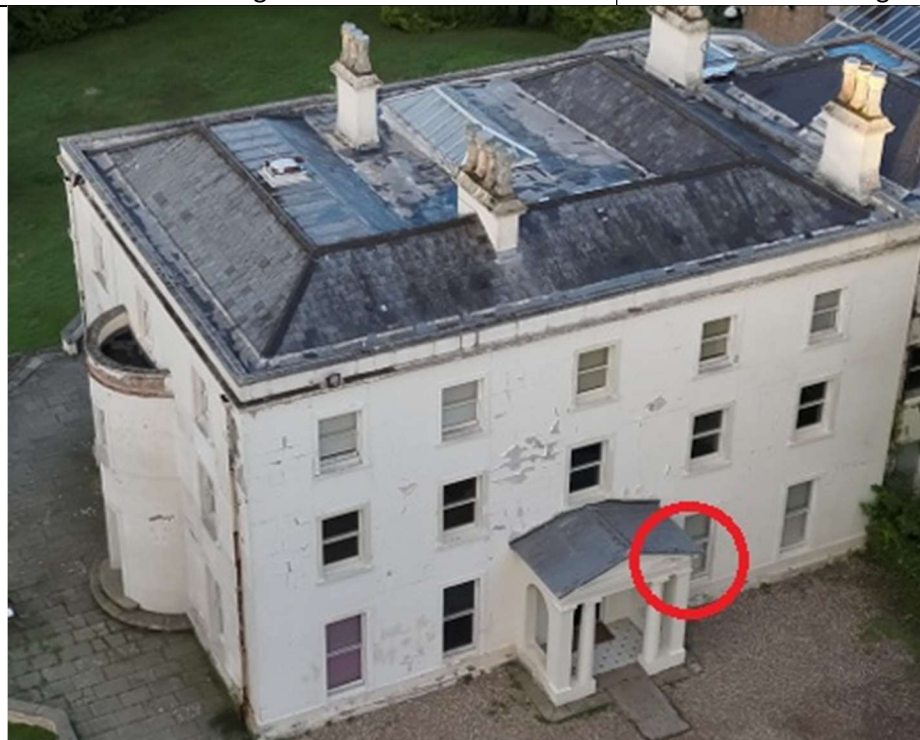
Above: sites of emergences on B3

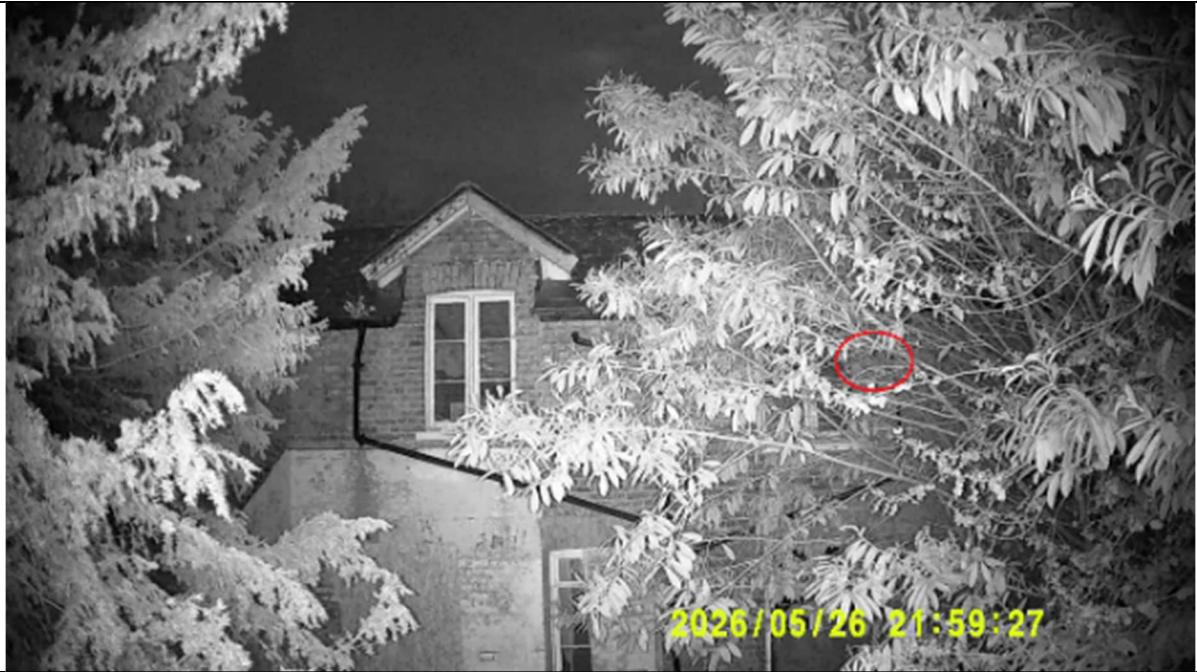
21/07/2026 - Common and soprano pipistrelles were recorded commuting and foraging throughout the survey. Occasional noctule activity was also recorded. At 21:30, 1 bat emerged from one feature on the front of the building (NW aspect). Between 21:25 and 22:36, 4 bats emerged from the south-western side of the building. At 22:04 and 22:05, 2 bats re-entered the south-western side of the building. **5 soprano pipistrelle emergences and 2 re-entry.**

Above: sites of re-entry on B6 (SW aspect)

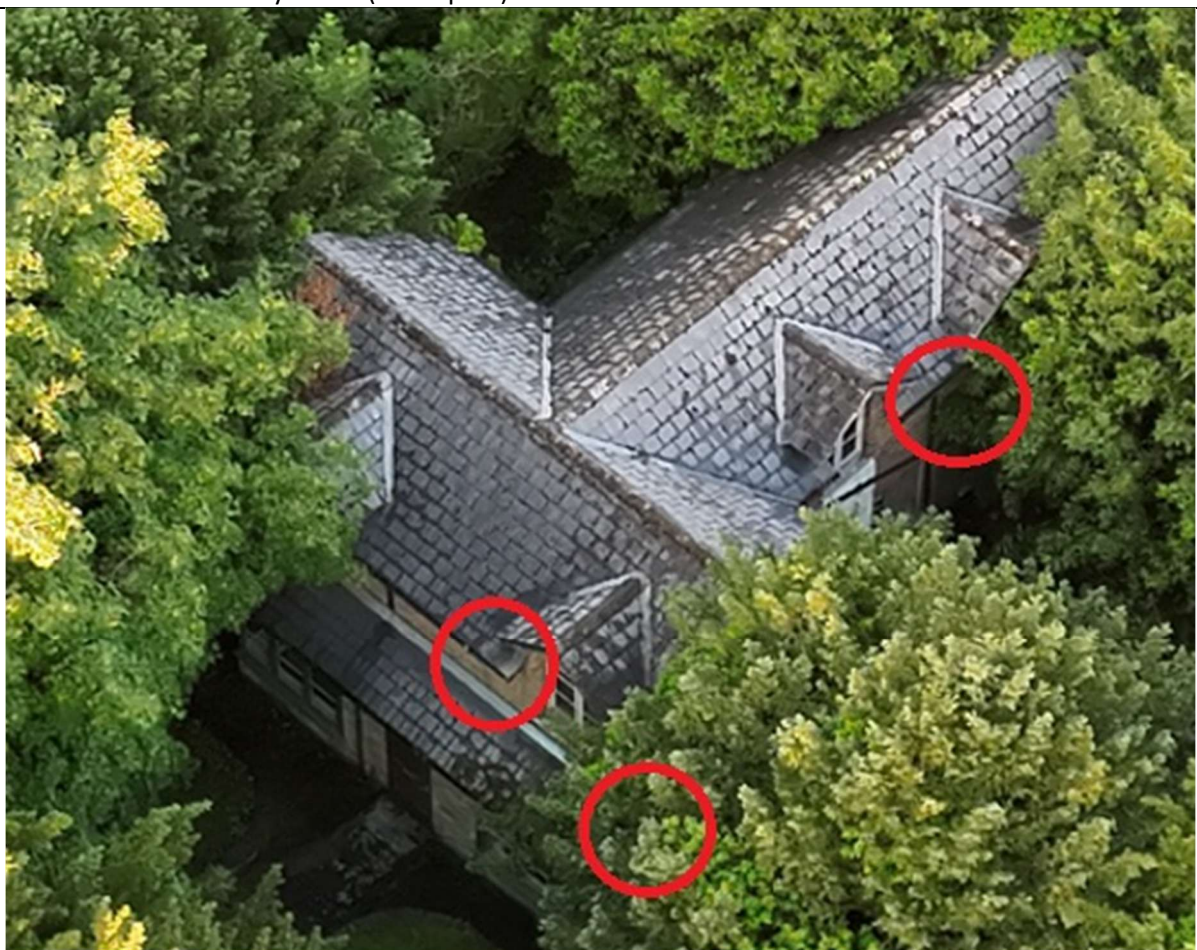
22/06/2026 - Common and soprano pipistrelles were recorded commuting and foraging throughout the survey. Occasional noctule activity was also recorded. At 21:46 a soprano pipistrelle emerged from the front of the building (NW side) and at 21:50 a soprano pipistrelle emerged from the SW aspect of B6. **2 soprano pipistrelle emergences.**

Above: sites of emergence on B6

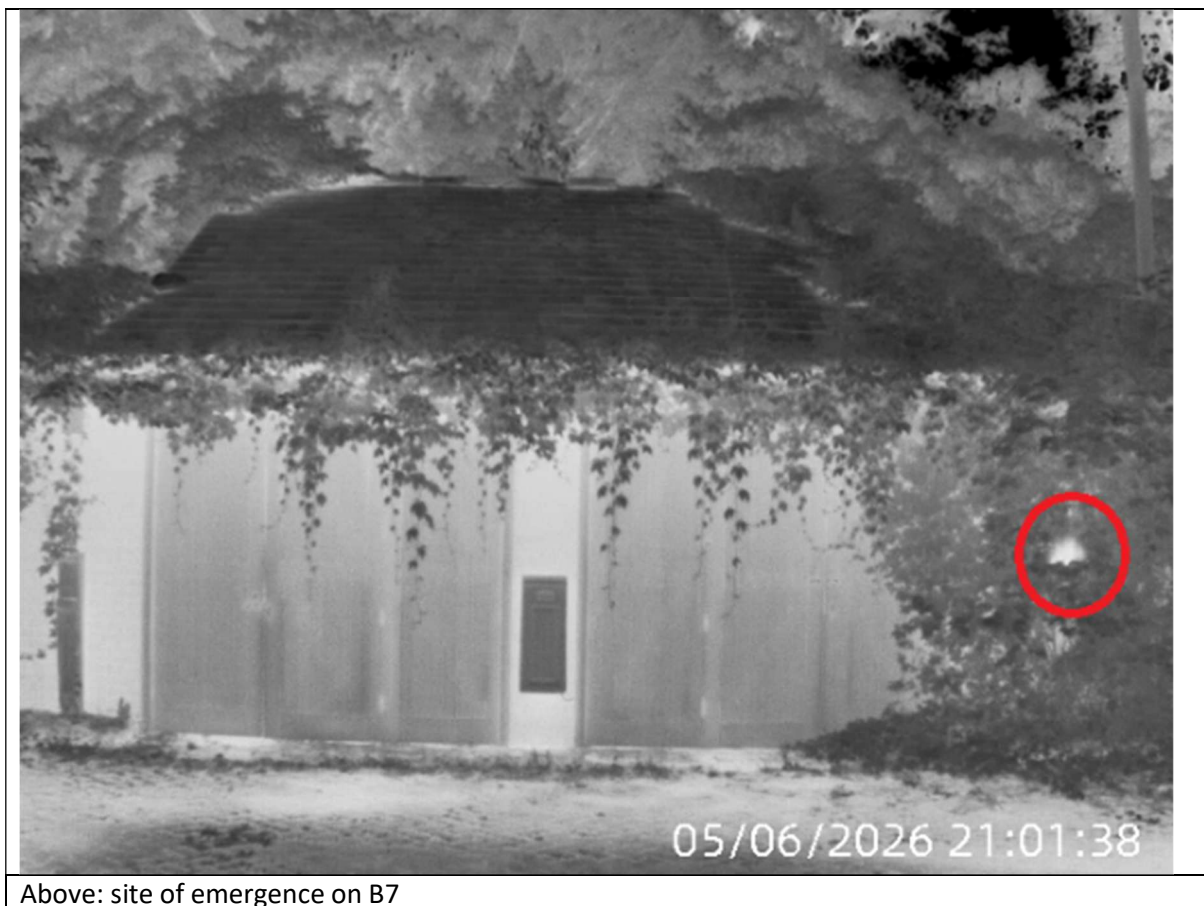
05/06/2026 – A single bat emerged at 21:01. A noctule echolocated at this time. Noctules often emerge earlier than other species: this was 13 minutes before sunset.

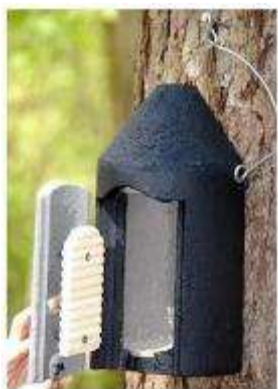
*Example of hanging or mounted bat box (Schwegler 2F Bat Box or similar) - suitable for crevice dwelling bats*

At least two 'rescue' bat boxes should be installed in an appropriate place in trees onsite so that these can be used for shelter in the event that a bat is found while works are being undertaken. The exact location would be specified by the Named Ecologist, however a general recommendation is that boxes should be placed approximately 5m from the ground facing between south and west.

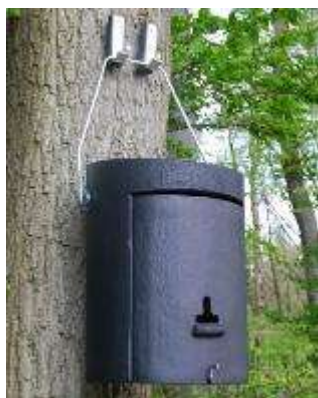
*Example of hibernation bat box (Schwegler 1FW Bat Box or similar)*

At least 10 bat boxes should be placed on retained mature trees within the grounds. The sites of the bat boxes should be 3 – 5m above ground, facing onto an uncluttered space with no branches or shrubs (some pruning of branches and removal of scrub may be required). The bat boxes should be a mixture of cavity and crevice boxes, and with one hibernation bat box provided.

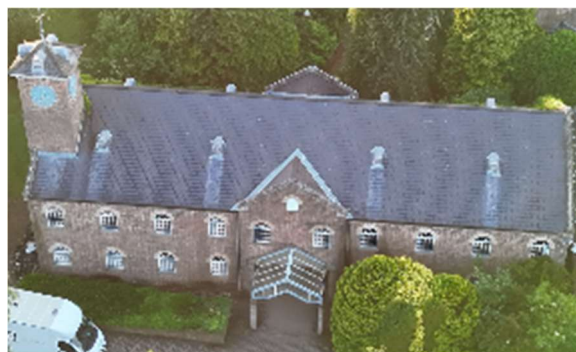
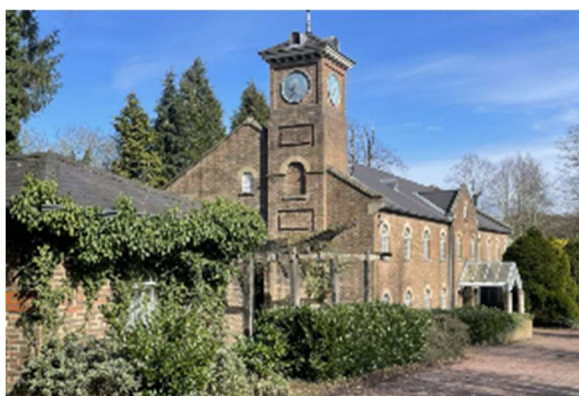
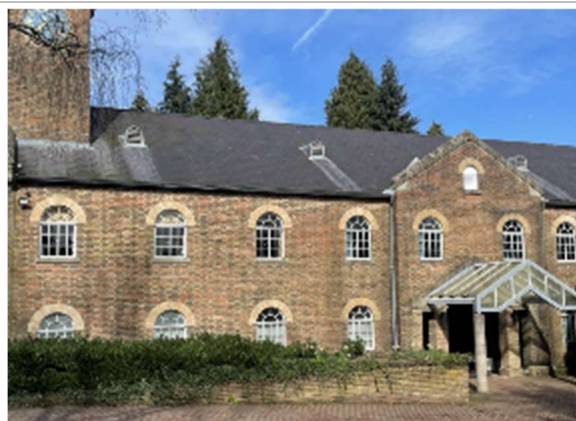
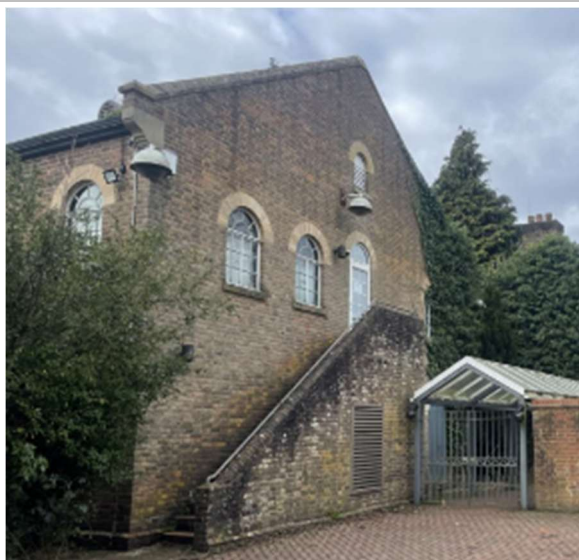
*B1 Stable building*

| Building | Building potential or presence of confirmed roost(s) | No. emergence surveys required |
|---|---|---|
| B1 Stable building | <p>B1 is a rectangular two-storey brick building.</p> <p><b>B1 is a confirmed roost.</b> A large number of droppings (confirmed by DNA analysis as brown long-eared bats) were found on the insulation across the whole loft space.</p> <p>B1 is assessed to have <b>high habitat value</b> for roosting bats due to a number of suitable roosting features on its exterior, and presence of optimal foraging and commuting habitat in the immediate surroundings.</p> | 3 |

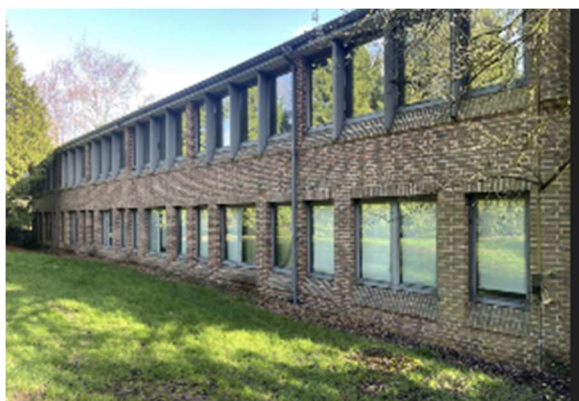
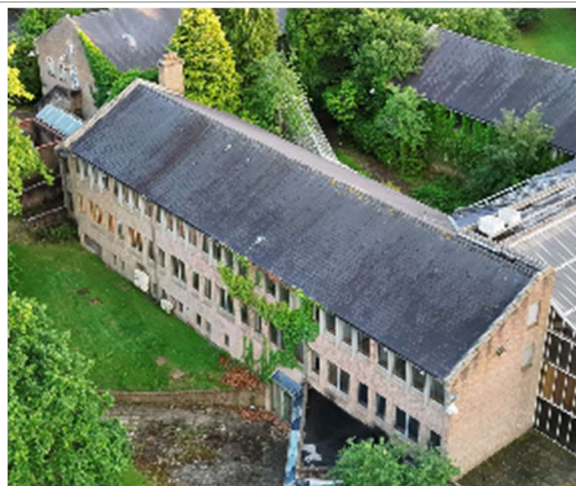
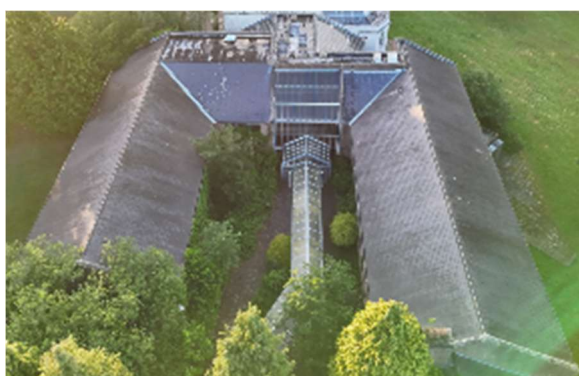
*B2 Office extension*

| Building | Building potential or presence of confirmed roost(s) | No. emergence surveys required |
|---|---|---|
| B2 Office extension | <p>B2 is a U-shaped, two-storey brick building, split into an east and west wing.</p> <p><b>B2 is a confirmed roost</b> and is assessed to have <b>moderate habitat value</b> for roosting bats due to the presence of suitable roosting features on its exterior, and optimal foraging and commuting habitat in the immediate surroundings.</p> <p>A small number of droppings (confirmed by DNA analysis as brown long-eared bats) were found on the insulation across the whole loft space of the west wing.</p> | 3 |

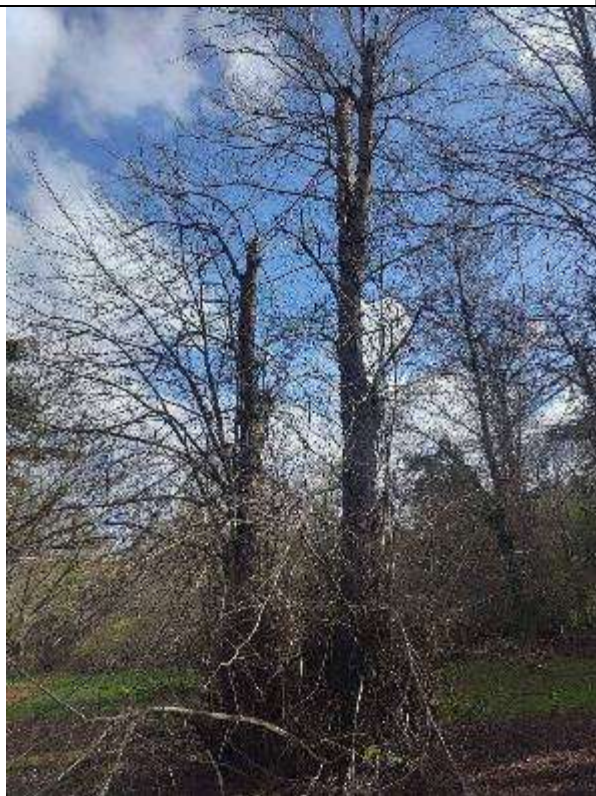
2560 Common lime – twin stemmed mature / dying (central stem has died). Both stems have large internal cavities. Appears unsafe.

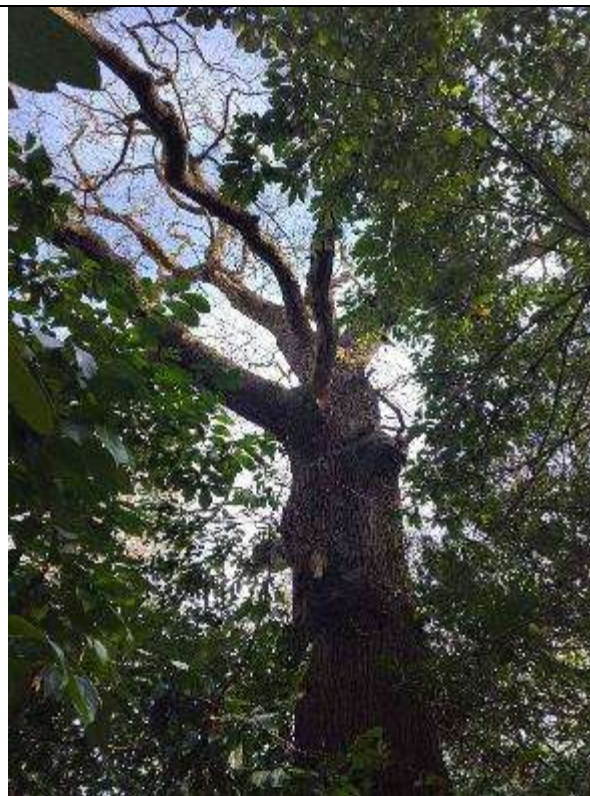
2565 - Veteran oak with significant amount of deadwood. View of crown obscured by vegetation
