## **Phase II Geo-environmental Report**

**Project:** The Bungalow,  
New Years Green Lane,  
Harefield.

**Client:** London Borough of Hillingdon Council

**Reference:** M44477-JNP-XX-XX-RP-G-1002 P03

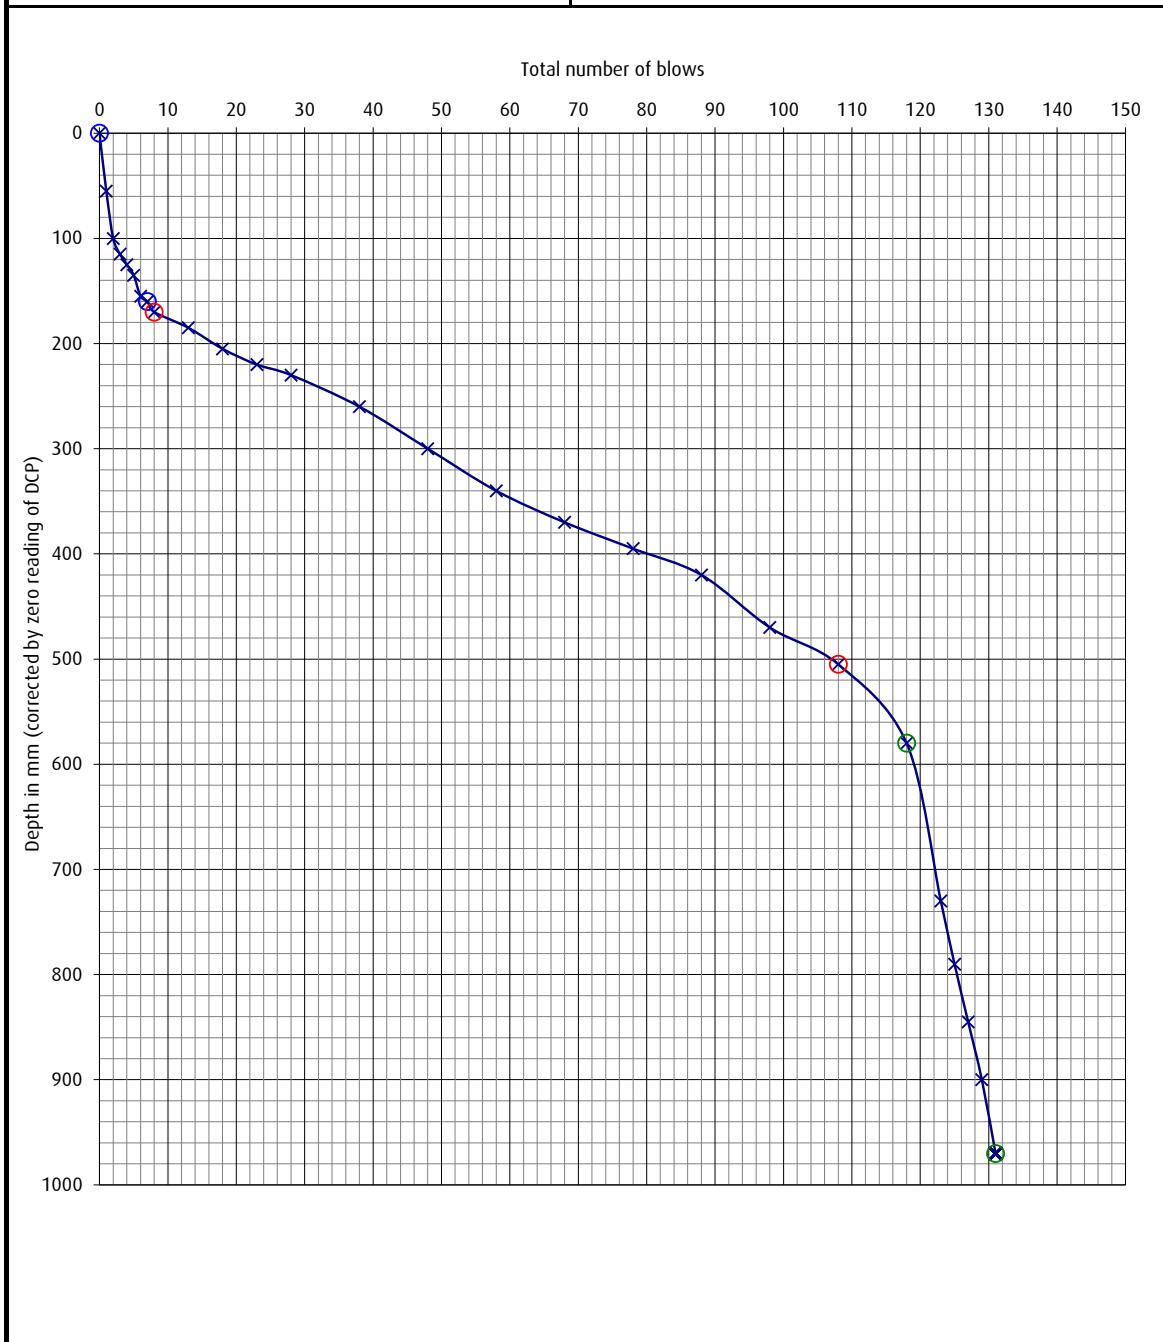
<b>JNP GROUP</b> <small>CONSULTING ENGINEERS</small>	
Name				
Project No.	M44477			
Engineer	Ben Thrift			
Client	London Borough of Hillingdon Council			
Test no	DCP1	Initial Depth	0 m

Remarks	Undertaken from ground level
Recorded by:	Ben Thrift
Date:	08/05/2024

Project	The Bungalow, New Years Green Lane	<b>Record of Results for TRL DCP (Dynamic Cone Penetrometer)</b>

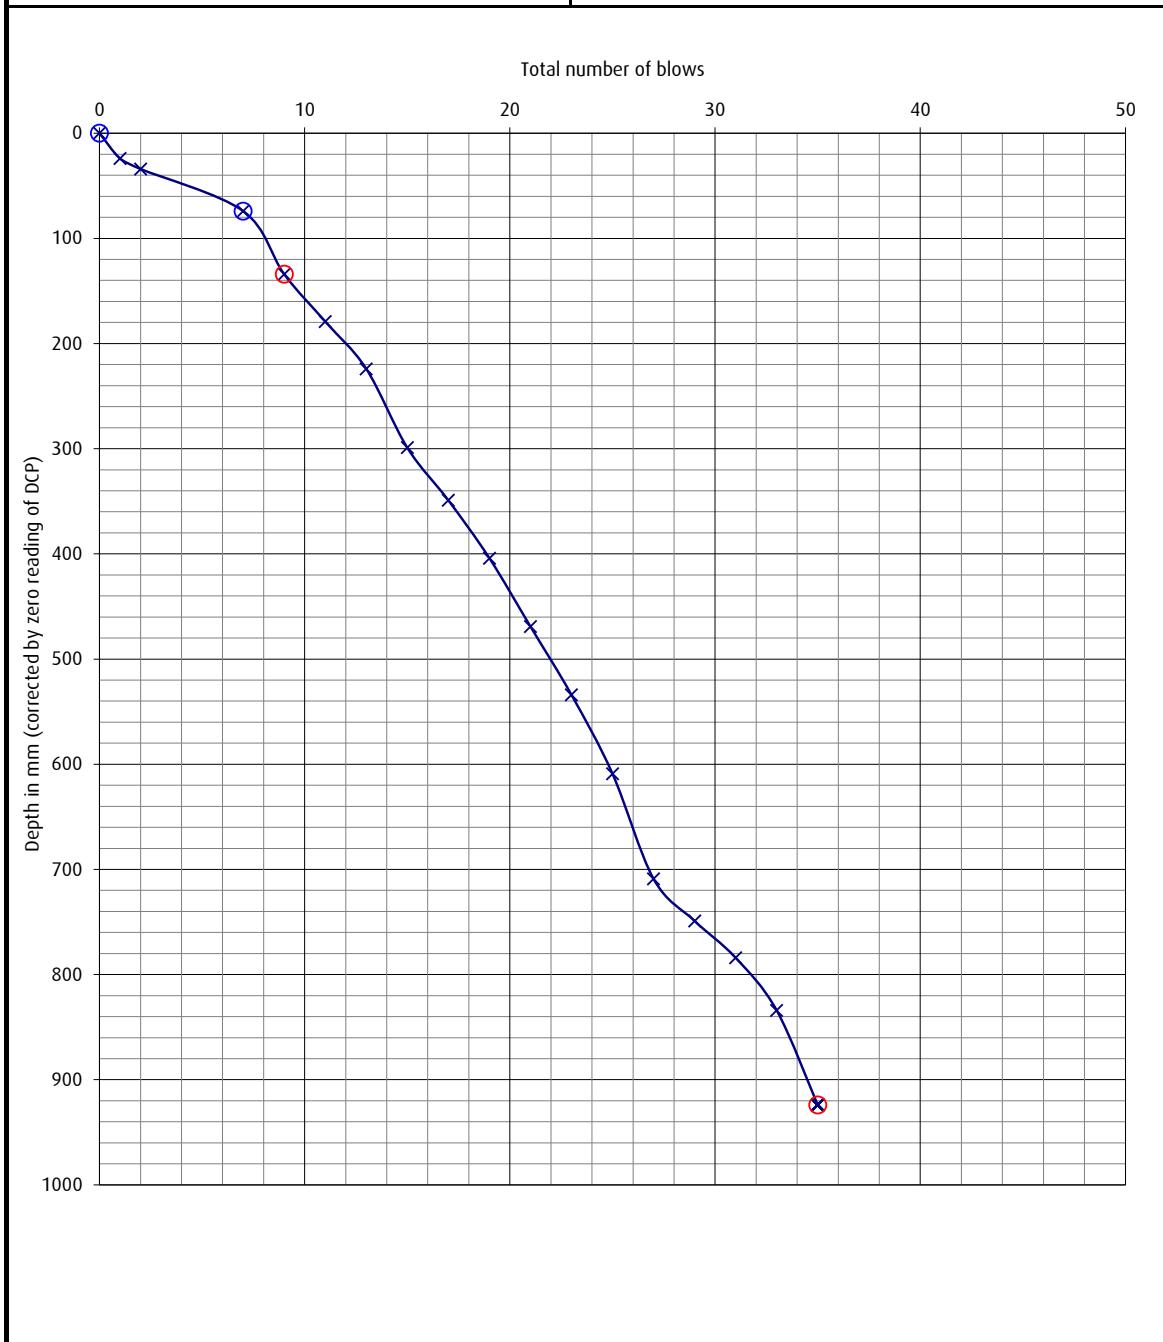
<b>JNP GROUP</b> <small>CONSULTING ENGINEERS</small>	
Name				
Project No.	M44477			
Engineer	Ben Thrift			
Client	London Borough of Hillingdon Council			
Test no	DCP2	Initial Depth	0 m

Remarks	Undertaken from ground level
Recorded by:	Ben Thrift
Date:	08/05/2024

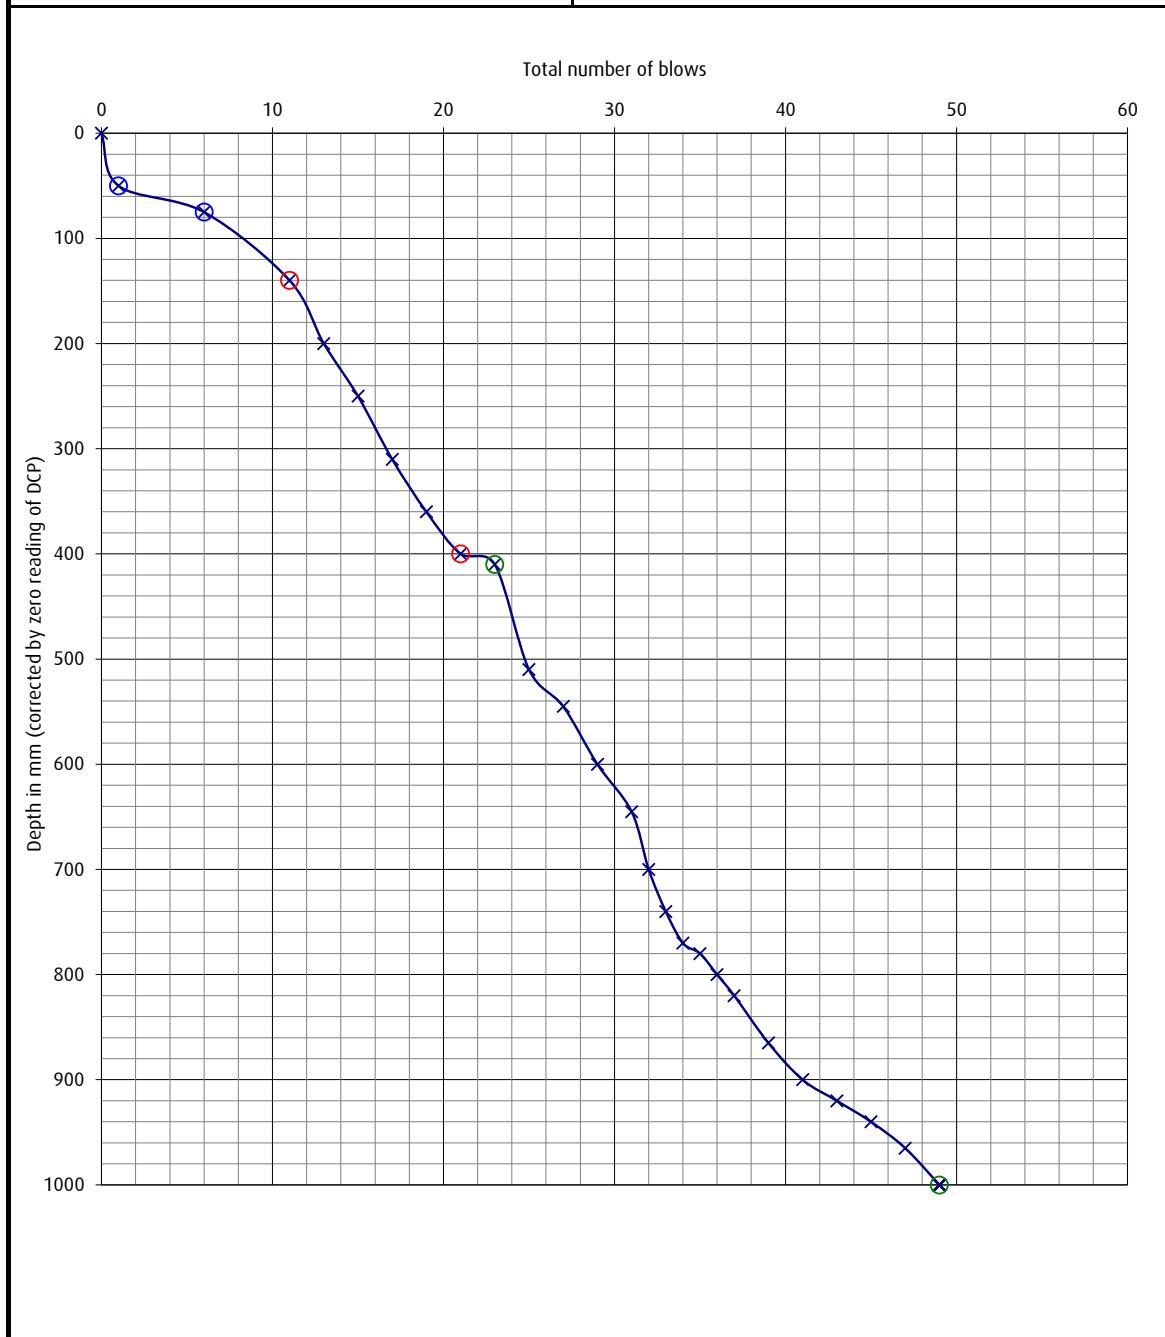
<b>JNP GROUP</b> <small>CONSULTING ENGINEERS</small>	
Name				
Project No.	M44477			
Engineer	Ben Thrift			
Client	London Borough of Hillingdon Council			
Test no	DCP-BH01	Initial Depth	0 m

Remarks	Undertaken from ground level
Recorded by:	Ben Thrift
Date:	08/05/2024

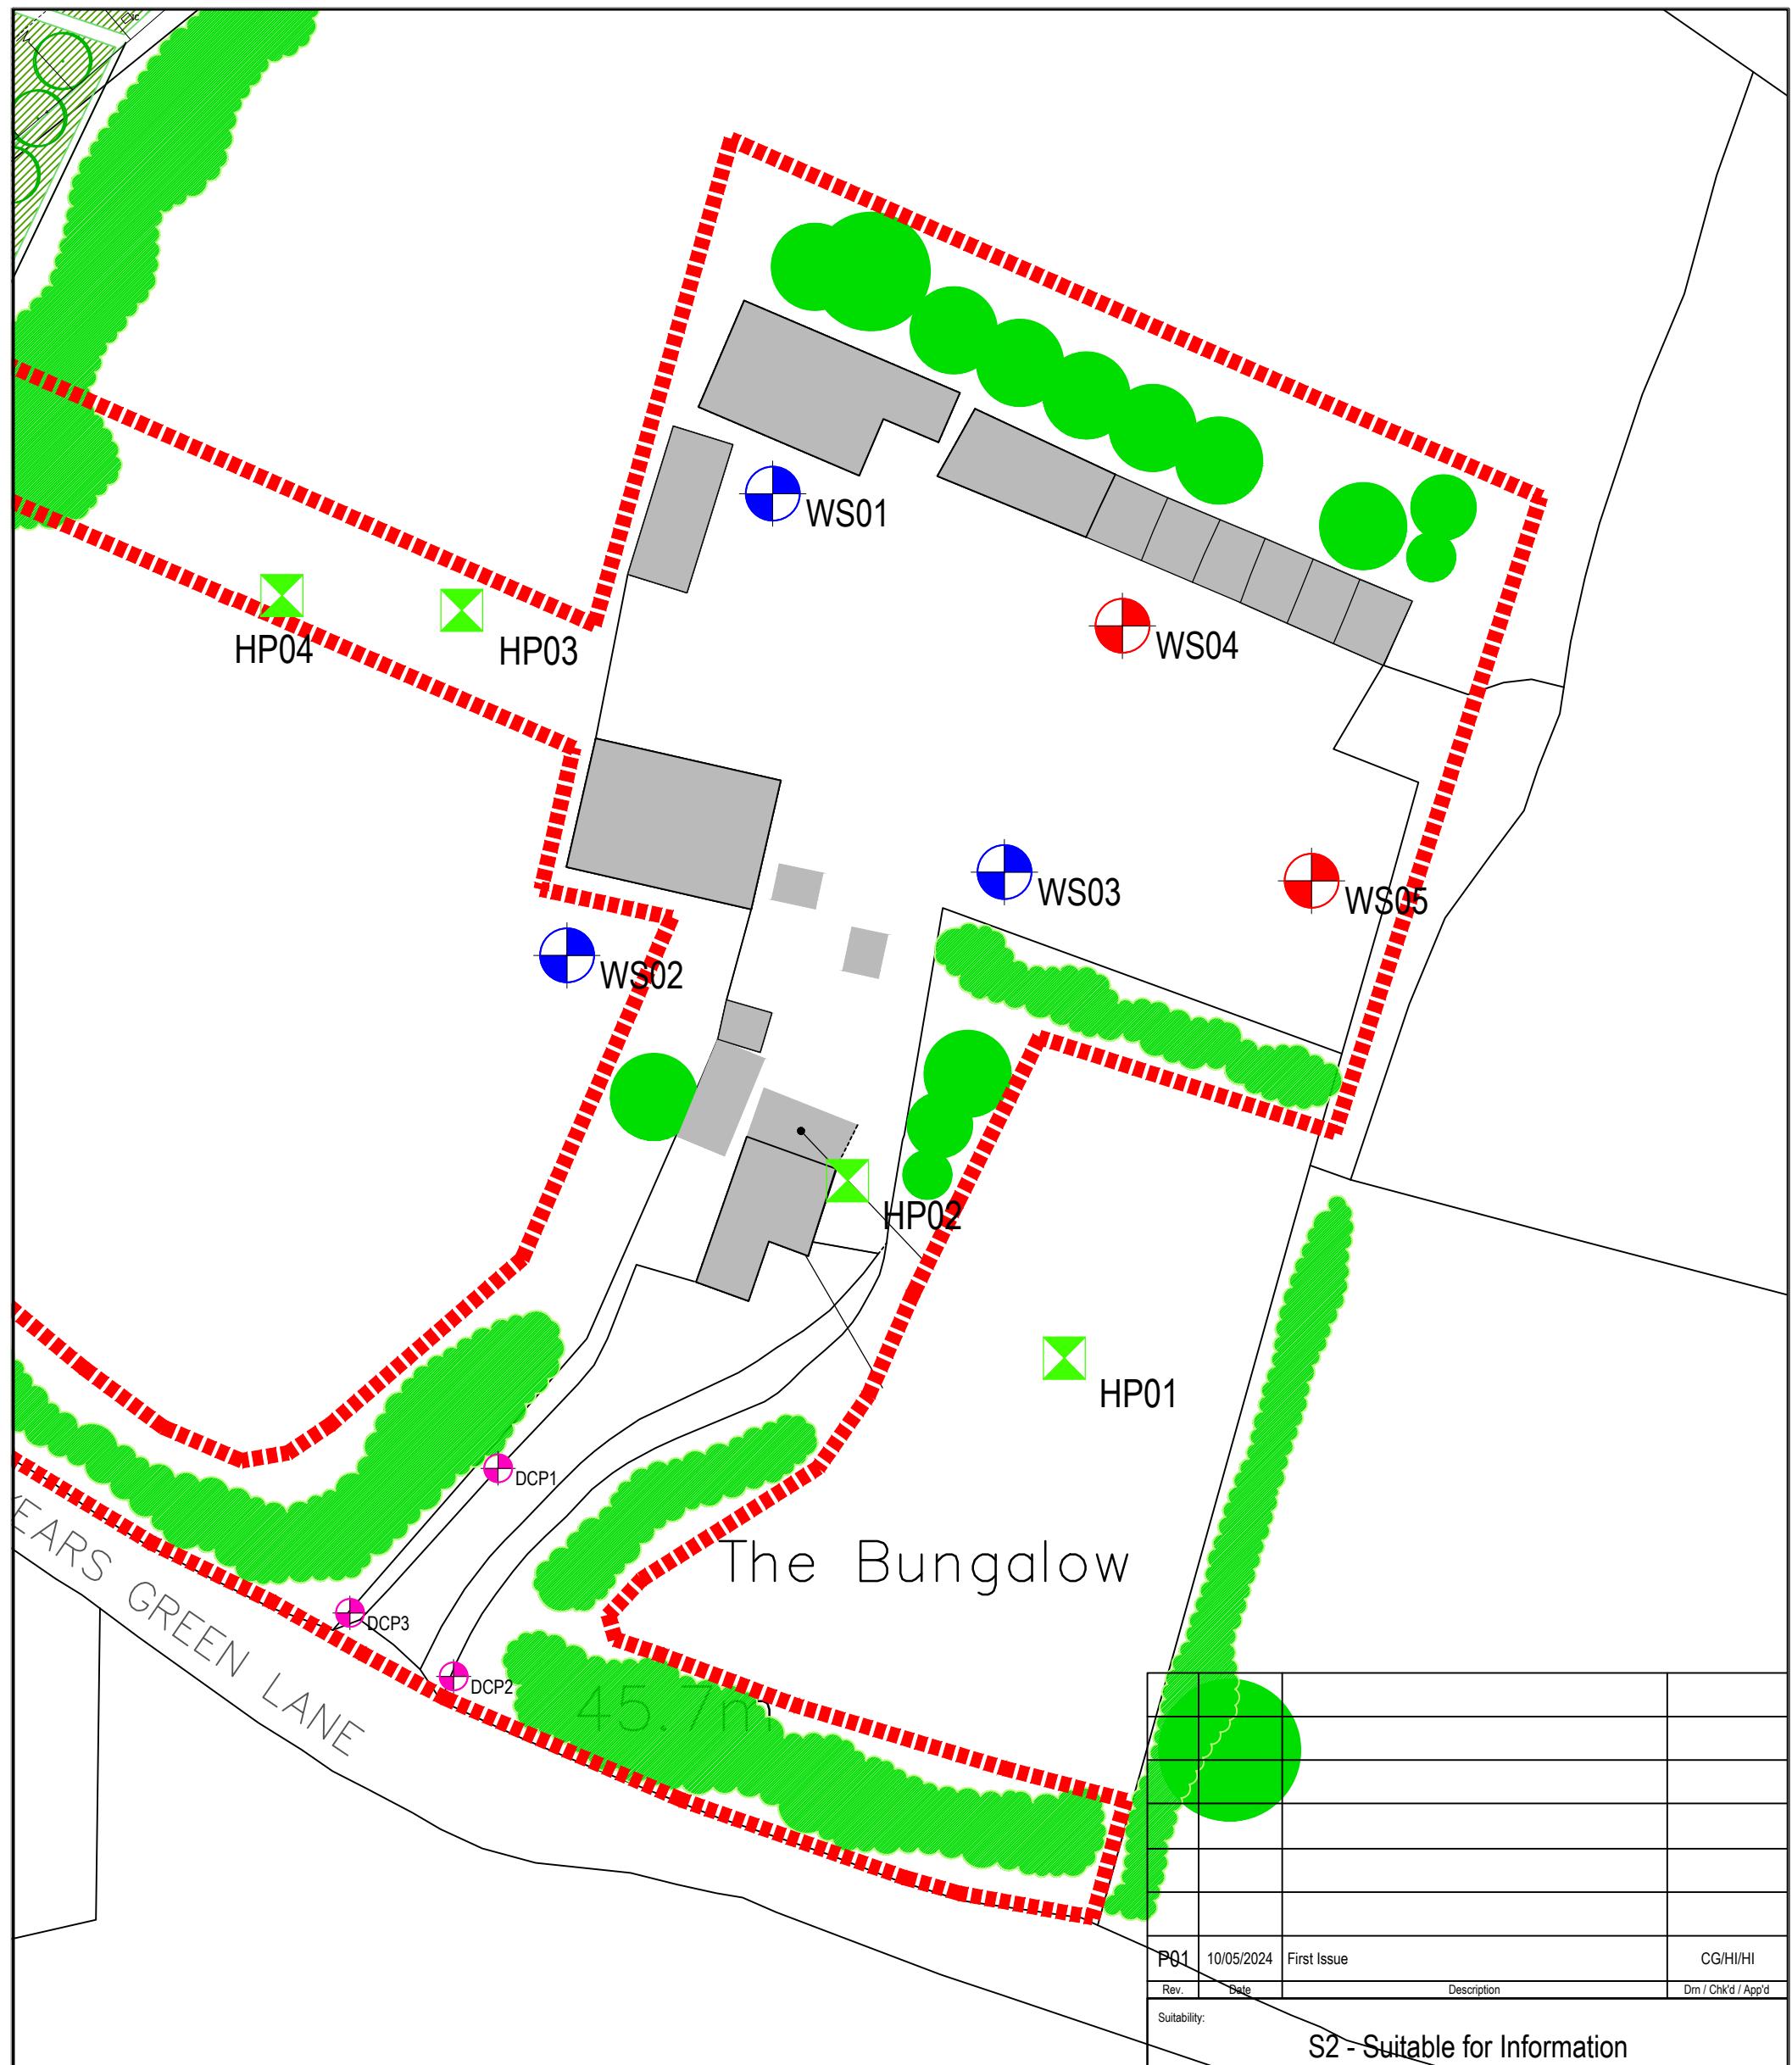
Client: London Borough of Hillingdon Council  Job: The Bungalow, New Years Green Lane  Title: Exploratory Hole Location Plan  Classification: FI_60_20  Scale @ A3: As Shown

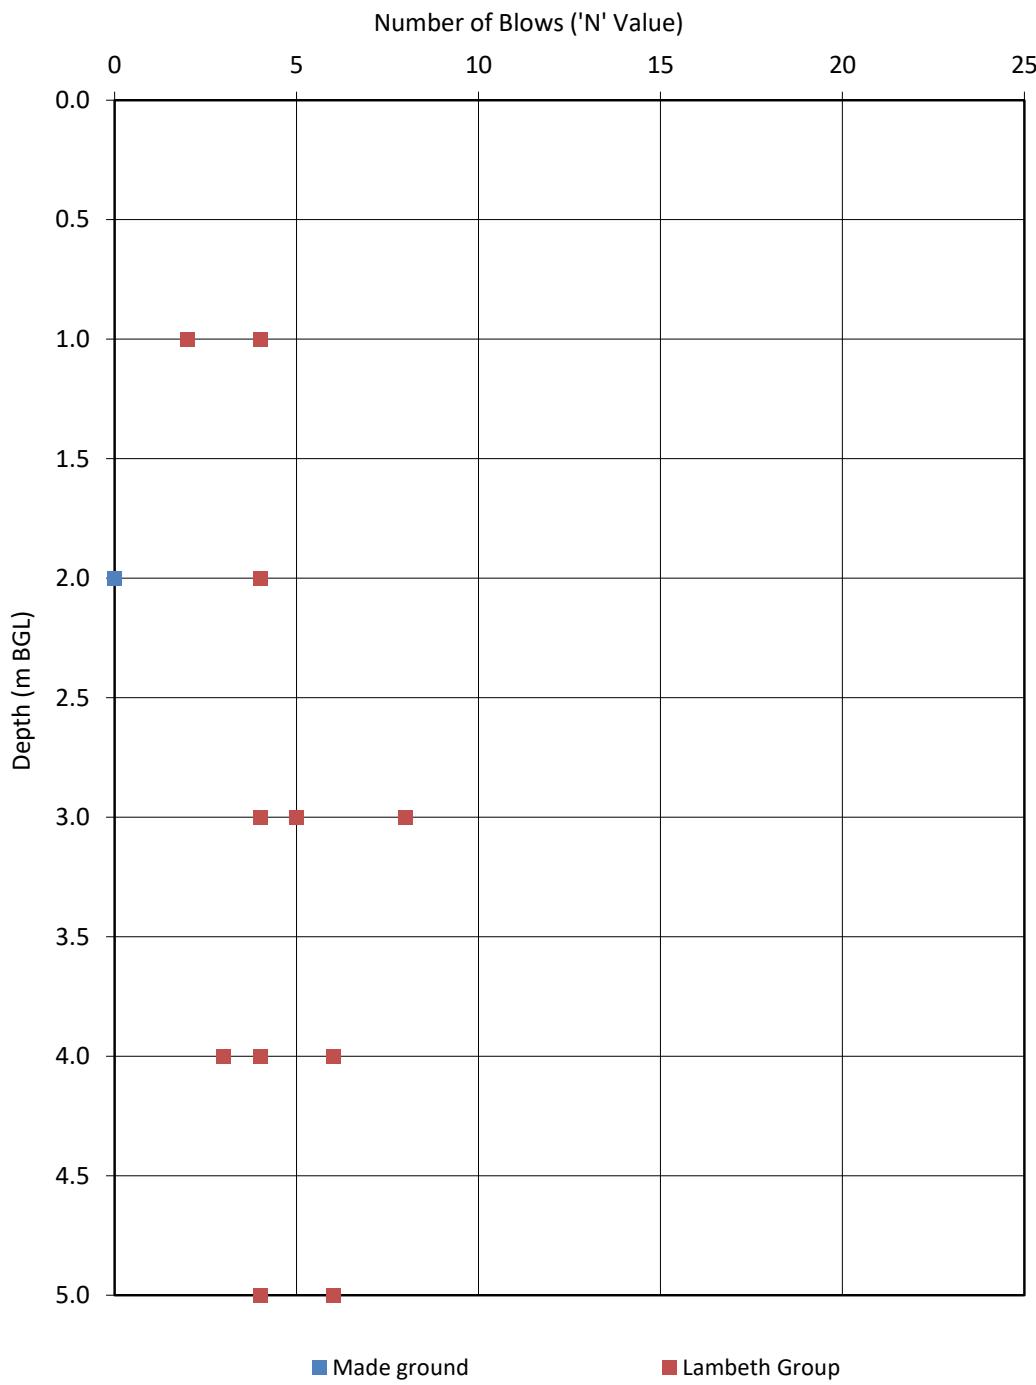
**Figure 3**  
**Project:**

**Undrained Shear Strength / Depth  
Relationship**

Property	Number of Tests	Range	Mean	Assessment
Modified Plasticity Index %	4	15 - 19	18	
SPT 'N' Values (granular)	5	2 - 8	4	Very loose to loose
$c_u = 4.5 \times \text{SPT } 'N' \text{ Value (kN/m}^2)$	14	18 - 27	20	Very soft to soft

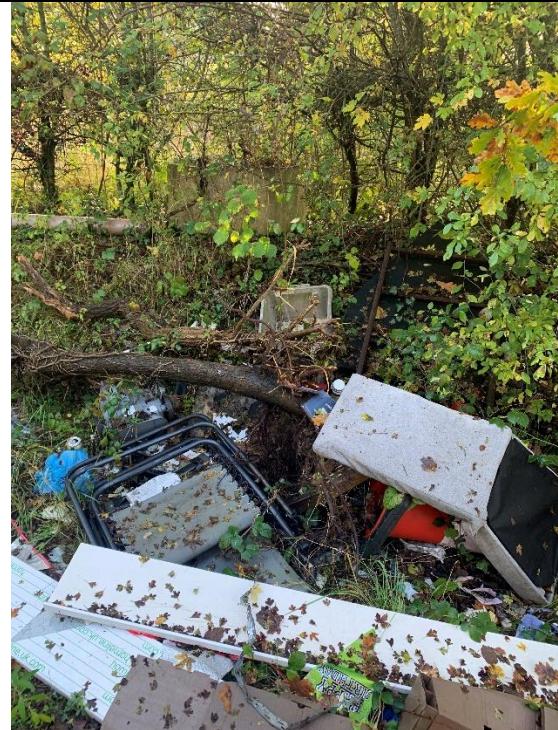
Fly tipping and litter next to site entrance.

- 2.1.6 Fly tipping and litter were present at the site entrance. The rest of the site was largely clear of any litter.
- 2.1.7 No invasive species were noted during the site work. However, JNP Group recommend that a specialist is consulted to confirm this assessment.

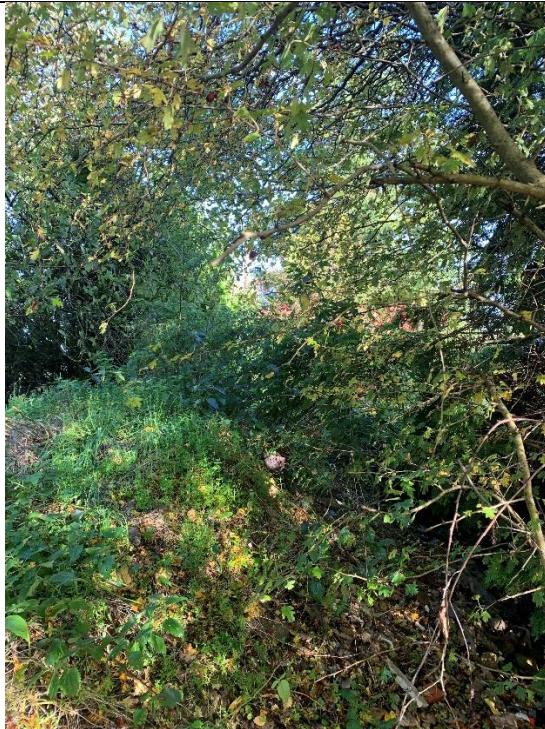
Large bund restricting access to site

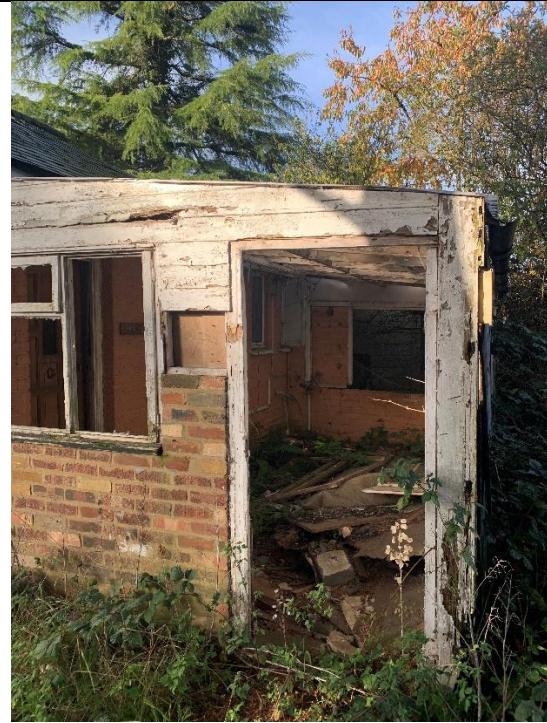
Vandalism and condition of the bungalow

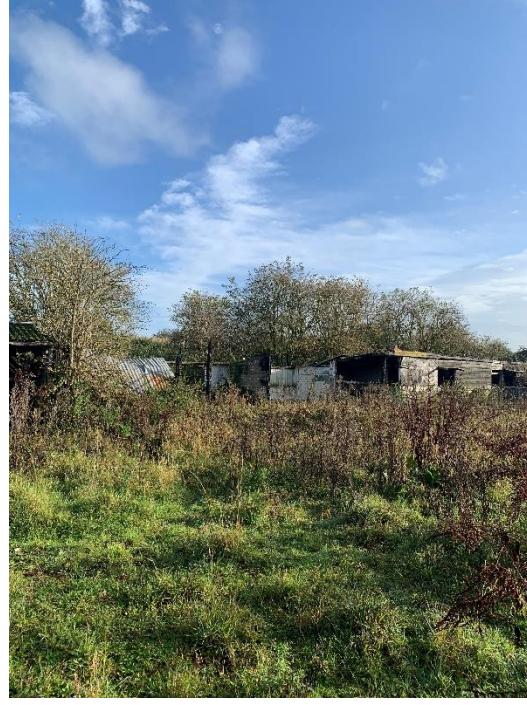
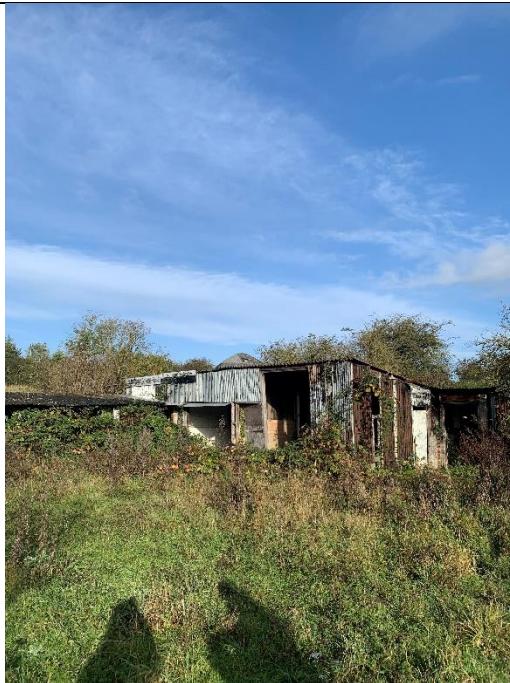
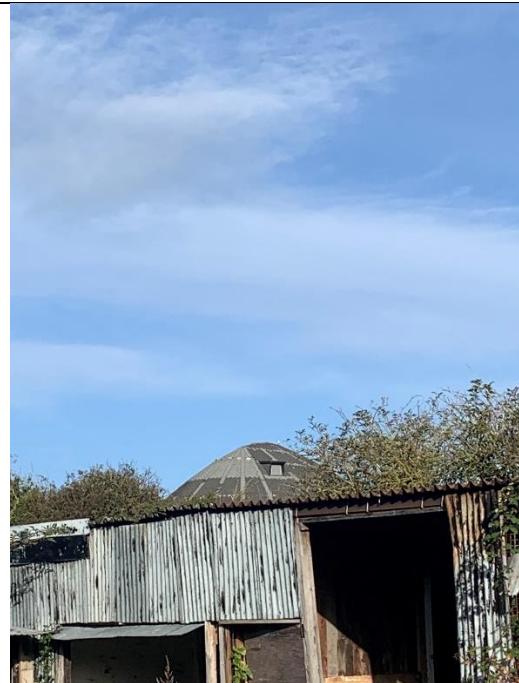
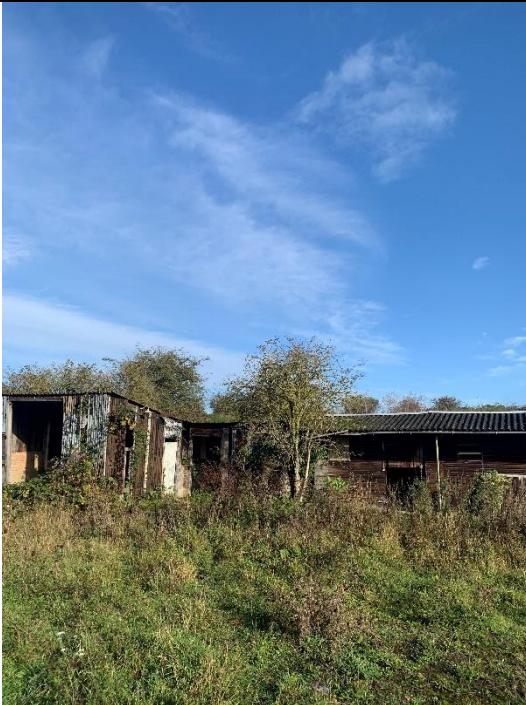
View of the abandoned and derelict stables in the north of the site.

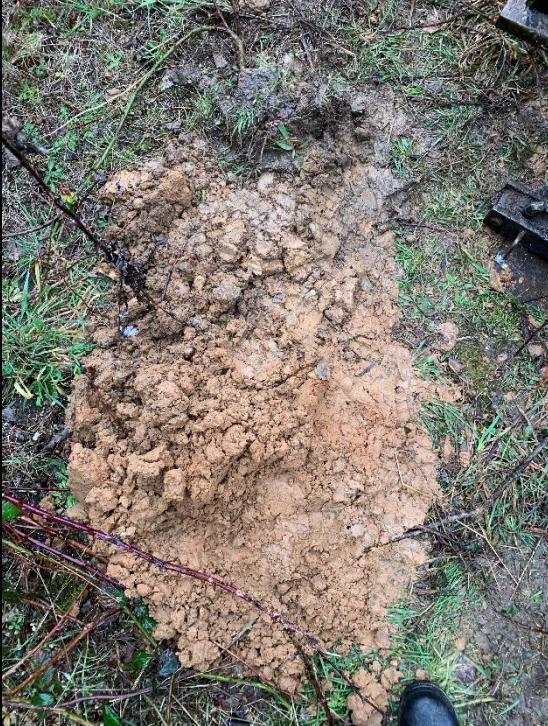
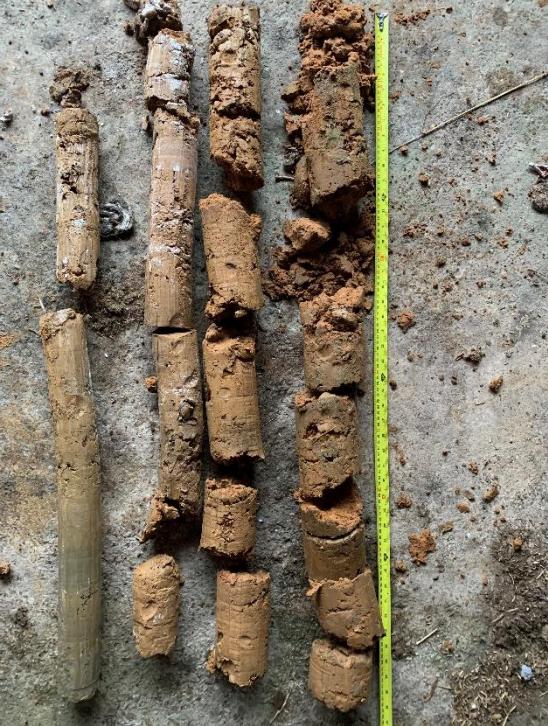
WS01 hand pit arisings (GL-1.00m bgl)	WS01 arisings (1.00-5.00m bgl)

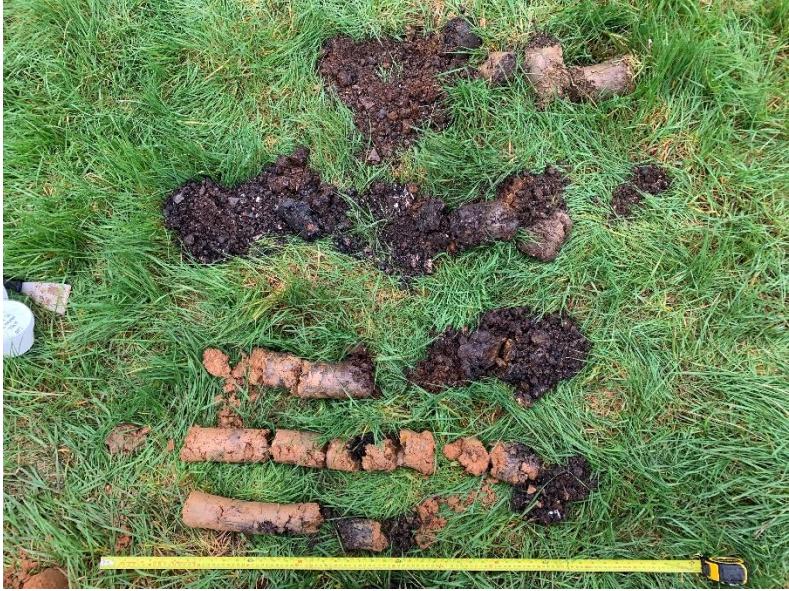
WS02 arisings (GL-5.00m bgl)

8.2.2 When compared with residential public open space screening values, elevated concentrations of arsenic were found in WS02 at 0.15 m. This borehole is located within the designated contaminated land area. The exploratory hole logs recorded black-brown made ground with deleterious material including charcoal, glass, brick, plastic and pottery.

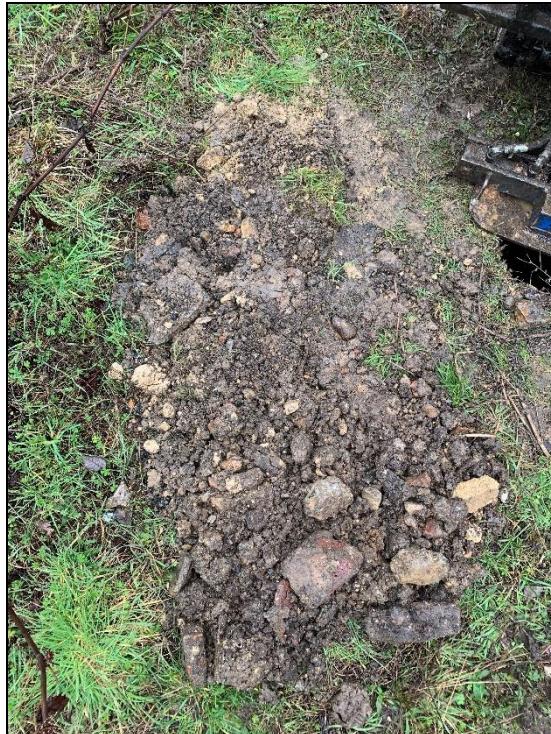
WS03 hand pit arisings (GL-1.00m bgl)

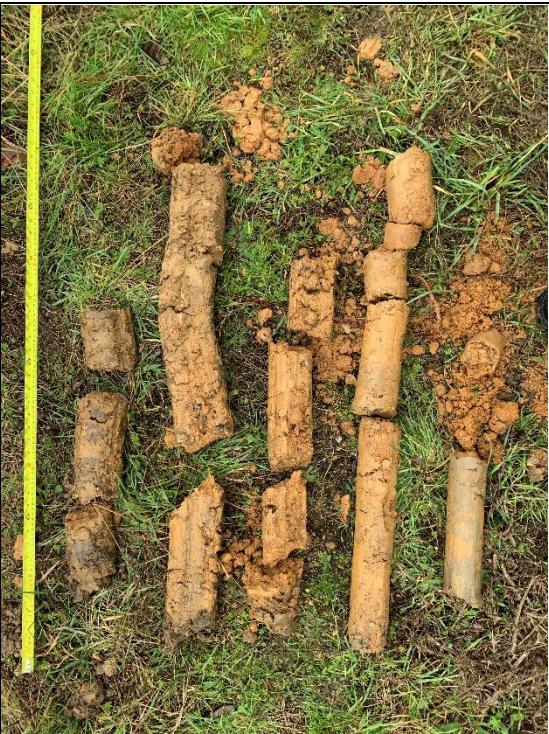
WS03 arisings (1.00-5.00m bgl)

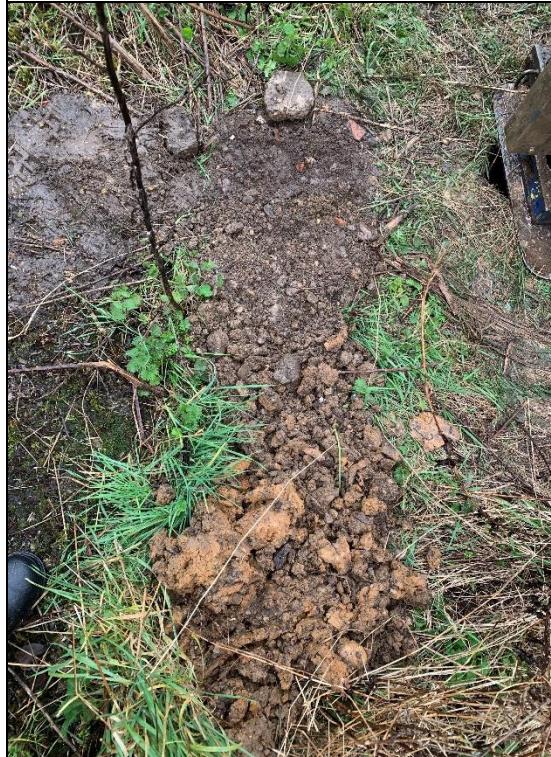
WS04 hand pit arisings (GL-1.00m bgl)

8.2.7 Asbestos was identified in WS04 at 0.25 m bgl. WS04 is located to the south of the derelict barns, situated to the north of the site. The asbestos was identified as amosite asbestos as loose fibres with a quantification of <0.001 %.

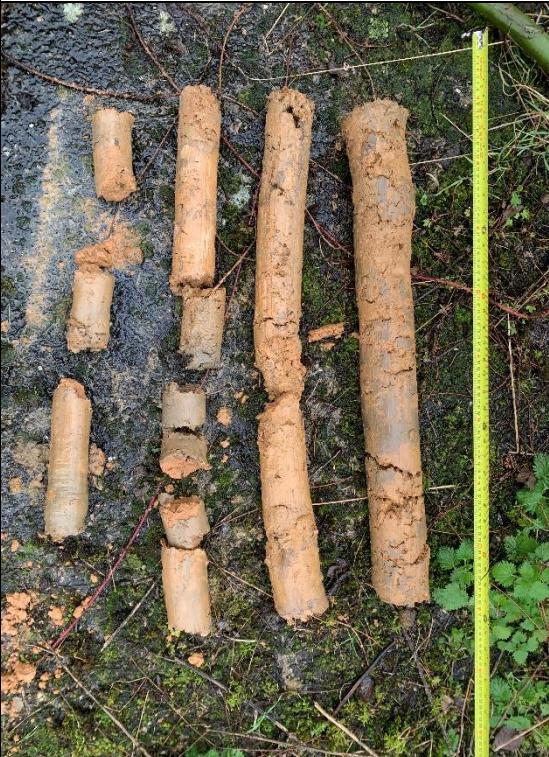
WS04 arisings (1.00-5.00m bgl)

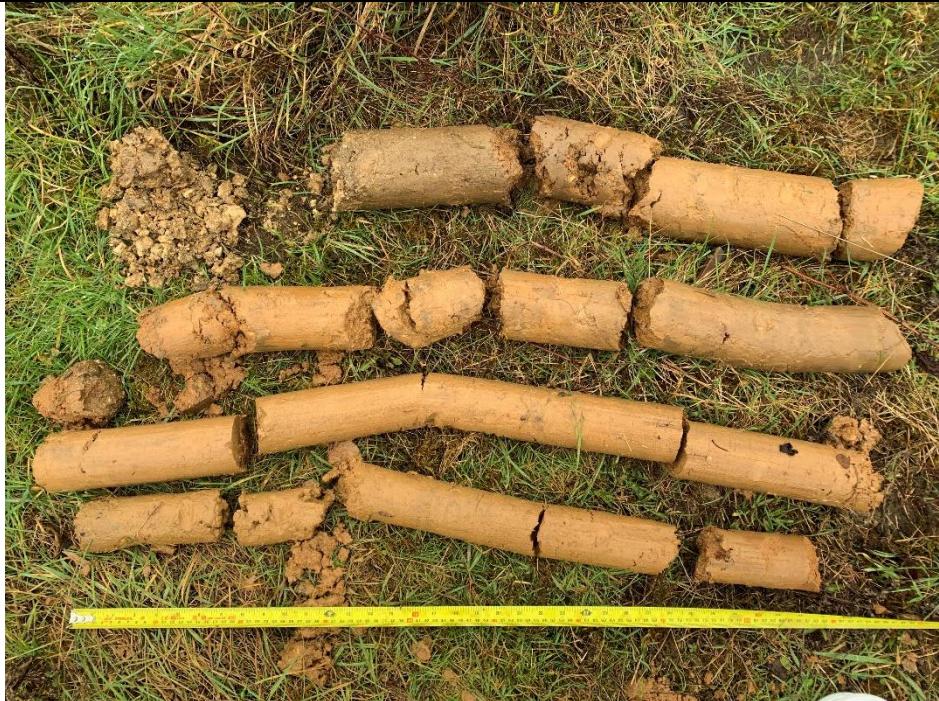
WS05 arisings (GL-4.00m bgl)

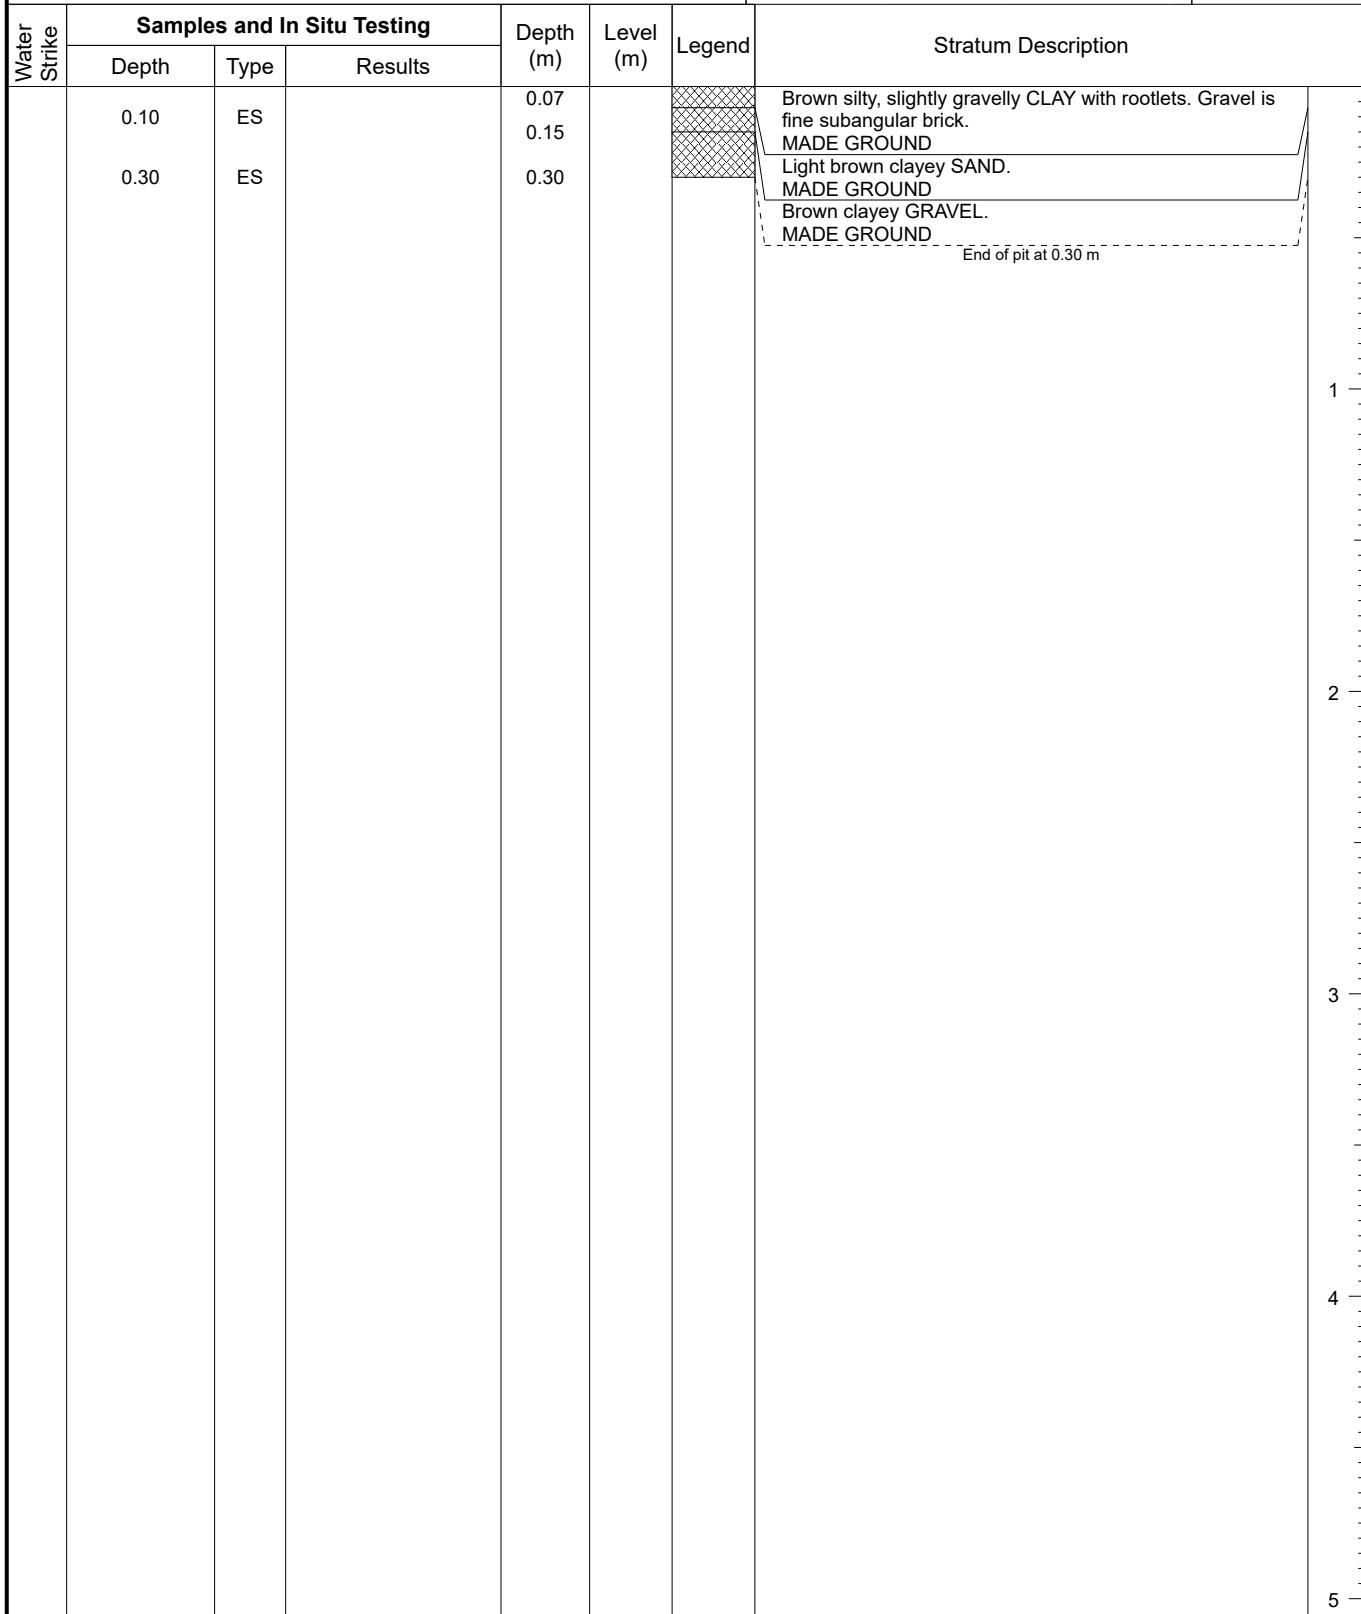
Project Name:	The Bungalow, New Years Green Lane	Project No.:	M44477	Co-ords:	506201.00 - 188210.00	Date
				Level:		21/03/2024

Remarks:	Hand excavated sampling pit for chemical testing.

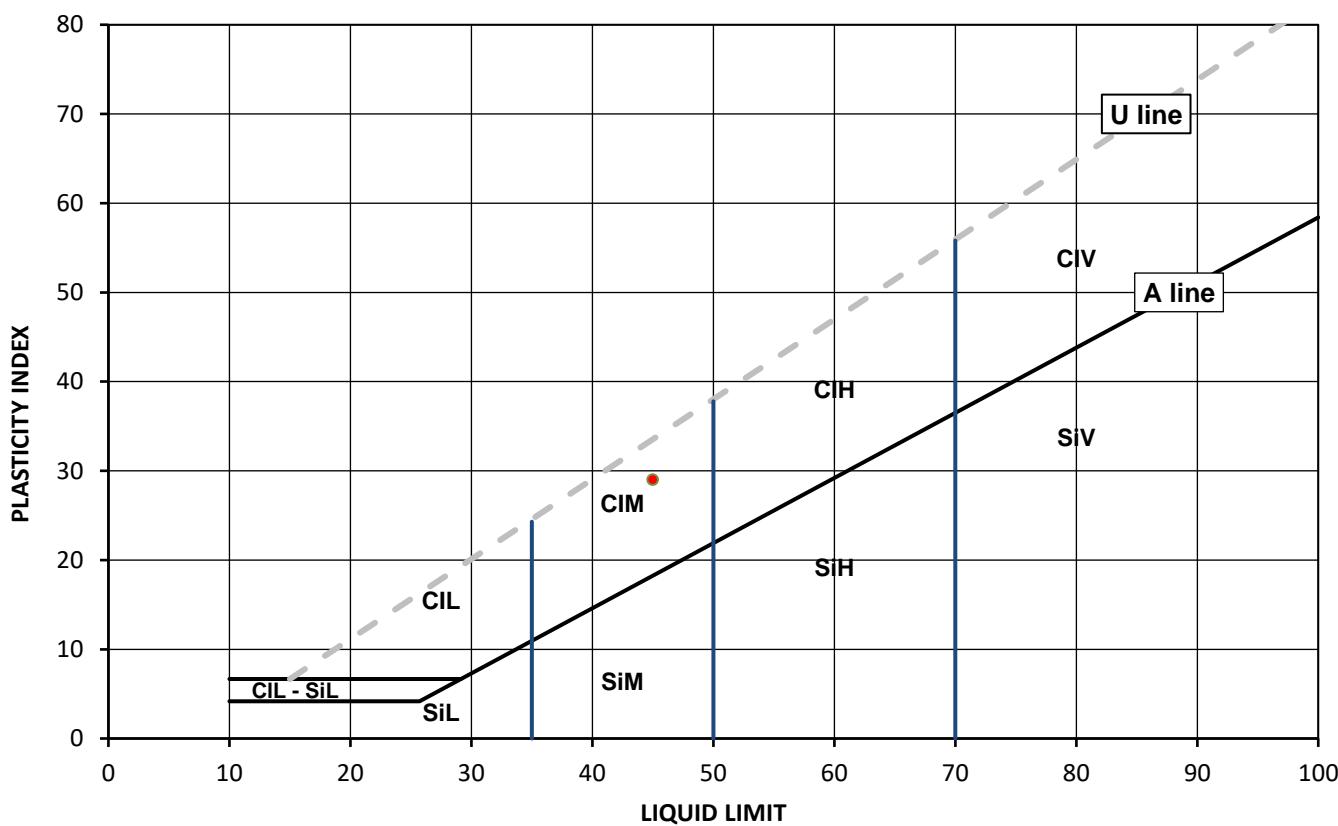
Sample Preparation: Tested after washing to remove >0.425 mm;  
Cone Type: 80g/30deg

As Received Water Content [W] %	Corrected Liquid Limit [WL] %	Correlation Factor	Plastic Limit [Wp] %	Plasticity Index [Ip] %	Liquidity index [IL] % #	Consistency index [IC] % #	% Passing 425µm BS Test Sieve
15.4	45	1.000	16	29	-0.03	1.03	51

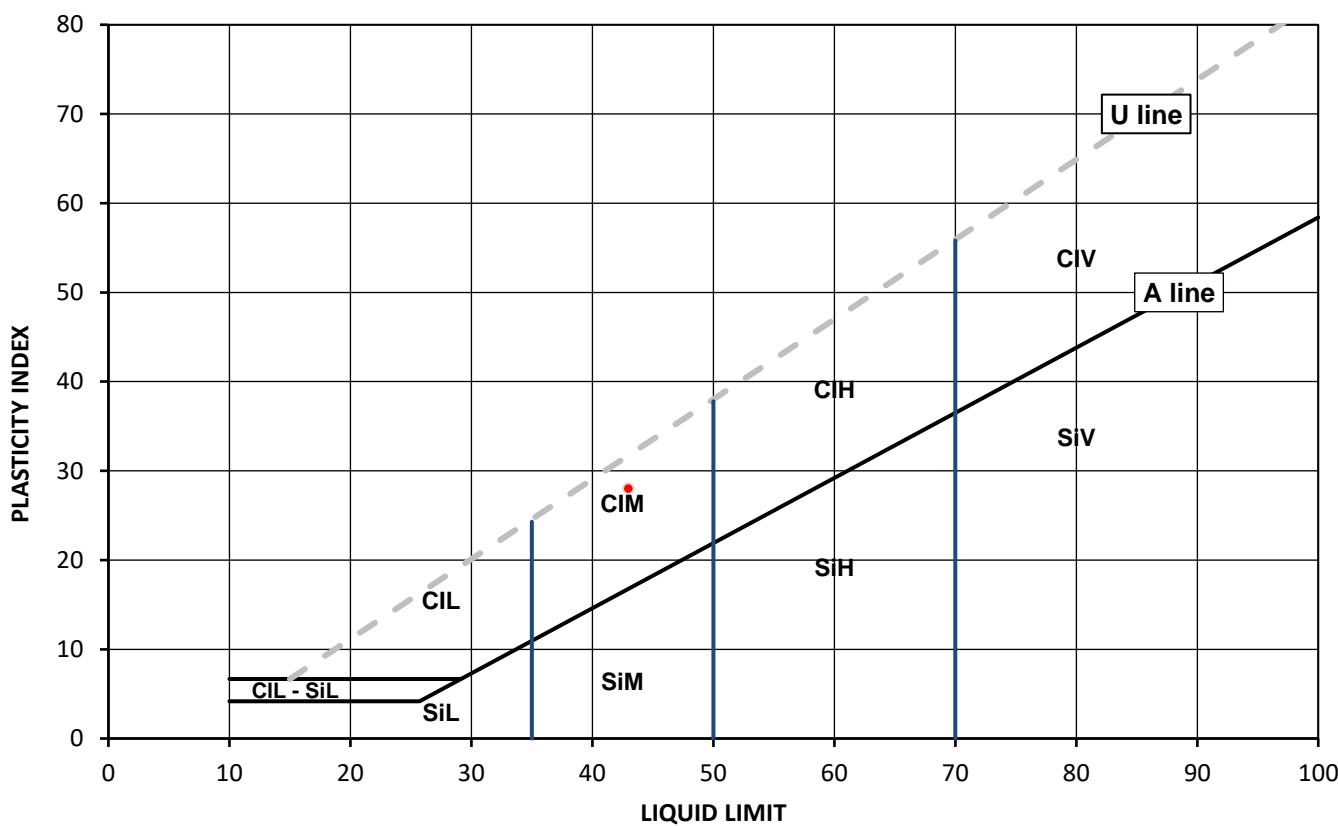
Sample Preparation: Tested after washing to remove >0.425mm; The water content in the sample was increased  
Cone Type: 80g/30deg

As Received Water Content [W] %	Liquid Limit [WL] %	Plastic Limit [Wp] %	Plasticity Index [Ip] %	Liquidity Index [IL] % #	Consistency Index [IC] % #	% Passing 425µm BS Test Sieve
12.4	43	15	28	-0.11	1.11	62

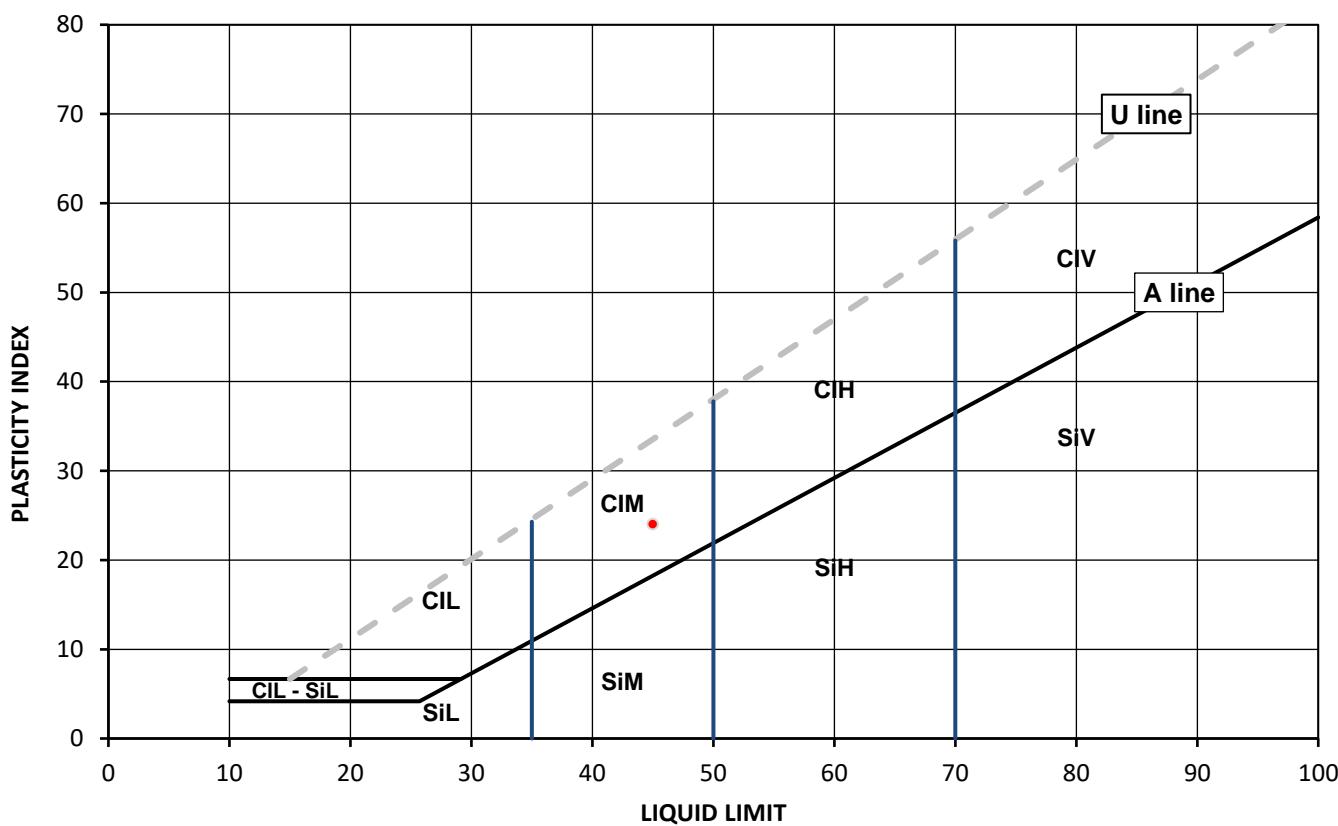
Sample Preparation: Tested after washing to remove >0.425mm; The water content in the sample was increased  
Cone Type: 80g/30deg

As Received Water Content [W] %	Liquid Limit [WL] %	Plastic Limit [Wp] %	Plasticity Index [Ip] %	Liquidity Index [IL] % #	Consistency Index [IC] % #	% Passing 425µm BS Test Sieve
21.4	45	21	24	0.00	1.00	79
