## **Phase II Geo-environmental Report**

**Project:** The Bungalow,  
New Years Green Lane,  
Harefield.

**Client:** London Borough of Hillingdon Council

**Reference:** M44477-JNP-XX-XX-RP-G-1002 P03

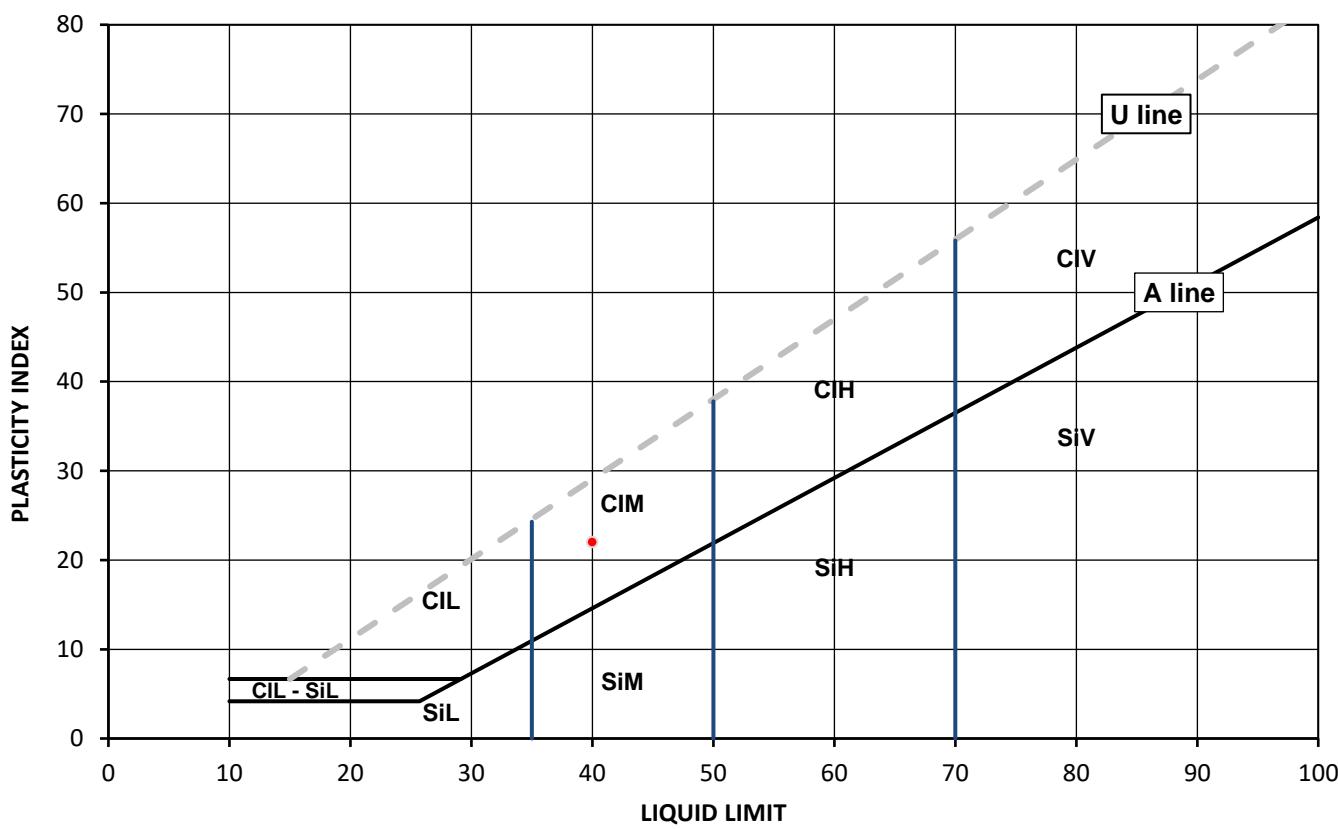
Depth Top [m]: 2.50  
Depth Base [m]: Not Given  
Sample Type: D

As Received Water Content [W] %	Liquid Limit [WL] %	Plastic Limit [Wp] %	Plasticity Index [Ip] %	Liquidity Index [IL] % #	Consistency Index [IC] % #	% Passing 425µm BS Test Sieve
17.7	40	18	22	0.00	1.00	88
