## **London Borough of Hillingdon**

# **Willow Tree Depot, Ditchfield Road**

## **Geoenvironmental and Geotechnical Assessment**

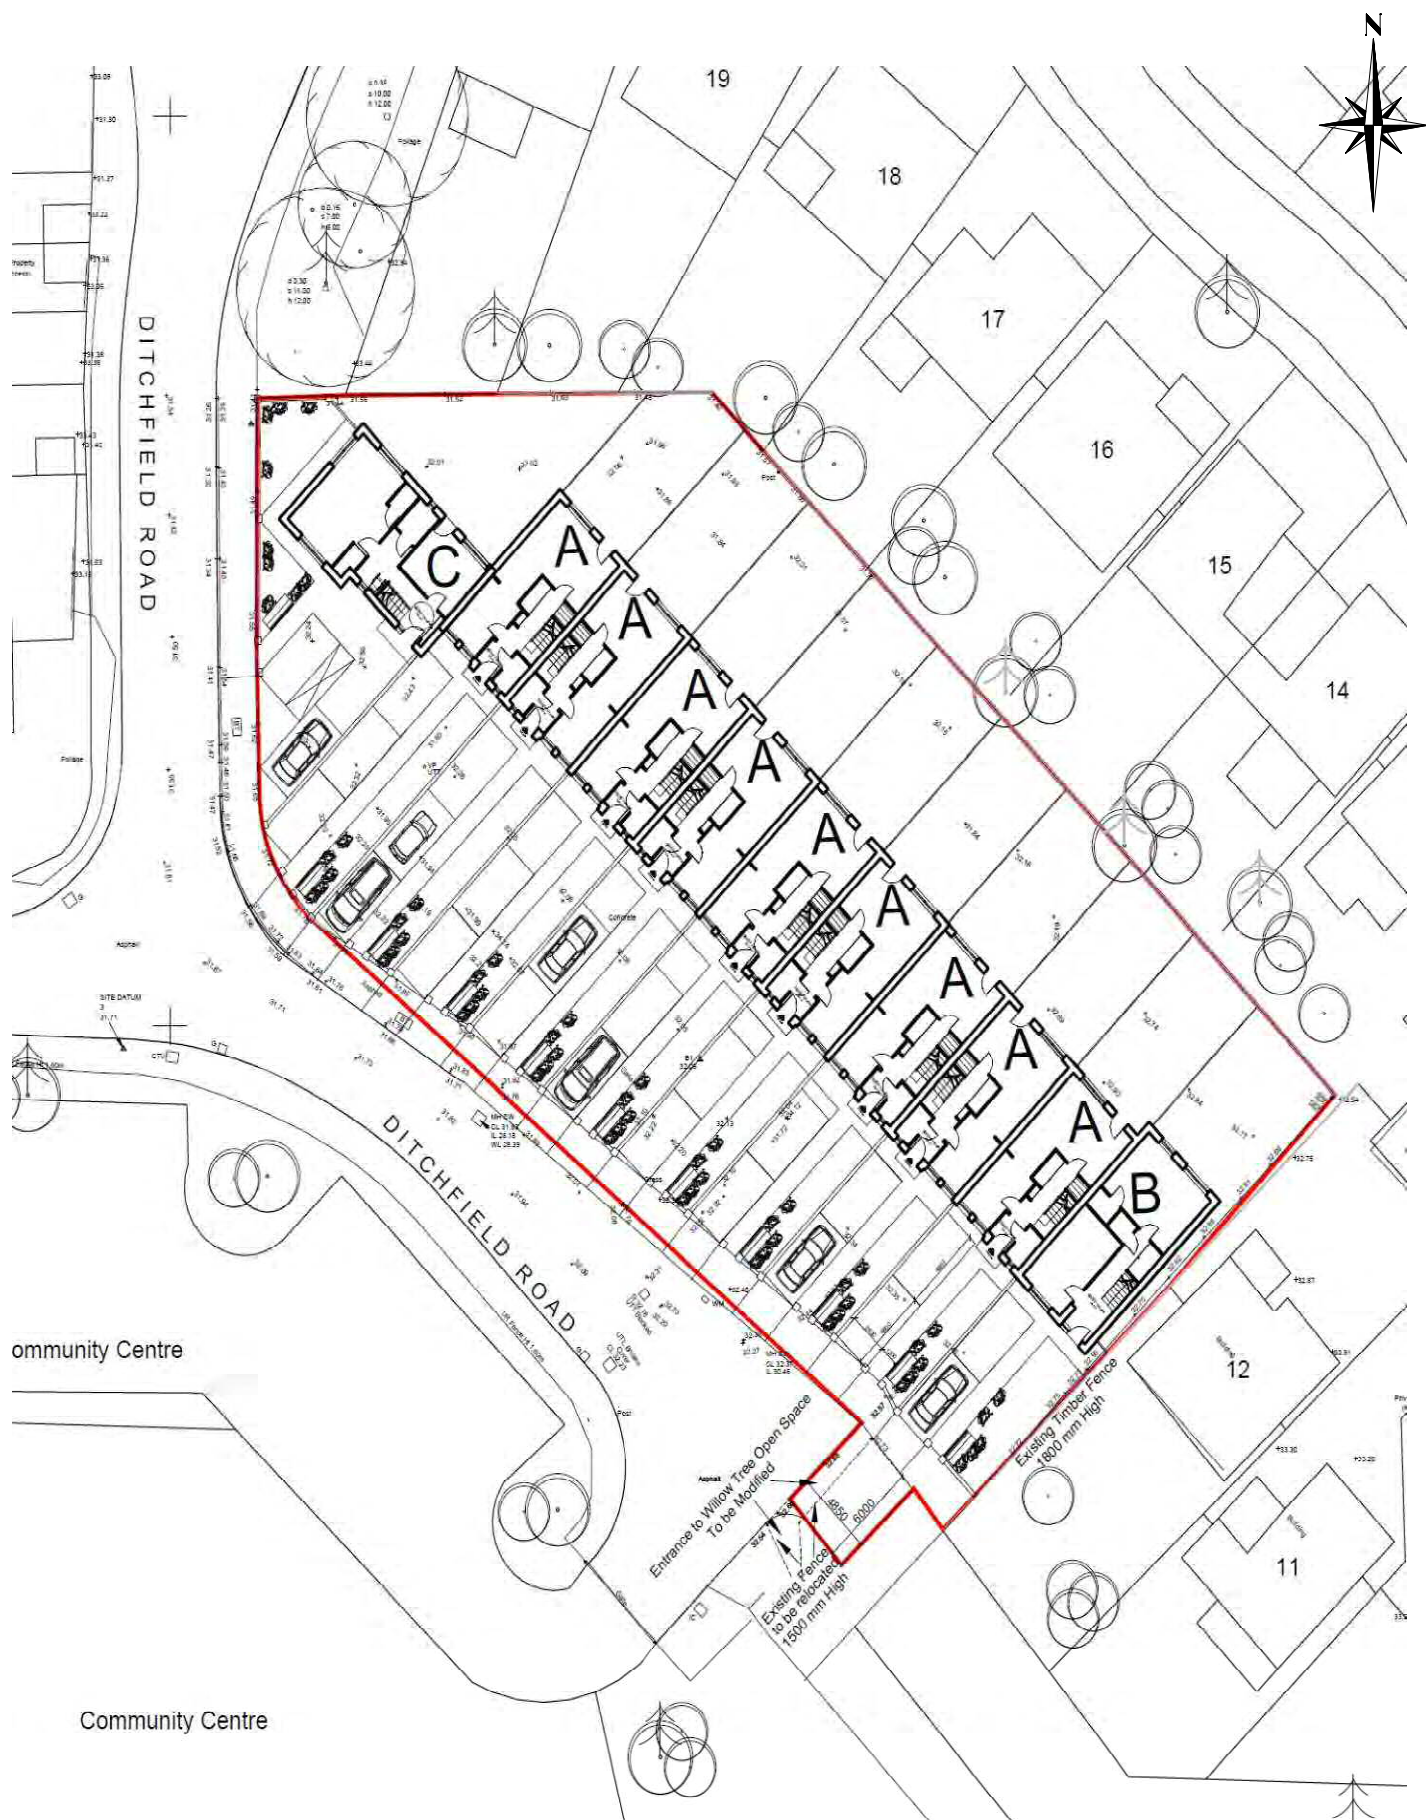
| Figure 2 | Proposed Development Plan |

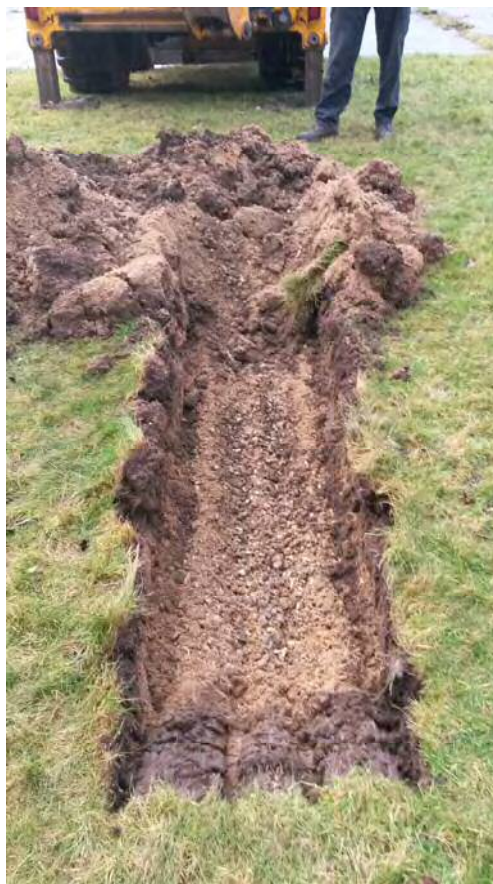
Photograph 1: View of TP01.

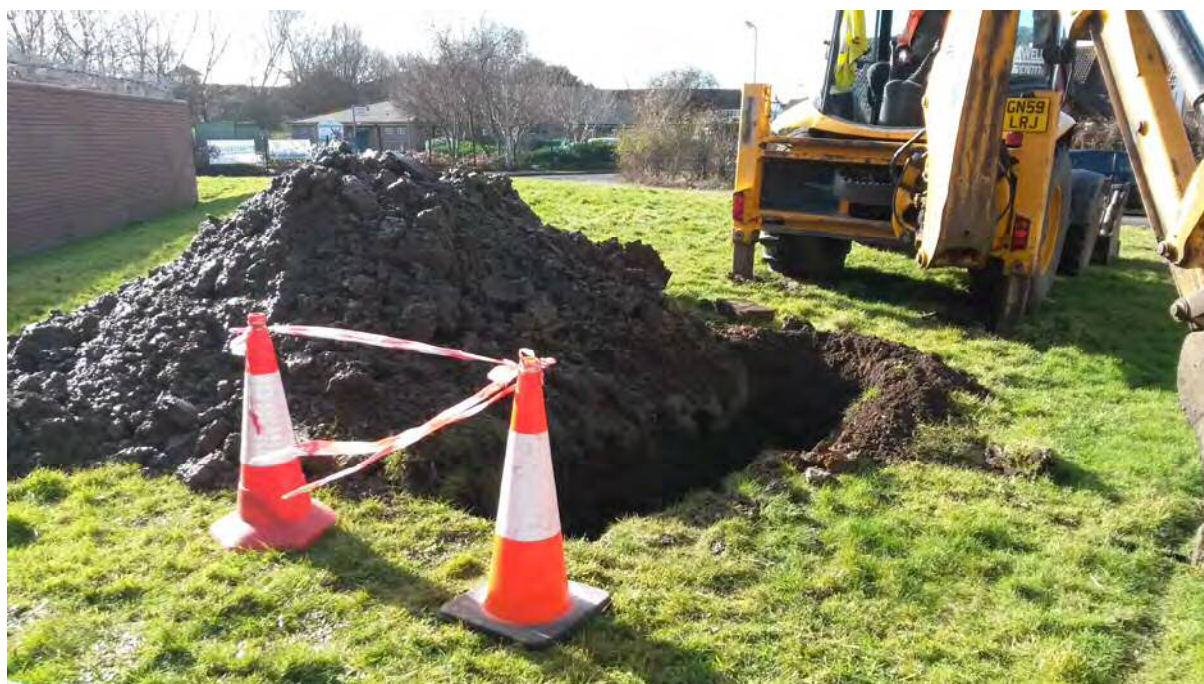
Photograph 2: Location of TP02 and encountered materials.

4.1.3 Made ground was encountered across the site to a maximum observed depth in excess of 4.0mbgl (TP02) and was observed to be variable across the site, although generally encountered as dark brown sandy clay, black gravelly sand or multi-coloured slightly clayey sandy gravel / gravelly sandy clay.

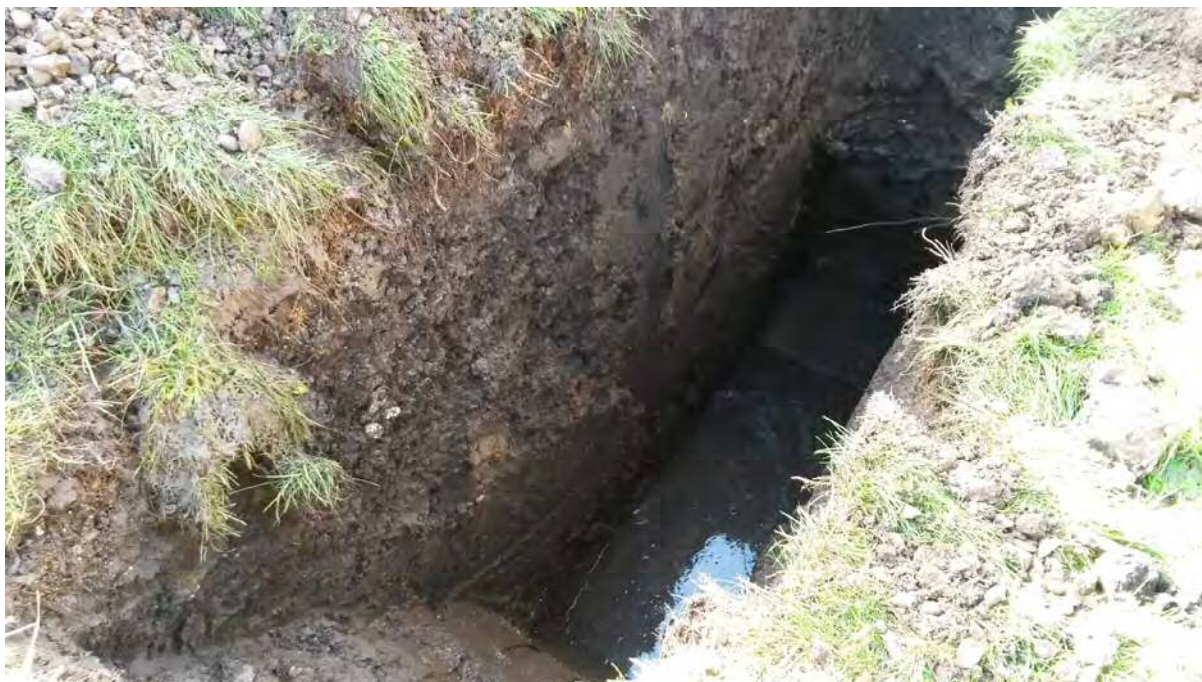
Photograph 3: View of TP02.

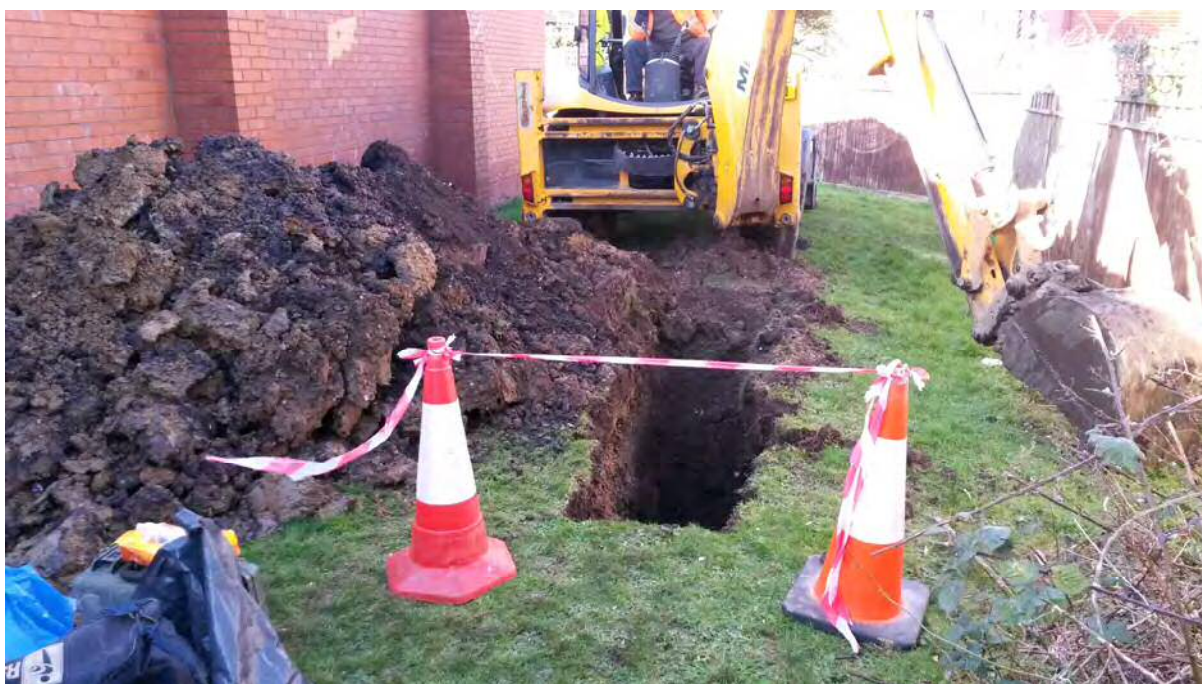
Photograph 4: Location of TP03.

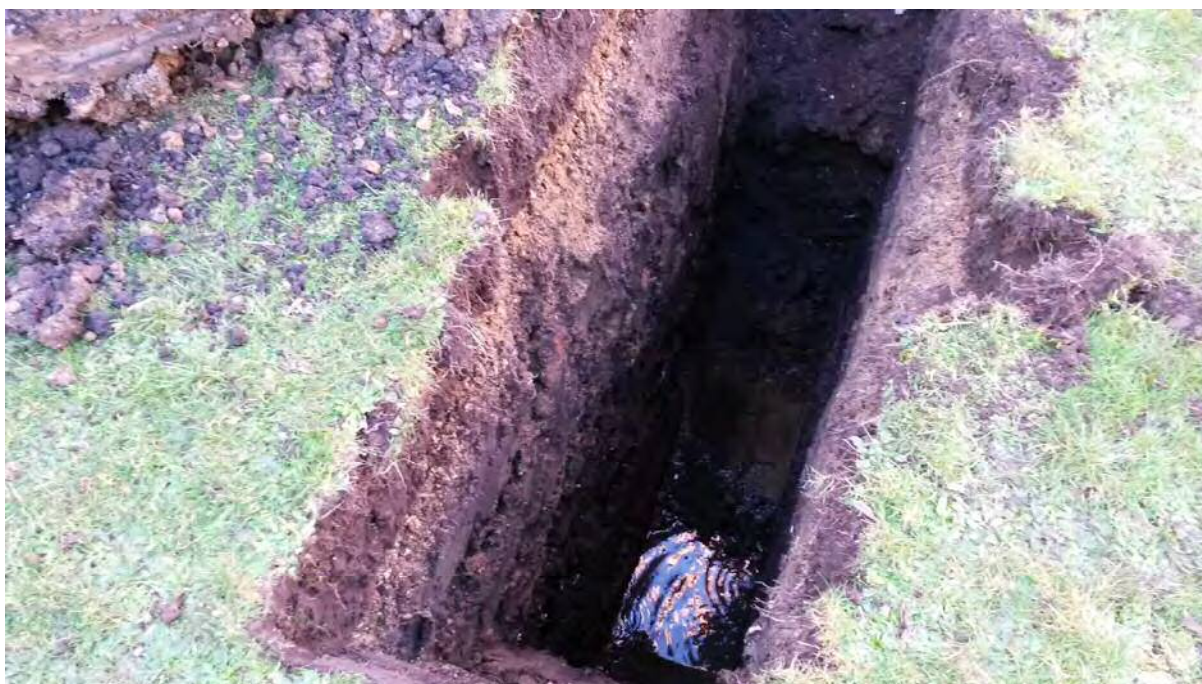
Photograph 5: View of TP03.

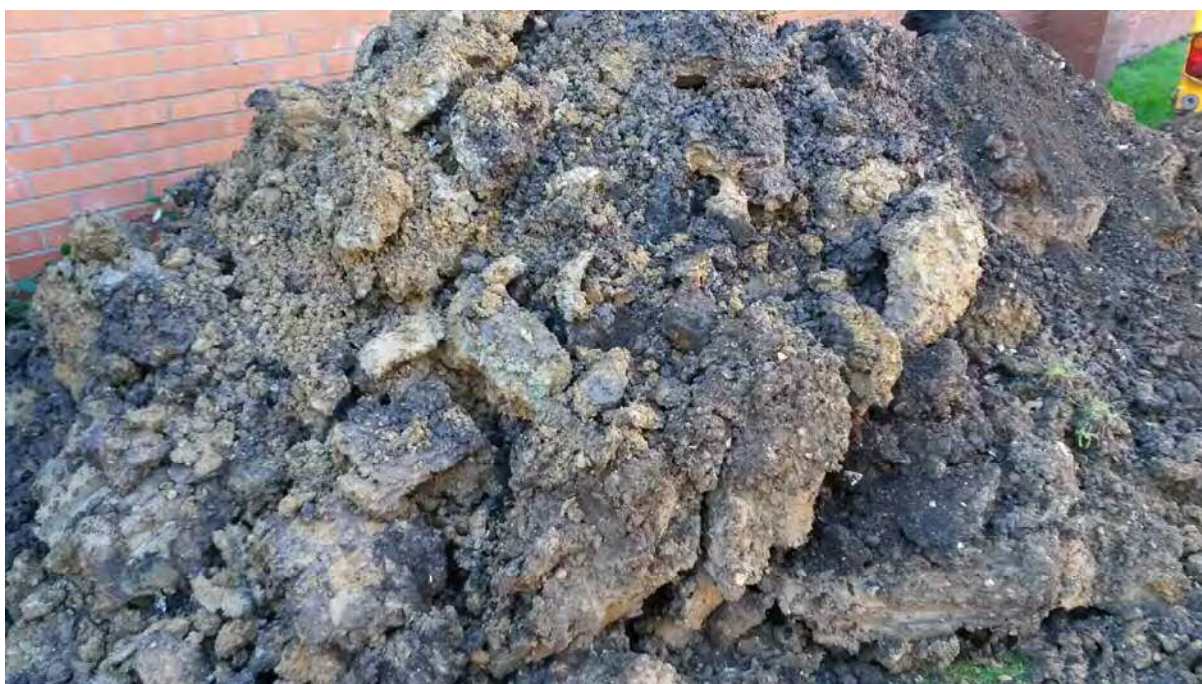
Photograph 6: View of materials encountered at TP03.

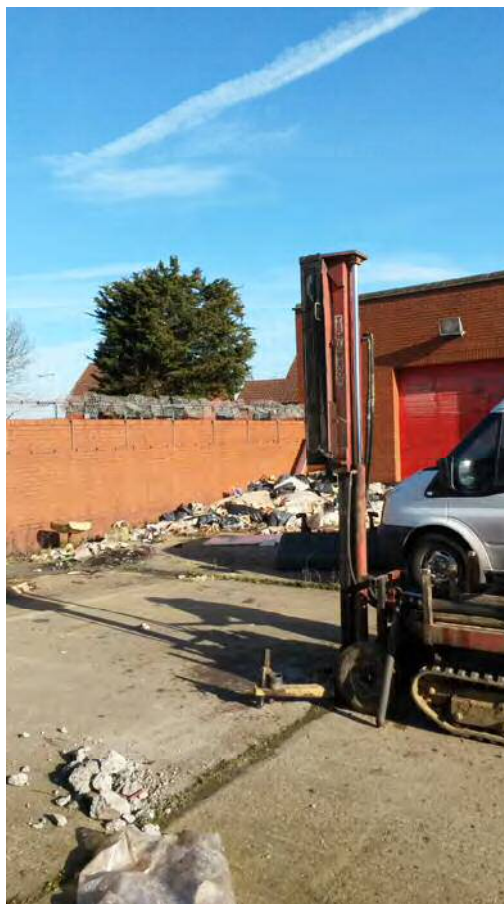
Photograph 7: Location of WS01.

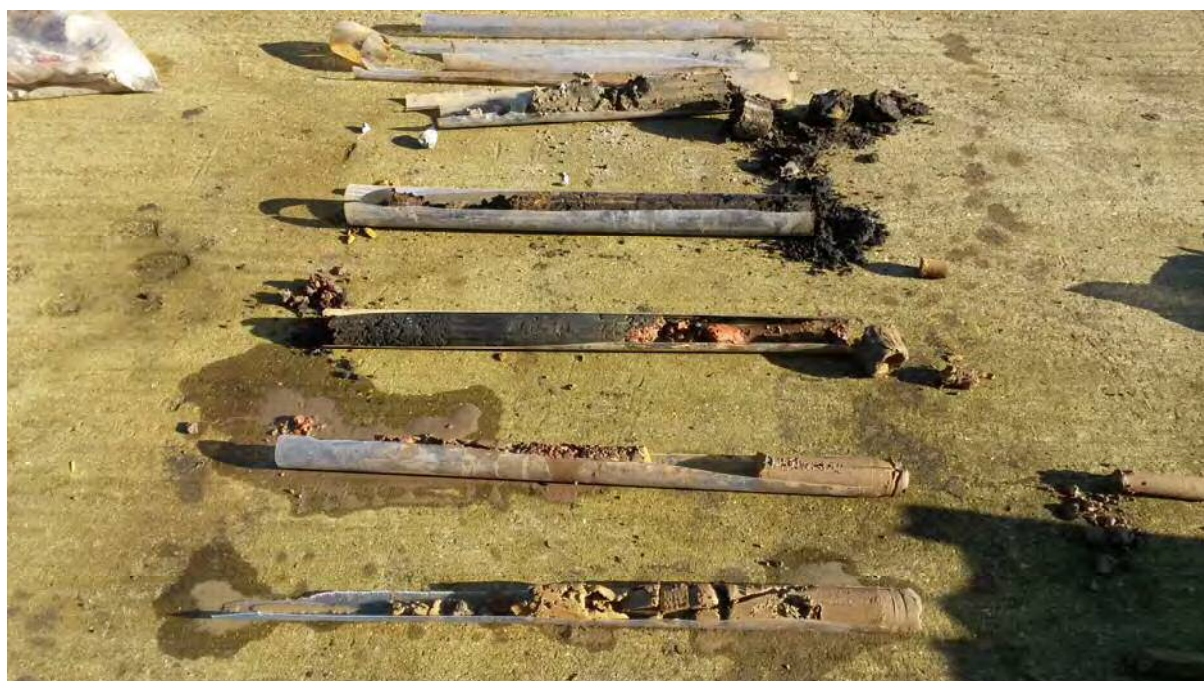
Photograph 8: View of materials encountered at WS01.

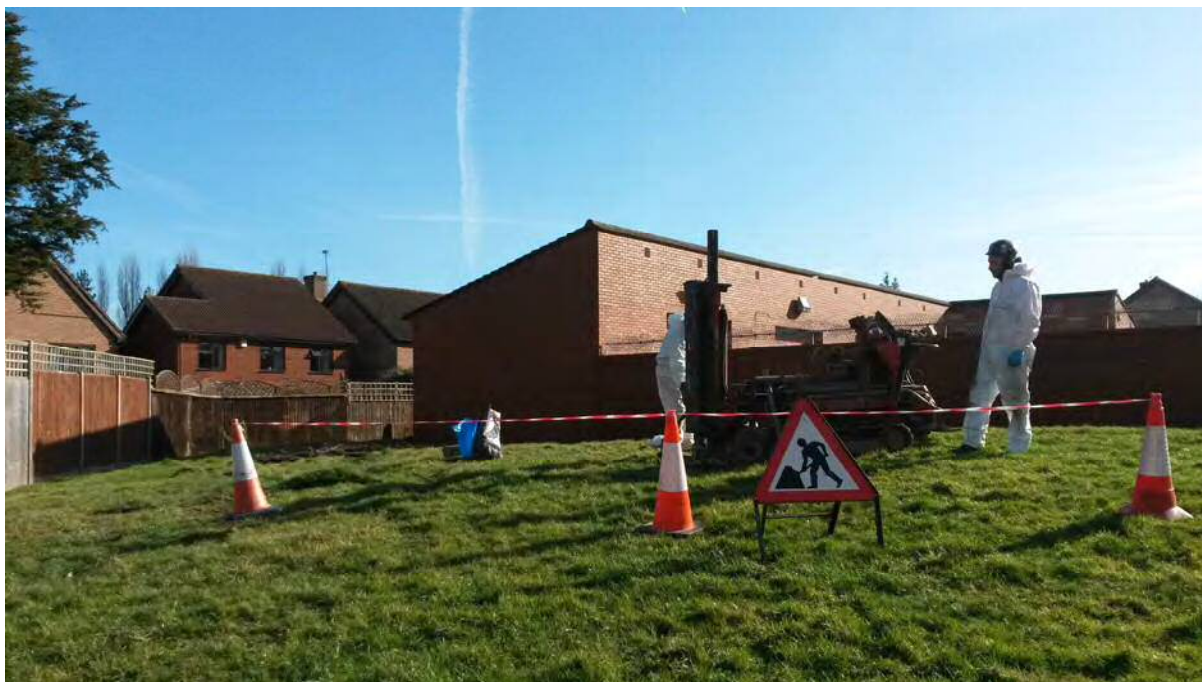
Photograph 9: Location of WS02.

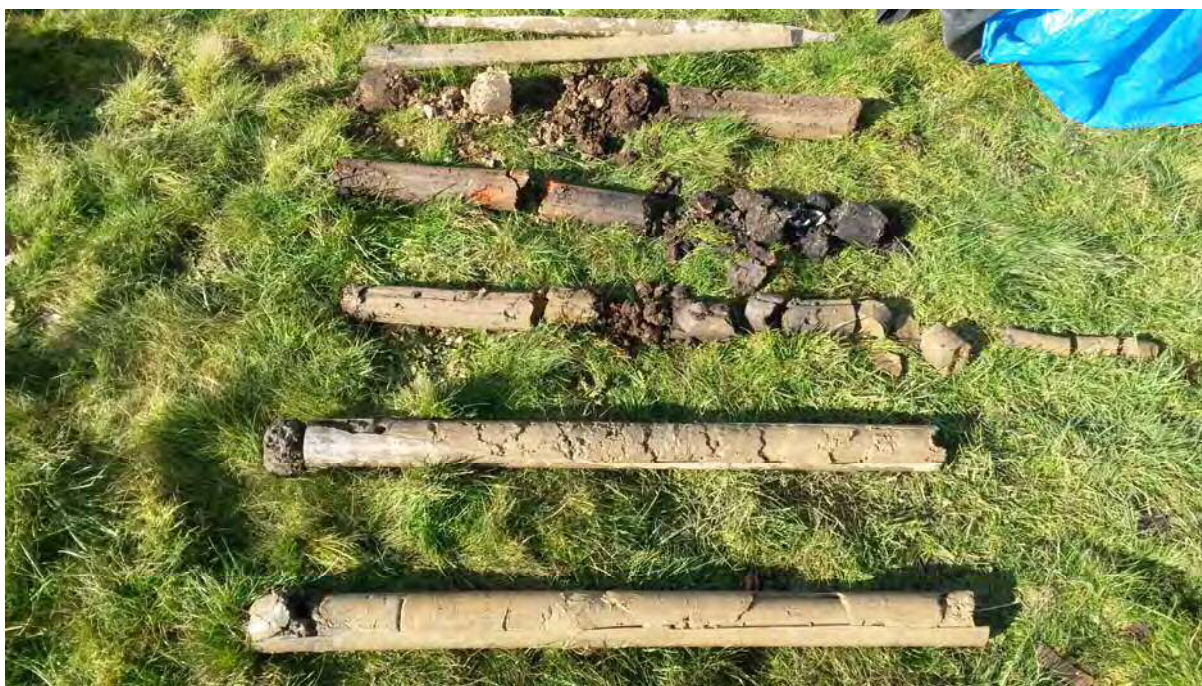
Photograph 10: View of materials encountered at WS02.

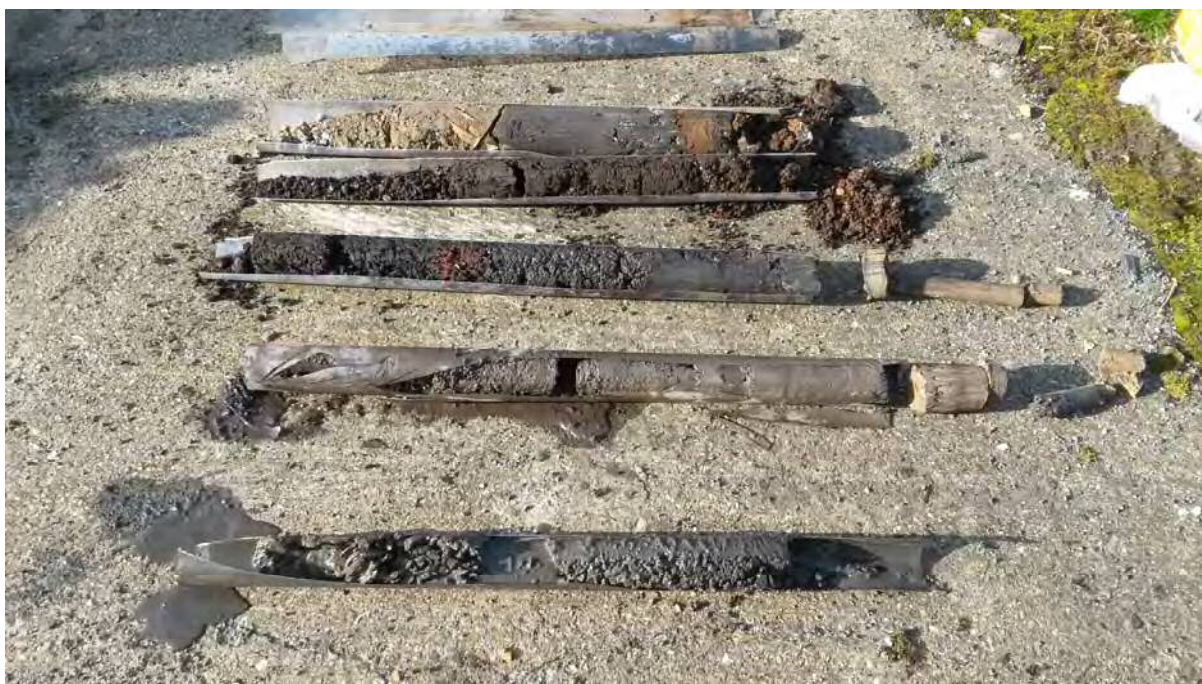
Photograph 11: View of materials encountered at WS03.

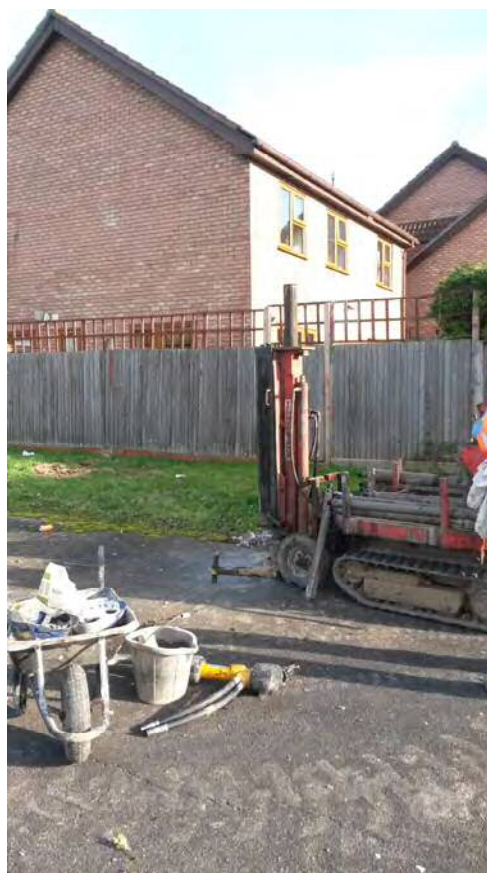
Photograph 12: Location of WS04.
